**Whitcher Wildlife Ltd.
Ecological Consultants.**

9 BROOM CLOSE, WORSBOROUGH.

BAT SURVEY REPORT.

Ref No: 230681

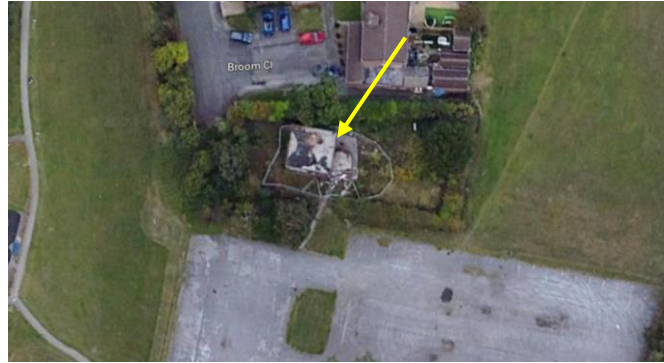
3.2.2. The actual building to be demolished is shown marked by the yellow arrow below.

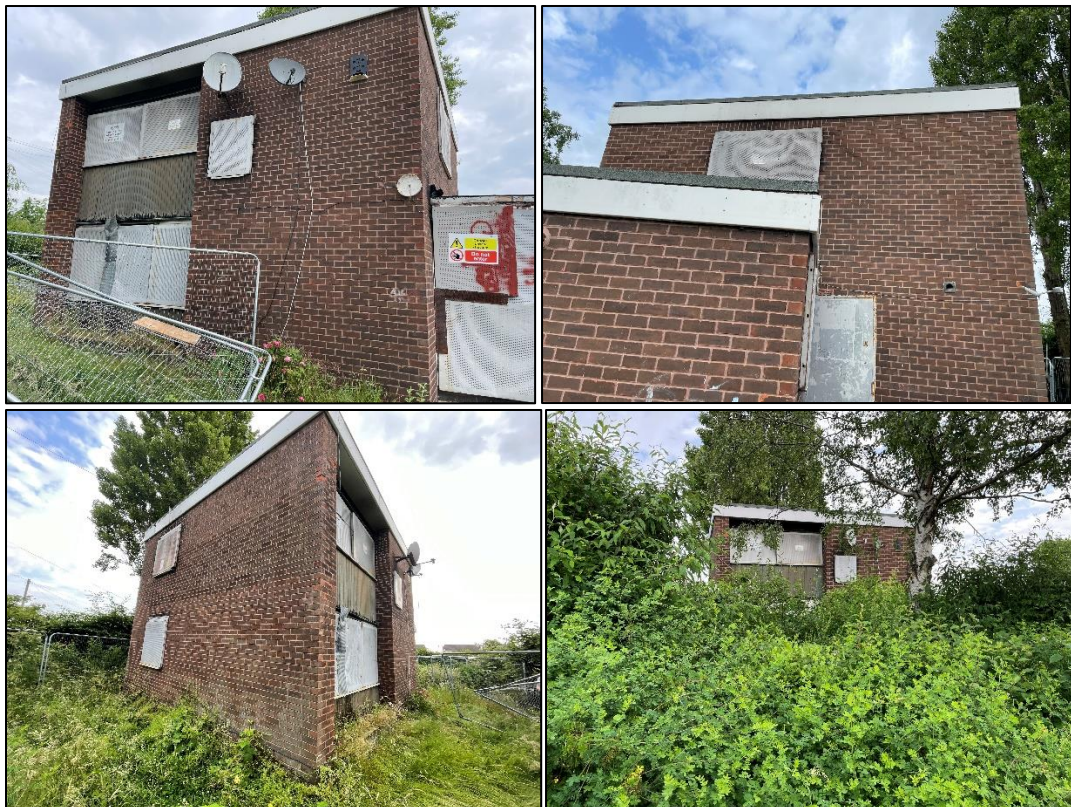
3.3.1. The building to be demolished is shown in the photographs below. It comprises a rectangular, two storey house with a single storey extension.

3.3.2. The building has brick cavity walls. Window and door frames are all in place but some of the windows are broken while some are covered by metal grids. There are gaps behind the metal grids and there are gaps behind the fascia boards.

3.3.3 The roof is flat and therefore unsuitable for roosting bats.

3.3.5. No bats or bat field signs were identified anywhere inside or outside the building but the building was assessed to have a low potential for roosting bats in line with the Bat Conservation Trust Good Practice Guidelines.

5.1. No bats emerged from the buildings on the site. Therefore, no further bat surveys are recommended and there is no requirement for a mitigation strategy or a Natural England bat licence in connection with the proposed development of the site.

5.2. Nevertheless, individual bats can seek shelter almost anywhere and therefore, demolition of the buildings should be undertaken with due care and in the unlikely event a bat is found, work should cease in that area, the bat should be covered and protected and the undersigned contacted for further advice.

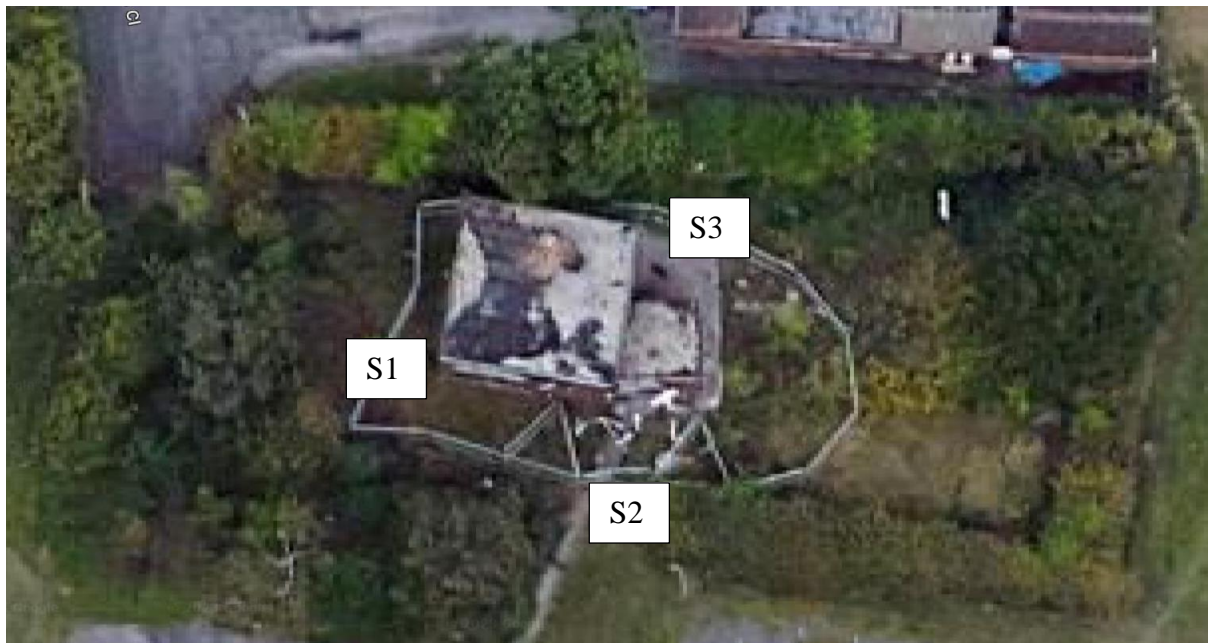
3.4.3. The positions of the surveyors and the static Anabats are shown on the aerial photograph below where S is a surveyor.
