**Birkett Cole Lowe**  
ARCHITECTS

Client  
**NORTHERN COLLEGE**

Project  
**DEFECTIVE CEILING**

Site  
**WENTWORTH CASTLE  
STAINBOROUGH  
BARNSELY S75 3ET**

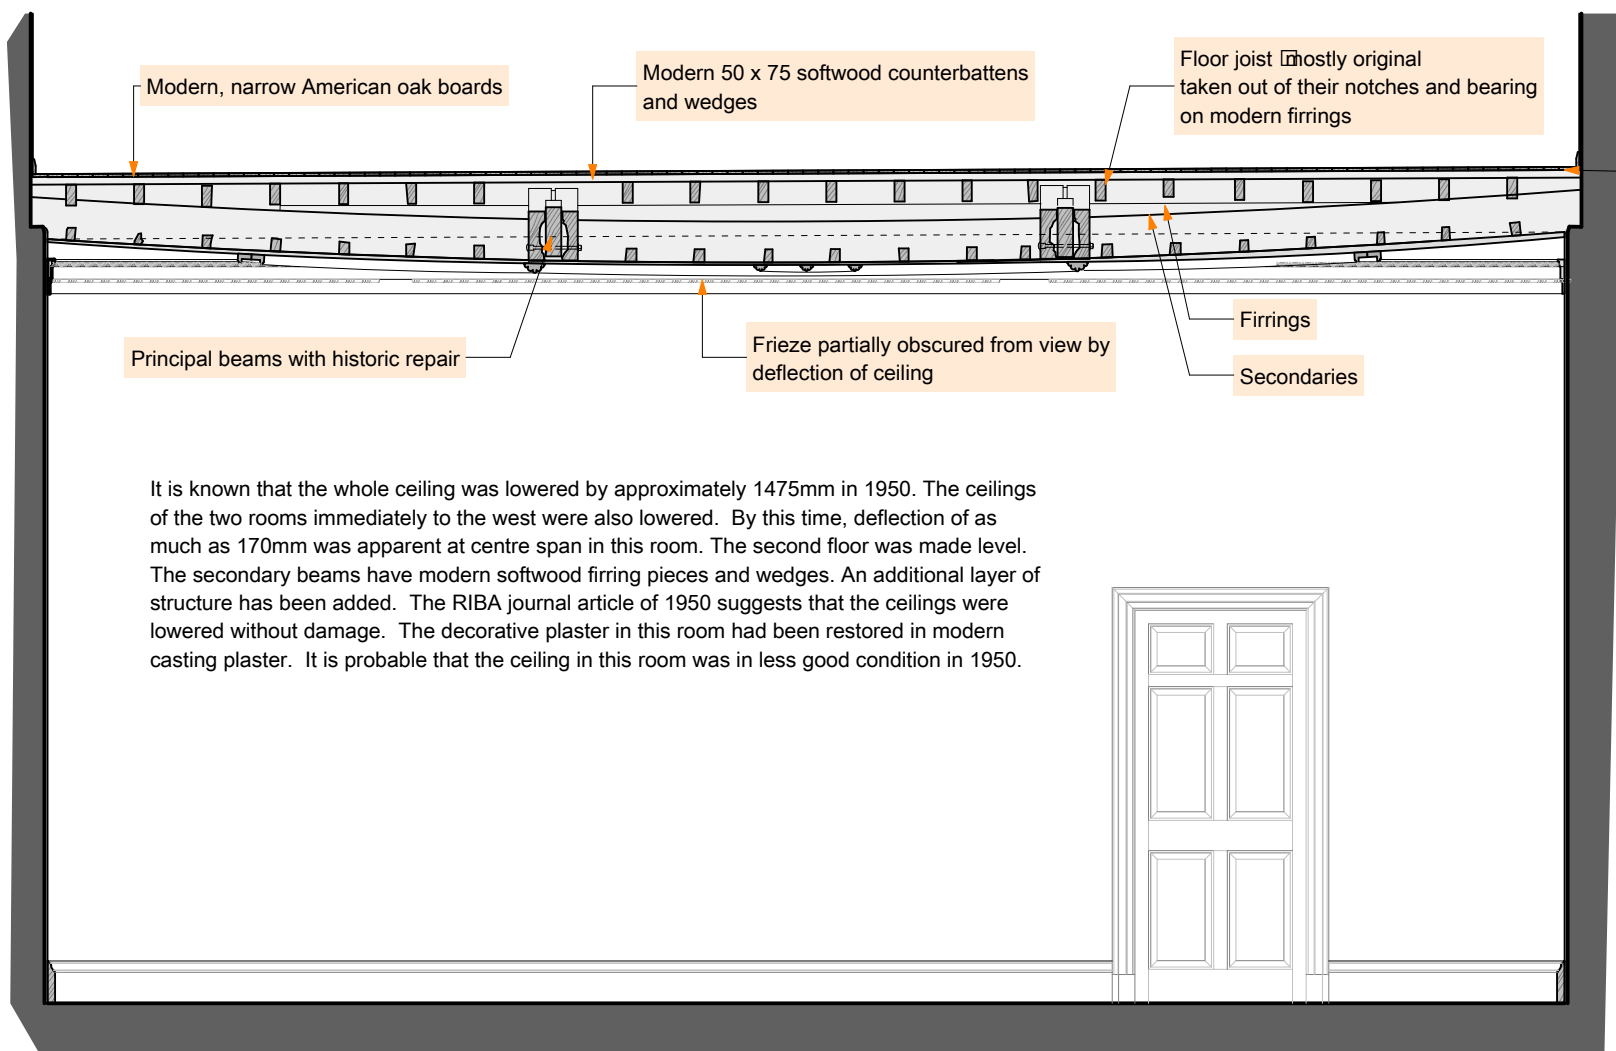
AS EXISTING 2011-12 1:50@A1

METHOD OF REPAIR ORIGINALLY PROPOSED BEFORE THE EXISTING CEILING WAS REMOVED AND THE FULL EXTENT OF DEFECTIVE TIMBER KNOWN

Steelwork was to have been provided to support the defective principal beams which would have been drilled and hung from steel channels bridging between steel beams. The deflection of the ceiling would have remained.

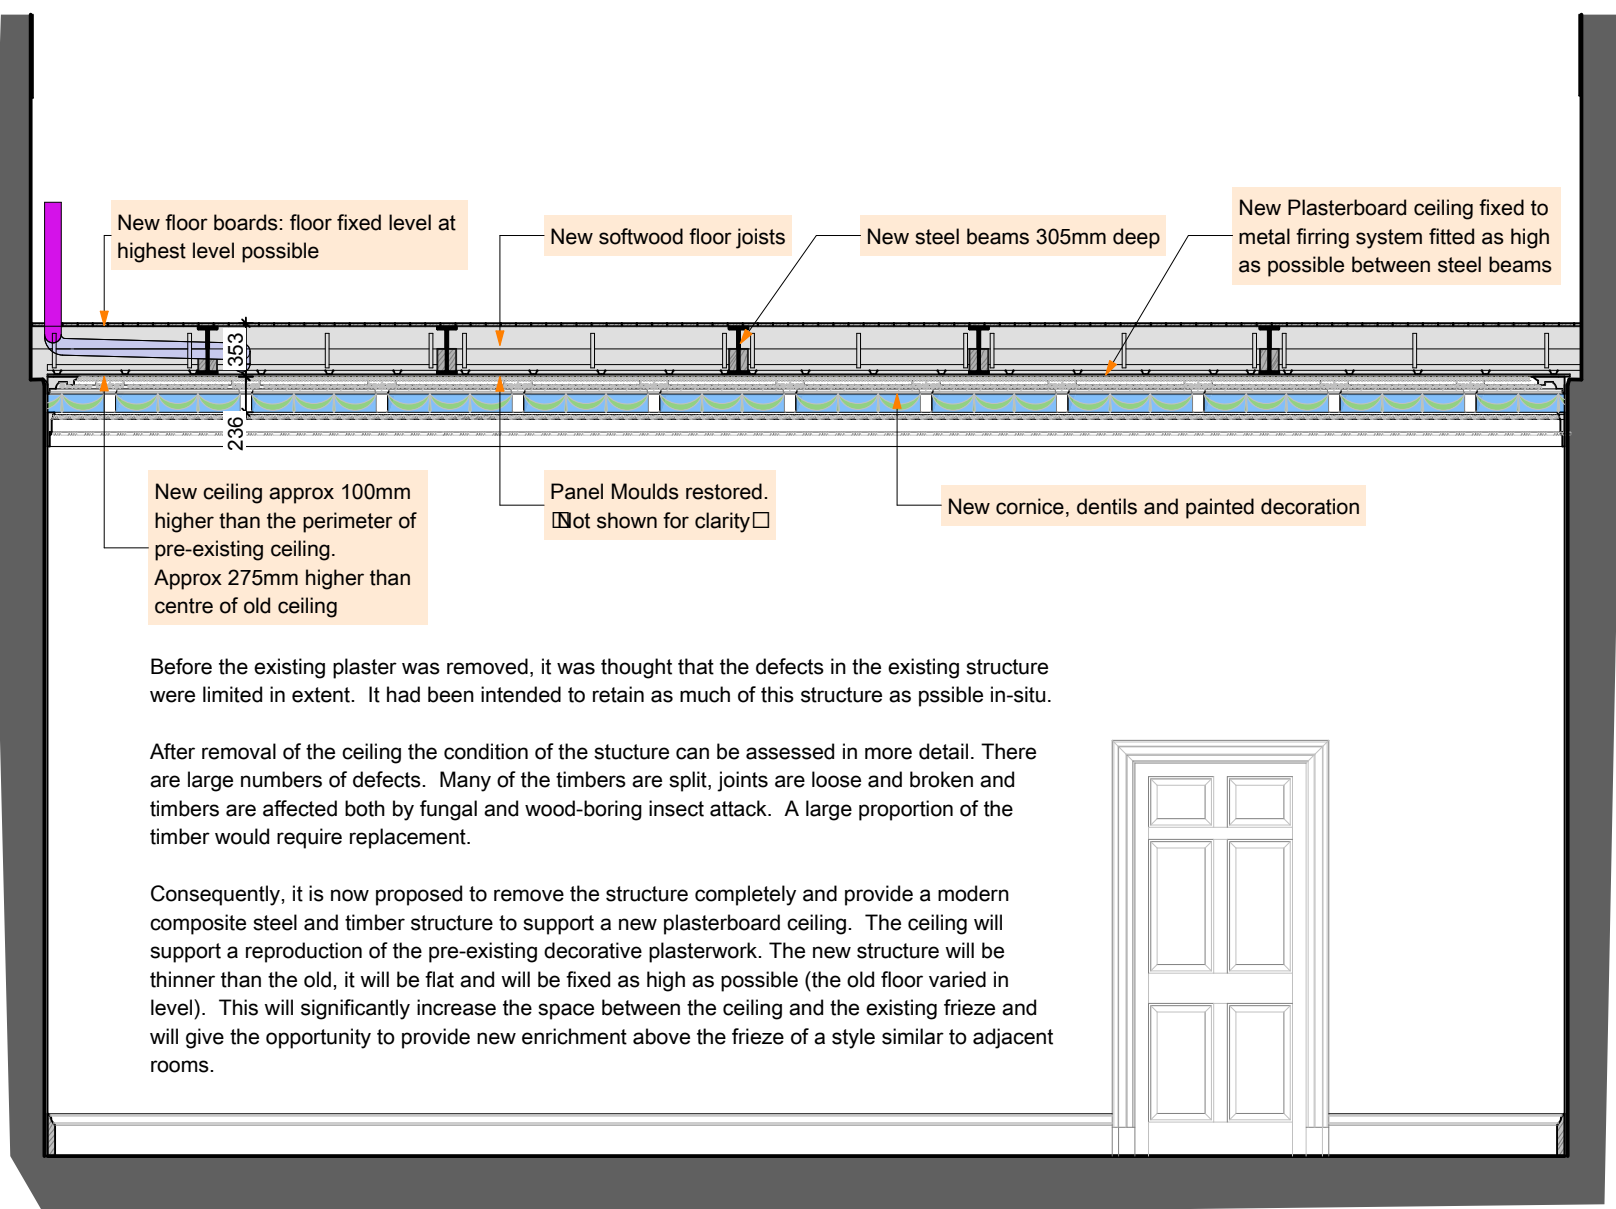
AS PROPOSED 1:50@A1

NORTH WALL

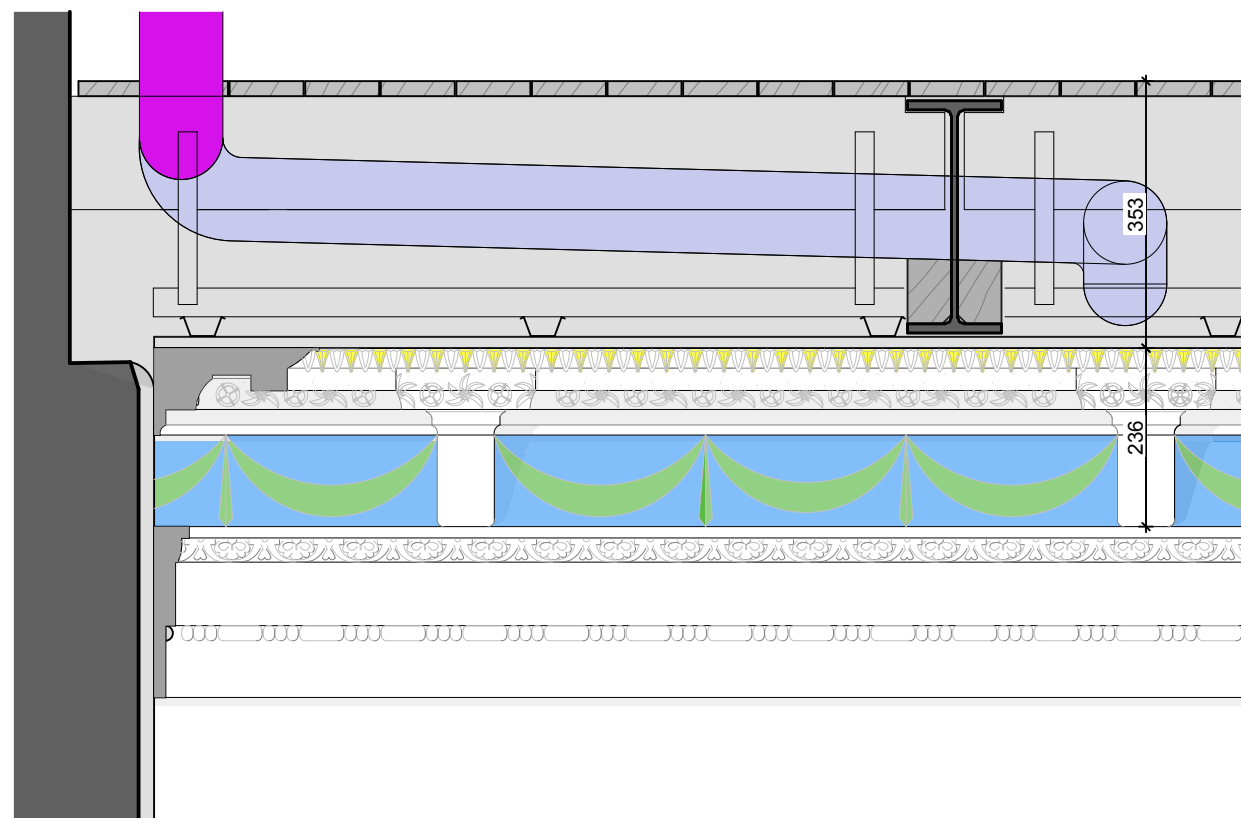
PRELIMINARY DESIGN FOR NEW CORNICE 1:10@A1

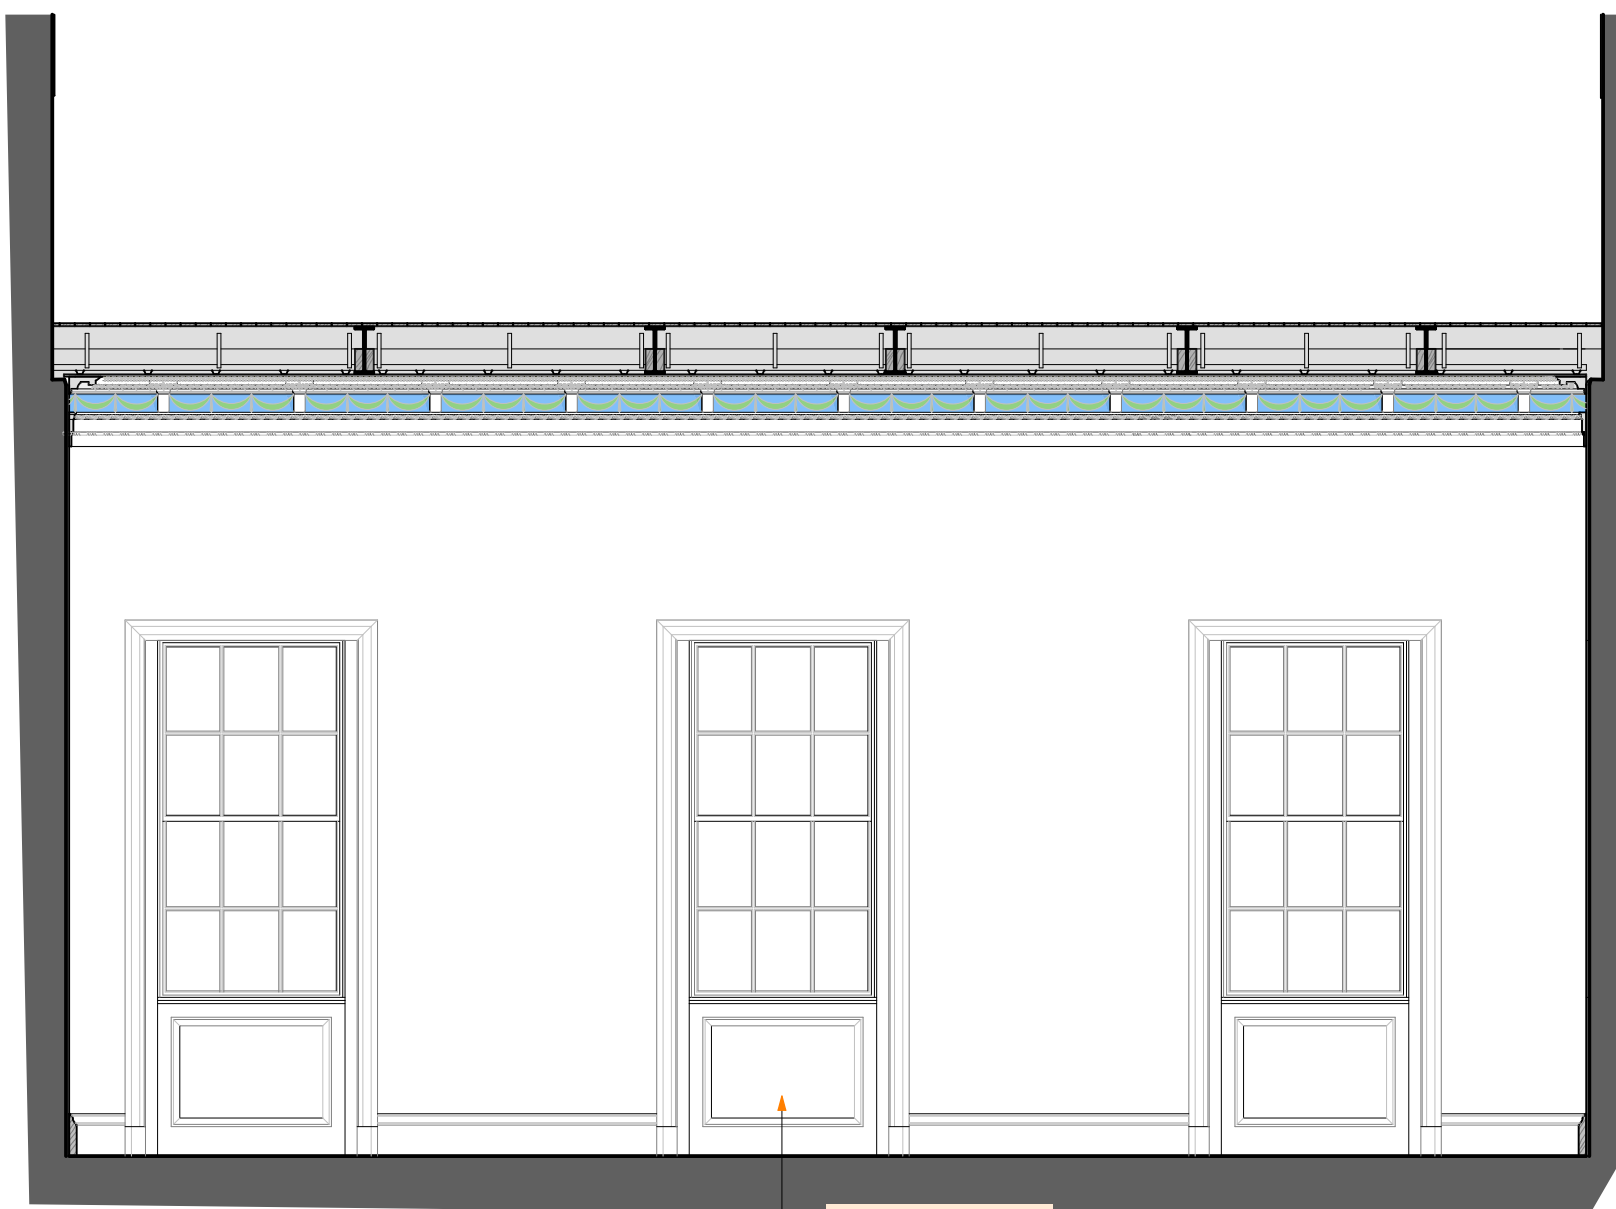
AS PROPOSED 1:50@A1

SOUTH WALL
