10, Worsbrough Village, Barnsley, S70 5LW

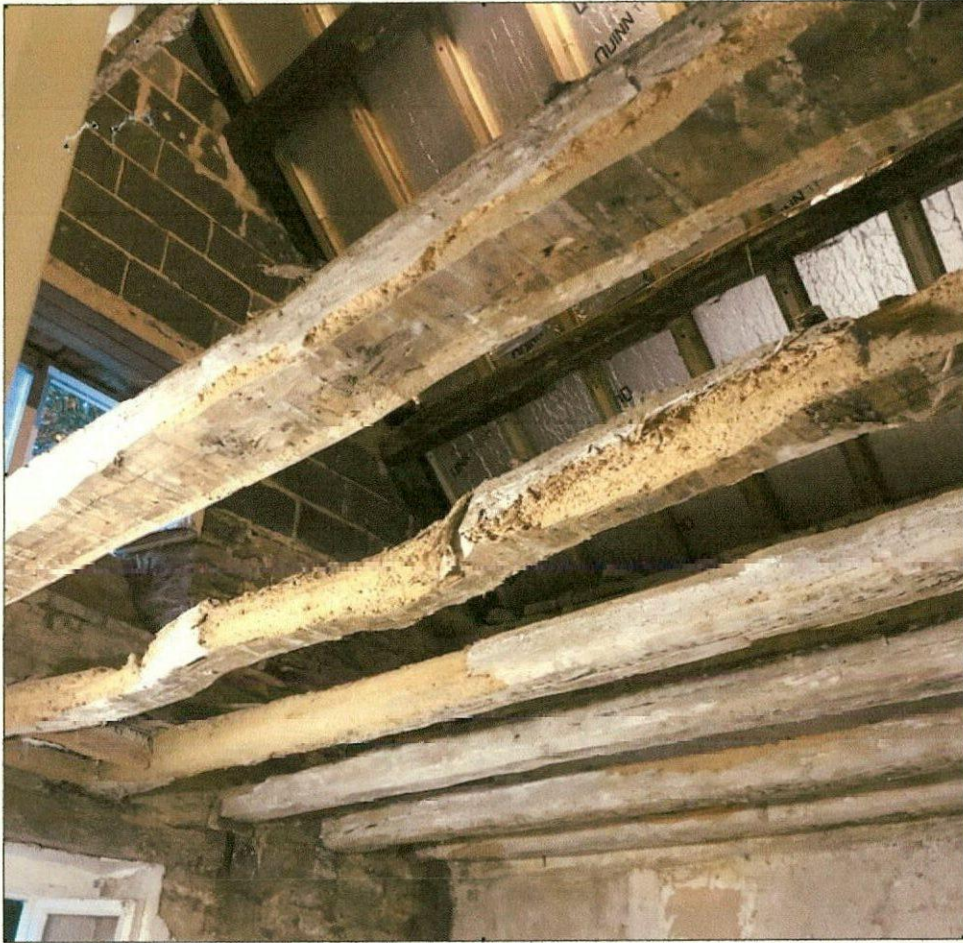
Photograph of Wood Worm Destroyed Ceiling Joists - Inspection of the wood shows it is easily removed leaving little of the original wood.

It is proposed that these joists are replaced with new oak beams. This will be necessary as they will also need to form the trimmers for the new staircase.
