*Bank House Farm, Silkstone*

*20220036-PRA*

*Preliminary Roost Assessment*

*12<sup>th</sup> September 2022*

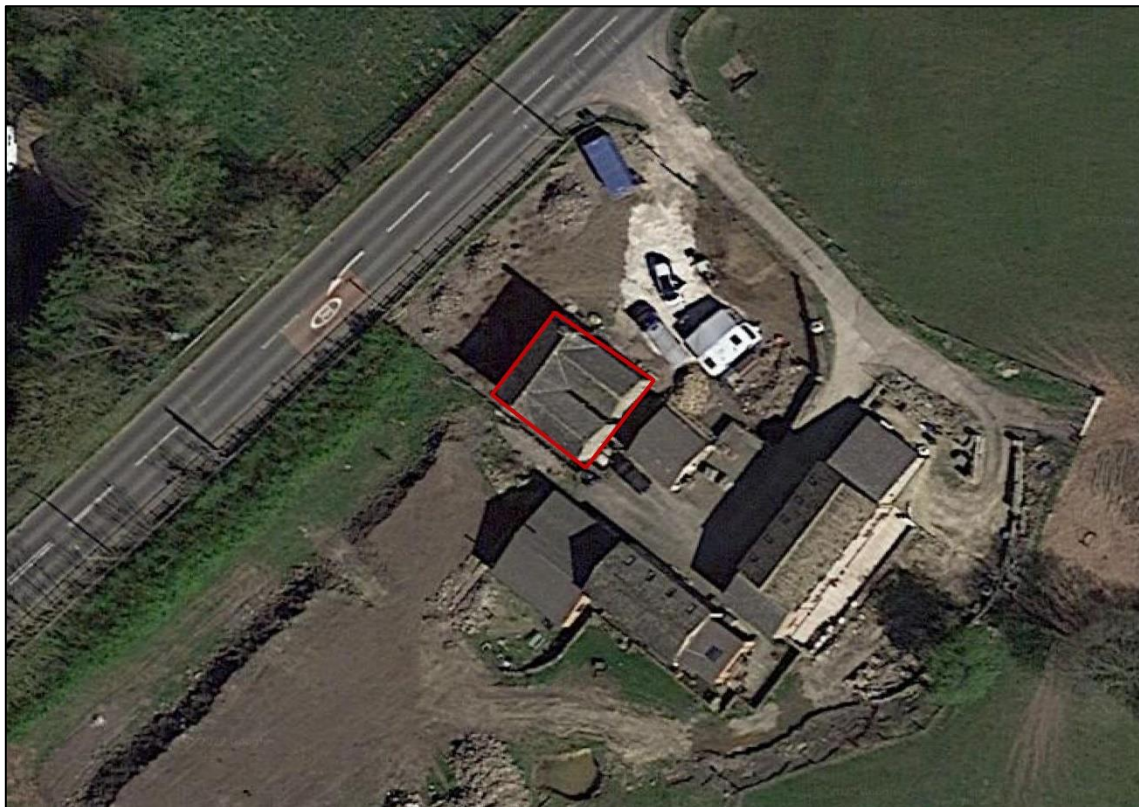
*Figure 1: Showing the building covered by this survey (old image from before works began).*

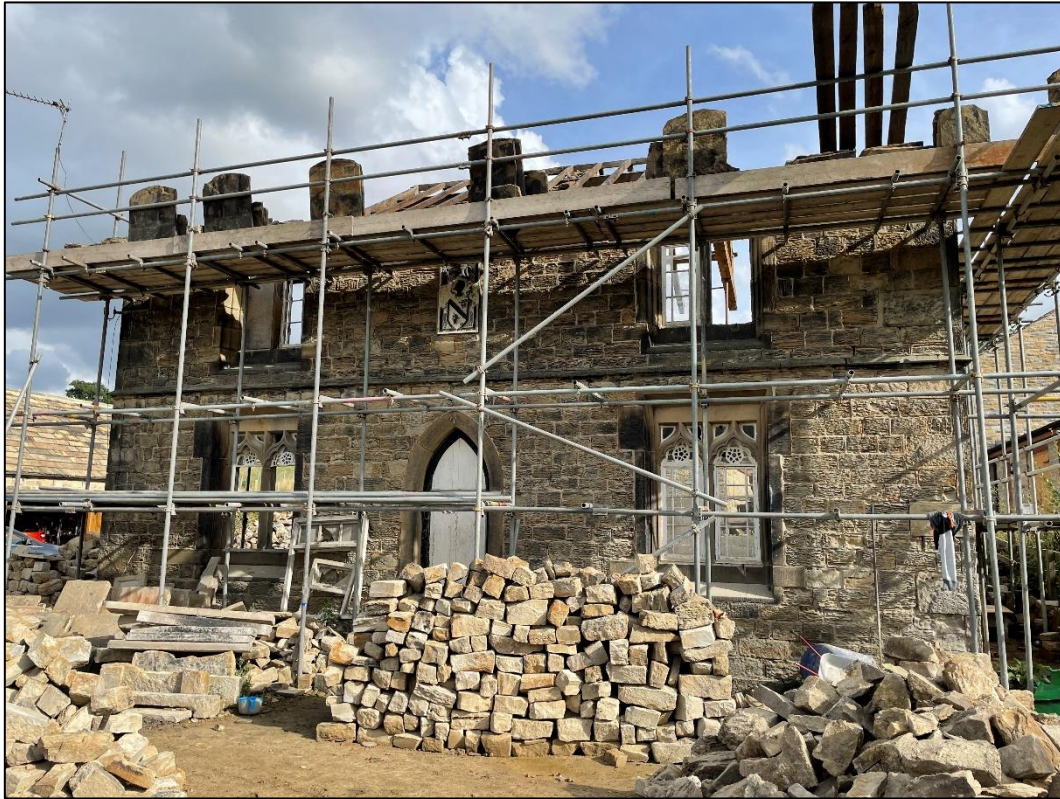
2.2.2. Works on the building commenced on receipt of planning permission, late 2021, and therefore the building currently only comprises two original walls supporting roof timbers but no roof covering. A small cellar space remains underneath the southern half of the building.

Figure 2: The remaining northwest elevation of the building.

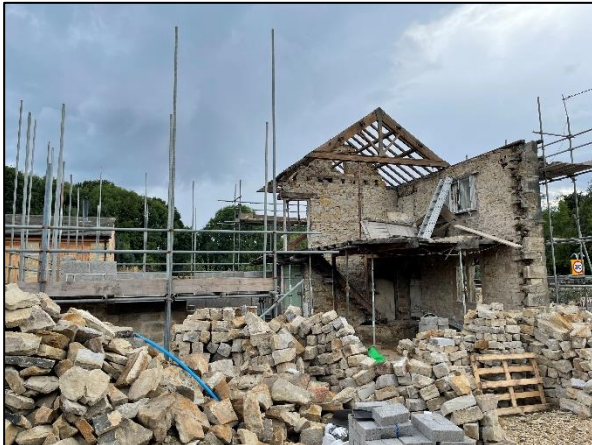
Figure 3: The building viewed from the east.

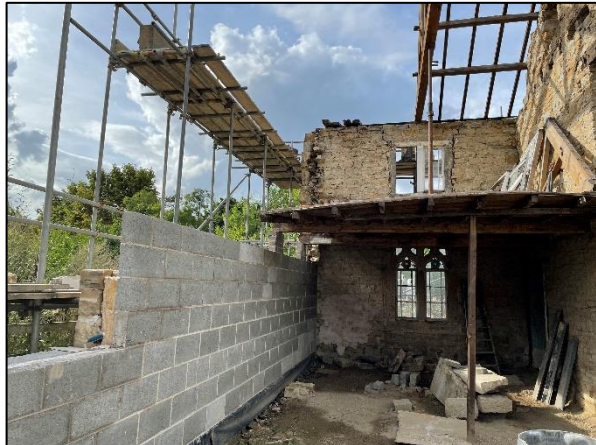
2.2.3. New build sections of wall are present to the southeast of the building, created as part of the ongoing works. The new sections tie into the old walls to a height of approximately 2m on the southwest elevation.

Figure 4: The new build walls to the southeast of the building.

4.2.6. The new build sections of wall to the rear of the building comprise breeze block internal with a stone external face. The cavity of these areas of the walls was found to be packed with insulation leaving no opportunities for bats.

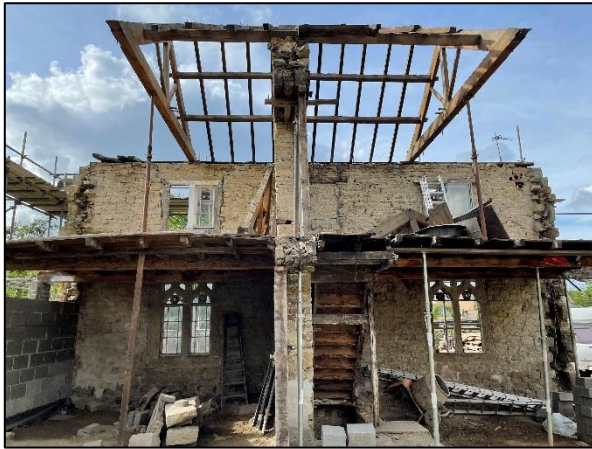
4.2.1. The walls of the building were found to be in a partially demolished state at the time of this survey. The walls therefore displayed extensive voids leading to the rubble fill where other walls had been demolished and where the internal plaster had been removed.

Figure 6: The partially demolished walls of the building.

4.3.1. The building, in its current state, was identified to provide suitable opportunities for bats due to extensive voids within the walls of the building, assessed to be equivalent to a moderate potential for roosting bats. However, the majority of the voids appear to have been created during the existing works on the building or would previously have been internal within the building and are now open and exposed due to the demolition works.

5.4. It is recommended that the remaining works on the building, notably the areas of old stonework, are carried out with care. In the event that any bats or bat field signs are encountered during the works it is recommended that all works on the site cease and further advice is sought immediately.

5.5. It is recommended that the development works are completed during the transitional/hibernation period for bats, September to April, when bats are unlikely to be present in the building due to the areas of potential being open to the weather conditions. It is then recommended that roosting opportunities are included in the building during the development, ensuring that roosting opportunities are present prior to the peak activity season of 2023.

5.6. It is recommended that the roosting opportunities are created through the inclusion of bat bricks located in the walls of the building. The bat bricks should include both cavity and crevice type boxes, providing opportunities for the species identified to be present around the site.

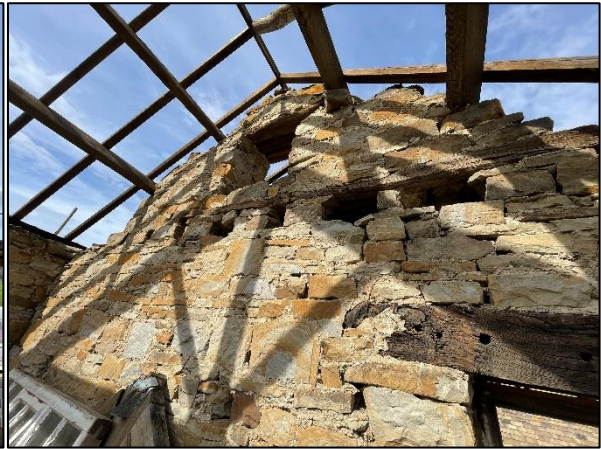
4.2.3. The building contained occasional wooden lintels that displayed voids leading between the timbers into the rubble fill of the walls, notably on previously internal walls.

Additional voids were identified in the walls where roof joist had been removed around the 1<sup>st</sup> floor ceilings.

Figure 7: The joist holes in the walls.

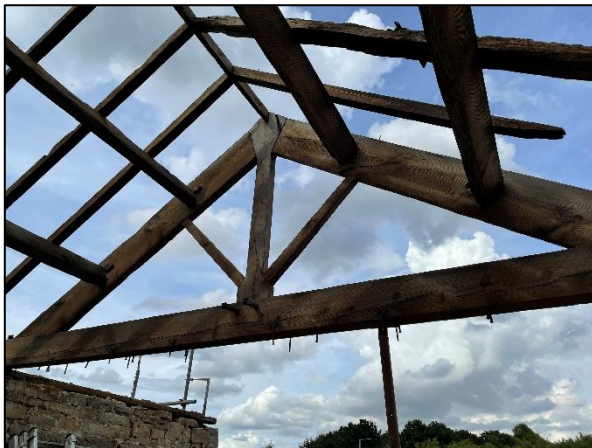
4.2.4. The roof timbers that remain within the building were found to be in a reasonable condition with tight fitting joints, although the timbers are open to the weather with no external covering due to the demolition works.

Figure 8: The exposed roof timbers.

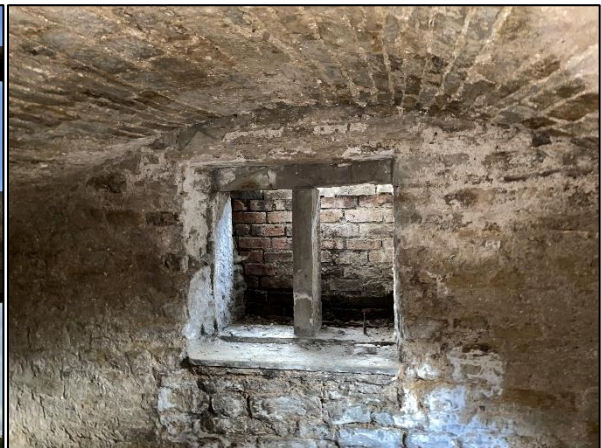
4.2.5. The cellar below the building was inspected and the stonework was found to be in a reasonable condition with no significant cracks or voids. The space was wet, potentially due to the opening created by the missing window and door that remains open to the elements.

Figure 9: The stonework and missing window within the cellar.
