# Preliminary Ecological Appraisal and Preliminary Bat Roost Assessment Foundry Street, Elsecar

| Project name | Foundry Street, Elsecar |
| Report title | Preliminary Ecological Appraisal and Preliminary Bat Roost Assessment |
| Date | 21/10/2019 |

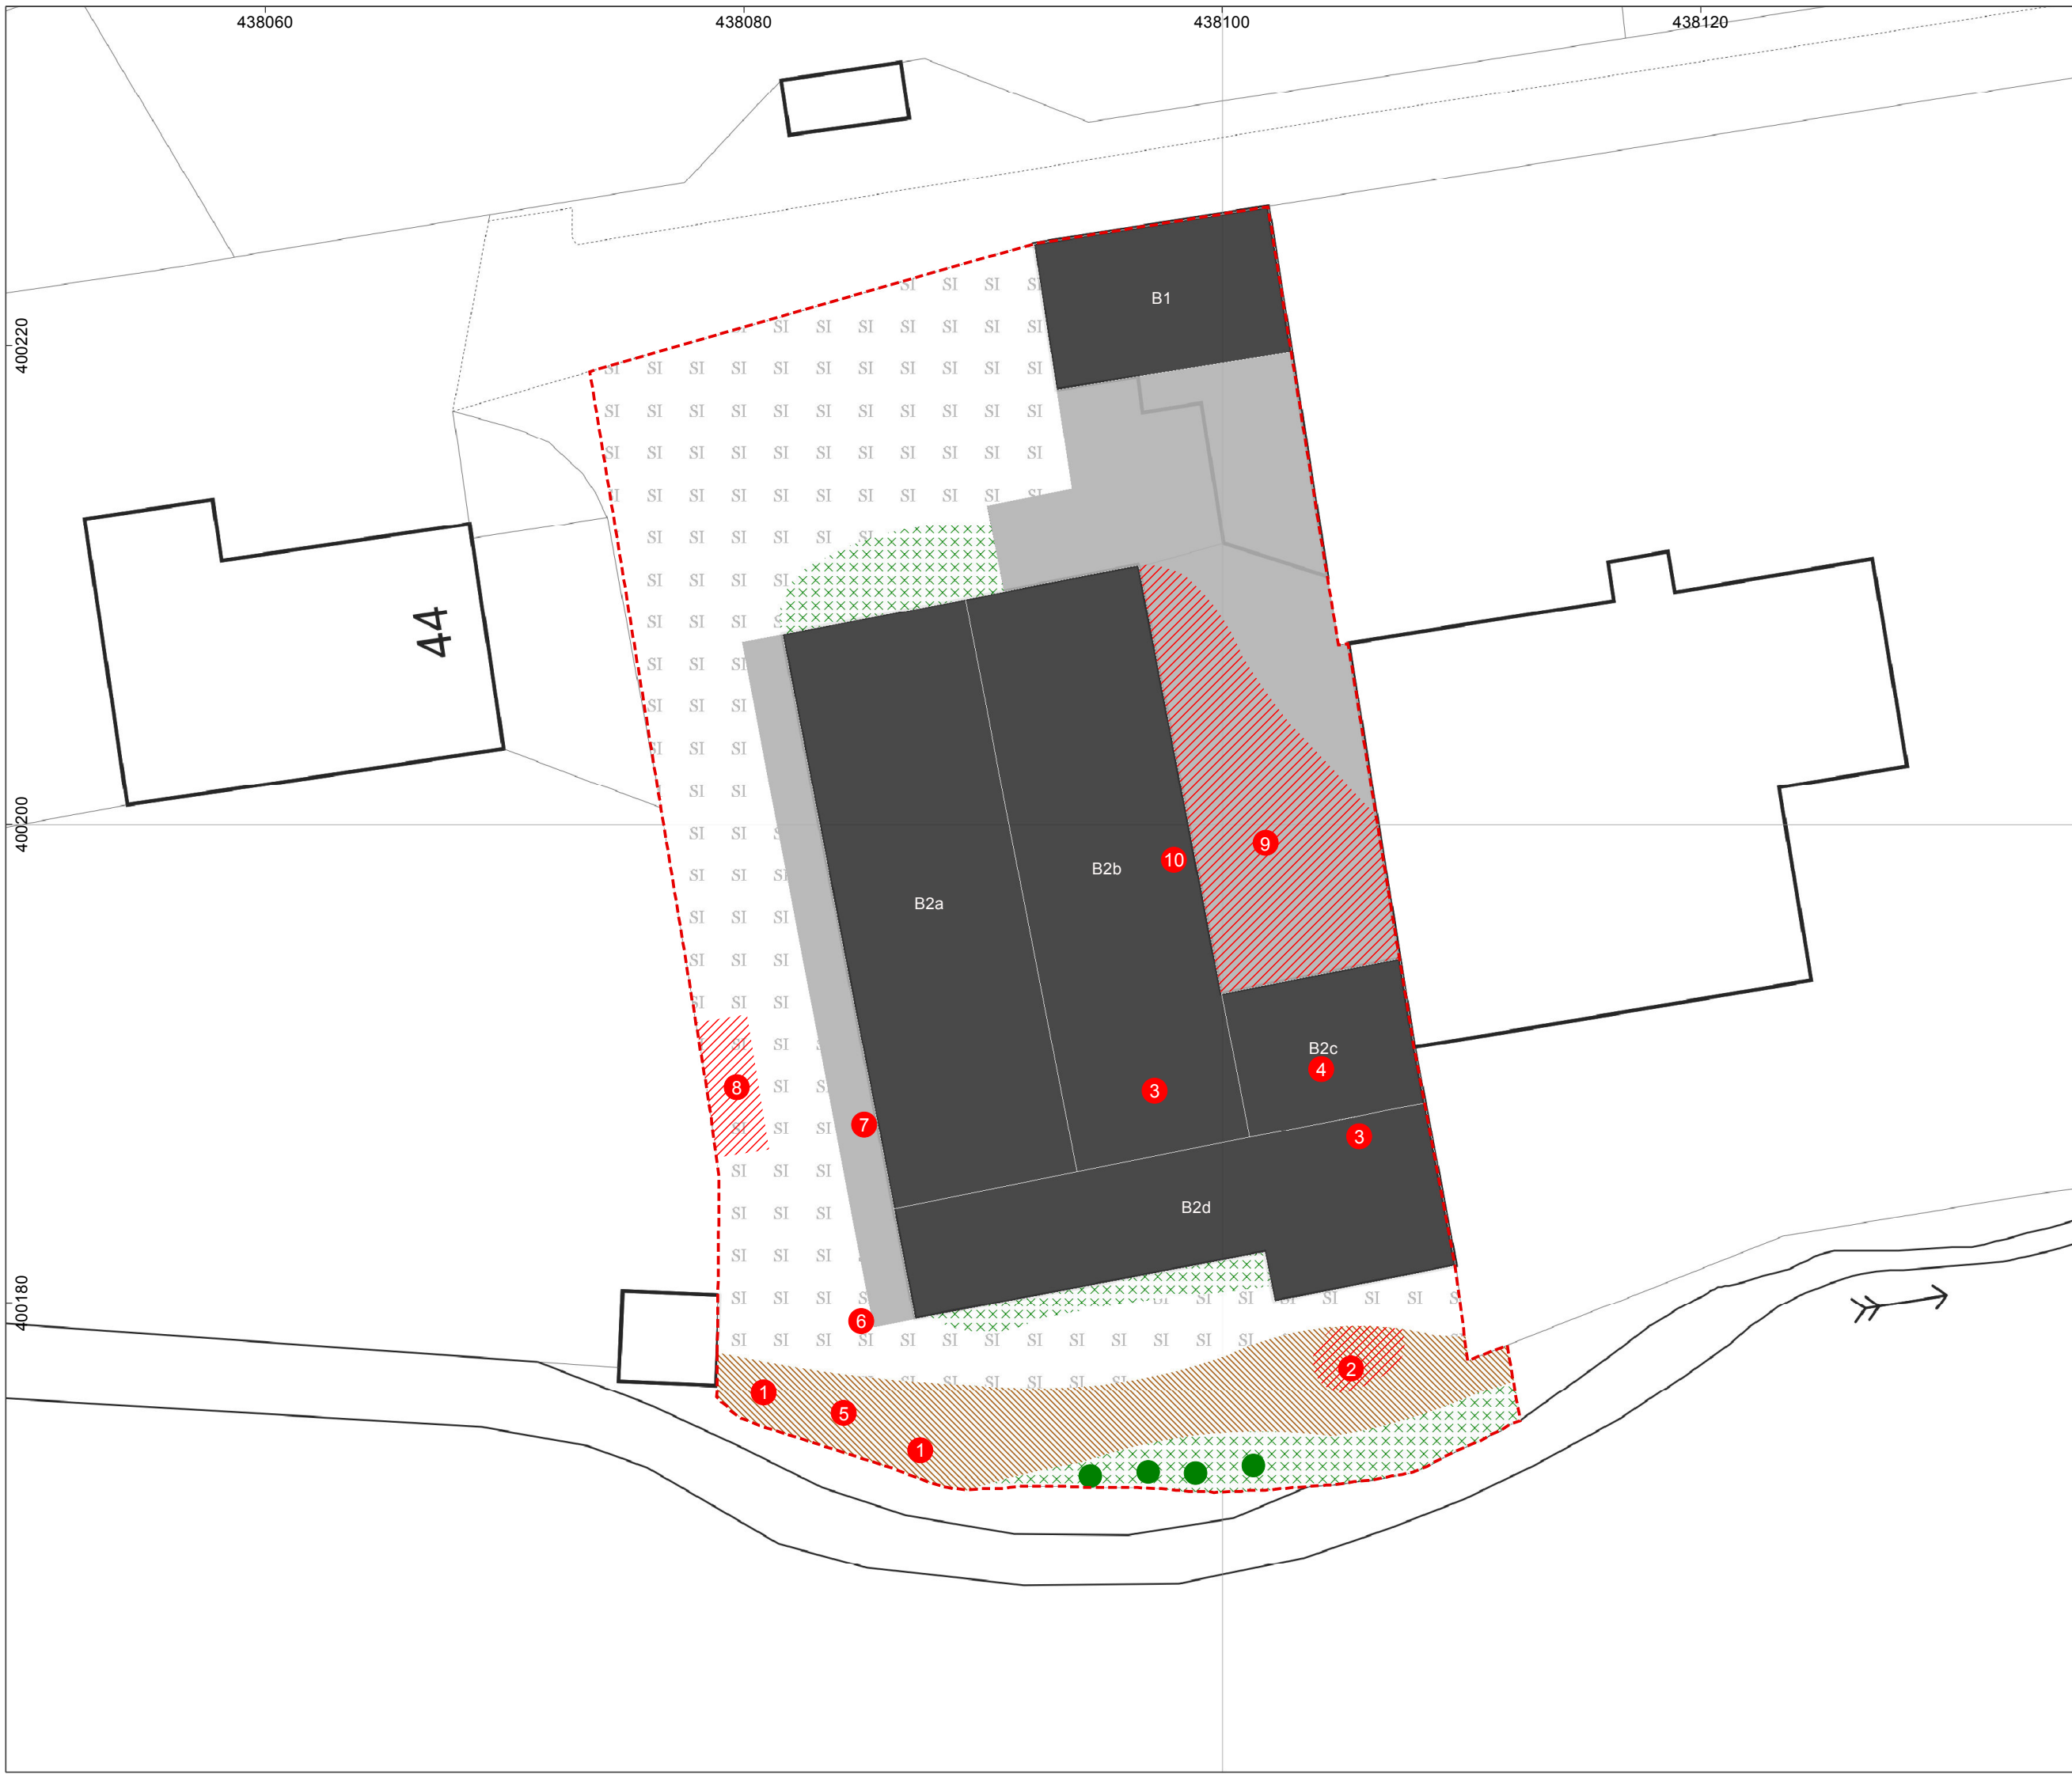
**Figure 2: Phase 1 Habitat Plan**

The individual habitat types recorded on site are described under the sub-headings below, with the location and extent of each illustrated on the Phase 1 Habitat Map in Figure 2. Details of target notes can be found on Figure 2. Representative photographs of the site are provided in Appendix E.

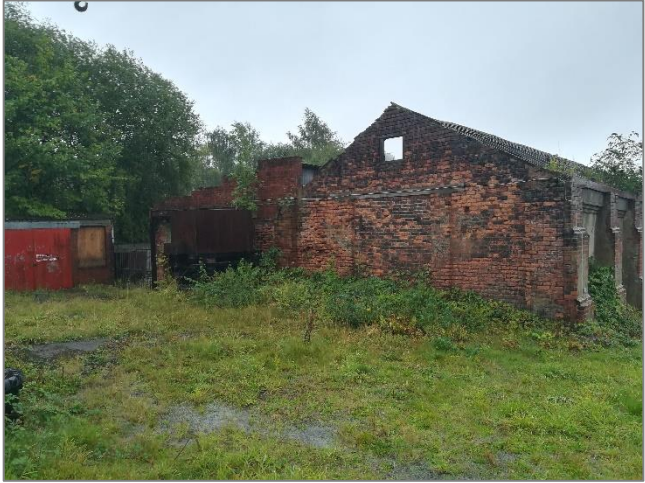
| No. | Description | Photograph |
|---|---|---|
| 1 | Semi-improved grassland with strip of scattered scrub in front of Building 2. | |

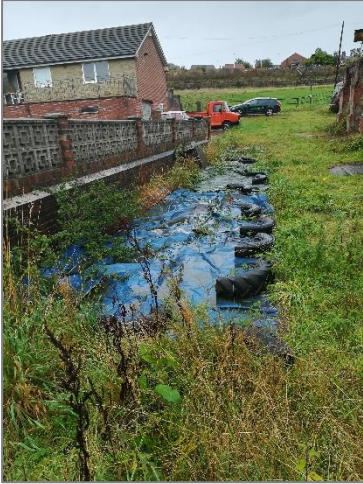
| No. | Description | Photograph |
|---|---|---|
| 2 | Looking north, with tall ruderal vegetation in the foreground, and semi-improved grassland beyond. Tarpaulin weighed down with tyres (TN8). | |

Vegetation removal should be carried out using hand tools such as strimmers in a coordinated approach, starting from the south west corner of site and progressing from south to north, and west to east. This will allow any reptiles present on site to disperse to a safe space, off site. It is also recommended that potential refugia on site, such as the rubble piles, grass clippings, tire piles, and tarpaulin are dismantled by hand to prevent harm to potential sheltering animals.

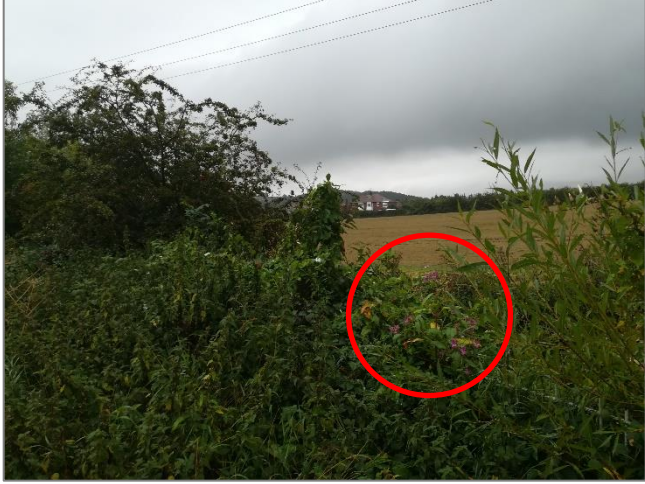
| No. | Description | Photograph |
|---|---|---|
| 3 | Tall ruderal vegetation at the southern boundary of site, showing flowering Himalayan balsam (TN1). | |

Although Himalayan balsam reproduces through the production of viable seeds, the soil surrounding stands of Himalayan balsam is likely to contain seeds from previous growing seasons. The areas in and around both Himalayan balsam, and variegated yellow archangel must therefore be treated with care. To avoid the potential spread of the invasive species on site, it is recommended that:

- Ground works in and around the affected areas should be carried out during the growing season for both species to aid identification, but before the plants set seed. This is usually from May-July for Himalayan balsam, and May-June for variegated yellow archangel, however flowering time will be dependent on location and weather conditions. Ground works in and around the affected areas should also be carried out towards the end of the work program (if practical);

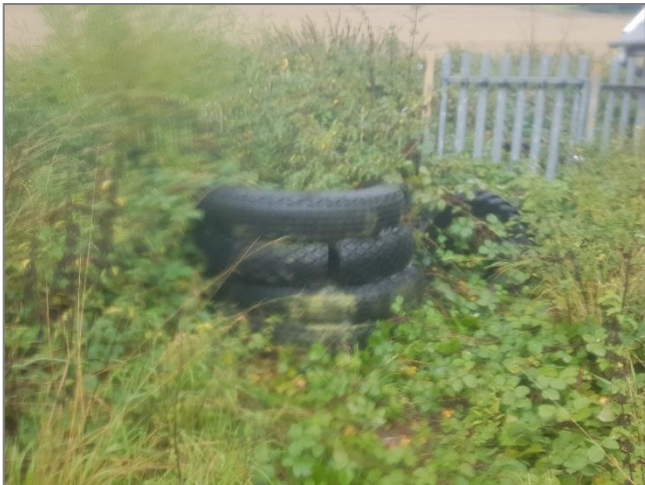
| No. | Description | Photograph |
|---|---|---|
| 4 | Tire pile in southwest corner of site (TN5). | |

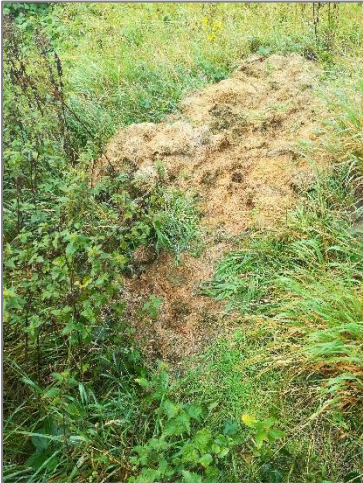
| No. | Description | Photograph |
|---|---|---|
| 5 | Grass clipping pile in southwest corner of site (TN6). | |

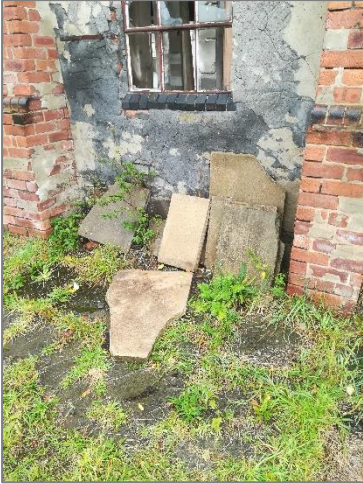
| No. | Description | Photograph |
|---|---|---|
| 6 | Rubble pile adjacent to Building 2a (TN7). | |

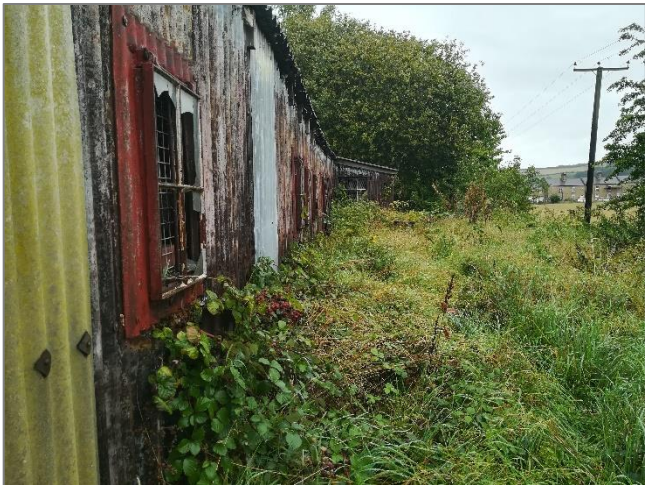
| No. | Description | Photograph |
|---|---|---|
| 7 | Semi-improved grassland and scattered scrub adjacent to the southern aspect of Building 2d. | |

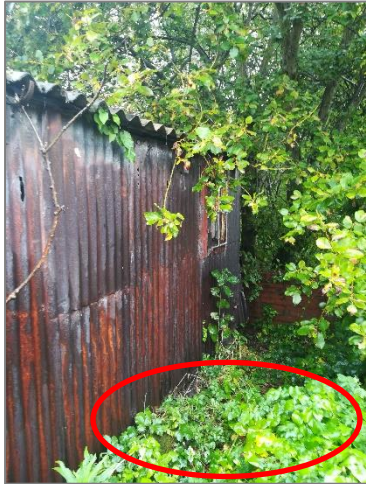
Variegated yellow archangel spreads and carpets the floor through the production of horizontally spreading stems called stolons. These stolons readily break off, and vegetative reproduction is possible through broken stolons with as little as two leaves present forming new plants. Variegated yellow archangel also produces viable seeds, and can reproduce through the spreading of such seeds.

| No. | Description | Photograph |
|---|---|---|
| 8 | Location of variegated yellow archangel (TN2), in the south east corner of site. | |

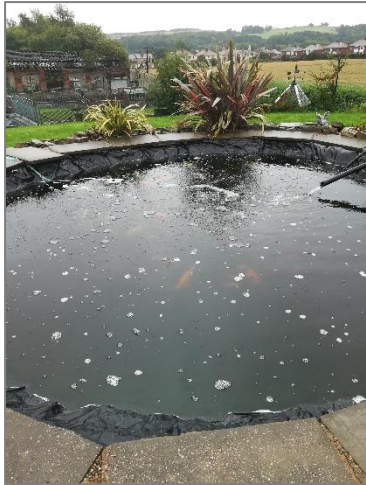
| No. | Description | Photograph |
|---|---|---|
| 9 | Ornamental pond located in the residential garden adjacent to site. Note the lack of vegetation and dense stocking of carp. | |

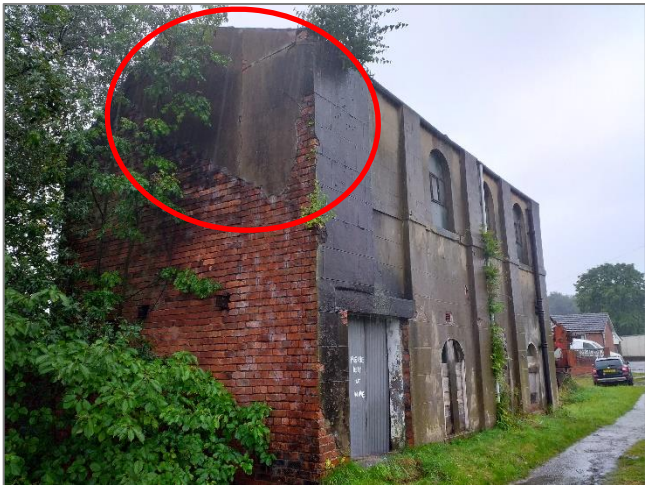
Building 1 (B1) – Externally, the building was in very poor condition. Several large cracks were present both within the external concrete render, but also within the red brick itself. These cracks provided potential crevice features for roosting bats. A number of roofing slates were either slipped or missing, and ridge tiles were lifted with missing mortar, providing potential access points into the building. Many of the windows had been vandalised leaving holes present, and therefore potential bat access points.

| No. | Description | Photograph |
|---|---|---|
| 10 | North east aspect of Building 1. Note large cracks in the mortar and brickwork on the gable end. | |

**It should be noted that no works can commence on Building 2 without an EPS derogation licence, and further surveys are required to inform whether Building 1 will need to be covered under such licence.**

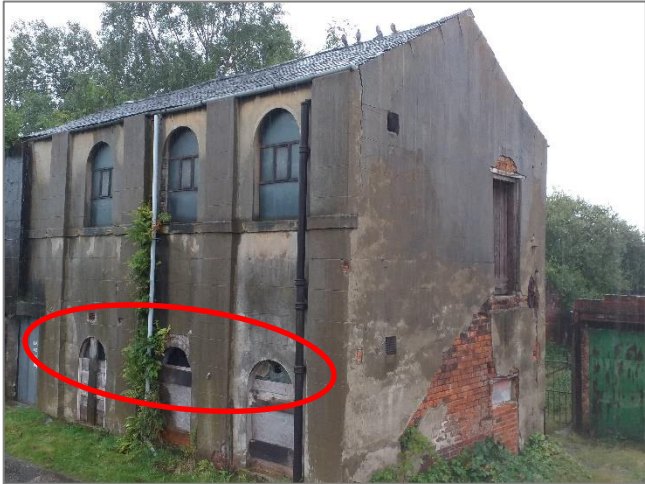
| No. | Description | Photograph |
|---|---|---|
| 11 | North west aspect of Building 1. Note the smashed windows providing potential bat access points. | |

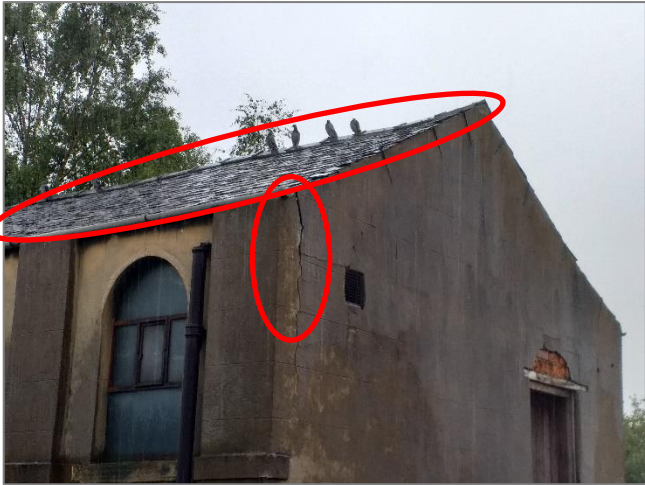
| Building | Potential for Roosting Bats | Evidence |
|---|---|---|
| B1 | High | <b>Not accessible internally.</b> Cracks present within the render and brickwork, creating small cavities beneath. Slipped and missing tiles present, and ridge tiles lifted with missing mortar. Many window panes were smashed, providing potential bat access points into the building. |

| No. | Description | Photograph |
|---|---|---|
| 12 | Close up of north west aspect of Building 1. Note crack in concrete render, slipped and missing slate tiles, missing mortar in ridge tiles, and presence of pigeons. | |

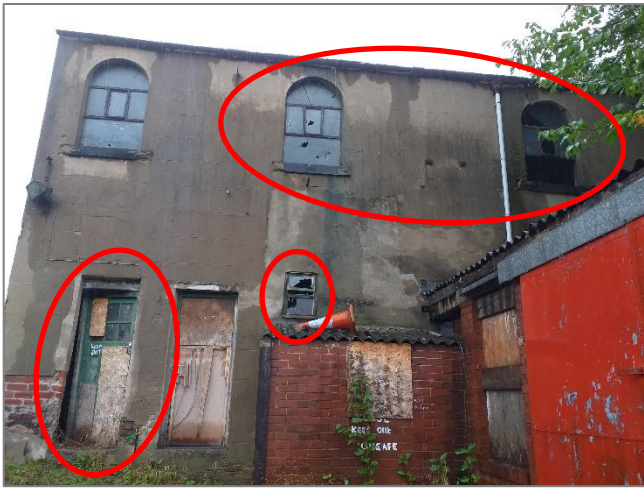
| No. | Description | Photograph |
|---|---|---|
| 13 | Southern aspect of Building 1, showing potential bat access points via smashed windows and open wooden door. | |

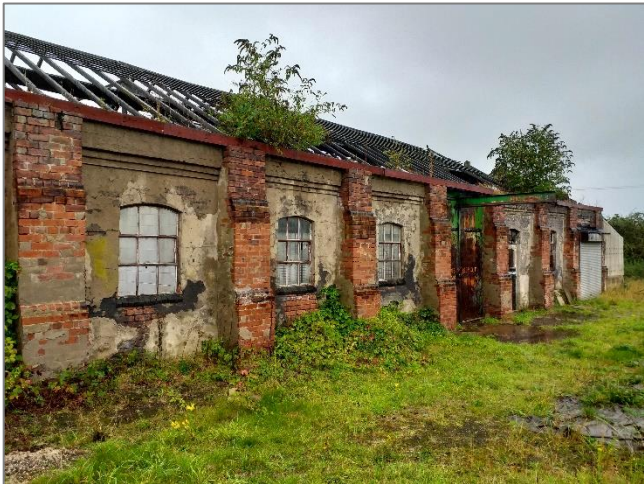
| No. | Description | Photograph |
|---|---|---|
| 14 | Western aspect of Building 2a. Note lack of roof covering, allowing bat access into the building. | |

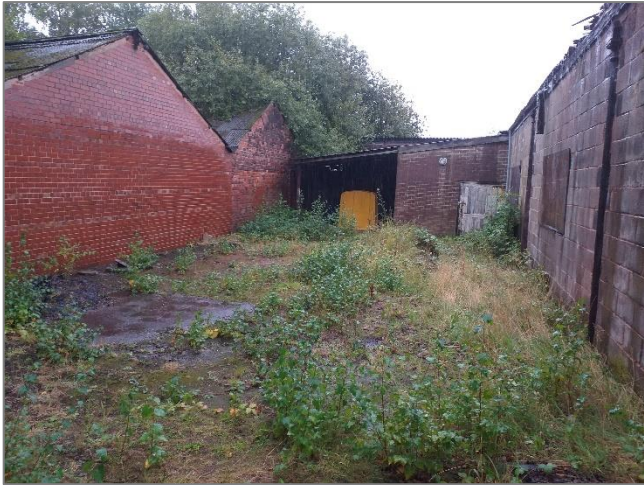
A small number of bat droppings were also found on top of stored materials in B2c. The droppings found in this area were indicative of pipistrelle species.

| No. | Description | Photograph |
|---|---|---|
| 15 | Eastern aspect of Building 2b (right), and open-fronted Building 2c in use for storage of materials. Note encroaching vegetation over hardstanding courtyard. | |

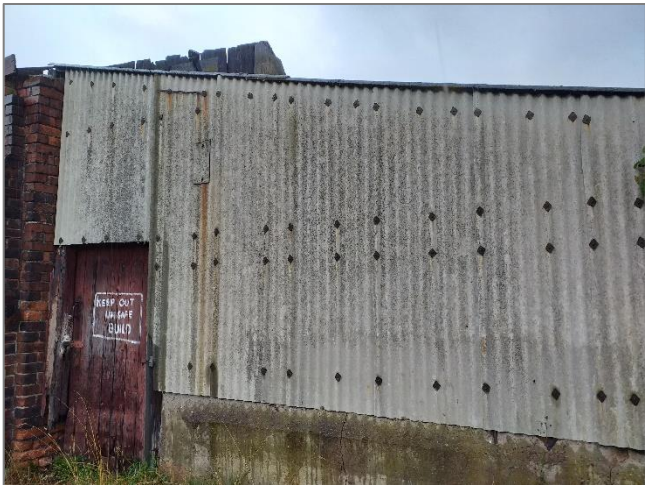
| No. | Description | Photograph |
|---|---|---|
| 16 | Western aspect of Building 2d. | |

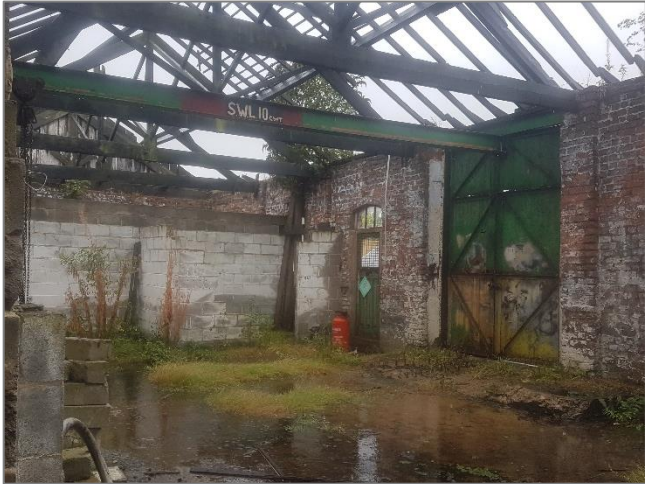
| No. | Description | Photograph |
|---|---|---|
| 17 | Internal of Building 2a, showing open access through the roof, and breeze block partition wall. | |

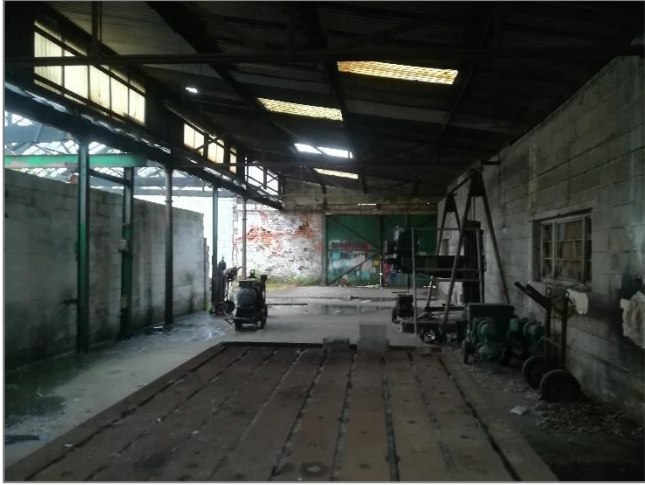
| No. | Description | Photograph |
|---|---|---|
| 18 | Internal of Building 2b, showing stored materials and direct access to Building 2a to the left. | |

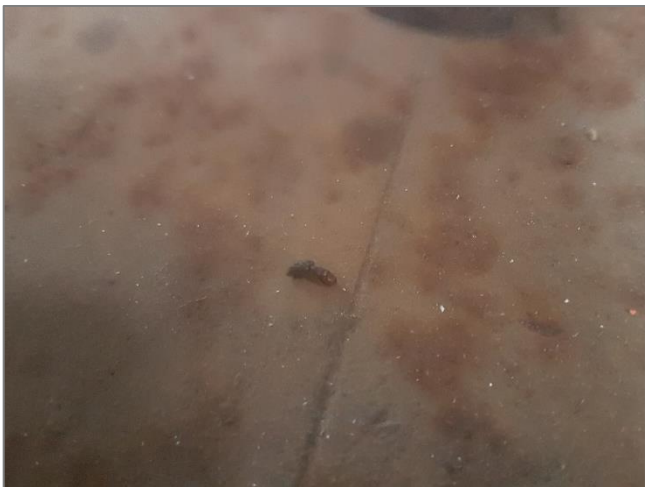
Bat evidence, in the form of droppings and feeding remains, was found during the survey in B2b, and B2d. A collection of peacock butterfly *Aglaia io*, and underwing moth *Catocala* sp. wings were located on the floor and walls of the corridor of B2d, and around the large metal workbench in B2b. Bat droppings were also found in the same areas. The characteristics of the droppings, coupled with the collection of insect wing feeding remains, are indicative of brown long-eared *Plecotus auritus* feeding activity. It is likely that a small number of bats use the building for feeding, and potential roosting purposes.

| No. | Description | Photograph |
|---|---|---|
| 19 | Internal of Building 2b, showing bat dropping on metal table (TN3). | |

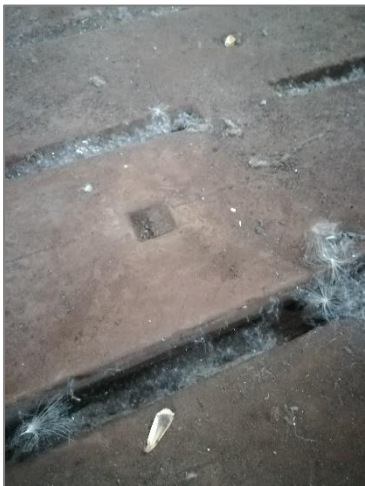
| No. | Description | Photograph |
|---|---|---|
| 20 | Bat feeding remains at same location as photograph 19 (TN3). | |

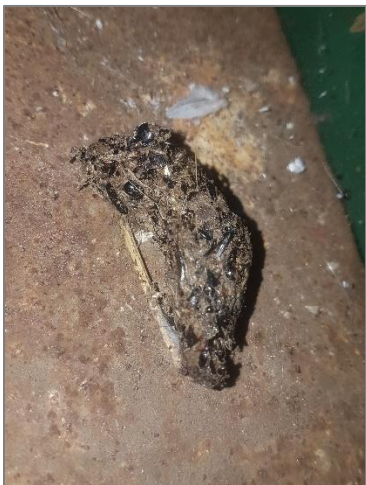
| No. | Description | Photograph |
|---|---|---|
| 22 | Example pellet found beneath feeding perch (TN10). | |

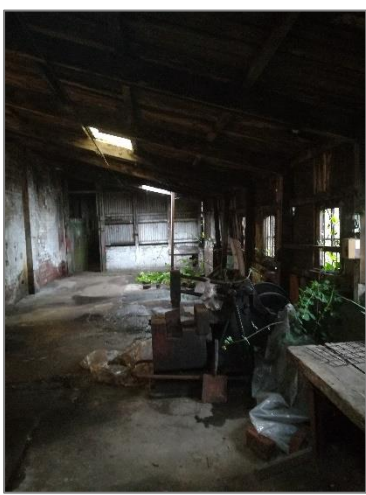
| No. | Description | Photograph |
|---|---|---|
| 23 | Main workshop space in Building 2d. | |

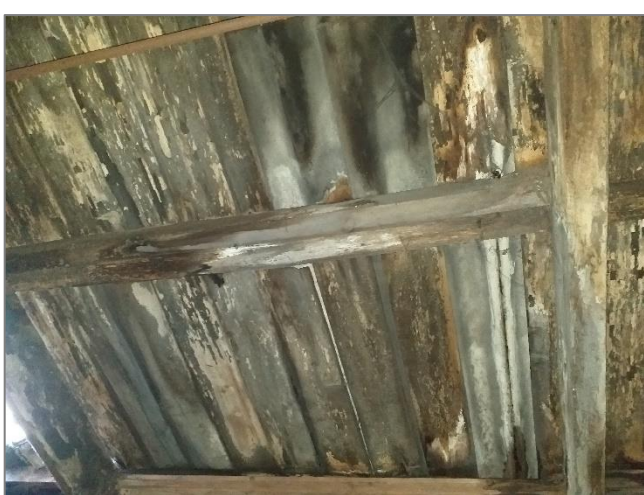
Internally, this section was made up of three separate rooms with an associated corridor. The main, largest room, appeared to have previously been used as a metal workshop, with old machinery still in place. The other two rooms were empty, apart from empty shelving and a safe. Walls were finished in a mixture of bare red brick, exposed corrugated metal sheeting, painted wooden cladding, and plasterboard. Wooden roof joists were present, with corrugated asbestos sheeting and wooden slats in place to form the roof. This was failing in a number of places, allowing water ingress into the building.

| No. | Description | Photograph |
|---|---|---|
| 24 | Example section of wooden slatted roof in Building 2d. | |

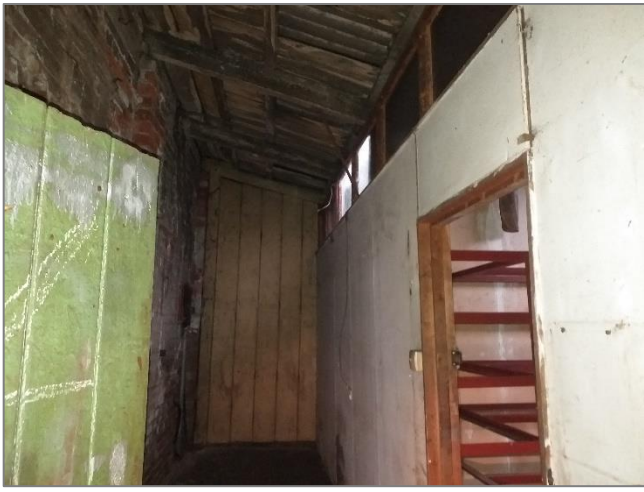
| No. | Description | Photograph |
|---|---|---|
| 24 | Corridor of Building 2d, where bat evidence was found (TN3). | |

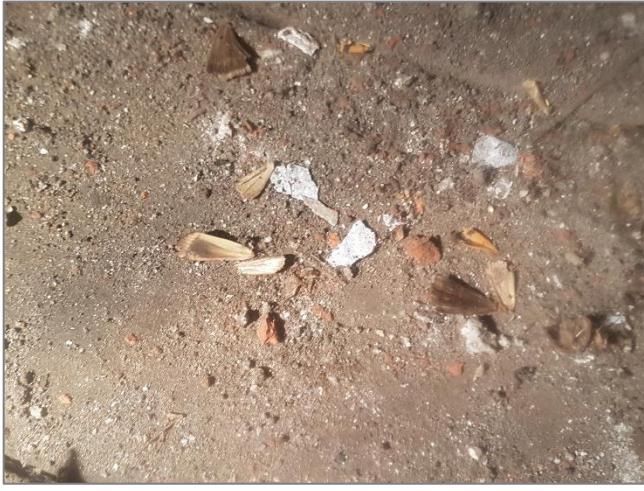
| No. | Description | Photograph |
|---|---|---|
| 25 | Bat feeding remains in Building 2d (TN3). | |

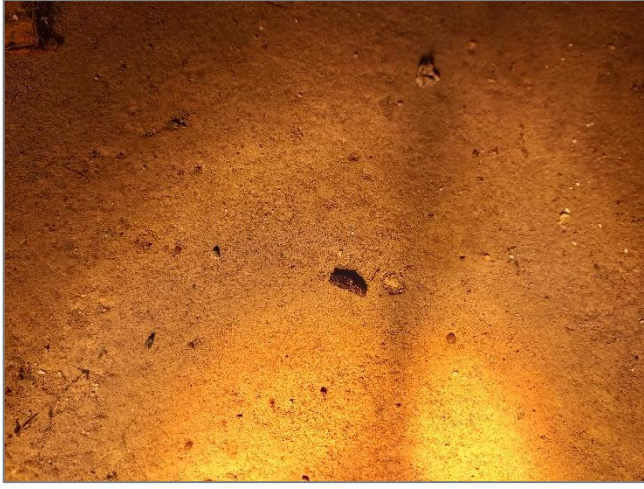
| No. | Description | Photograph |
|---|---|---|
| 26 | Example bat dropping in Building 2d (TN3). | |
