SOAKAWAY LETTER REPORT

Report on Soakaway Testing

| Location: | 28 Low Cudworth Green Cudworth, Barnsley, S72 8EF | | |
| Report No. | C3124/23/E/5408 | Report Date: | May 2023 |

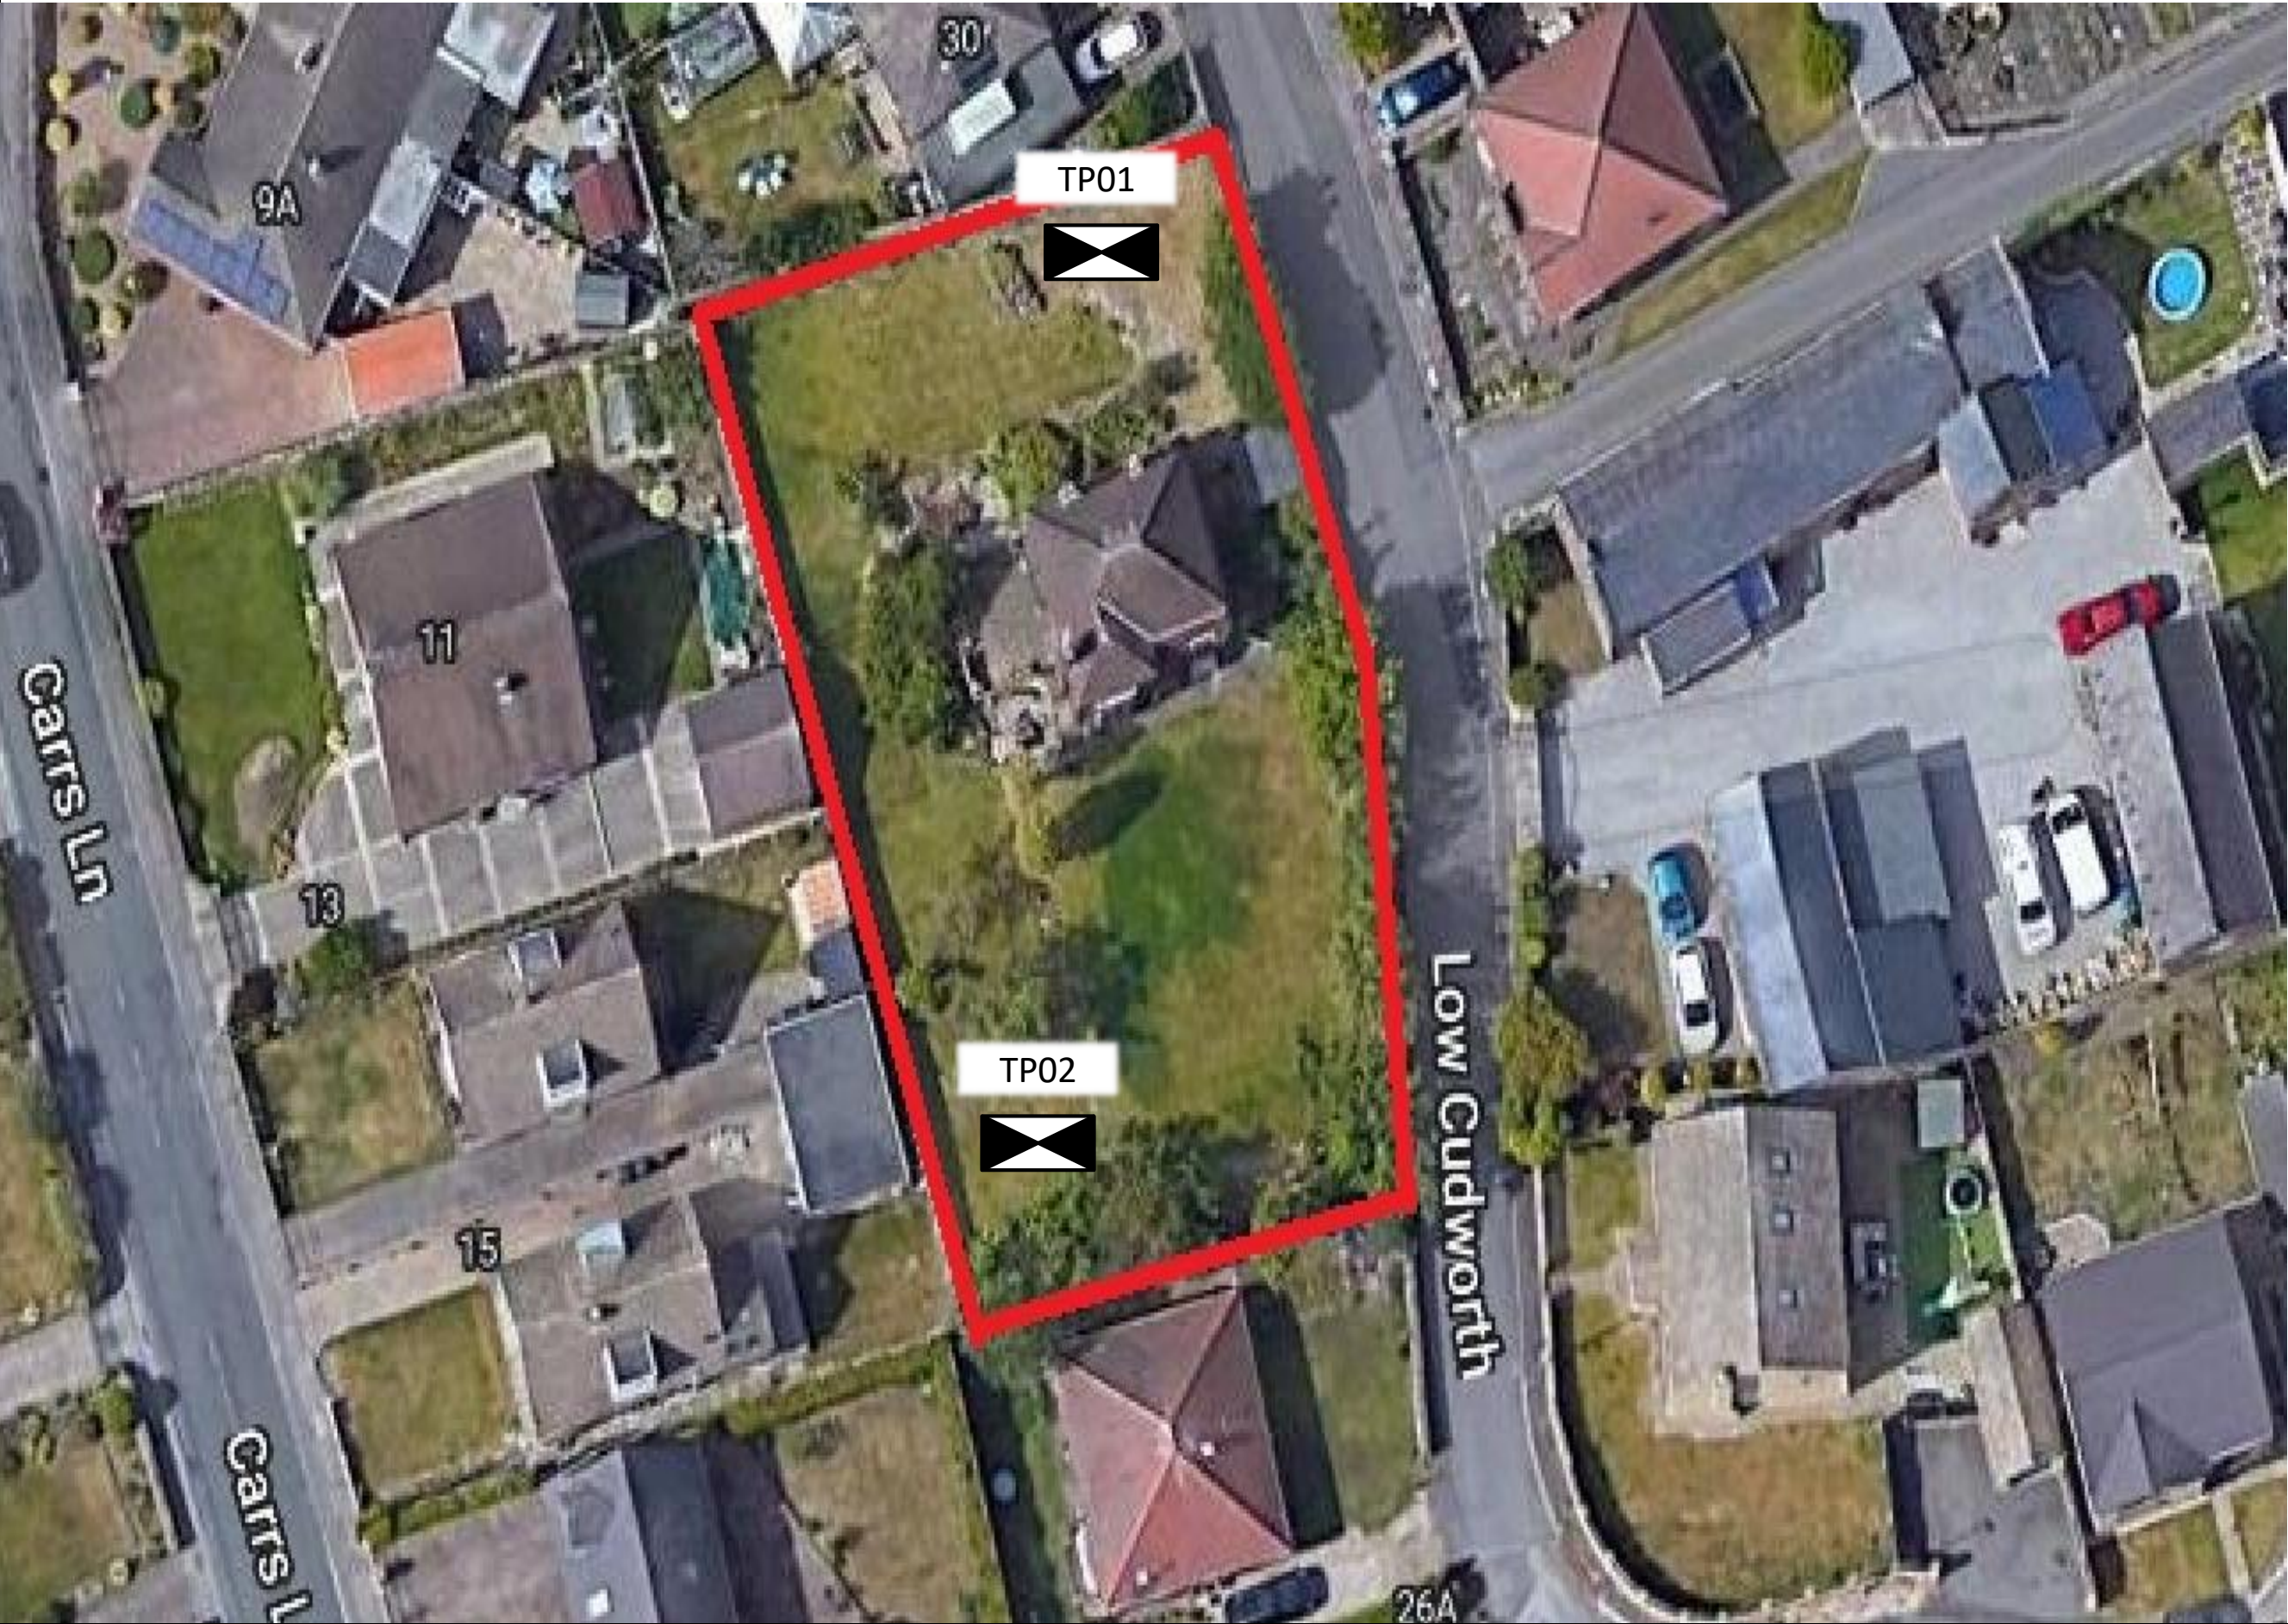
Site Plan

Notes:
Investigation positions approximated from site operative's notes.

Two trial pits were excavated in order to undertake soakaway testing, the positions of which are shown in Appendix 1. The soakaway tests were undertaken at the base of the pit at depths rational to the construction of soakaways. The soils exposed in the trial pits were logged on site in general accordance with BS5930: 2015 +A1: 2020, and full descriptions are given on the trial pit records which are presented in Appendix 2. Photographs of the trial pits are included within Appendix 3.

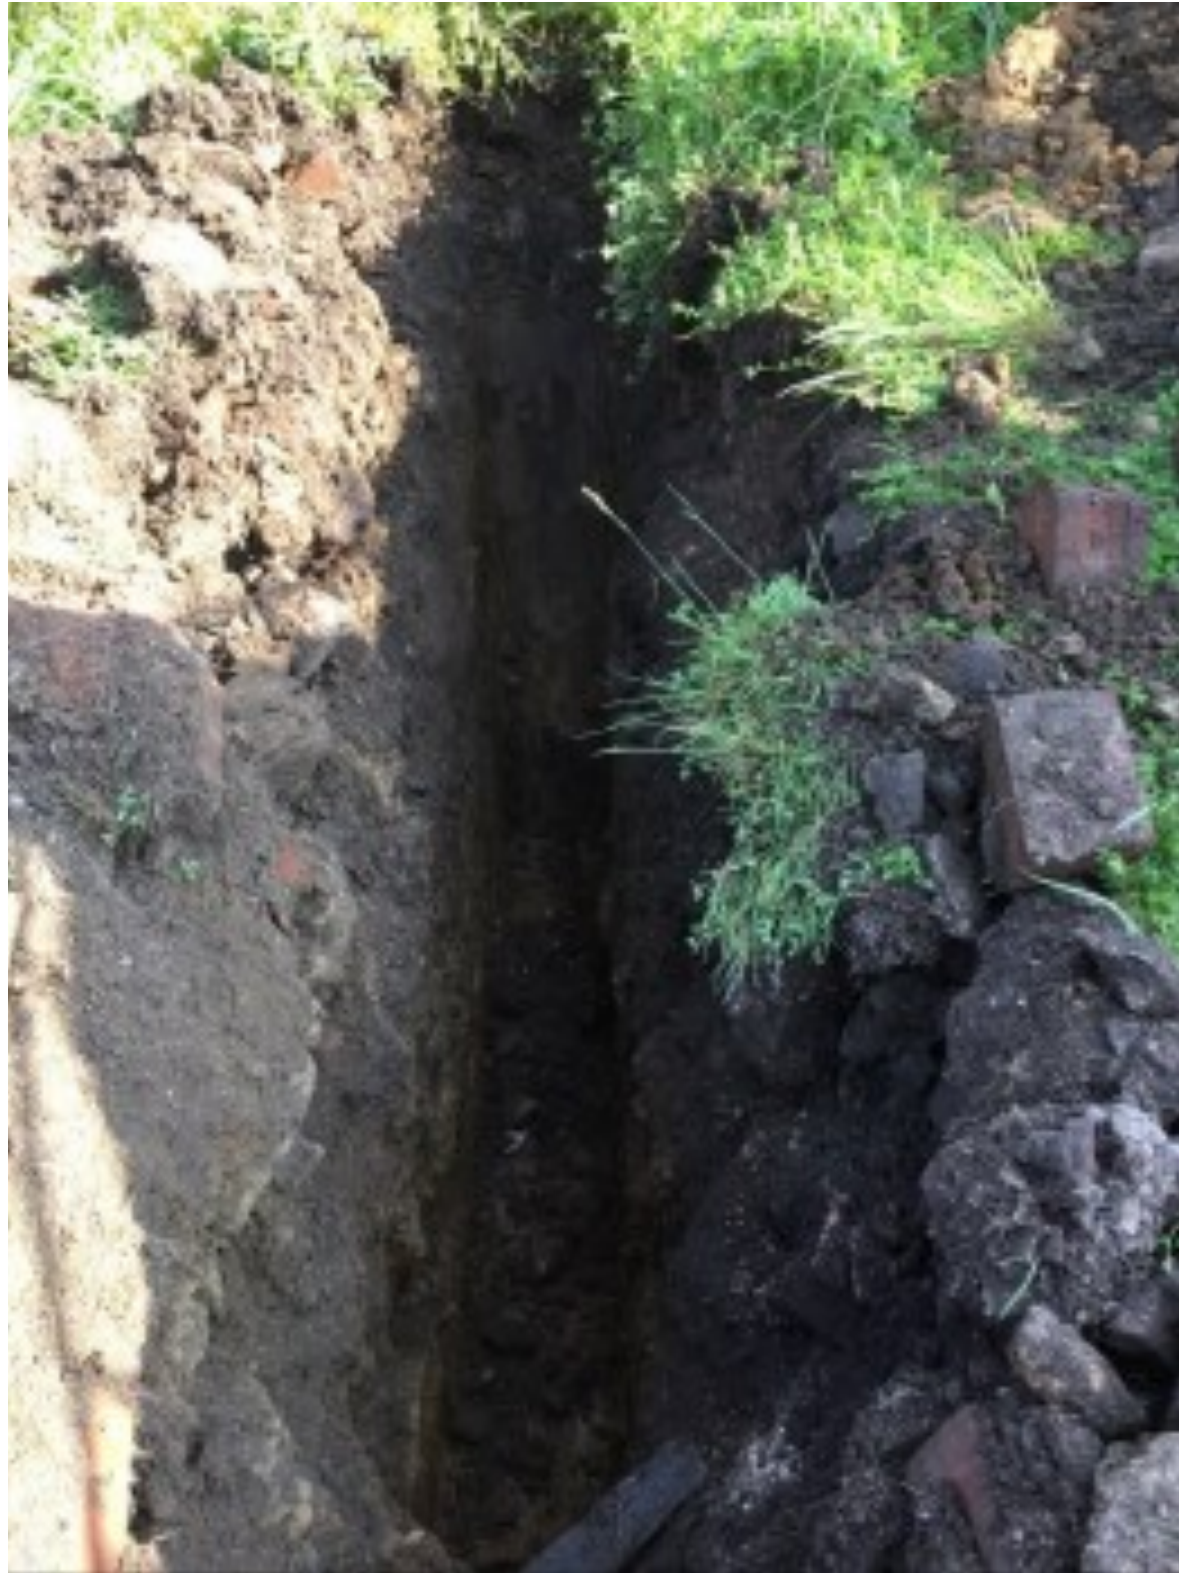
Photo 1: Image showing TP01.

| Water Strike | Samples and In Situ Testing | | | Depth (m) | Level (m) | Legend | Stratum Description | |
|---|---|---|---|---|---|---|--|---|
| | | | | 0.60 | | | TOPSOIL (Dark brown slightly sandy gravelly clayey SILT with low cobble content. Sand is fine to medium. Gravel is angular to subrounded and fine to coarse of sandstone and brick. Cobbles are angular to sub-angular and less than 200mm of sandstone and brick. | 1 |
| | | | | 1.29 | | | Soft to firm brown mottled light grey sandy slightly gravelly silty CLAY. Sand is fine to medium. Gravel is sub-angular to sub-rounded and fine to medium sandstone. | 2 |

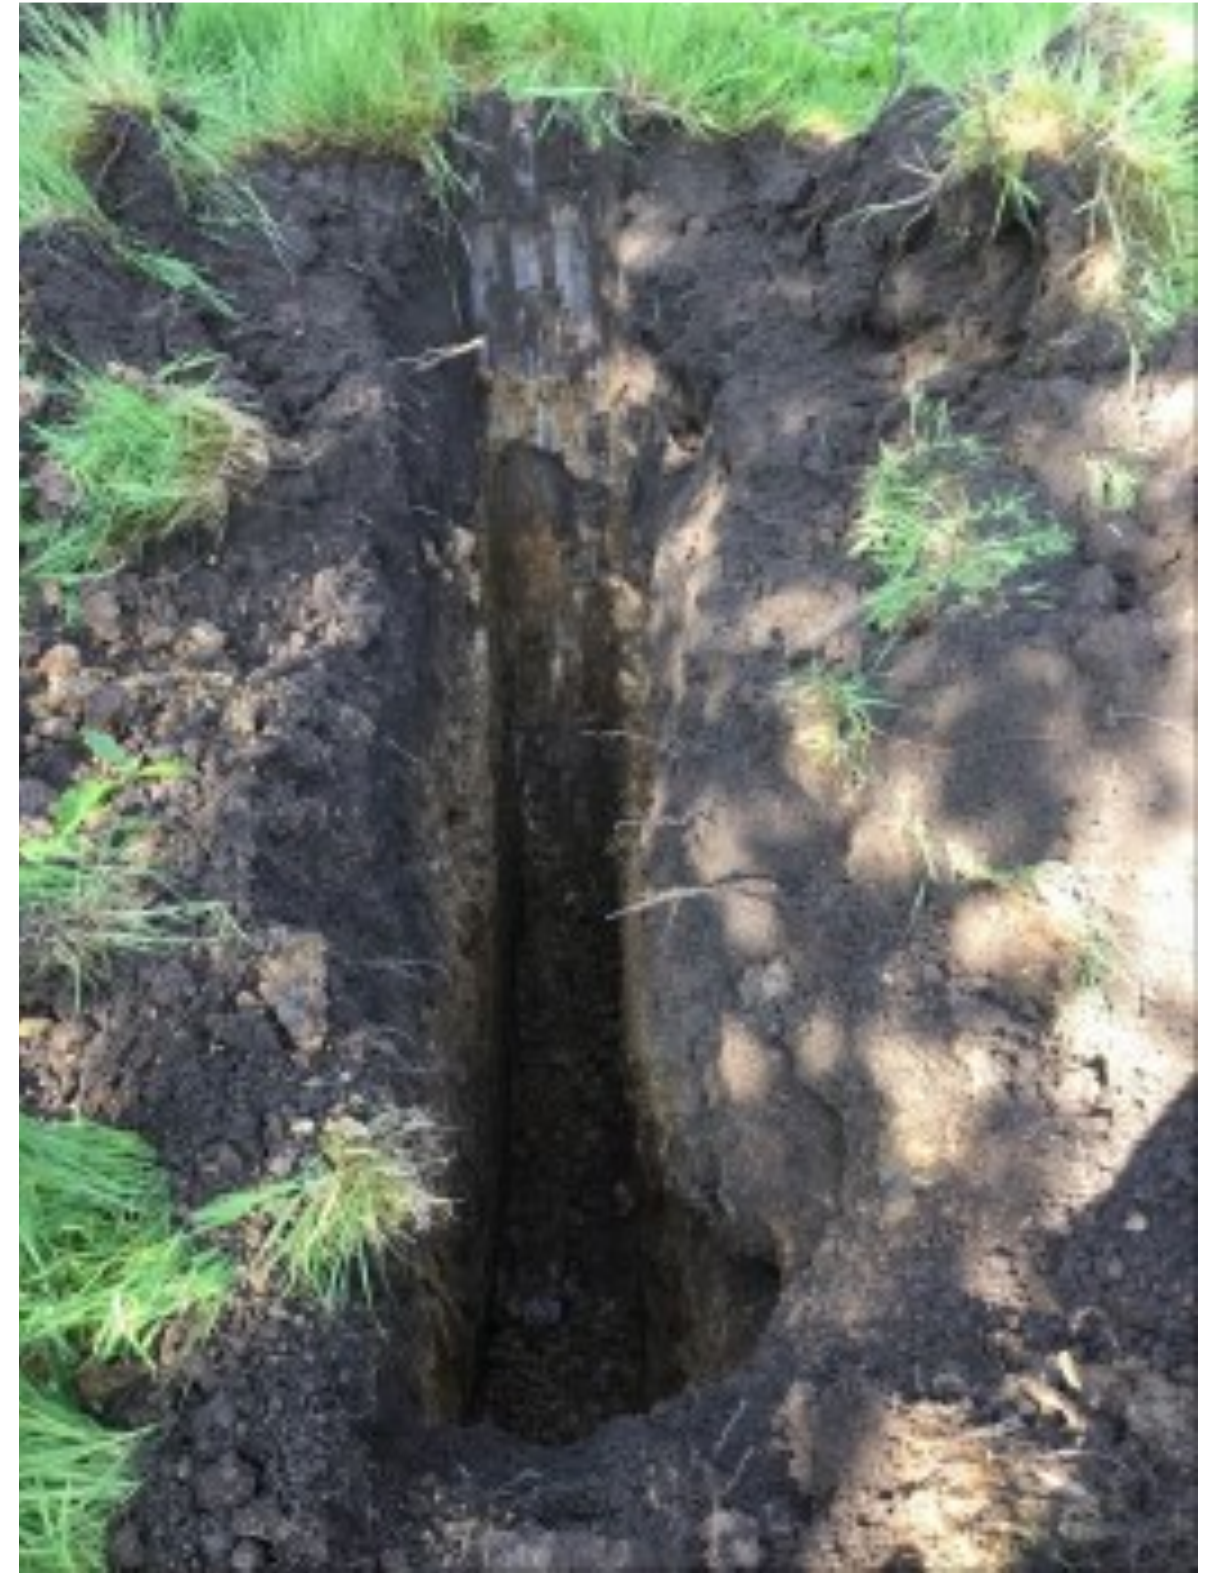
Photo 2: Image showing TP02.

| Water Strike | Samples and In Situ Testing | | | Depth (m) | Level (m) | Legend | Stratum Description | |
|---|---|---|---|---|---|---|---|---|
| | | | | 0.40 | | | TOPSOIL (Dark brown sandy, slightly gravelly, clayey SILT. Sand is fine. Gravel is sub-angular and fine to medium sandstone). | |
| | | | | 0.95 | | | Soft to firm brown mottled light grey slightly sandy silty CLAY. Sand is fine. | 1 |
| | | | | 1.28 | | | Firm light grey mottled brown slightly sandy silty CLAY. Sand is fine. | |
