**Project:** 23\_PRA\_08\_28  
**Site:** 25-27 Millhouses Street, S74 9BQ  
**Client:** Sam Shaw

| Report Type: | Preliminary Bat Roost Assessment Report [PRA] |
| Site Address: | 25-27 Millhouses Street, S74 9BQ |

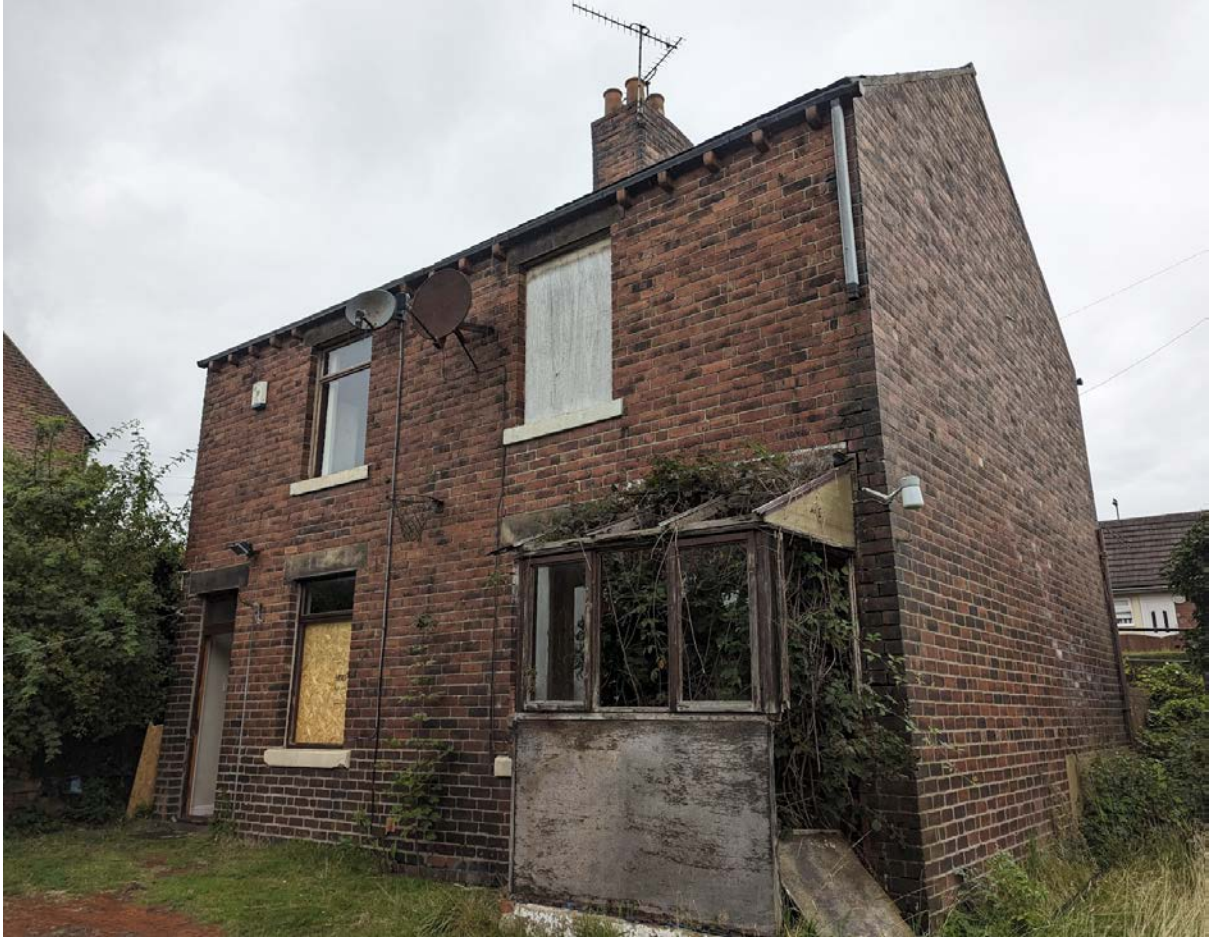
Building B1 is a detached two storey residential dwelling house that is dilapidated. It has a pitched roof covered with slate tiles. The loft void is unlined and there is no boarding in the loft. Some windows are missing and the property is only partially glazed. Mortar is missing from the eaves and there are no soffits or bargeboards present. There are some slipped and missing tiles on the northern and southern elevations.

*Plate 1: The southern elevation of B1.*

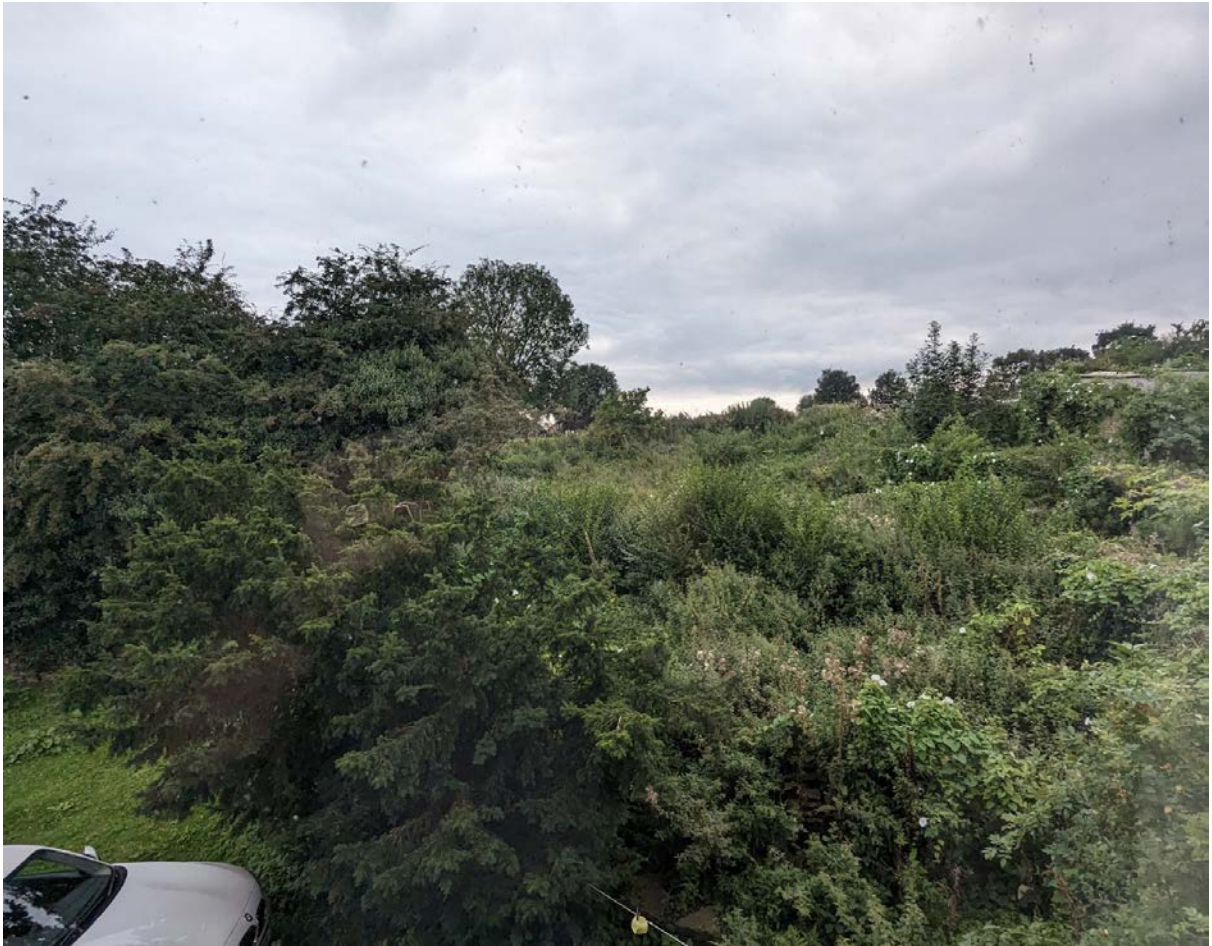
The landscape immediately adjacent to the property supports patchy scrub, hedgerows and broadleaf trees that provides excellent foraging habitat for bats in calm conditions.

*Plate 2: Foraging habitat to the south of B1.*

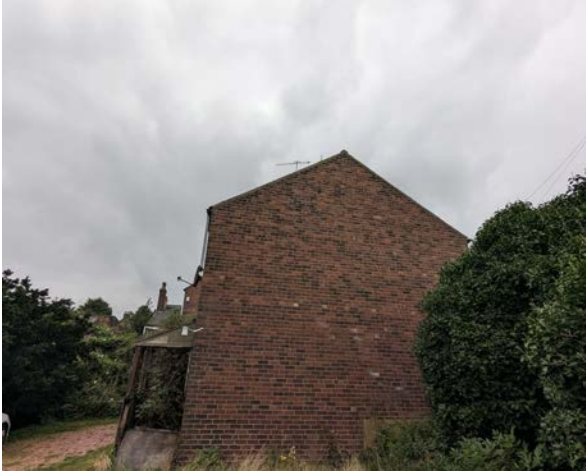
| Detail | Photograph |
|---|---|
| <p><i>Plate showing the eastern elevation</i></p> | <p>A photograph showing the eastern elevation of a large, multi-story brick building. The building has a steep gabled roof and is surrounded by greenery. The sky is overcast with grey clouds.</p> |

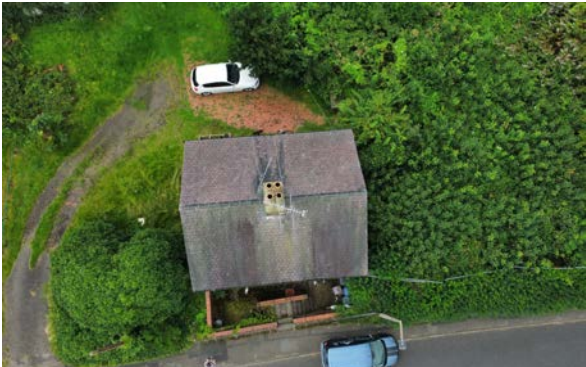
| Detail | Photograph |
|---|---|
| <p><i>Aerial plate showing the roof of the property</i></p> | <p>An aerial photograph showing the roof of the property. The roof is dark and appears to be made of tiles or slates. The surrounding area is lush green with trees and a road is visible at the bottom.</p> |

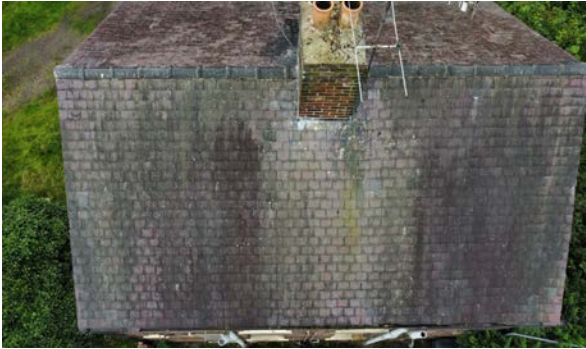
| Detail | Photograph |
|---|---|
| <p><i>Aerial plate showing the roof of the property</i></p> | <p>A close-up aerial photograph of the roof of the property. The roof is covered in dark, weathered tiles or slates. There is a small, light-colored structure or chimney on the roof.</p> |

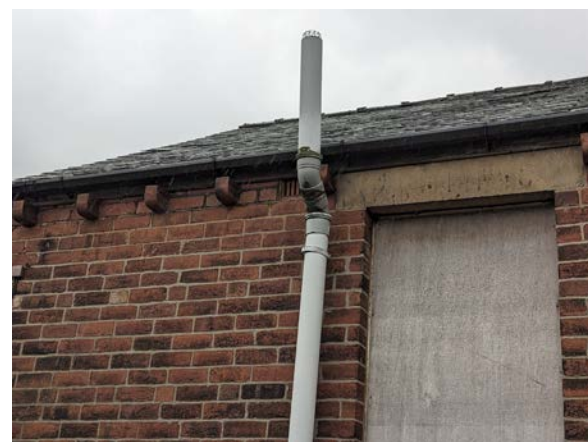
- 5.3 The missing mortar beneath the eaves and ridges provide roosting potential for crevice dwelling bats species such as Common and Soprano Pipistrelle species which are known to be present in the local area. Therefore, based on this information and the guidance outlined by the Bat Conservation Trust, the building has been assessed as having moderate suitability for roosting bats.

*Plate showing the eaves of the property and missing mortar*

- 5.4 To determine whether roosting bats are using the building, further bat emergence/re-entry surveys should be carried out. This would require 2 separate survey visits by 2 surveyors at dusk supported by night vision aids and thermal cameras. The visit should be carried out between May and August inclusive as the optimal period. September is considered sub-optimal.

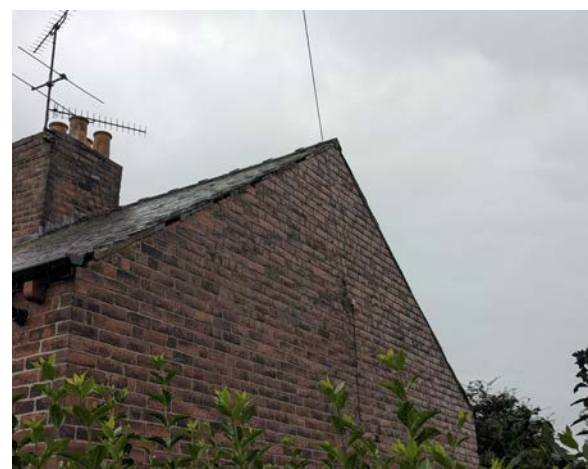
*Plate showing the eaves of the property and missing mortar*

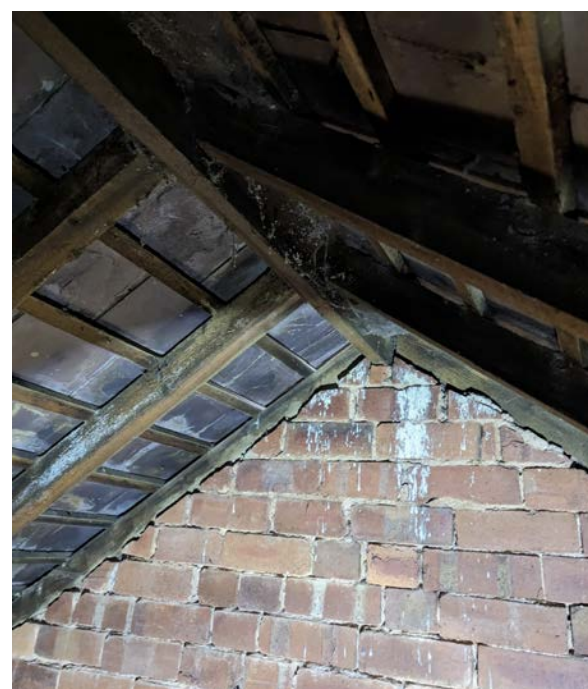
*Plate showing the loft void which is unlined and with a large number of suitable cracks and crevices*

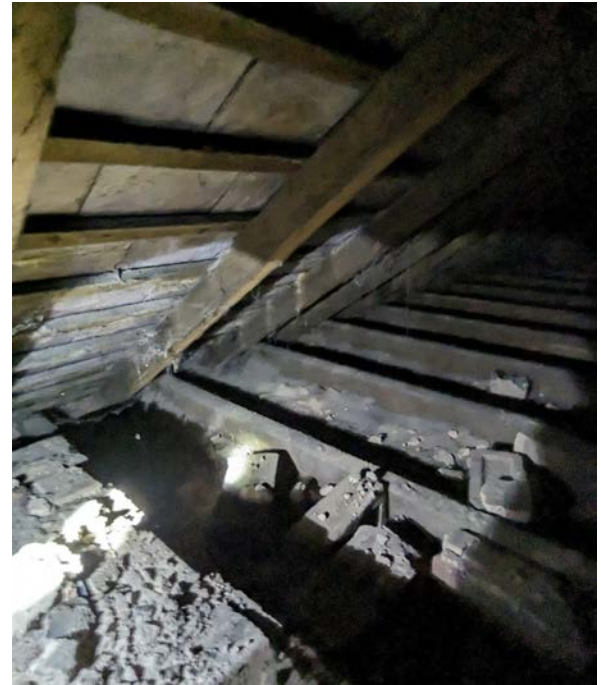
*Plate showing the loft void floor which is not lined.*
