# Mill Farm House, Oxspring

## Bat Survey Report

26<sup>th</sup> September 2019

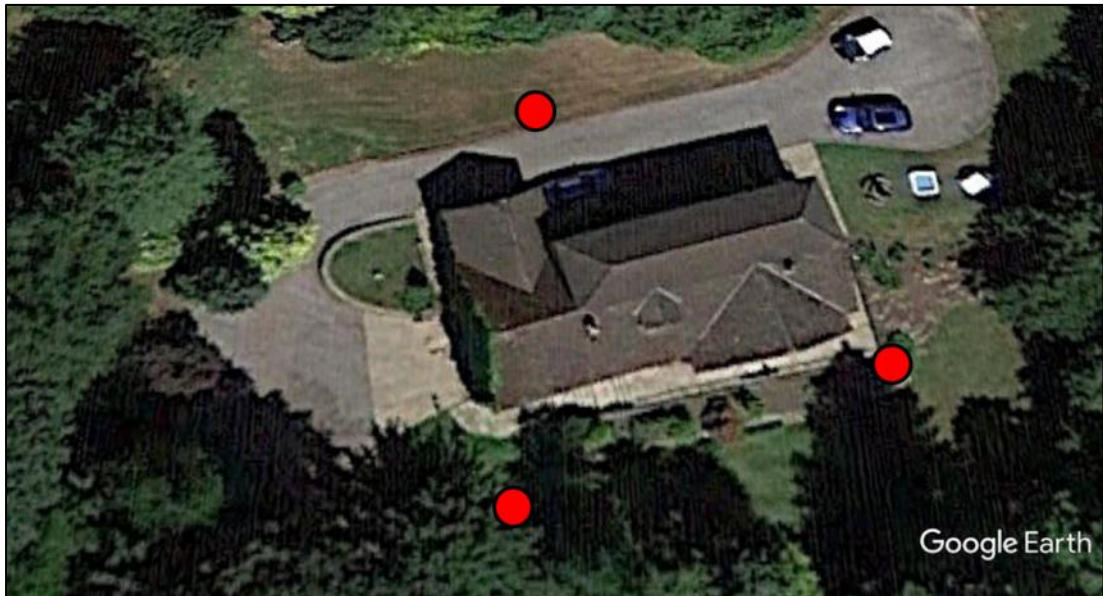
**Figure 2. Nocturnal surveyor location plan**

- A dawn return survey on the building was undertaken by RB, LM and AM on 28<sup>th</sup> August 2019, continuing from 90 minutes prior to sunrise until 15 minutes after this time.
- A dusk emergence survey was undertaken by RB, GS and AM on 25<sup>th</sup> September 2019, continuing from 15 minutes prior to sunset until 1.5 hours after this time.

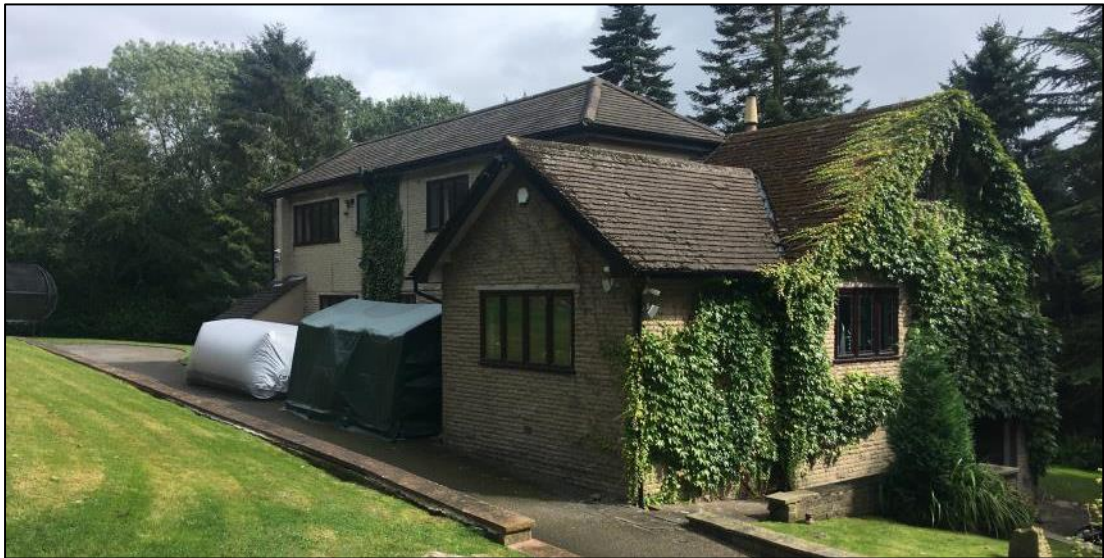
**Plate 1. Northwest corner of dwelling**

- 5.2.1 The two storey detached dwelling was constructed in 1966 from imitation stone concrete blocks with a multi-pitched concrete tile covered roof. The dwelling is partly constructed into a northwest to southeast orientated slope with a basement garage included at the southwest end of the dwelling. Roof fittings including wooden soffit boards, fascia board and barge boards are present, whilst the building has cavity walls and timber framed double-glazed windows. A dormer built into the southeast roof pitch has timber cladding. Dense vegetation is growing against the southwest gable. Security lighting is present on all elevations of the dwelling.

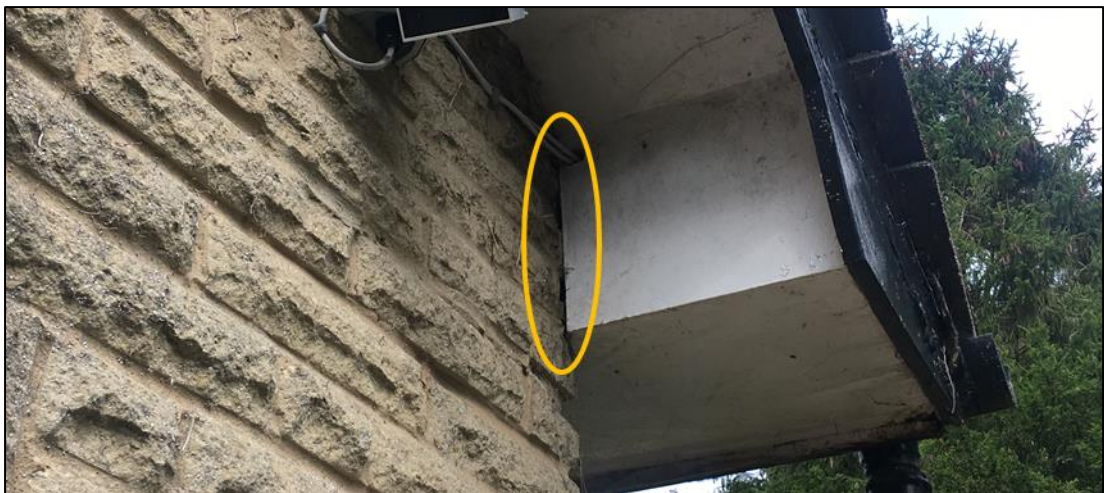
**Plate 3. Potential bat access points between soffit and wall**

- 5.2.2 The dwelling exterior is generally in a reasonable state of repair, however, there are occasional small crevices (up to 20mm deep) between soffit boards and the adjacent walls. There are also crevices between roof tiles above gables verges on all elevations of the house and there are crevices between hip tiles. A rotten soffit board is present at the southeast corner of the dwelling.

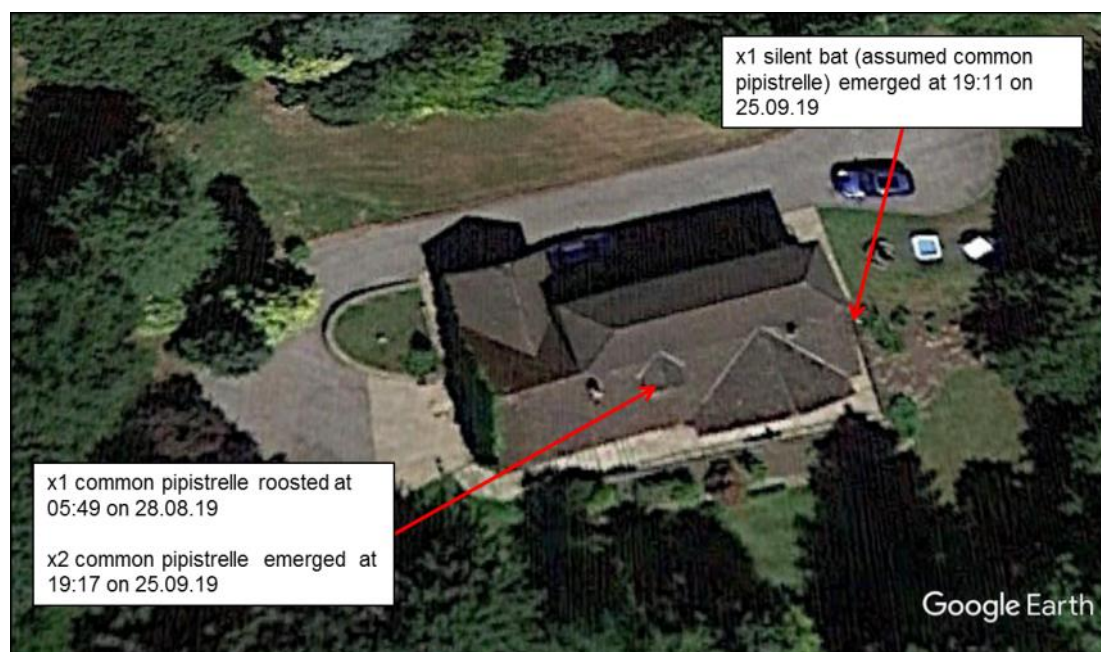
**Figure 3. Roost observations made during nocturnal survey**

- 5.2.5 All bat roost observations are shown on Figure 3. Two roost locations were recorded

from the dwelling, used by a maximum count of three bats. All bats were confirmed, or assumed to be common pipistrelle.

- 5.2.7 A single common pipistrelle was recorded returning to roost in the roof verge of the dormer window (southeast pitch) at 05:49 (17 minutes before sunrise). This was preceded by regular common pipistrelle activity recorded on all sides of the dwelling. A single soprano pipistrelle pass was heard at 04:46, with a pass by a *Myotis* bat species recorded at 05:26. This bat is considered likely to be Daubenton's bat on the basis of automatic species identification and the close proximity to the river.

- 5.2.9 At 19:11 (12 minutes after sunset) a silent bat emerged from the northeast roof verge. This bat was considered likely to be a common pipistrelle on the basis of time of emergence, flight pattern and the predominance of this species on site. At 19:17 (18 minutes after sunset) two further common pipistrelle bats emerged from the verge of the dormer window, the roost location also recorded during the dawn survey.
