Section 19 application for insertion of new timbers to support ceilings

Northern College, Wentworth Castle, Stainborough, Barnsley

Section 19 application: Ceiling timber reinforcement at the Northern College

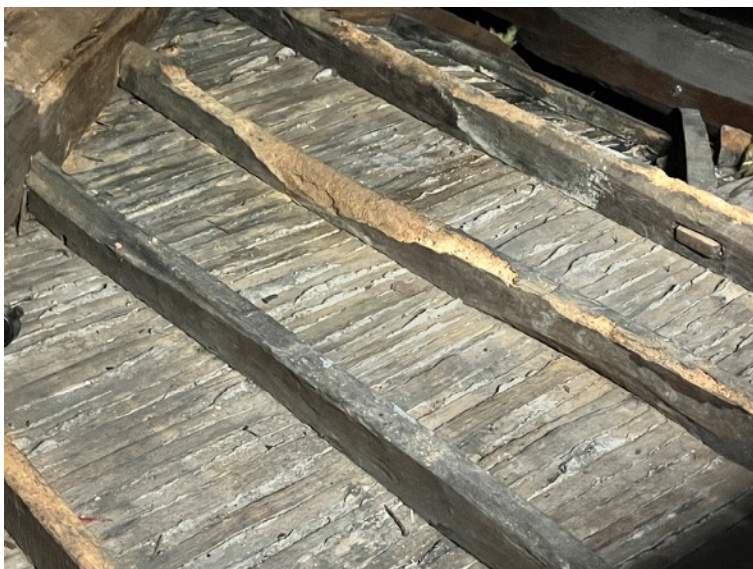
Photo showing the reduced size of timbers. New timbers of similar size will be placed alongside and screwed to the existing.

Where section sizes are considerably depleted it is proposed to double up the timbers with treated softwood. The new timbers will be fixed to the existing using Reisser Cutter (or similar) Wood Screws of as small a diameter as possible. Screws to be driven with a driver with a torque setting to avoid over sinking of head to reduce risk of splits.

If required new timbers will be fixed with binders fixed spanning joists to either side to spread load and bearing of joists. The new timbers will be date marked to identify the repair in future years.

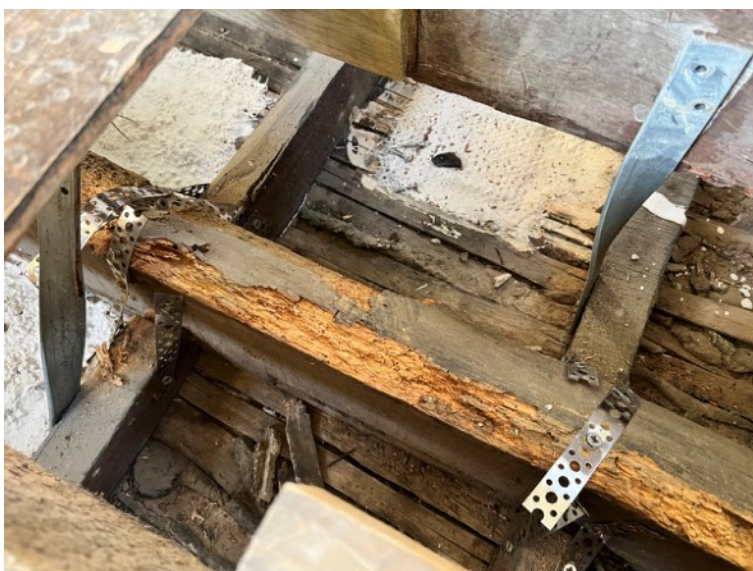
Similar damage has occurred in the floor void below the south of the long gallery.
