# **Phase 2 Ground Investigation Report**

## **Caretakers House, Bank End Primary School**

Document No. 251012/2

Prepared for **Barker Associates Limited**

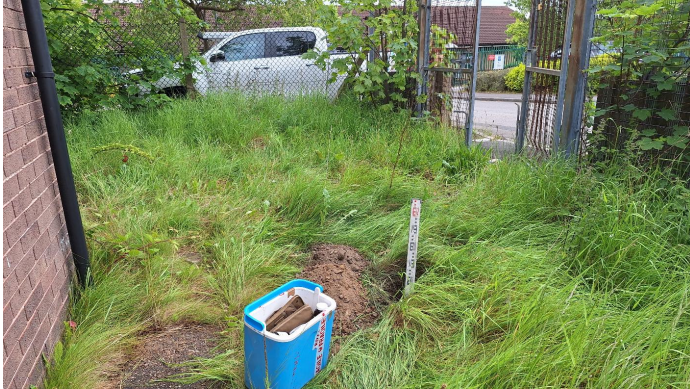
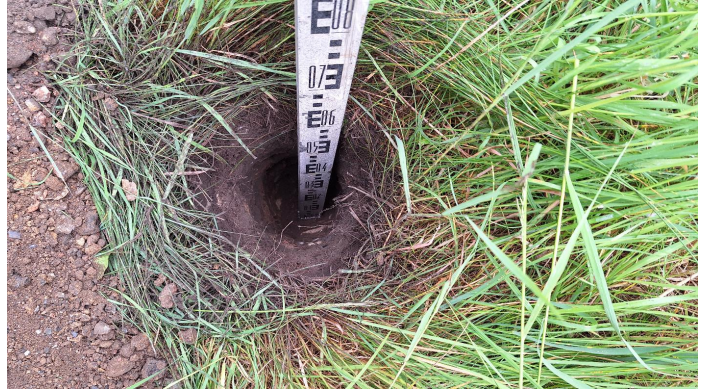
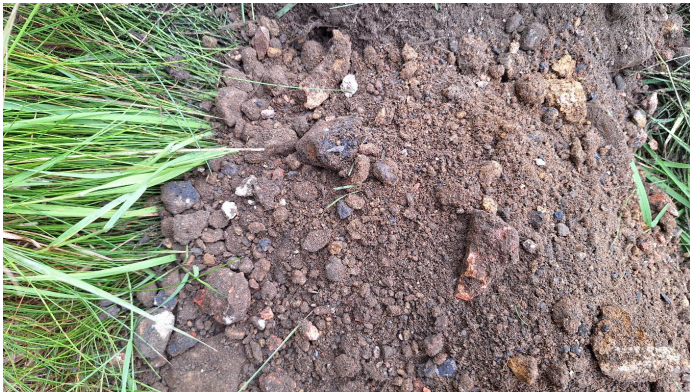
<b>Hole Type</b> HP	<b>Easting</b> 436176.00	<b>Northing</b> 404491.00	<b>Ground Level (m)</b>	<b>Scale</b> 1:25
<b>Project Name</b> Caretakers House Bank End Primary School		<b>Project No.</b> 251012	<b>Start Date</b> 2025-05-29	<b>End Date</b> 2025-05-29

**Remarks**  
Terminated due to an obstruction

**Method, Plant, Stability, Dimensions**      **Logger**  
0.00 - 0.75m    HP Hand dug      D Treanor  
Stable

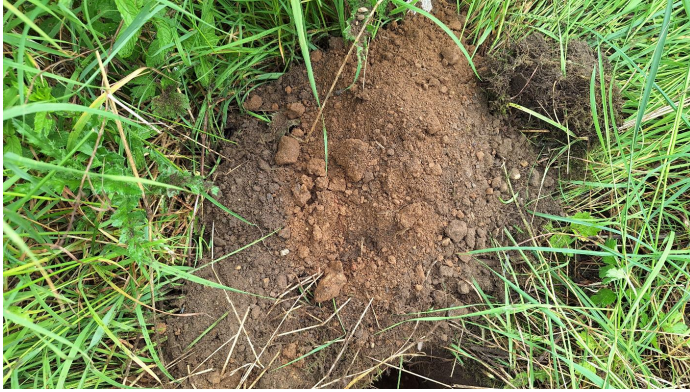
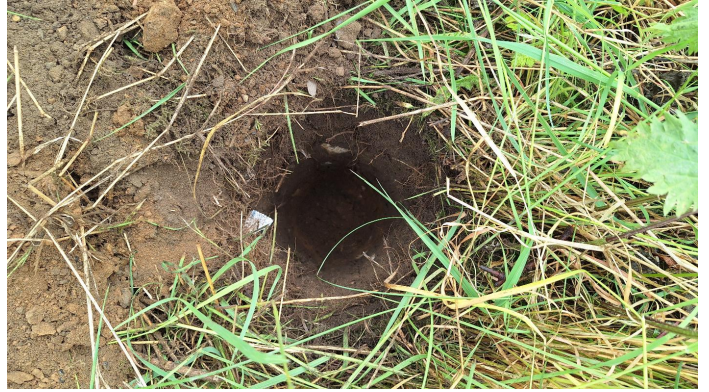
<b>Hole Type</b> HP	<b>Easting</b> 436161.00	<b>Northing</b> 404491.00	<b>Ground Level (m)</b>	<b>Scale</b> 1:25
<b>Project Name</b> Caretakers House Bank End Primary School		<b>Project No.</b> 251012	<b>Start Date</b> 2025-05-29	<b>End Date</b> 2025-05-29

**Remarks**  
Terminated due to an obstruction

**Method, Plant, Stability, Dimensions**      **Logger**  
0.00 - 0.60m    HP Hand dug      D Treanor  
Stable

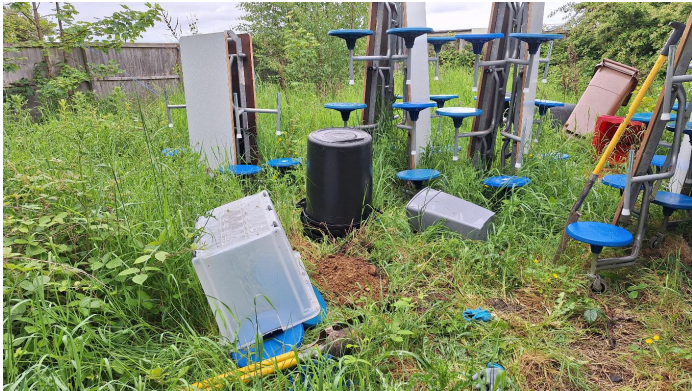
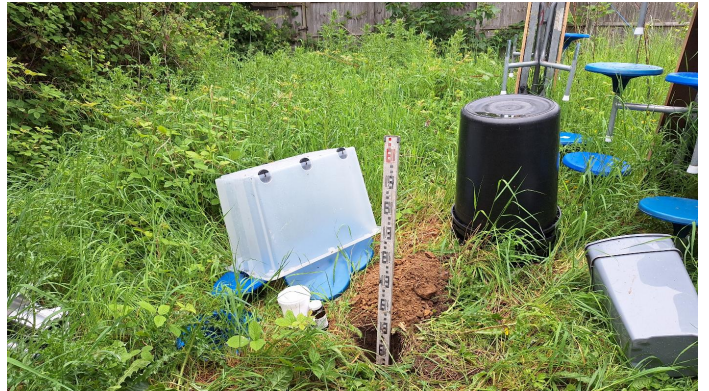
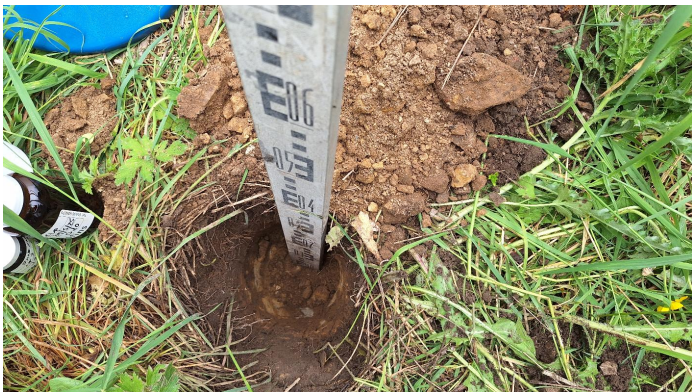
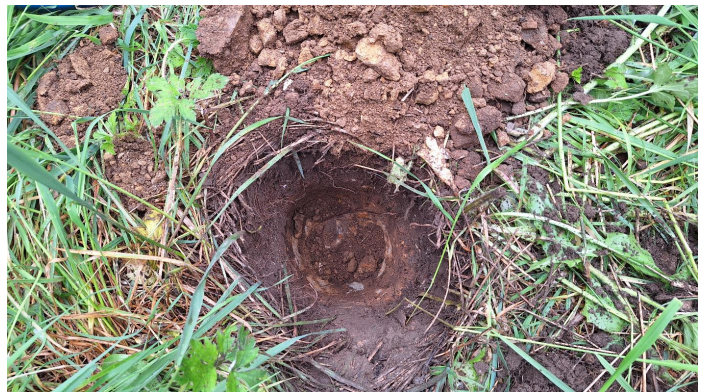
<b>Hole Type</b> HP	<b>Easting</b> 436161.00	<b>Northing</b> 404500.00	<b>Ground Level (m)</b>	<b>Scale</b> 1:25
<b>Project Name</b> Caretakers House Bank End Primary School		<b>Project No.</b> 251012	<b>Start Date</b> 2025-05-29	<b>End Date</b> 2025-05-29

**Remarks**  
Terminated due to an obstruction

**Method, Plant, Stability, Dimensions**  
0.00 - 0.60m HP Hand dug  
Stable

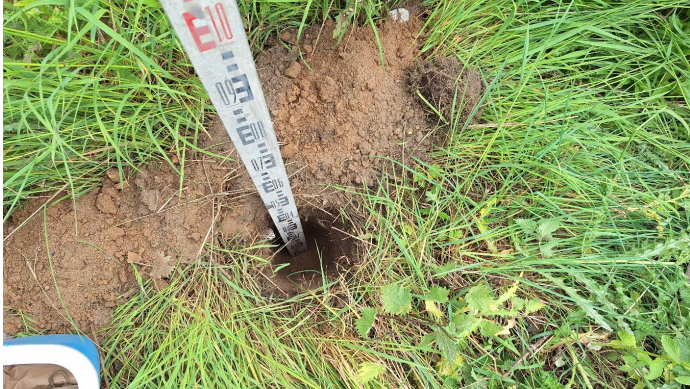
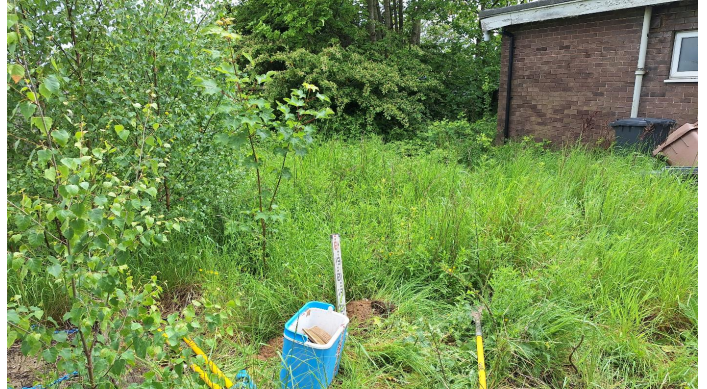
<b>Hole Type</b> HP	<b>Easting</b> 436170.00	<b>Northing</b> 404505.00	<b>Ground Level (m)</b>	<b>Scale</b> 1:25
<b>Project Name</b> Caretakers House Bank End Primary School		<b>Project No.</b> 251012	<b>Start Date</b> 2025-05-29	<b>End Date</b> 2025-05-29

**Remarks**  
Terminated due to an obstruction

**Method, Plant, Stability, Dimensions**      **Logger**  
0.00 - 0.40m    HP Hand dug      D Treanor  
Stable
