BARNESLEY WEST

OTTER AND WATER VOLE SURVEY

DATE ISSUED: October 2023
JOB NUMBER: LD10361
REPORT NUMBER: APPENDIX 7.6
VERSION: V0.1
STATUS: Final

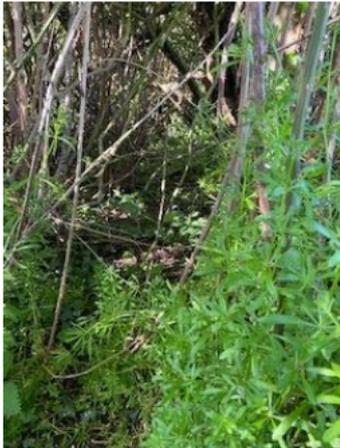
Watercourse ID Number	Description	Photo	Suitability
D1	Field boundary ditch with mature hedge above. Ditch is partially dry becoming wet with shallow water 0.02m max depth. Channel is approximately 1m wide with and predominantly bare earth due to heavy shading from hedge above. No emergent or aquatic vegetation is present. Banks are 0.5m high with limited sparse vegetation comprising ivy Hedra helix and common nettle.

Negligible

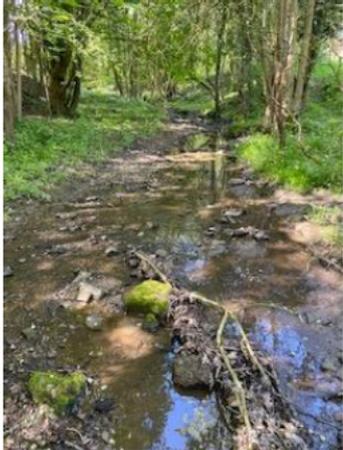
Watercourse ID Number	Description	Photo	Suitability
D2	<p>Stream (western leg). Banks are shallow almost flat in places and support woodland flora and ruderal species to include common nettle, creeping buttercup <i>Ranunculus repens</i>, cleavers <i>Galium aparine</i>, broadleaved dock <i>Rumex obtusifolius</i>, Ramsons <i>Allium ursinum</i> and lesser celandine <i>Ranunculus ficaria</i>. To the south the banks become steep greater than 45° and undercut in places. The channel is various widths ranging from 0.5m-1m wide with a slow flow. No aquatic or emergent vegetation is present in this area. The water flows south to north</p>

Poor but Suitable
D3	<p>Stream through Craven wood (Eastern leg). Here the banks are steep sided and vertical and in places undercut. Banks extended to approximately 3m high in places. Channel sides are bare due to heavy shading from Craven wood. The channel is 1m-1,5m wide with slow to moderate flow. No aquatic vegetation or emergent vegetation was present in this section of the stream.</p> <p>The stream continues beyond Hermit Lane to the South along the edge of Craven Wood. Banks are steep and variable in height steep and greater than 45° or vertical and undercut. Banks are also variable in height.</p>

- 4.1.1 Otters are very mobile species and can cover large territories extending approximately 40km. Given that otters were recorded by the desk study within 2km of the site boundary it is recommended that as a precaution a 10m buffer from the larger streams namely D2 and D3 is retained to provide a sheltered undisturbed corridor for commuting. This buffer should be fenced to ensure breaches by construction vehicles during the construction period is avoided.
- 4.1.2 As no evidence of otter or water vole was recorded from Site they are considered likely to be absent as resident species.

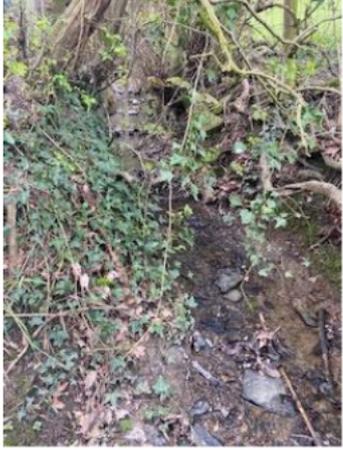
Poor but Suitable

- 3.3.2 No water vole field signs to include burrows, latrines, droppings, feeding stations or pathways were recorded during the survey of watercourses on site.
- 3.3.3 Several rat burrows were recorded along D3. Burrows were larger in diameter, and some had a fan of spoil outside the entrance.

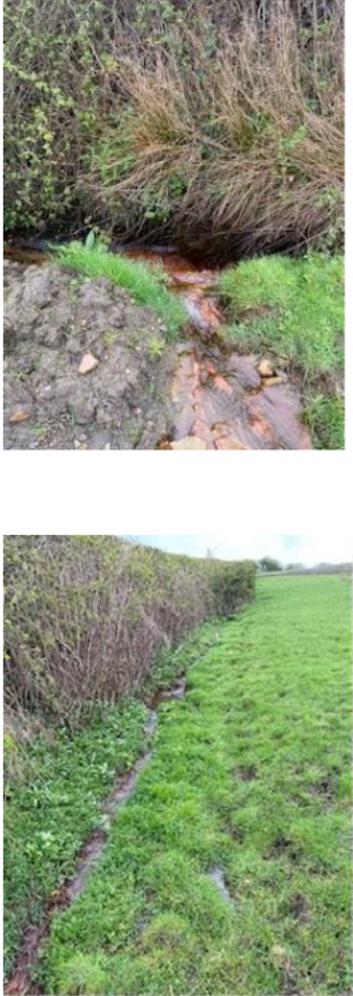
Watercourse ID Number	Description	Photo	Suitability
	Water flows in a south to north direction and merges with the Stream listed as D2.		
D4	<p>Partially culverted drain. Break in pipe exposes water run-off which seeps into field and meets a natural spring in the centre of the field. Here some aquatic vegetation is present such as floating sweet-grass <i>Glyceria fluitans</i> and brooklime <i>Veronica beccabunga</i>. The water collects in a half culvert along the base of a hedgerow and scrub. Here the flow is of moderate speed. No aquatic/emergent are present in this area. The water flows from the culvert into the natural watercourse along the base of the hedge. The channel here is very narrow only 0.2m wide but the water varies in depth between 0.02-0.1m. Banks along the natural section of the water course are also variable in gradient, being almost flat and poached to the west as its unfenced to the field. The east side supports a mature but managed hedge and a steeper bank. The ditch terminates at the field gate to the north, at this point the ditch is culverted beneath Hermit Lane and adjoins Craven Wood Stream (D2)</p>

Negligible

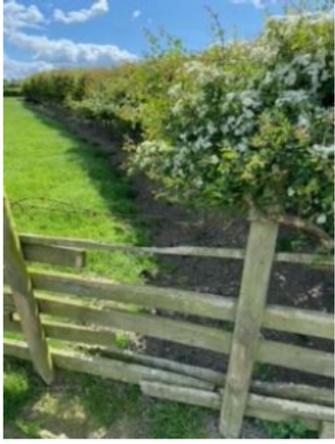
Watercourse ID Number	Description	Photo	Suitability
D5	A small section of ditch along an internal hedge that is no longer present. No evidence to suggest the area become wet or holds water during periods of high rain fall.

Negligible
D6	Field drain is no longer present. No depressions or waterlogging within areas mapped.

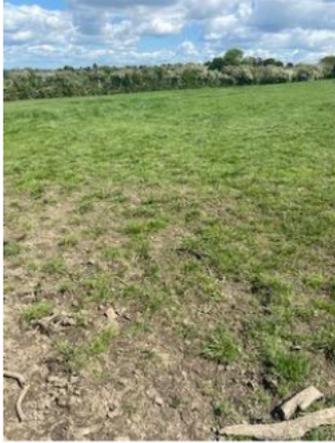
Negligible
D7	Dry internal field drain. Depression present along the base of hedge but no evidence of it ever supporting water. Dry ditch is narrow and meandering in nature. The ditch is predominantly bare dry earth and heavily horse poached as it is currently unfenced from the field.

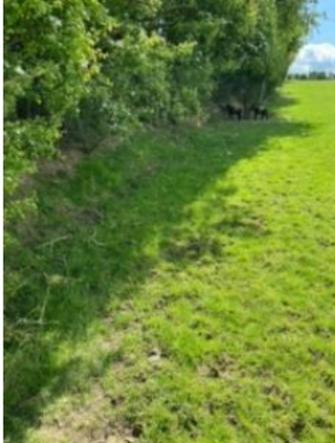
Negligible

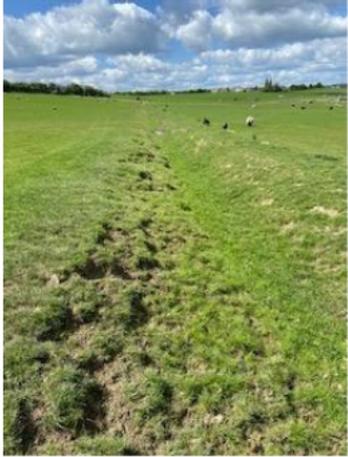
Watercourse ID Number	Description	Photo	Suitability
D8	<p>Wet/Damp man-made drain through field. Drain is approximately 1m wide and supports damp ground and shallow water max depth 0.04m, and supports annual meadow grass <i>Poa annua</i>, creeping bent <i>Agrostis stolonifera</i> and where the drain is wetter floating sweet-grass. The banks are approximately 45° and covered in short grazed grassland which extends from adjacent field. Drain is unfenced and sheep grazed.</p>

Negligible
D9	<p>Dry ditch, no visible signs the ditch has been wet over recent years.</p>

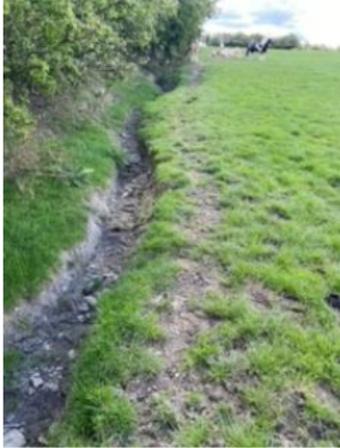
Negligible
D10	<p>Dry ditch present along internal field boundary hedge. Dry channel is approximately 0.5m wide with shallow banks <0.5m high. Banks support common nettle, creeping thistle and cleavers.</p>

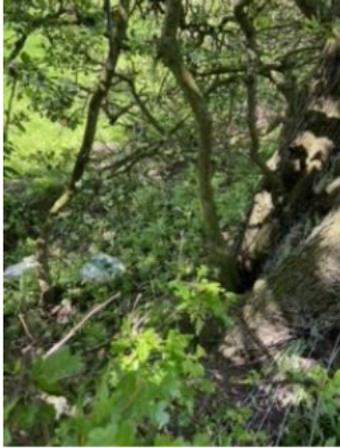
Negligible

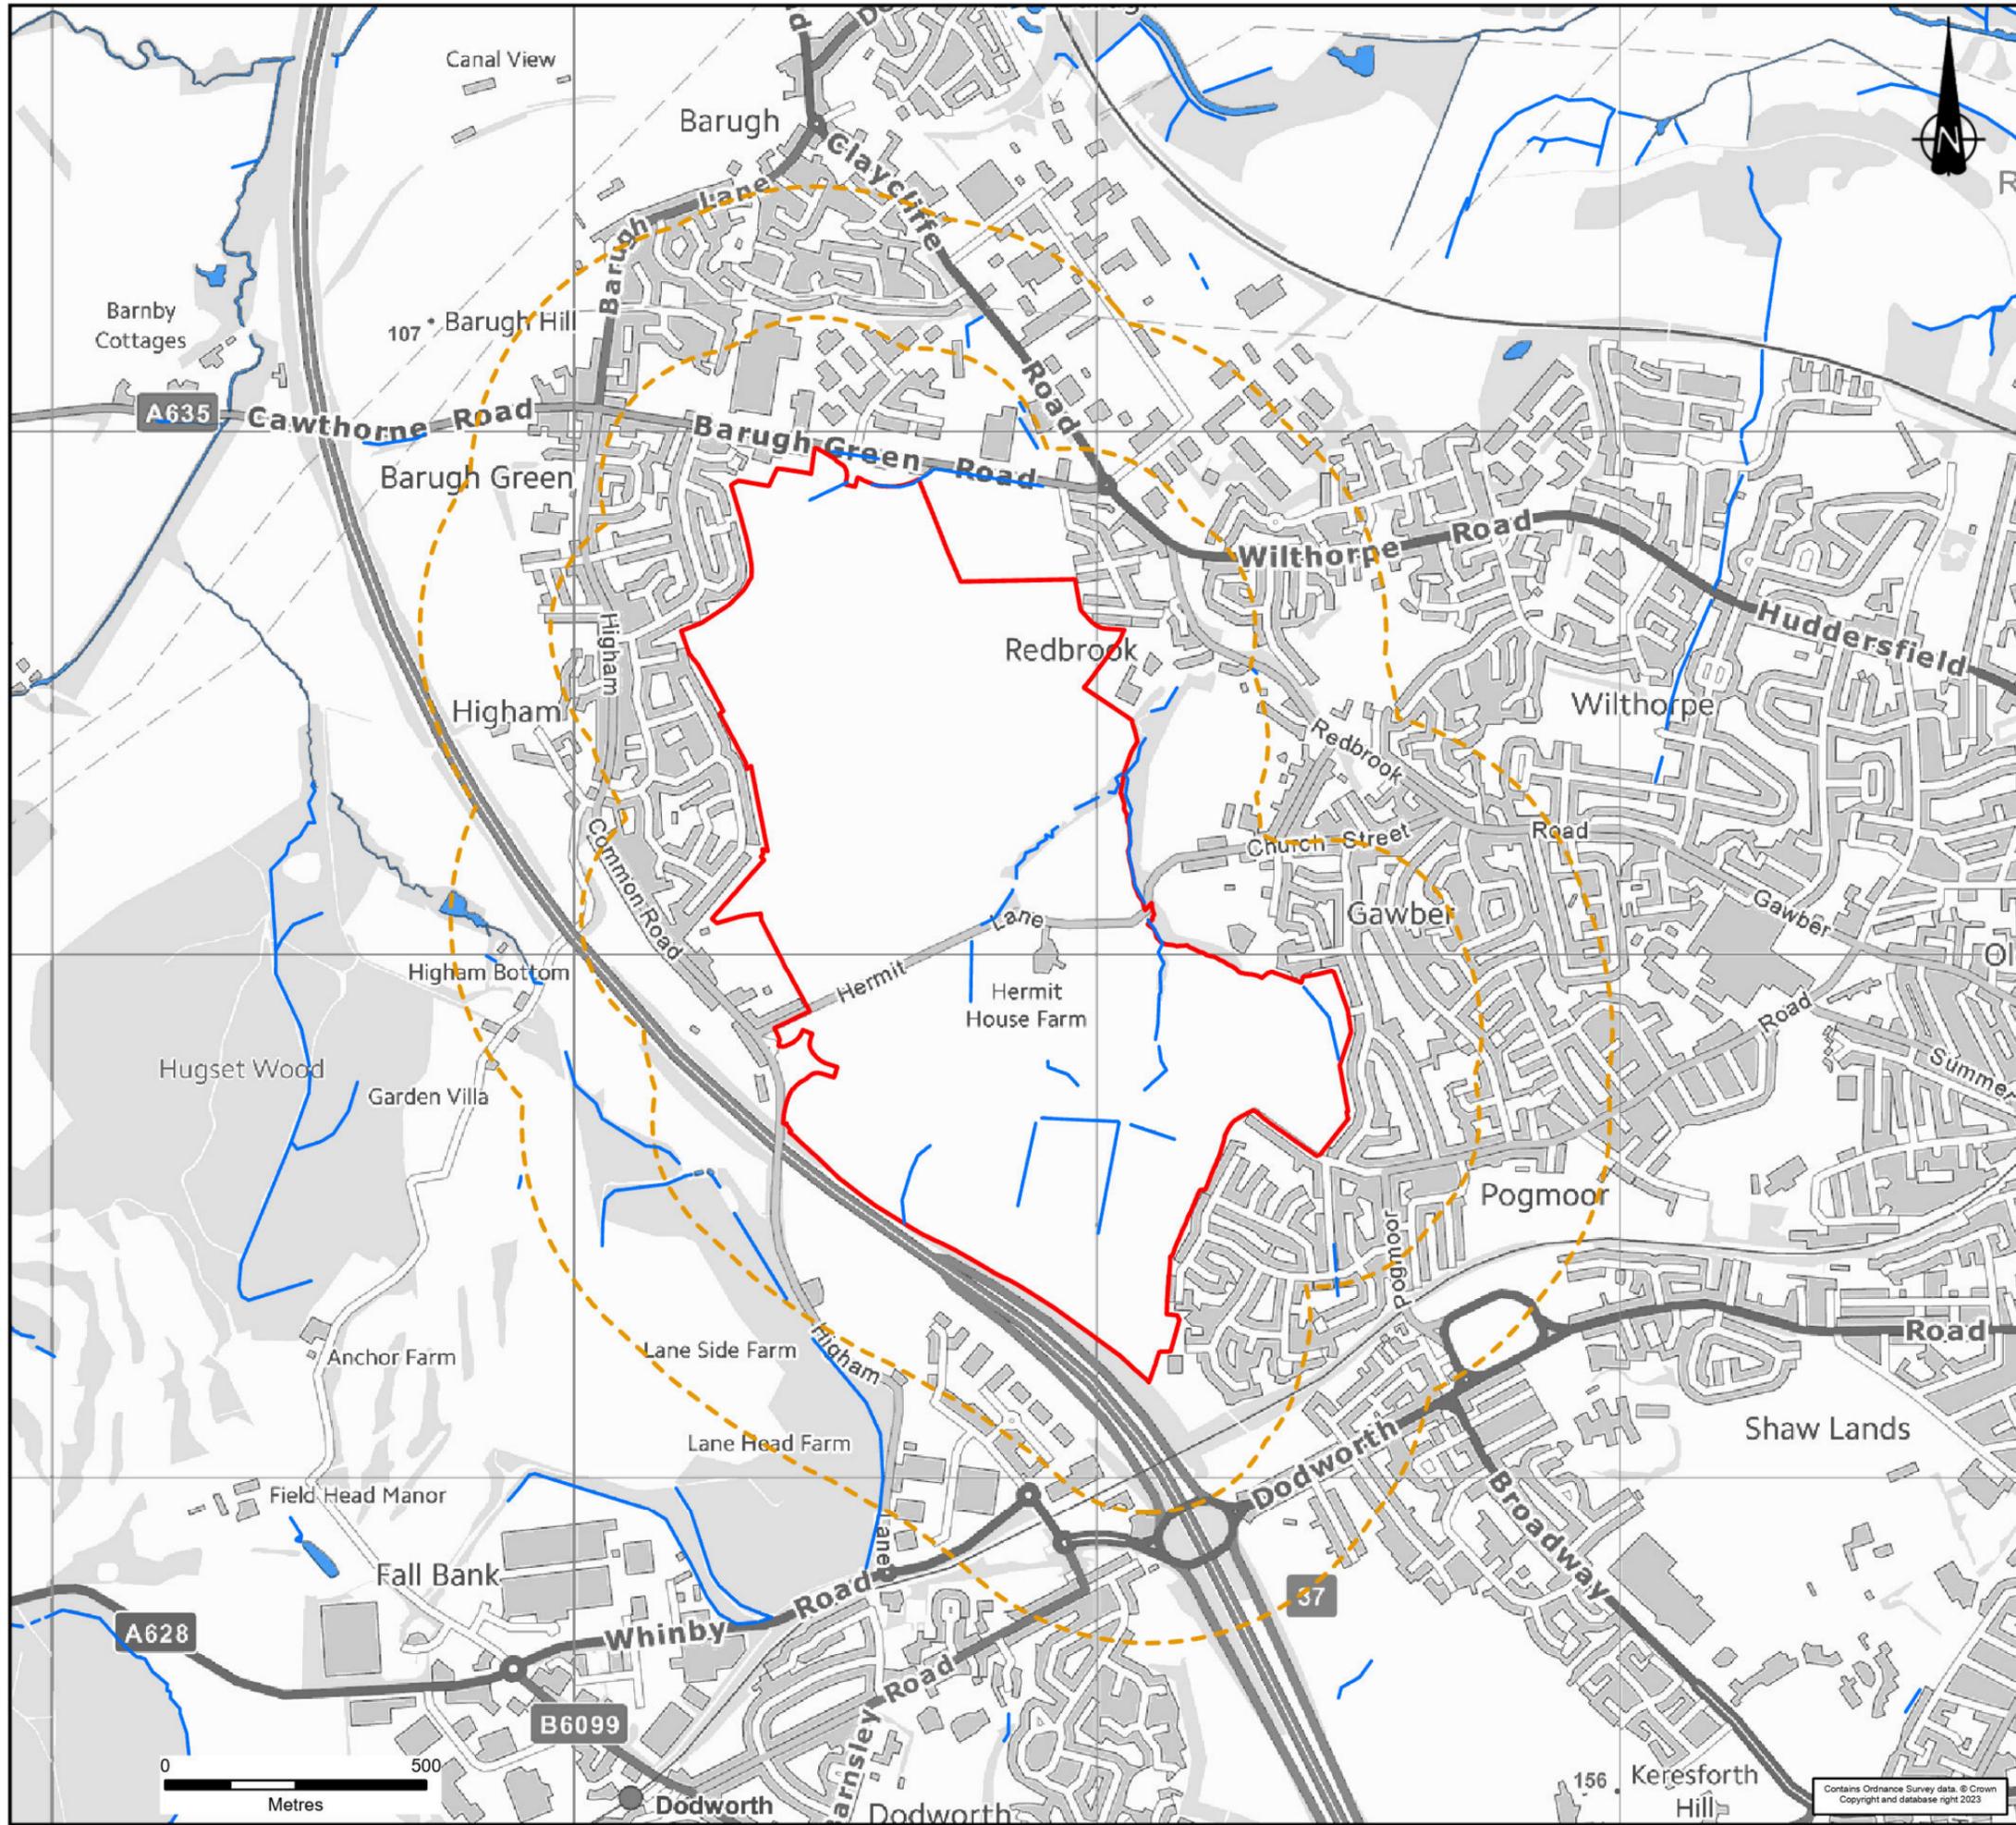
2.2.1 The otter survey broadly followed the standard guidance outlined in Monitoring the Otter, Conserving Natura 2000 Rivers, Monitoring Series No. 10 (Chanin, 2003). The ditches and streams were searched for signs including sightings, couches, holts, spraints, slides, feeding areas and remains, footprints and mammal paths. See Drawing LD10361/020 for waterbody locations.
