Bat Emergence and Re-Entry Surveys (BERS)

Alexandra Working Mens Club, 59 High Street, Royston, Barnsley, S71 4RF

9th July 2025

“The demolition of the on-site working men’s club building (B1) and two small outbuildings (B2 and B3).”

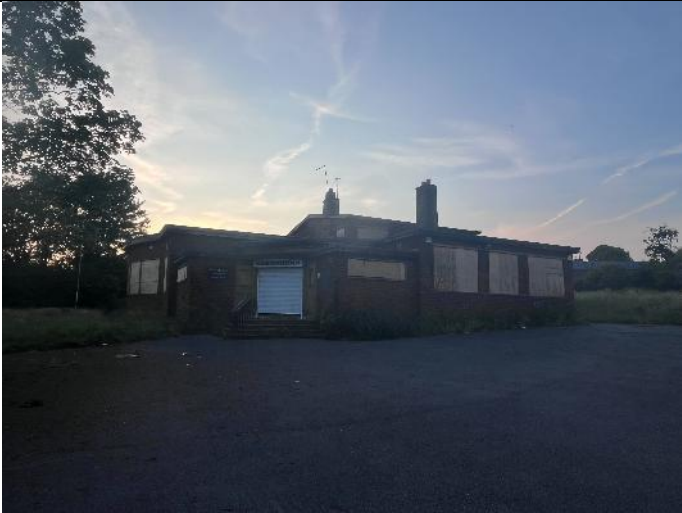
<i>IR position 1</i>	<p>Camera position: observing the south and east elevations of B1.</p> <p>Emergences observed: None.</p> <p><u>Summary of general activity:</u></p> <p>Activity was consistent with that observed by the surveyor of position 1.</p>

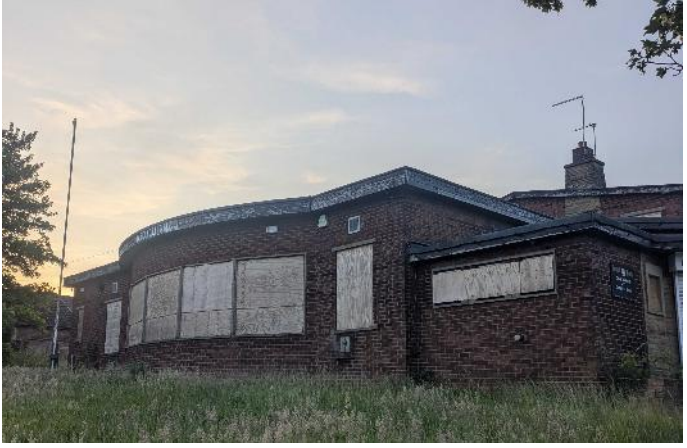
<p><i>IR position 2</i></p>	<p>Camera position: observing the south elevation of B1. Emergences observed: None.</p> <p><u>Summary of general activity:</u> Activity was consistent with that observed by the surveyor of position 2.</p>

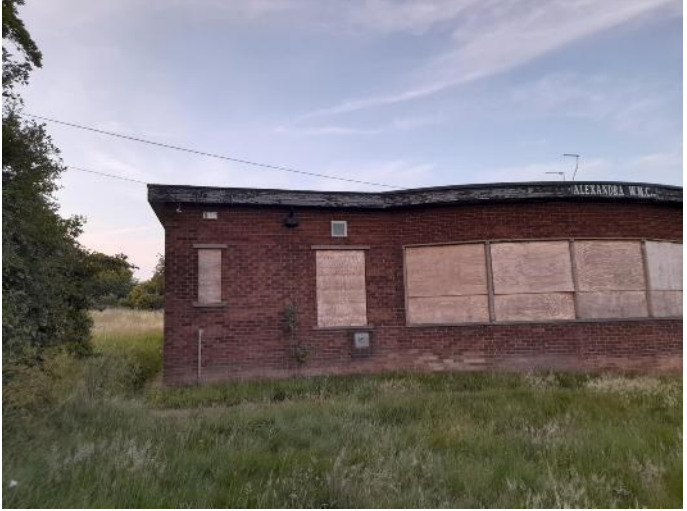
A photograph showing the exterior of a brick building. The building has several windows that are boarded up with plywood. The roofline is visible, and there is some text on the roof that reads "ALEXANDRA W.M.C.". The building is surrounded by tall grass and some trees in the background.
<p><i>IR position 3</i></p>	<p>Camera position: observing the south and west elevations of B1.</p> <p>Emergences observed: None.</p> <p><u>Summary of general activity:</u></p> <p>Activity was consistent with that observed by the surveyor of position 3.</p>

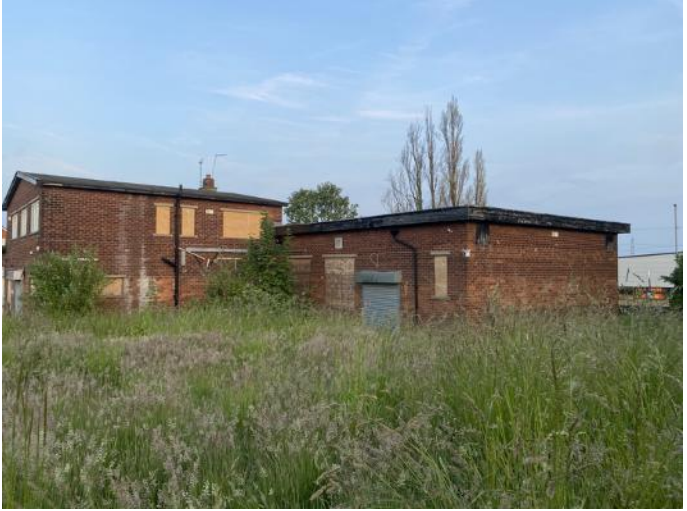
<p><i>IR position 4</i></p>	<p>Camera position: observing the north and west elevations of B1.</p> <p>Emergences observed: None.</p> <p><u>Summary of general activity:</u></p> <p>Activity was consistent with that observed by the surveyor of position 4.</p>

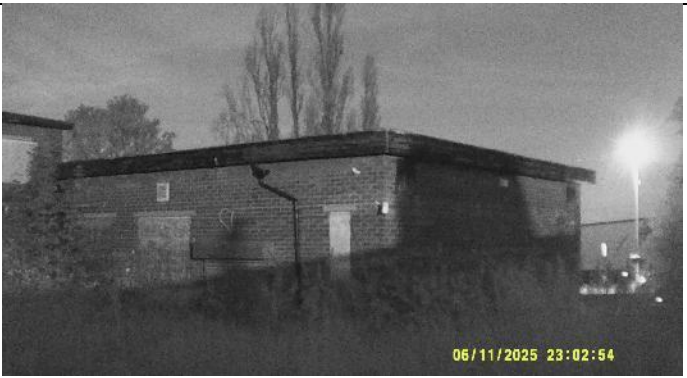
<p><i>IR position 5</i></p>	<p>Camera position: observing the north elevation of B1. Emergences observed: None.</p> <p><u>Summary of general activity:</u> Activity was consistent with that observed by the surveyor of position 4.</p>

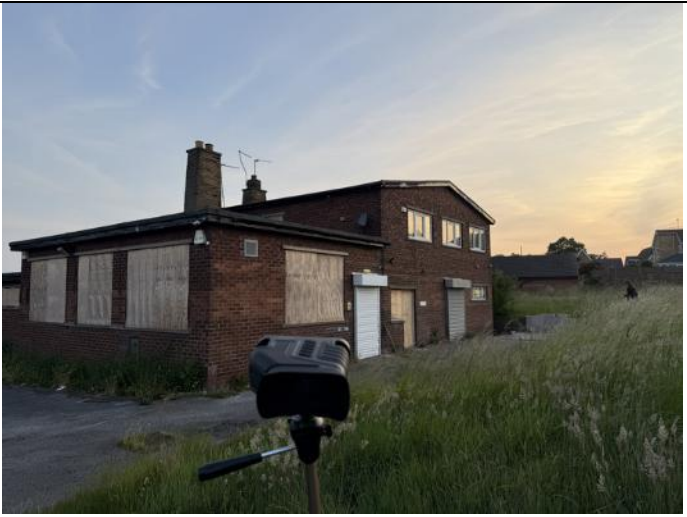
<i>IR position 6</i>	Camera position: observing the north and east elevations of B1. Emergences observed: None. <u>Summary of general activity:</u> Activity was consistent with that observed by the surveyor of position 6.

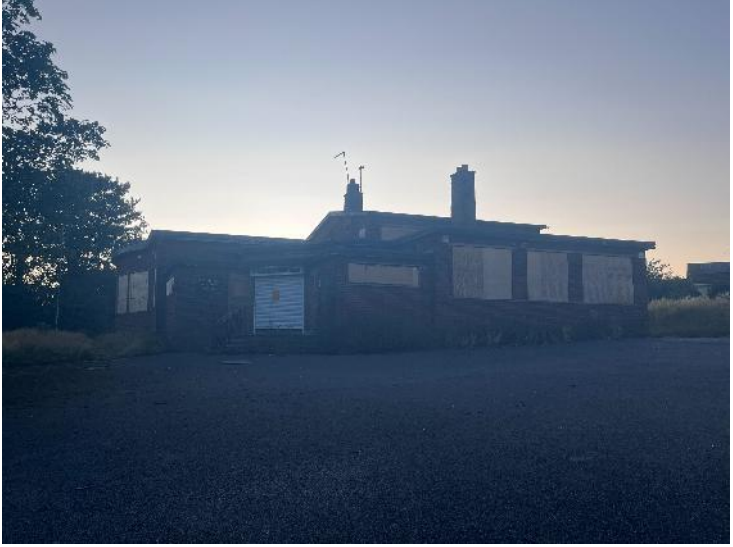
<p>IR position 1</p>	<p>Camera position: observing the south and east elevations of B1.</p> <p>Emergences observed: None.</p> <p><u>Summary of general activity:</u></p> <p>Activity was consistent with that observed by the surveyor of position 1.</p>

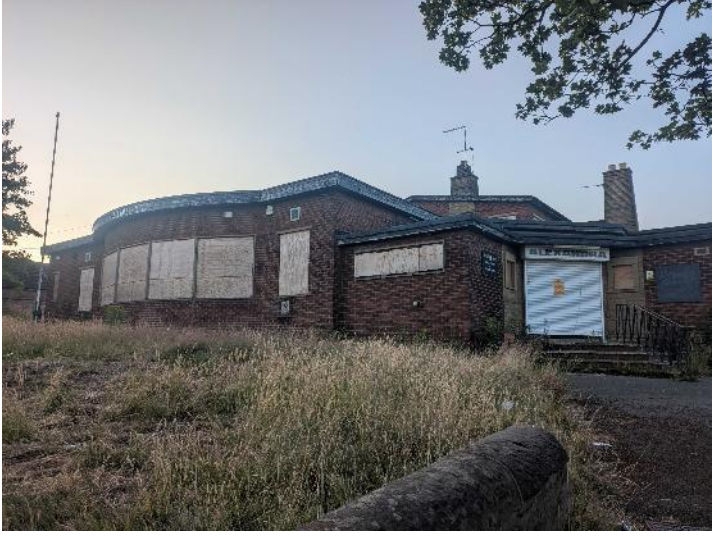
<p>IR position 2</p>	<p>Camera position: observing the south elevation of B1.</p> <p>Emergences observed: None.</p> <p><u>Summary of general activity:</u></p> <p>Activity was consistent with that observed by the surveyor of position 2.</p>

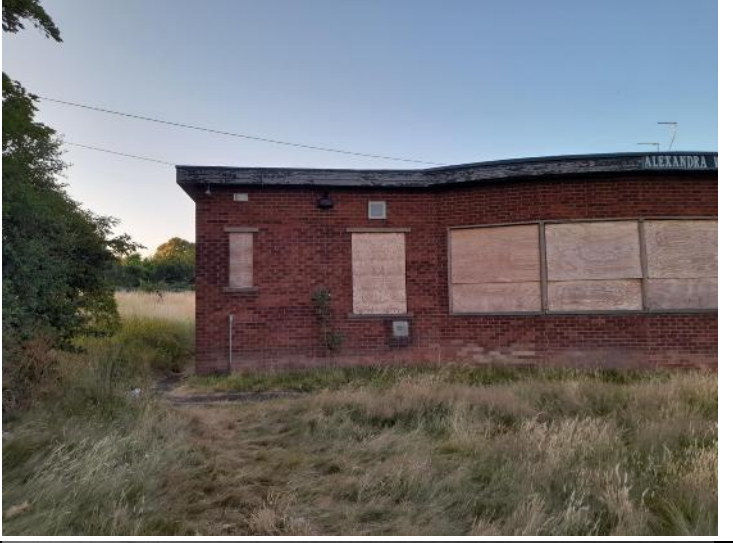
<p>IR position 3</p>	<p>Camera position: observing the south and west elevations of B1.</p> <p>Emergences observed: None.</p> <p><u>Summary of general activity:</u> Activity was consistent with that observed by the surveyor of position 3.</p>

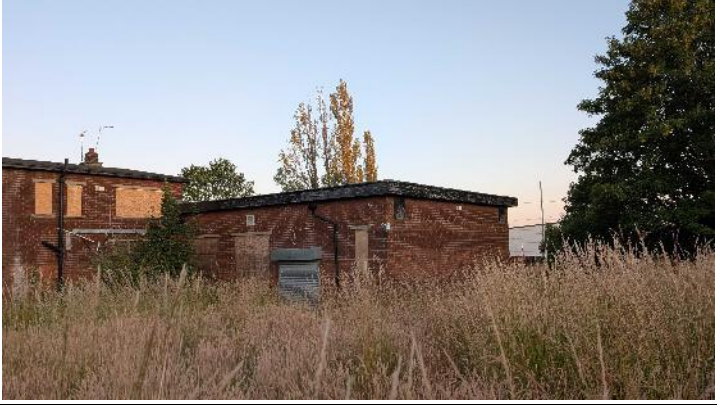
<p>IR position 4</p>	<p>Camera position: observing the north and west elevations of B1.</p> <p>Emergences observed: None.</p> <p><u>Summary of general activity:</u> Activity was consistent with that observed by the surveyor of position 4.</p>

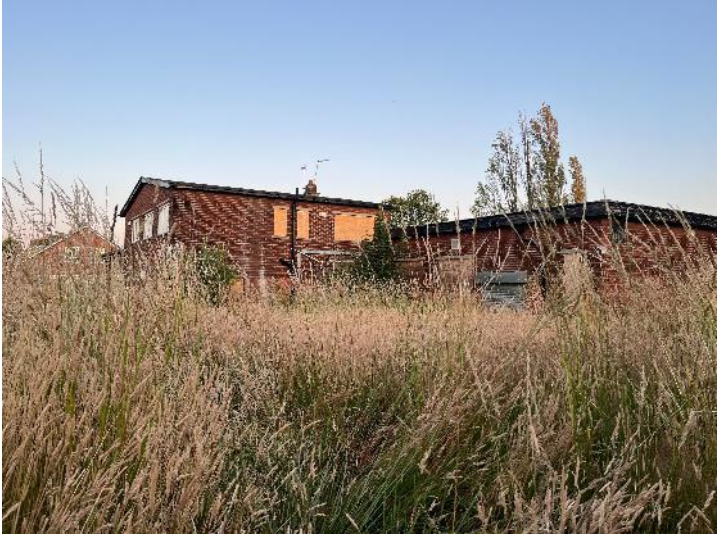
<p>IR position 5</p>	<p>Camera position: observing the north elevation of B1. Emergences observed: None.</p> <p><u>Summary of general activity:</u> Activity was consistent with that observed by the surveyor of position 4.</p>

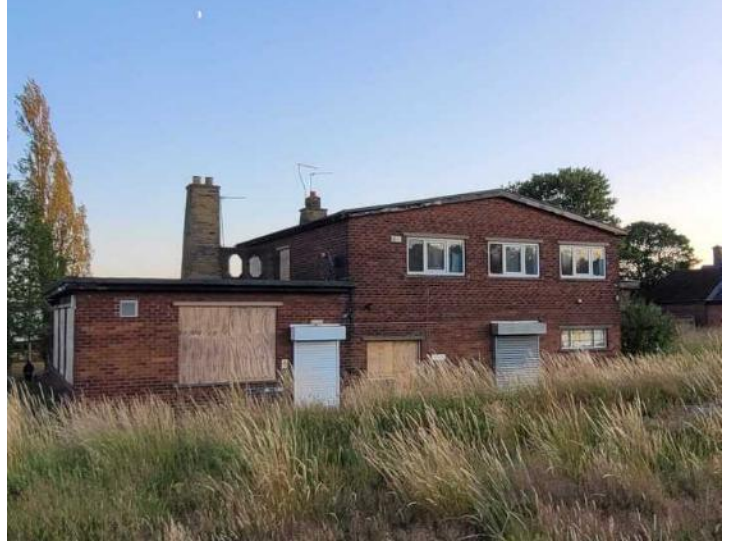
<p>IR position 6</p>	<p>Camera position: observing the north and east elevations of B1.</p> <p>Emergences observed: None.</p> <p><u>Summary of general activity:</u></p> <p>Activity was consistent with that observed by the surveyor of position 6.</p>
