**Whitcher Wildlife Ltd.
Ecological Consultants.**

PLASHWOOD STABLES, GREEN MOOR.

BAT SURVEY.

Ref No:- 150748.

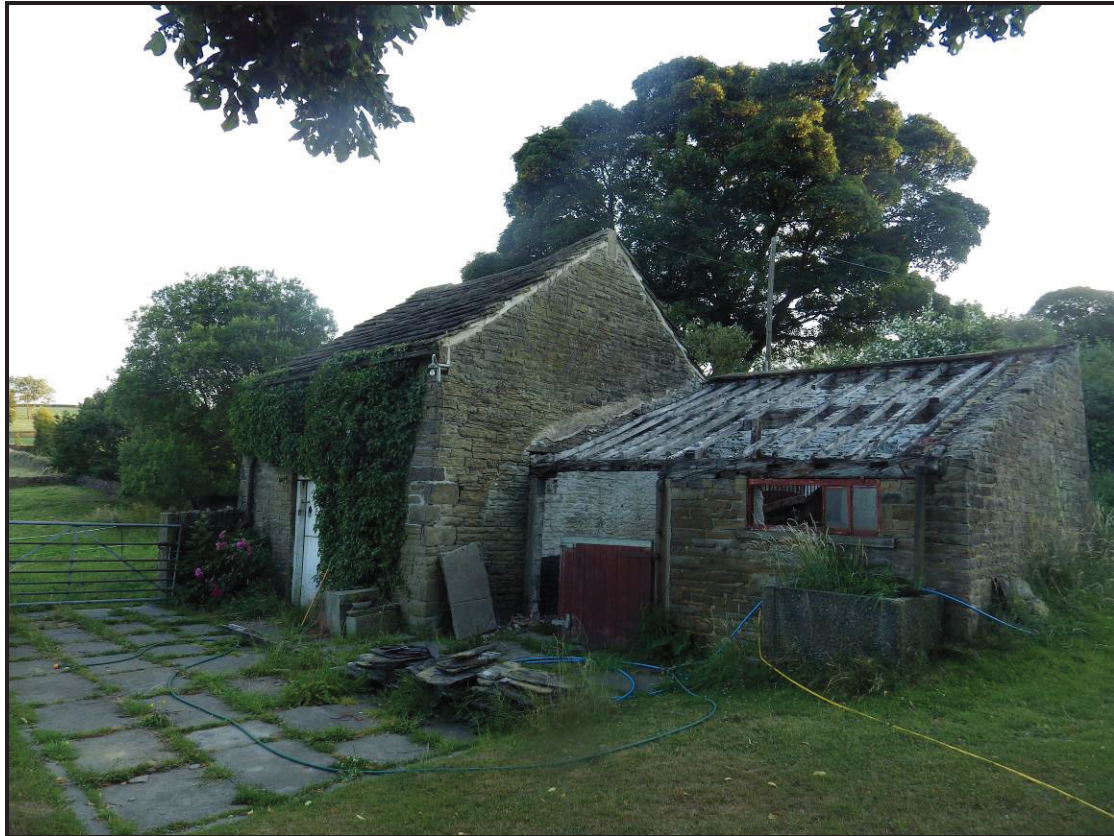
3.3.1. The Stables is a group of stone buildings in three separate parts forming one block, as shown in the photograph below.

3.3.2. The main block is a two storey section with stables and storage on the ground floor and a with a mezzanine floor with more storage space above.

3.3.3. The walls are built from stone that is generally well pointed but with a few open joints and cracks low down on the walls. There is a large clump of ivy growing against the eastern elevation.

5.5. It is recommended that the ivy on the walls of the building is removed outside the nesting bird season, which extends from March to September as the ivy provides ideal nesting bird potential.

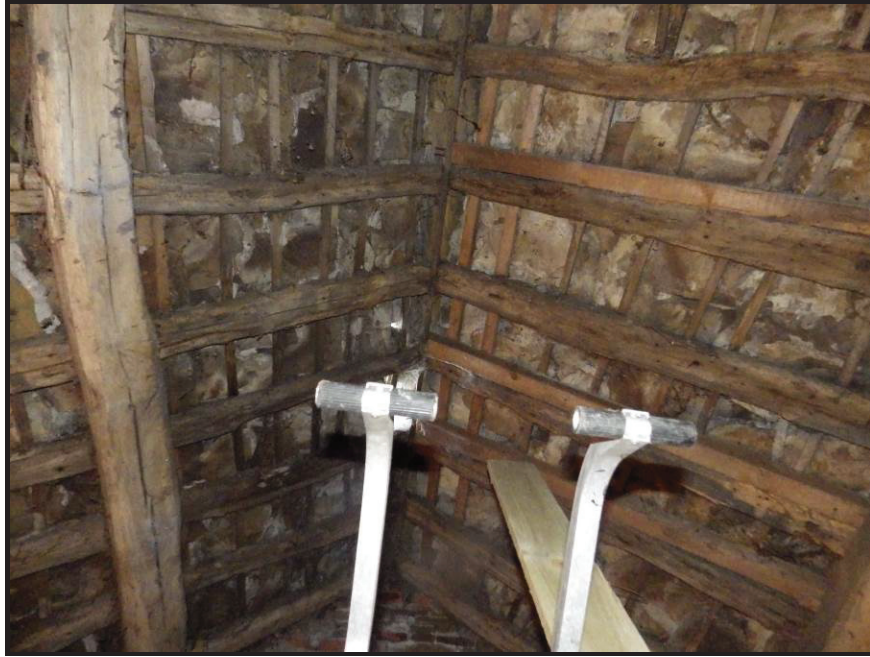
3.3.4. The roof is supported on a traditional purlin timber frame and is covered with stone slates with no lining. All roof slates are in place and the ridge tiles are well pointed although further deterioration since the previous survey has resulted in larger gaps beneath the stone slates. The photograph below shows the underside of the roof.

4.2. The inside of the stables and the underside of the roof were assessed to be totally unsuitable for roosting bats during both surveys.

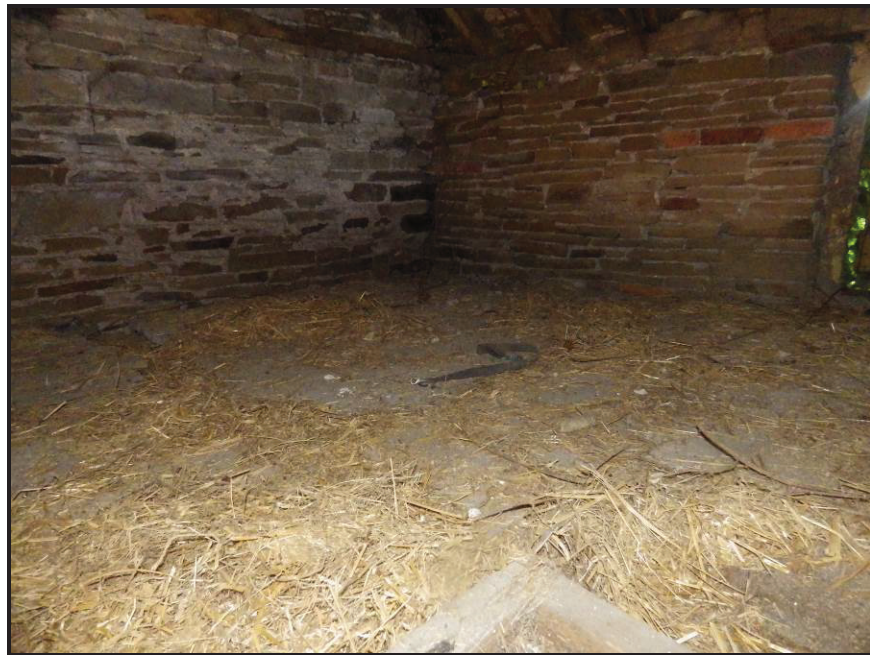
3.3.5. No bat droppings or field signs were identified on the outside of the building. No bat droppings or field signs were found inside the building. The photograph below shows the mezzanine floor.

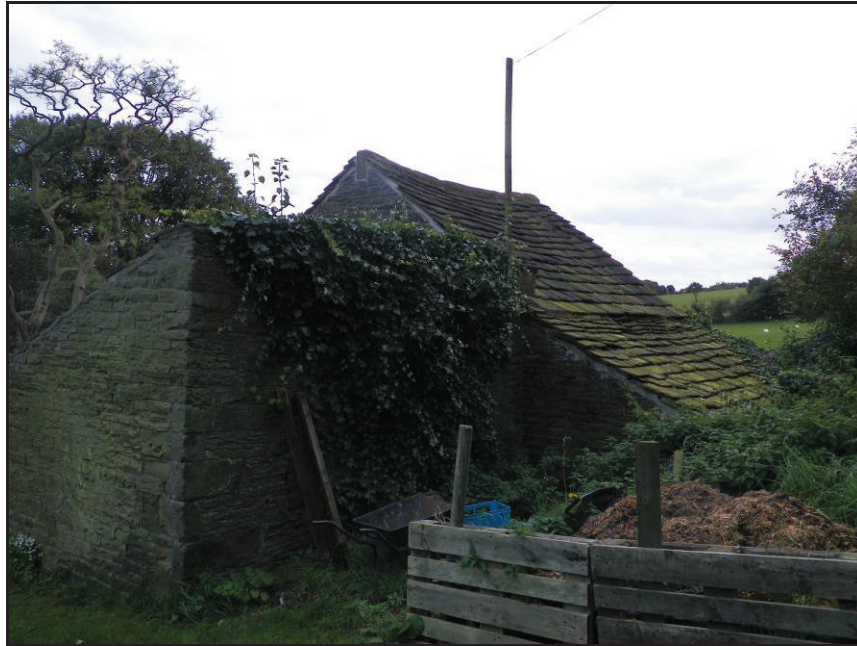
3.3.9. To the rear of the buildings there is a further single storey lean-to section that is built low into the ground as shown in the photograph below. The walls are mainly below ground level and the roof is covered with stone slates. Some of these are misplaced but all are present.

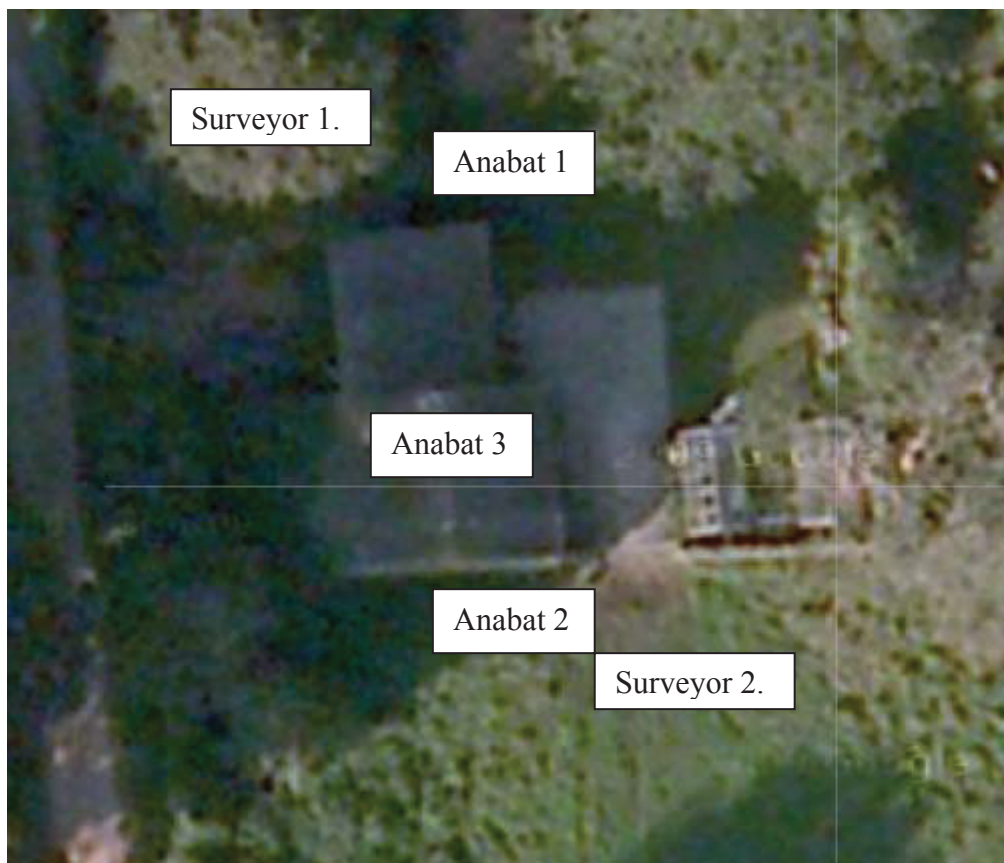
3.4.3. The following aerial photograph shows the positions of the surveyors and the Anabat recorders. Anabat 3 was placed inside the buildings.
