**WEMBLEY WORKS, HEMINGFIELD ROAD,
WOMBWELL.**

BAT SURVEY REPORT.

Ref No: 240520.

Date: 16th July 2024.

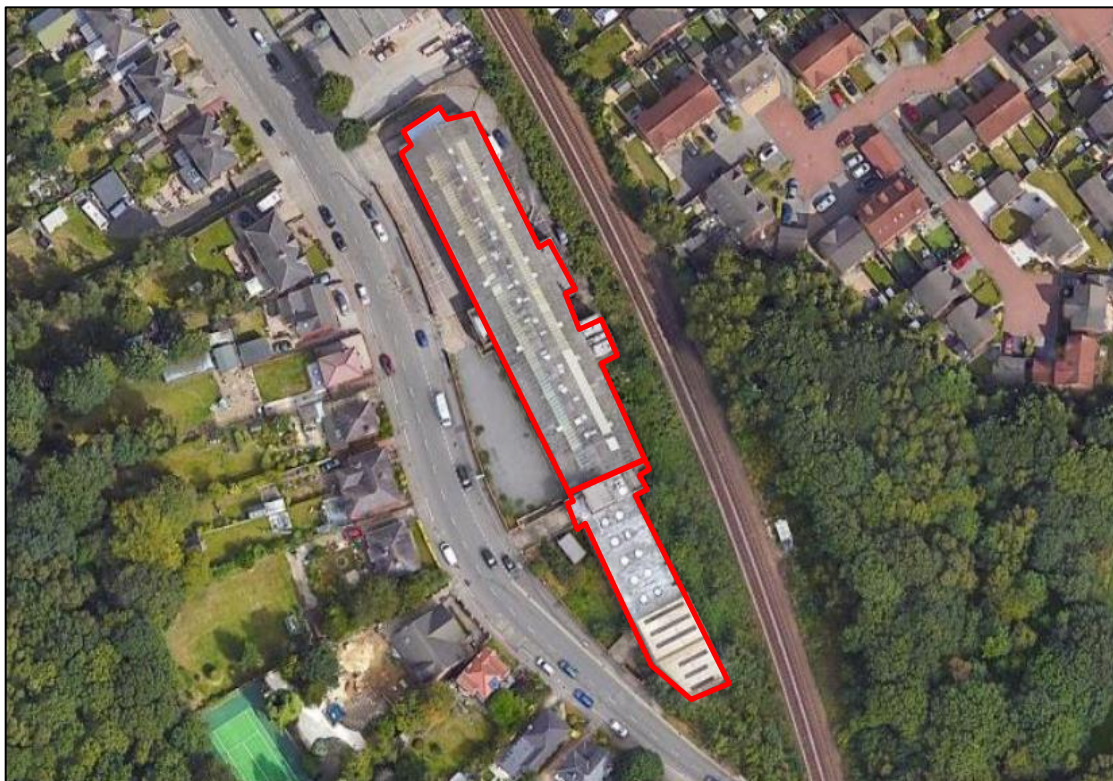
3.2.1. The survey area comprises the Old Wembley Works Factory, located just off Hemingfield Road in Wombwell. This is shown on the aerial imagery below.

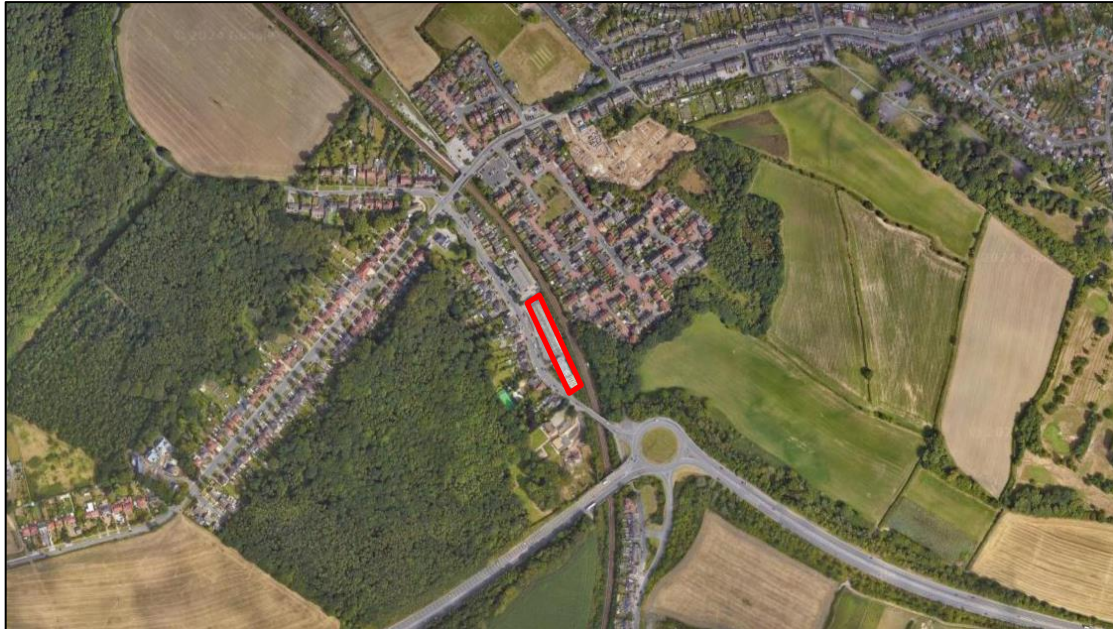
3.2.2. The further surrounding area comprises the western outskirts of Wombwell with the ancient woodland of Wombwell Woods located to the further west and Hillies Golf Course with its associated woodlands to the northeast. The Sheffield to Barnsley railway line runs adjacent to the east of the site.

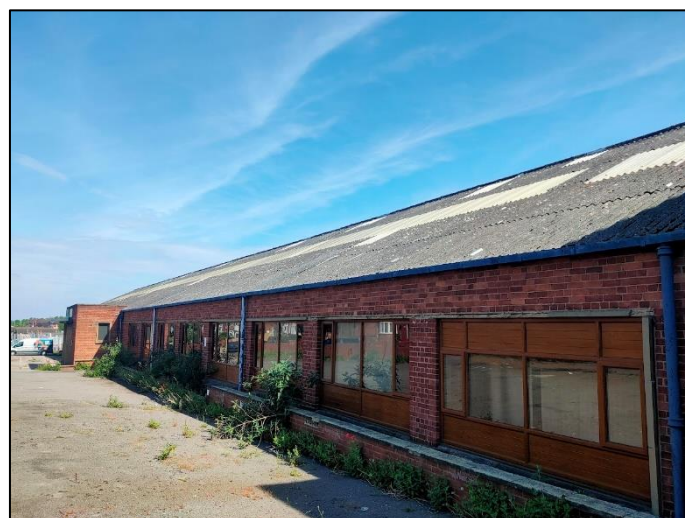
3.3.1. The building is split into two main sections. The first of these is the larger northern section which houses the factory part of the building. This section comprises an 85m long, single storeyed building, extending to two storeys at the rear, with brick walls and a gabled roof with asbestos sheeting.

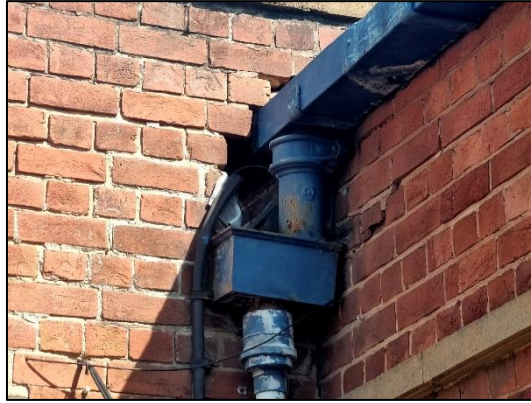
3.3.2.1. One of these is a gap in the brickwork around the guttering, although this is not a roost feature as it leads only to the opposite side of the parapet wall.

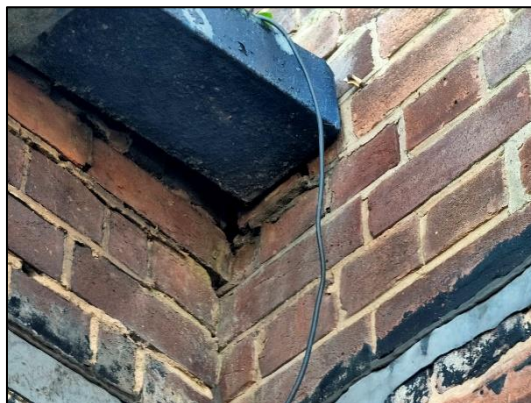
3.3.2.2. The second is a gap beneath the guttering over the entrance door, this does act as a potential roost feature although from inspection with a bright torch, is only shallow.

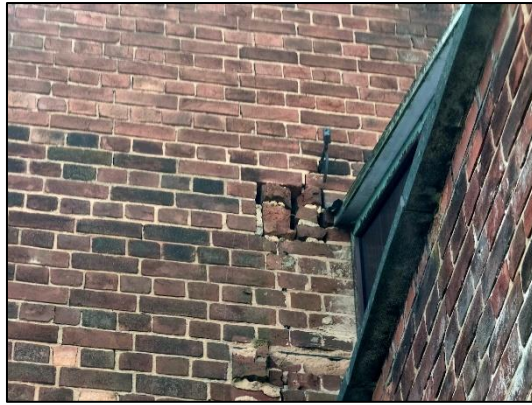
3.3.2.3. The third is a defect within the brickwork on the northern gable, which again, when inspected by torch, only runs to the depth of a brick, but could be suitable for individual opportunistic bats.

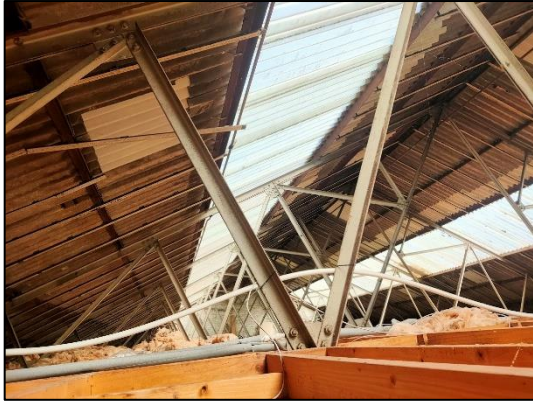
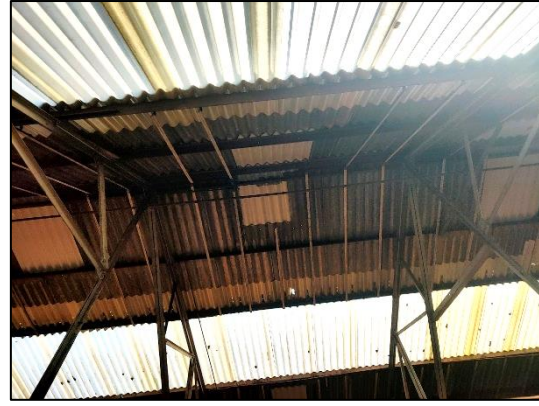
3.3.4. Internally, the loft space was inspected as well as reasonably possible, but due to having only a false floor it cannot be walked on. The loft space is very light and offers no suitability for roosting bats. Furthermore, no field signs were found where it could be inspected.

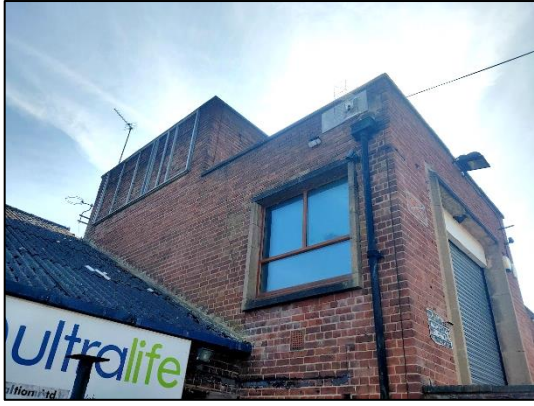
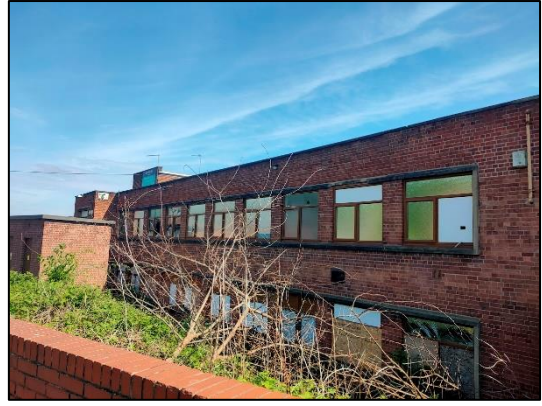
3.3.8. The southern section is a taller two storey building, with some areas extending to three storeys, although the old loading bay area is only single storey. The building comprises brick walls with a complex, but always flat, roof structure.

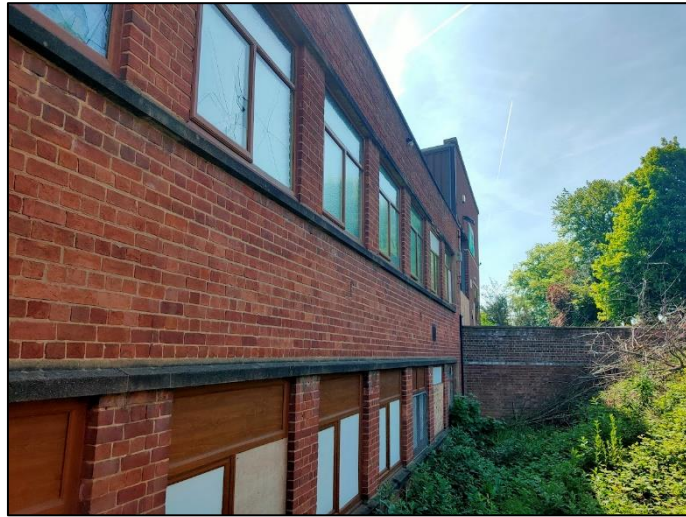
3.3.9. The walls of this section are again in very good condition, with no defects visible.

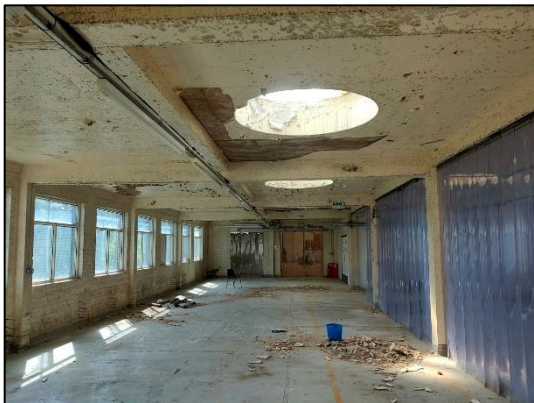
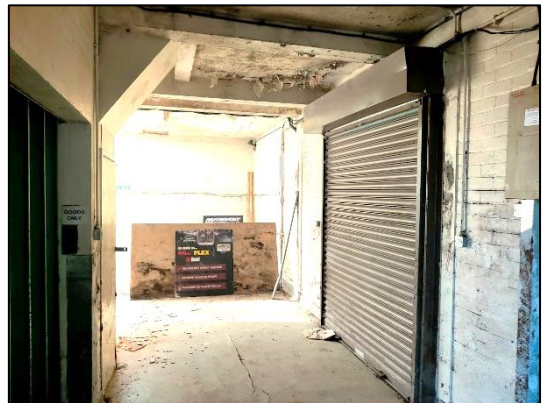
3.3.10. Internally, this section of the building has no loft space, with all top floor rooms used for machinery and office space.

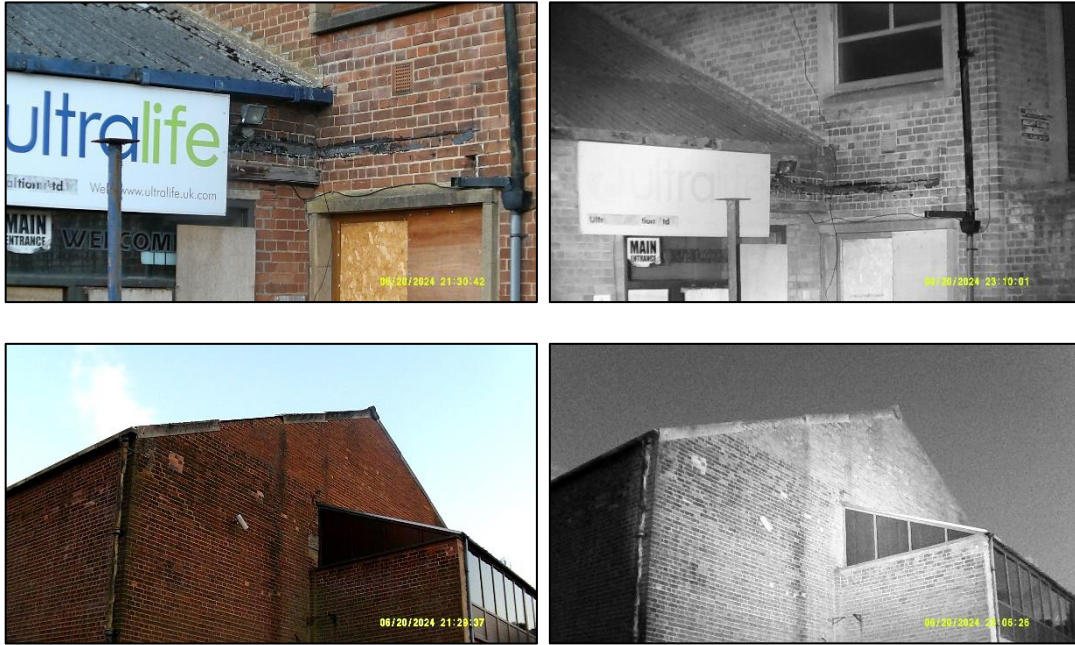
3.4.4. Two infra-red cameras and infra-red torches were also set up around the building, ensuring all suitable features were covered. The gap alongside the window was

surveyed again by torchlight and no bats were seen. Therefore, it was not covered with the cameras. Shown below are photographs which show the view of each camera at both the start and end of the survey.
