Bat Survey to  
Green Farm  
High Lane  
Ingbirchworth  
S36 7GG

29<sup>th</sup> July 2022

# 1. Summary

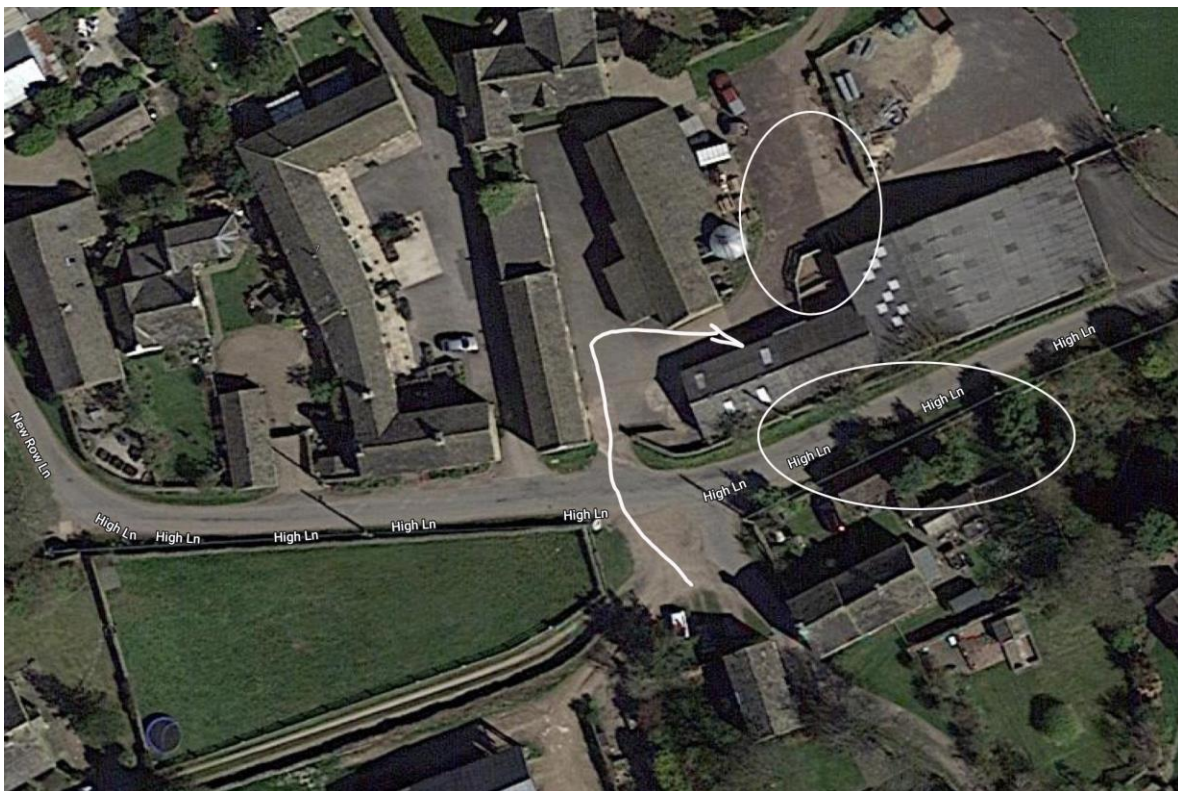
Figure 4. Illustration of bat activity at sunset

The first bat recorded was a noctule bat high overhead at 21.30 but is not associated with the site. A common pipistrelle bat appeared to fly into the site and flew through the site along the east side of the barn at around 21:45 followed by a second bat around 6 minutes later. No bats were seen to emerge from the barn and bat numbers were considered low. On and off throughout the survey, individual bats were seen foraging on the south side of the site and to the east of the barn on the opposite side of the farmyard. Several searches of the inside of the barn were made during the survey but no bats were recorded using the interior. The barn showed no signs of use by brown long-eared or Myotis bats.

Bats recorded during the survey were seen entering the site from the south and it is likely that common pipistrelle are roosting in a nearby residential or other farm building. The site offers very little foraging but is used by bats as they pass through the site on their way to other foraging grounds, but the site is not significantly important to bats in terms of foraging. The roof has been replaced at some point in the near past, but it will be stripped and replaced during the current project in order that the roof can be lined. Adding a roof lining increases the potential for bat to use a roof as they can access the area between the tiles and roofing felt so there could be an increase in the site's appeal to bats. Adding bat boxes along the western elevation will compensate for loss of crevices in the wall and including an access gap in the ridge pointing will create potential use of the ridge area.

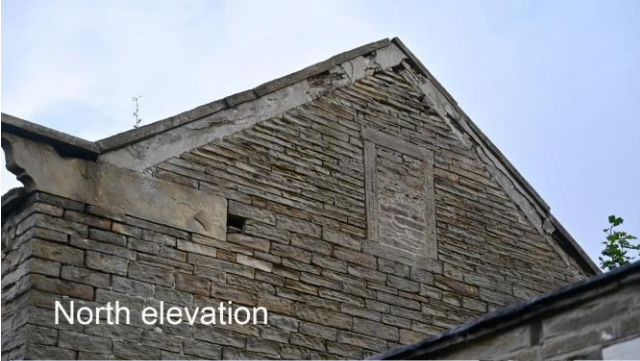
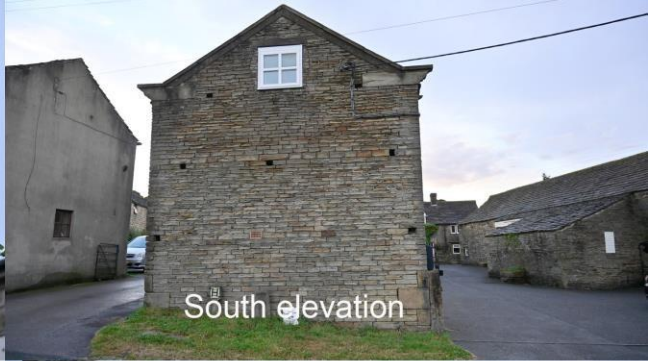
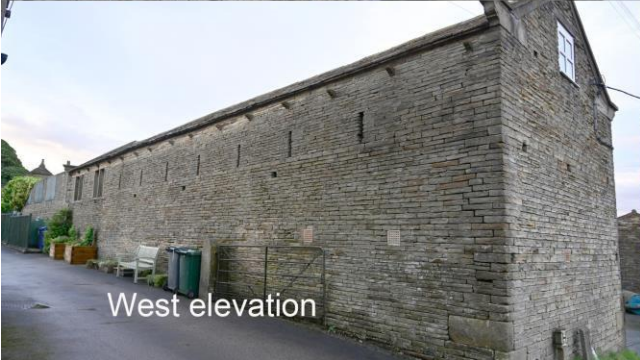
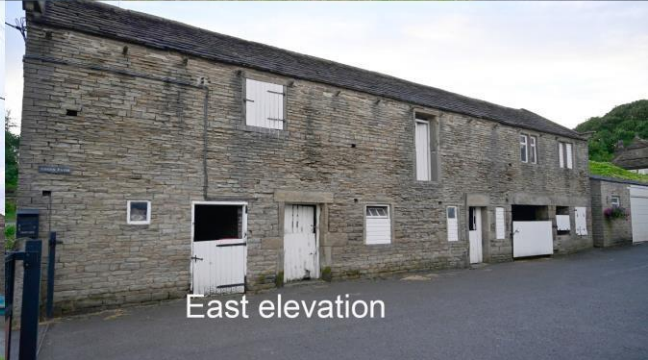
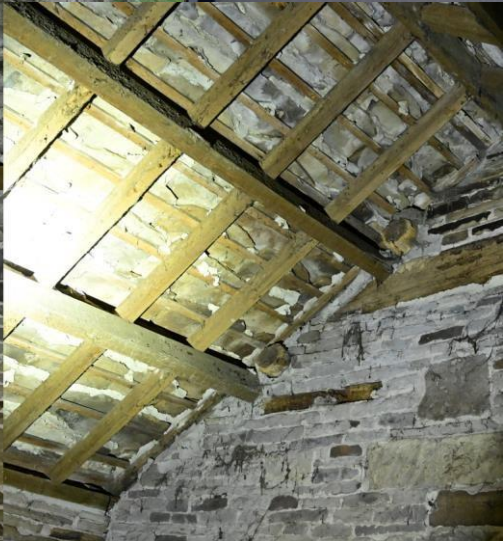
way to better foraging habitat. The works are unlikely to impact the local bat population. Barn owls are considered absent from the site.  
Appendix 1: Photographs of the site

The roof is covered with large stone tiles and is in good condition without missing or slipped tiles. The ridge tiles are all present though there are areas of failed mortar which provide access to the ridge section. The gables have capping stones which are all present. The stone tiles provide natural gaps which would allow bats to roost though the roof is unlined and therefore is less likely to support larger clusters of bats beneath the tiles. Internally, the unlined roof has a good clean ridge section and light ingress can be seen where the ridge mortar has failed. Despite the clean ridge, there was no evidence of roosting bats; no accumulation of droppings beneath the ridge or at the gable walls and no scattered prey remains suggestive of brown longeared bats. The upper floor of the main section of barn is used as a hay loft and therefore no evidence of bats is present. There is a partition wall to the north end of the barn which creates a smaller tack room at that end of the barn. The floor is too unsafe to enter but the room is thick with dirt and the ridge in this section has a heavy coating of cobwebs. There did not appear to be any use by bats, but active swallow nests were noted. The roof shows evidence of being replaced in previous years and is not the original timber work and all wall tops on the interior have been pointed and blocked with mortar which excludes bats from using the wall tops.

The gable walls have large coping stones and these are all present though there are large sections of failed mortar on the north elevation creating large gaps in the dry verge. Many of these gaps are considered too large to be of interest to bats as they could also be accessed by starlings etc. The south gable has a cement covered dry verge that is sound and without gaps.

The walls appear to have many gaps and areas of missing pointing and while some may be deep enough to support roosting bats, many are quite shallow and are simply the result of spalling mortar caused by frost. Inspection using a powerful lamp and binoculars allows for easy inspection
