**65 Station Road, Worsborough, Barnsley, S70 4SZ**

**Bat Report**

Final Report

09 May 2024

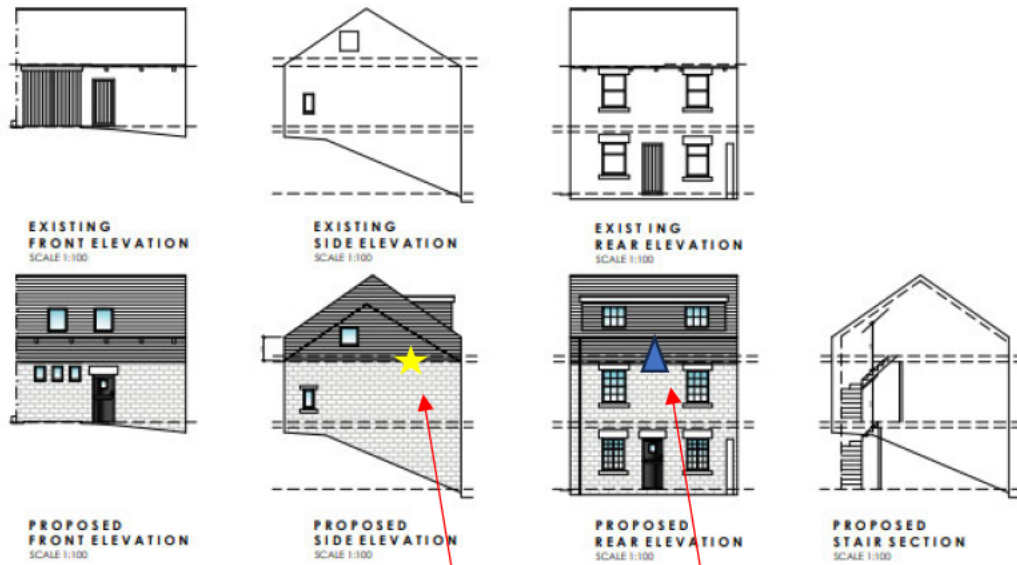
Integrated rendered  
sparrow boxes.

- 5.1 In line with the National Planning Policy Framework (NPPF) to provide net gains for biodiversity, the installation of a bat brick or tube and integrated sparrow nest brick/boxes on the new walls of the building.
- 5.2 This would provide additional habitat for bats and birds in the area. The bat brick/box should be fitted on south or west facing walls, as close to the eaves as possible. Bat bricks/boxes should not be fitted above or immediately adjacent to windows. These bat boxes are self-contained with only a small entrance slot visible on the external wall. The integrated bird brick/boxes should be installed on the north or east elevation at the eaves. Boxes for house sparrows are best fitted in groups of

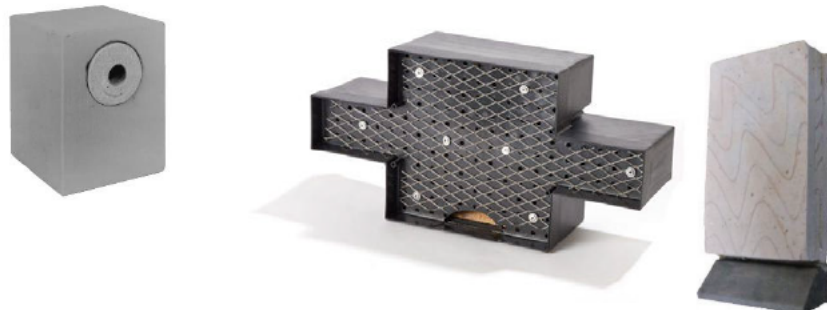
An integrated rendered  
bat box to be fitted at the  
eaves- examples below

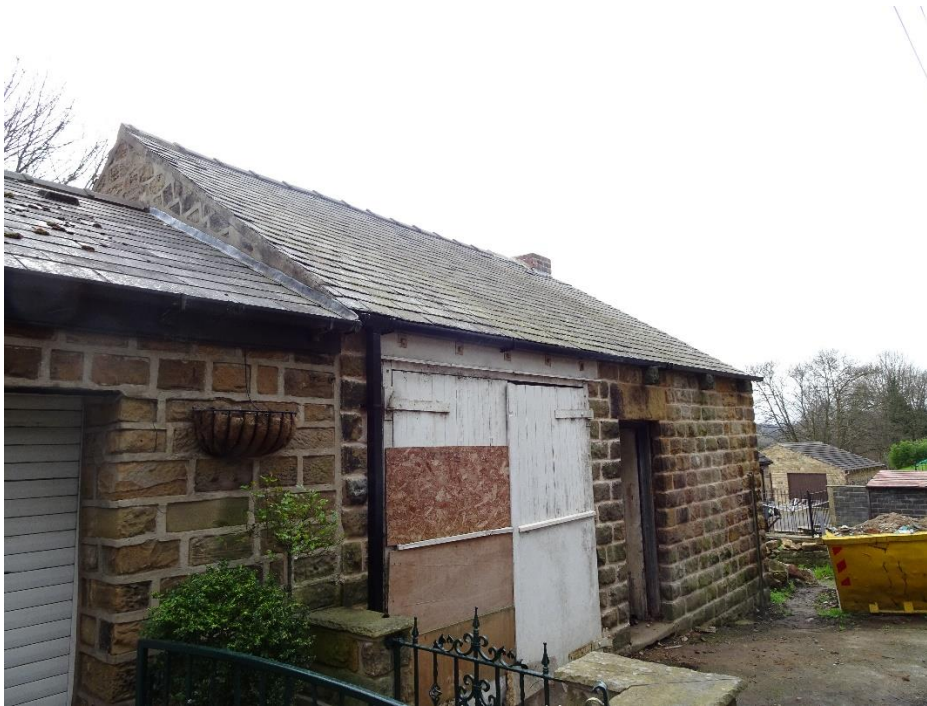
Photograph 1: Front of property

- 3.7 The following was noted:
- The building is a semi-detached garage building, constructed from stone. The walls were re-pointed in September 2023, leaving no crevices externally for roosting bats.
  - The roof is pitched, with slate roof tiles, and a clay ridge. The roof was fixed and re-pointed in September 2023, prior to the client's ownership. As such there are no access points on the roof which offer potential for roosting bats.
  - The chimney was capped as part of the roofing works conducted in September 2023. There is no access for bats on the chimney, and the lead flashing is reasonable well sealed with no access for bats.

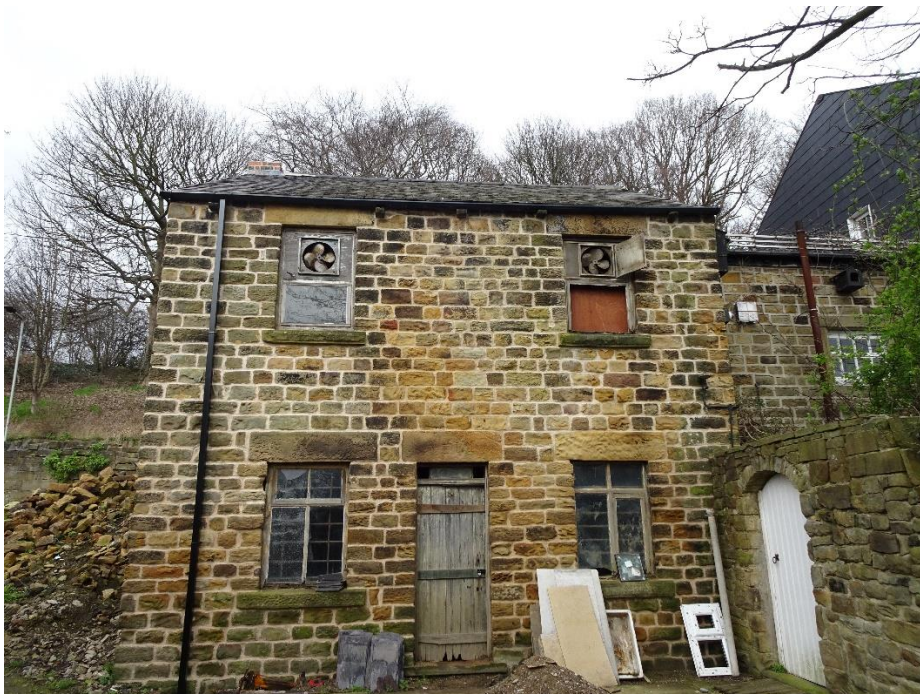
Photograph 2: Rear of property

- The window and door frames are constructed from wood and metal and are in poor condition with some gaps.
- No signs of nesting birds were recorded.

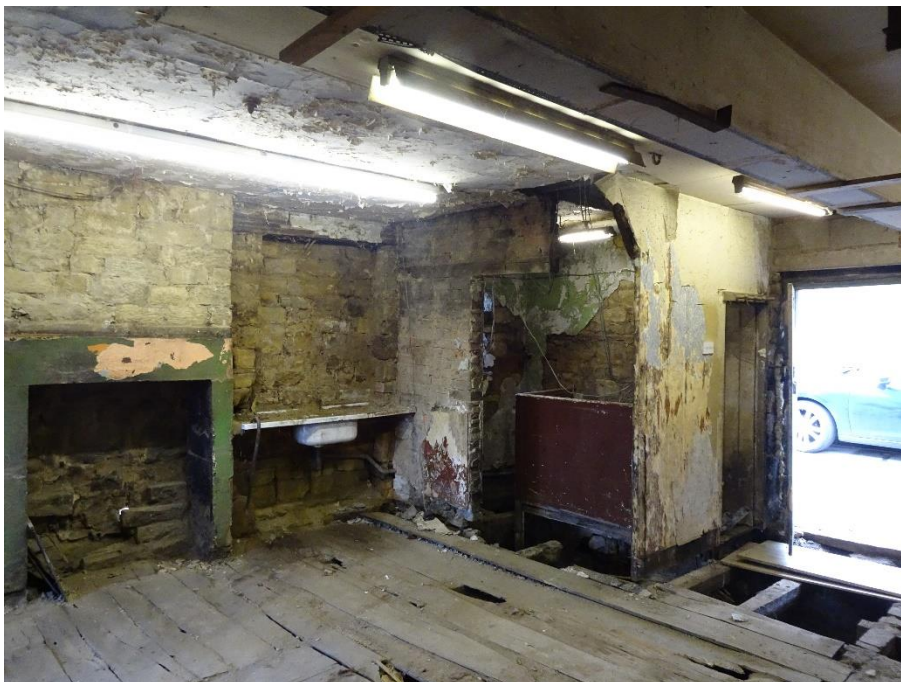
- 3.8 The inside of the property is split across three levels, the basement, the first floor and the attic. Full access was available to the basement and first floor, both of which were heavily cobwebbed. There were distinct rooms within the basement, all of which had boarded wooden ceilings, with heavy cobwebbing on the beams. The cobwebs on the beams had an accumulation of dust which suggested the cobwebs have been there for a number of years. A thorough search of all areas, especially under any gaps in windows was completed and no bat droppings were noted. There were very few crevice features noted which offered suitability for bats. There was access into the chimney from the room, however, externally the chimney was capped. The chimney was surveyed internally through use of a torch and endoscope and no evidence of use by bats was noted. The client also stated that until this January the building was cluttered with an accumulation of items, which would have prevented the building from offering flying space to bats. There are a small number of areas of access into the building through openings around windows, however, where possible these had been boarded over to prevent access.

Photograph 4: Inside first floor, showing area where floor is missing under attic entrance

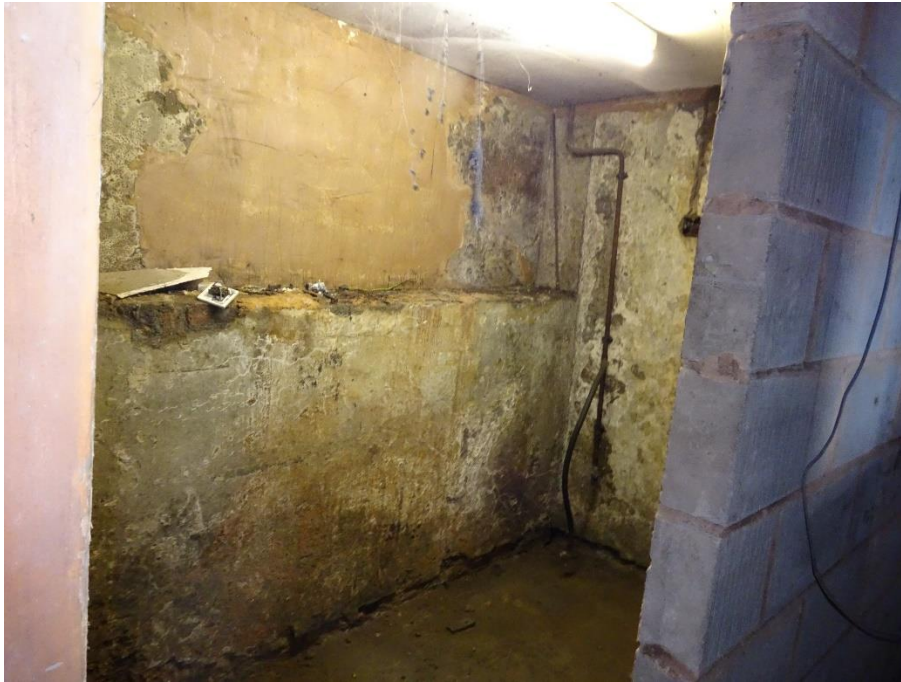
Photograph 5: Inside basement

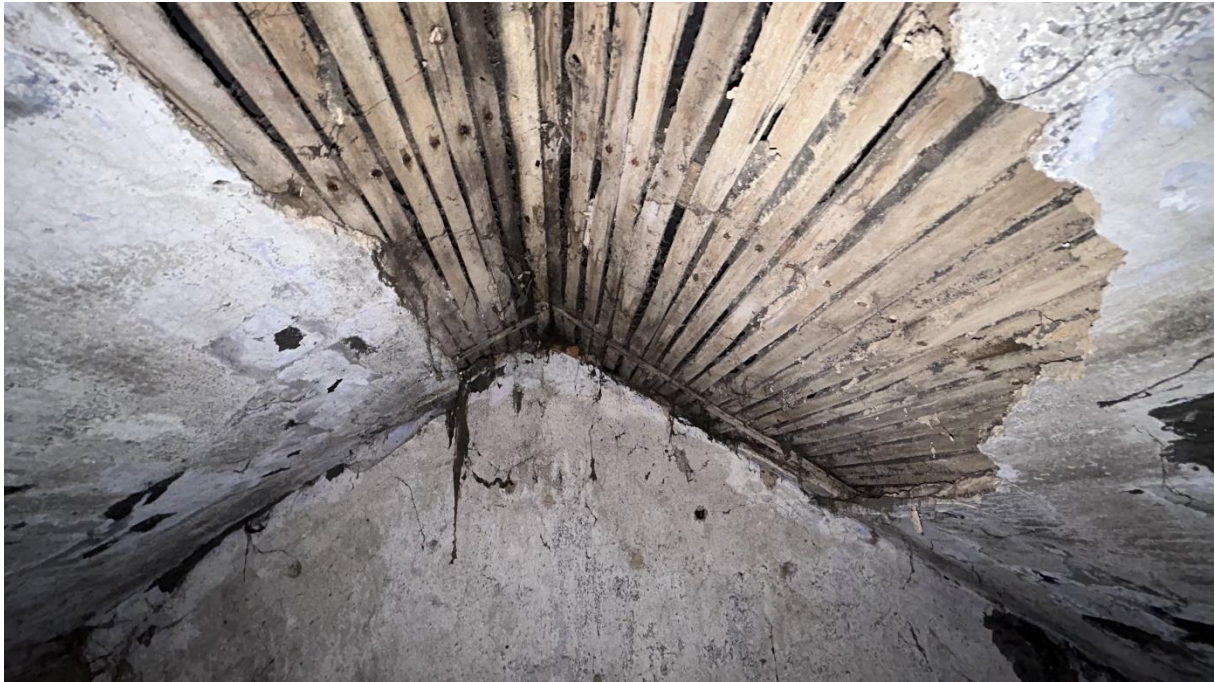
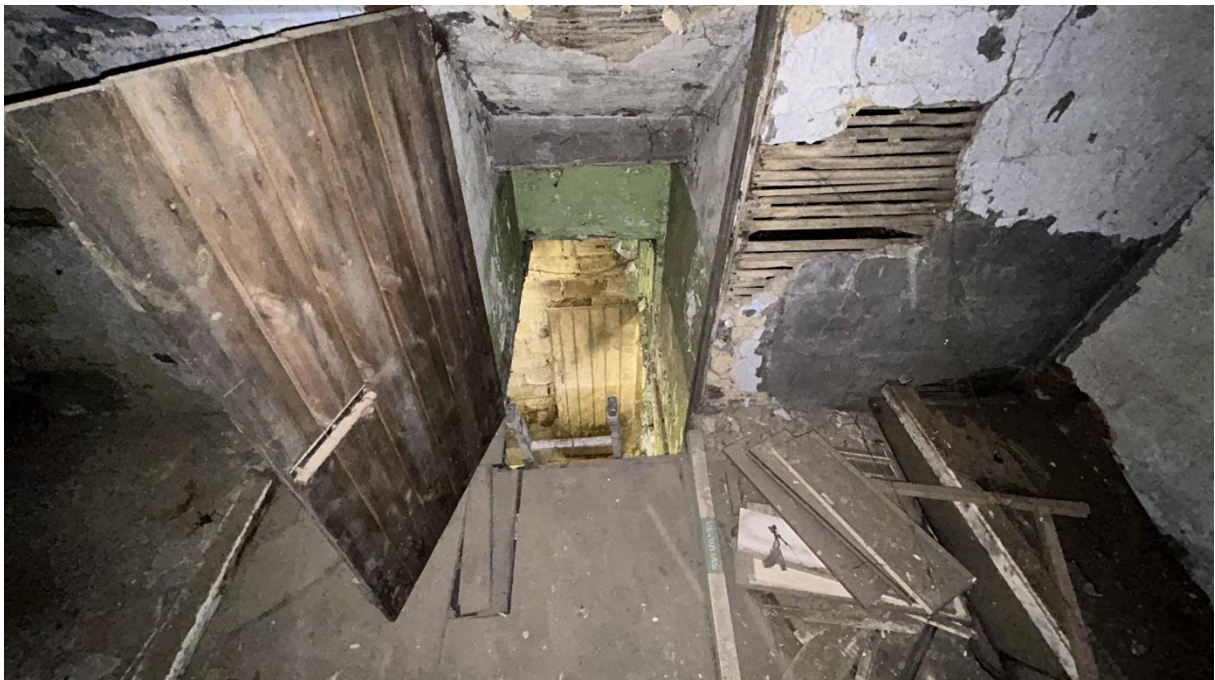
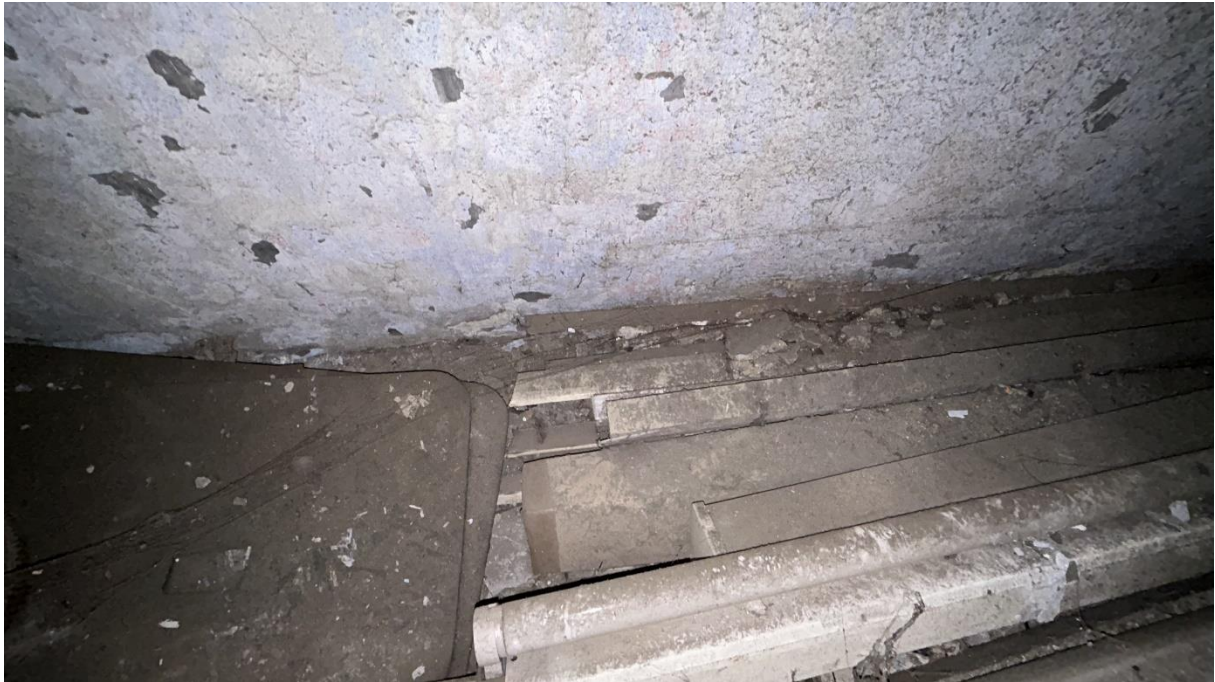
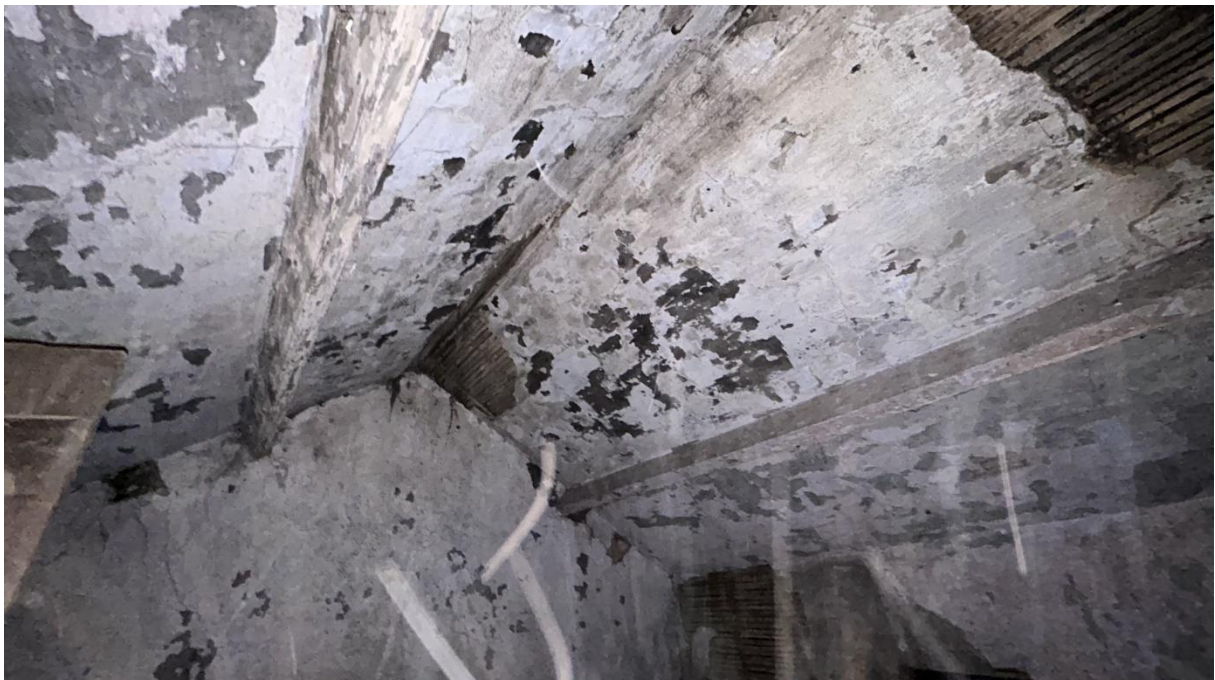
- There were lath and plaster ceilings, which were mostly intact. There was one area of ceiling where the lath was intact but the plaster had fallen off. The lath does not offer any access for bats from the outside of the building due to the small size of the gaps between each lath.

- The gable of the property was plastered, which was in moderate condition with a few small gaps showing brickwork.
  - The attic is partitioned from the rest of the building with a lath and plaster wall. The lath is visible in some areas on this wall where plaster has fallen away.

- The floor is boarded, with no visible insulation present. The boarding on the floor is in moderate condition, with some areas of boarding no longer present.

- There is heavy cobwebbing within the attic, which is very dusty and shows the cobwebs have been in place for a long time.
- 3.10 The garage is considered to hold negligible potential to support roosting bats due to a lack of suitable access points, or roosting opportunities.

Photograph 7: Inside attic
