**ALDHAM BRIDGE, WOMBWELL.**

**PHASE 1 HABITAT AND PROTECTED SPECIES  
SURVEY.**

**Ref No:- 140237/2.**

**Date:- 14<sup>th</sup> January 2015**

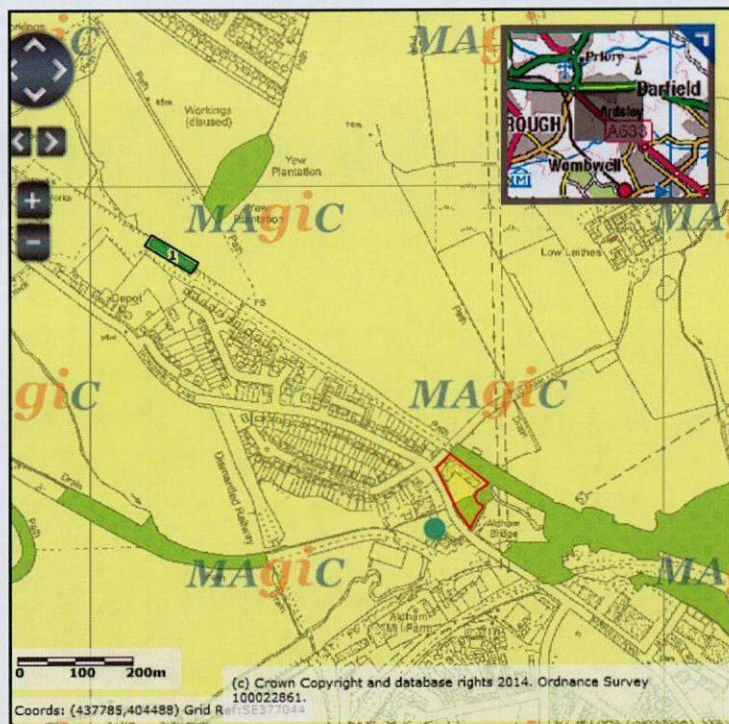
3.1.4. The MAGIC website shows that Stairfoot Brickworks is a Site of Special Scientific Interest (SSSI) 550m to the northwest of the survey area and BAP priority habitat deciduous woodland was found within the survey area. This area includes the south corner of the site and the disused railway bank along the north east of the site.

Figure 1. Red outline shows survey area in relation to SSSI (black outline) and national BAP habitats (deciduous woodland depicted in green).

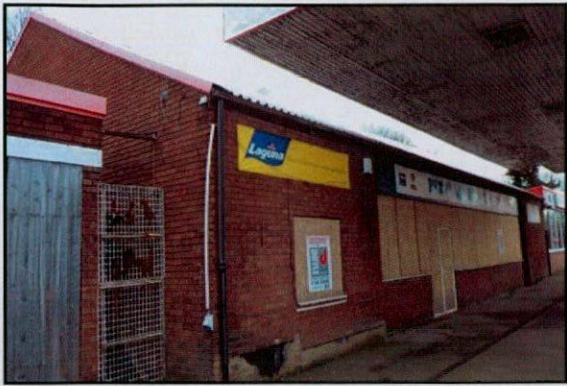
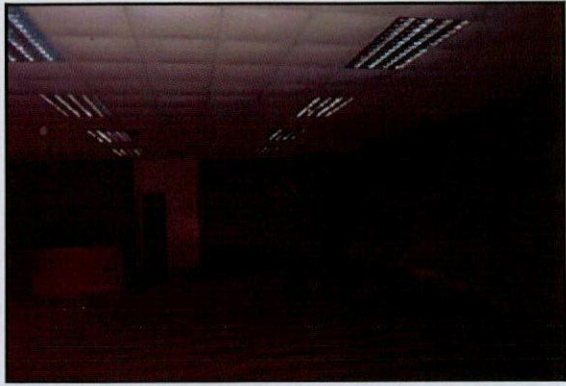
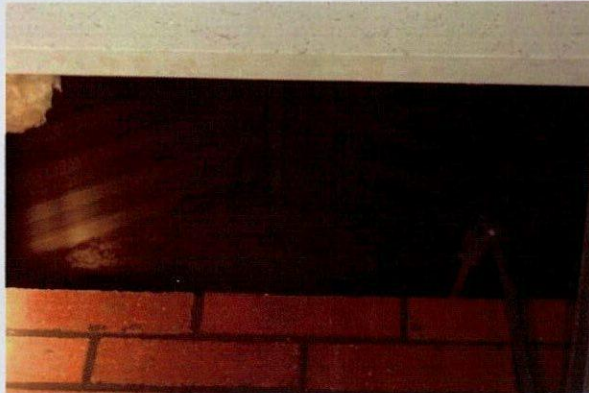
3.3.2.2. Building B is a single story brick/breeze block building with cavity walls, a pitched corrugated roof with a metal ridge and a large roof space containing supporting wooden beams. All windows are boarded up securely. Internal features include a suspended ceiling with small welfare rooms containing plastered ceilings.
