Bat Scoping Survey to

Birkland Farm

Langsett

6th February 2024

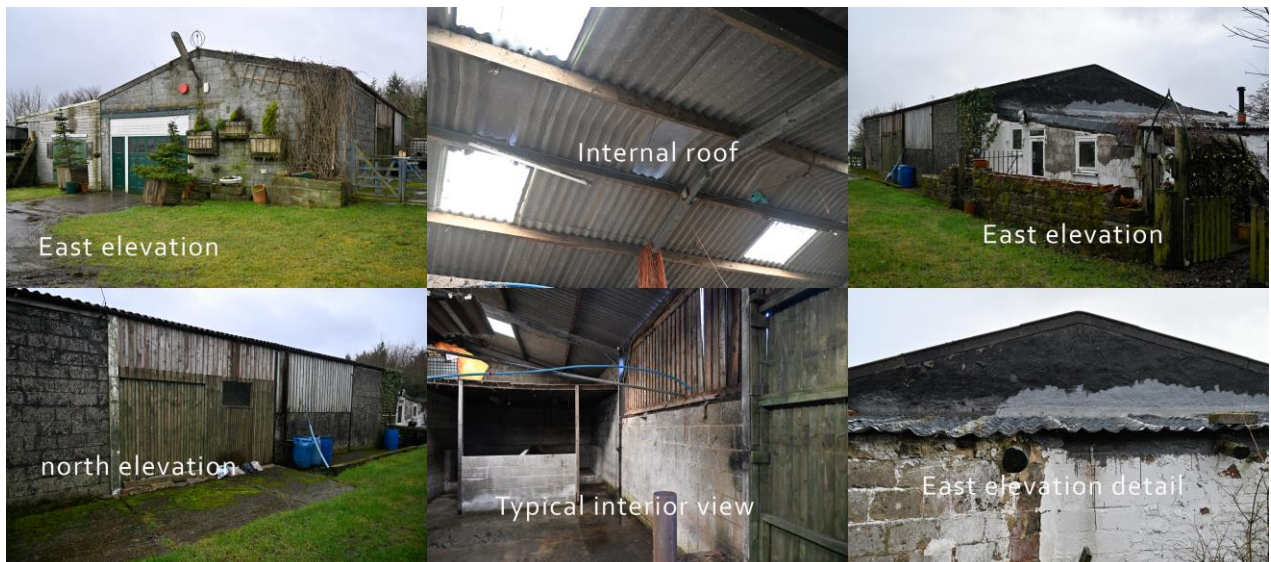
Photo 1 showing the main barn

The site comprises a large, prefabricated barn with adjoining barn and associated outbuildings. The main barn is constructed from single thickness blockwork walls with inset wooden slatted sections. The roof is single thickness cement fibre sheeting over a steel portal frame and there are several large translucent light panels allowing daylight to the interior. The sheeted roof has no ridge beam and is wholly unsuited to ridge dwelling species and the single thickness sheeting offer no roosting potential. There are no other features internally that would allow bats to roost. The walls are single thickness blockwork without any form of wall cavity and in some sections, the walls are full height while in other sections they reach around 2m and have wooden infill. The wooden sections are single thickness and have no potential roosting features. The west elevation has been coated with a bitumen sealant which also extends over the sheeting on the roof of a small, single-storey lean-to. The east elevation is blockwork and has been covered in a climbing plant at some stage which obscures the fascia section. The fascia, however, sits flush to the wall and has no roost potential. The west elevation has a wooden lean-to stable against and also has no value to bats. This building is considered to have negligible value to bats.

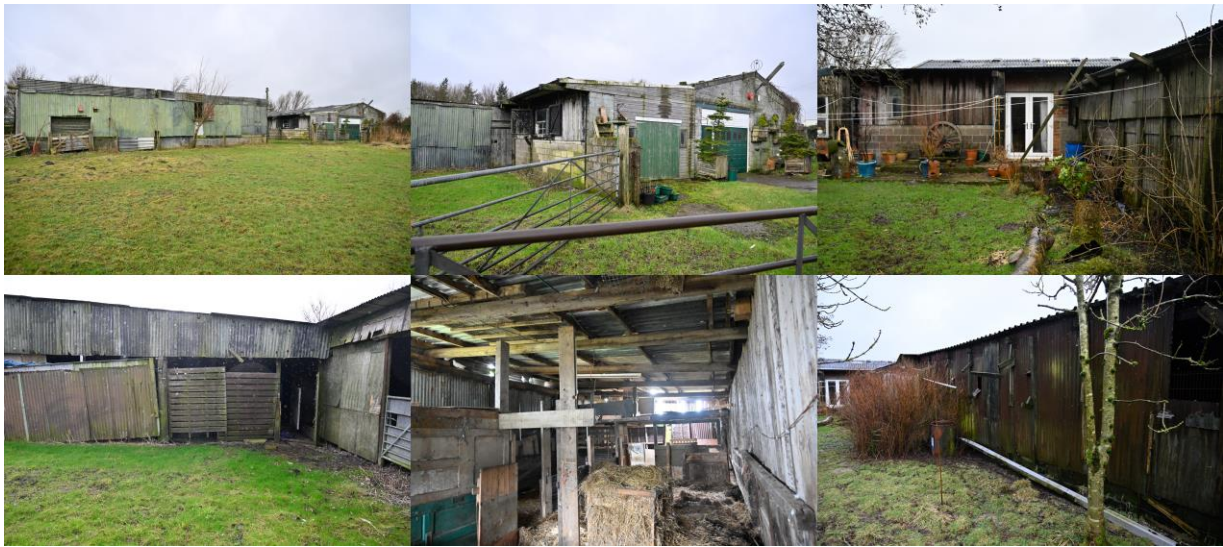
Photo 2. Showing large ramshackle barn extending south off main barn

Running off the south elevation of the main barn is a small wooden lean-to stable and a large barn which has been cobbled together from various materials and is in a poor state of repair. The walls are general made of tin sheeting as is the roof. Internally, the barn is partition off into livestock sections using all kinds of odd timbers, all of which are single thickness and do not offer roost potential. The roof is flat and made from tin sheets and is of no value to bats and has been assessed as being of negligible value to bats.

- The large tin-covered barn on the south of the site should have the roof stripped before mid-April as this will prevent swallows from nesting there. The smaller outbuilding could be left in situ for them to use until a new building with nesting facilities is created or artificial swallow nesting sites are provided.
- The barn owl box currently in the barn should be erected on site either on the side of a building or it can be pole mounted along a boundary.

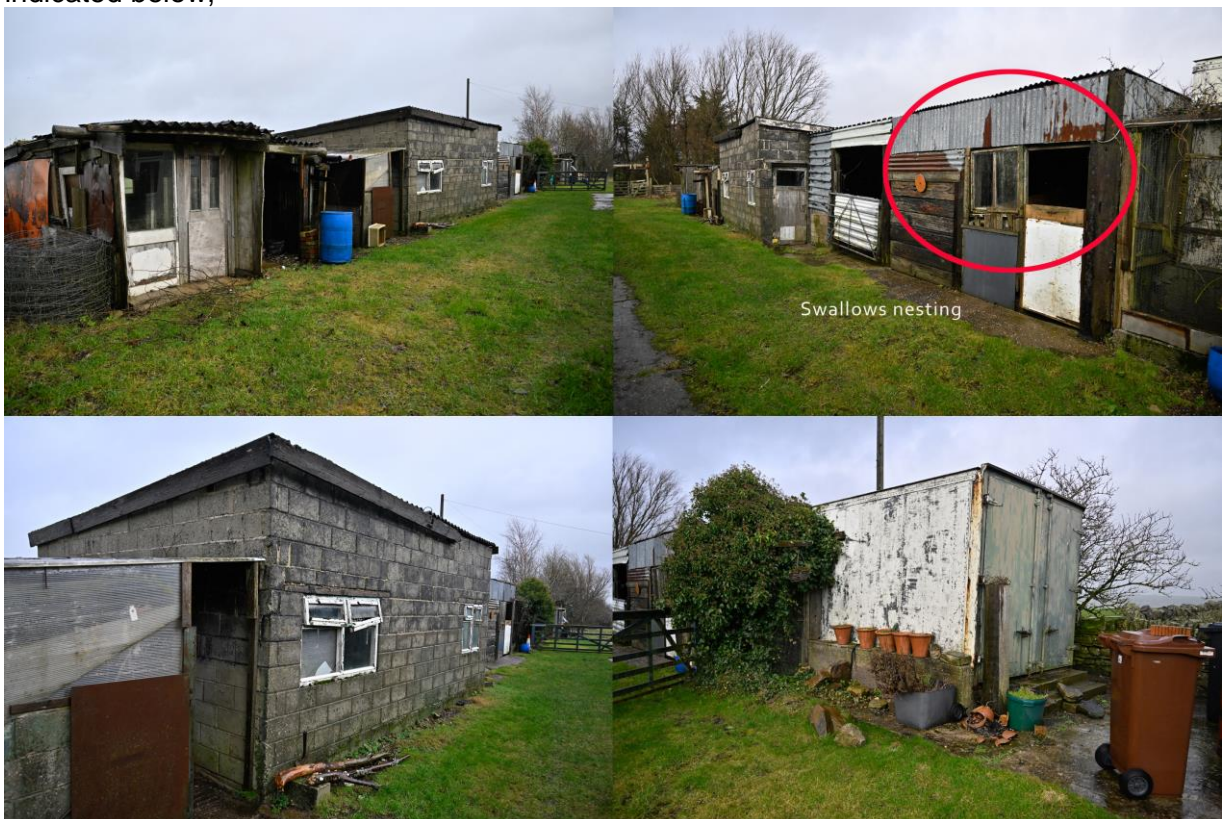
Photo 3. Showing the outbuildings including one used by swallows.

Running along the north boundary is a set of outbuildings that have been knocked together using a variety of materials from old doors to railway sleepers and bits of tin sheeting. One building is constructed from breezeblock but has no potential roosting features. None of the buildings are considered to be of any potential interest to bats and certainly would not be capable of supporting a maternity roost. One of the buildings is favoured by swallows and is indicated below,
