**LAND AT WHITES BAKERY LIMITED
CHARLES STREET
WORSBOROUGH BRIDGE
BARNSELY
SOUTH YORKSHIRE**

**PHASE 2 REPORT ON
GROUND INVESTIGATION**

SILKSTONE ENVIRONMENTAL LTD

OCTOBER 2014

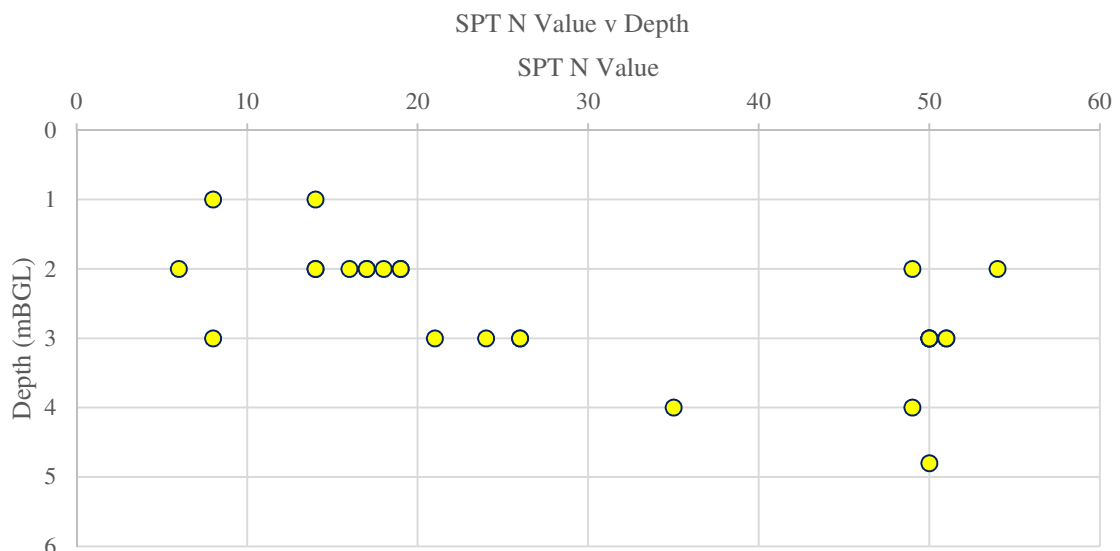
Standard Penetration Testing (SPT) was carried out in all of the window sample holes and these have been plotted against depth on the graph below. Made ground is not suitable material for founding upon and these values or those for the first 0.5m of penetration below made ground have not been included.

Due to the variable thickness and nature of the made ground across the site is not considered a suitable bearing stratum for foundations. Similarly the near surface clays have been shown to be soft to firm, with material at shallower than 0.70m penetration into natural soils yielding SPT N values of less than 8.

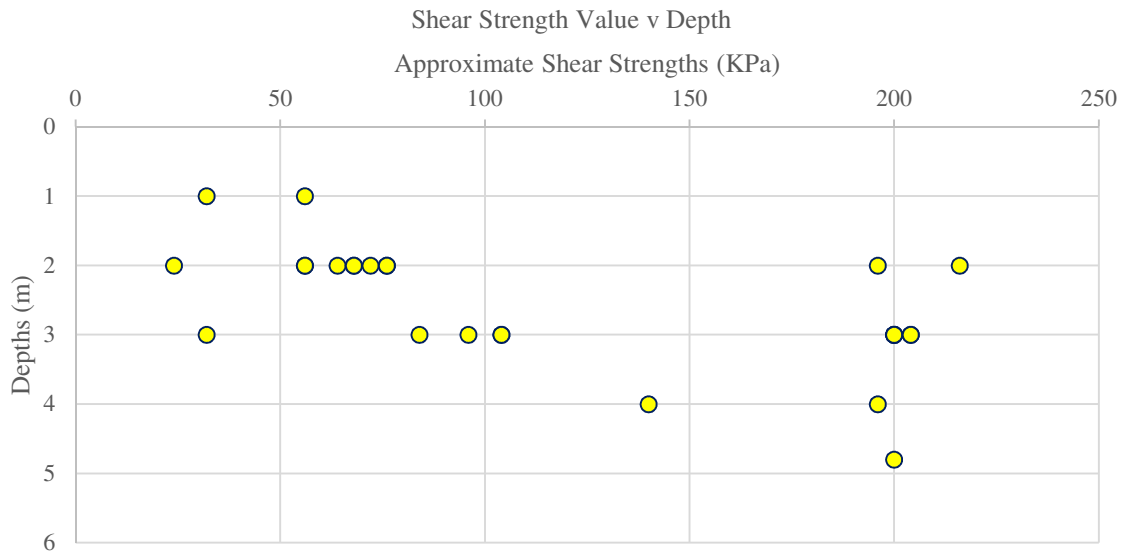
Using the correlation between PI and SPT N values, presented in Fig 1.4 of Tomlinson (Ref N), we can derive a correlation factor of greater than 4 for the clay materials. Using these we have converted the SPT N values to undrained shear strength and these are plotted on the graph below against depth.

It is therefore recommended that foundations be taken down to the underlying weathered rock head, found to be between 0.70 and 3.00m below existing ground levels. For design purposes an undrained shear strength of 50kPa can be used for clays below these depths.

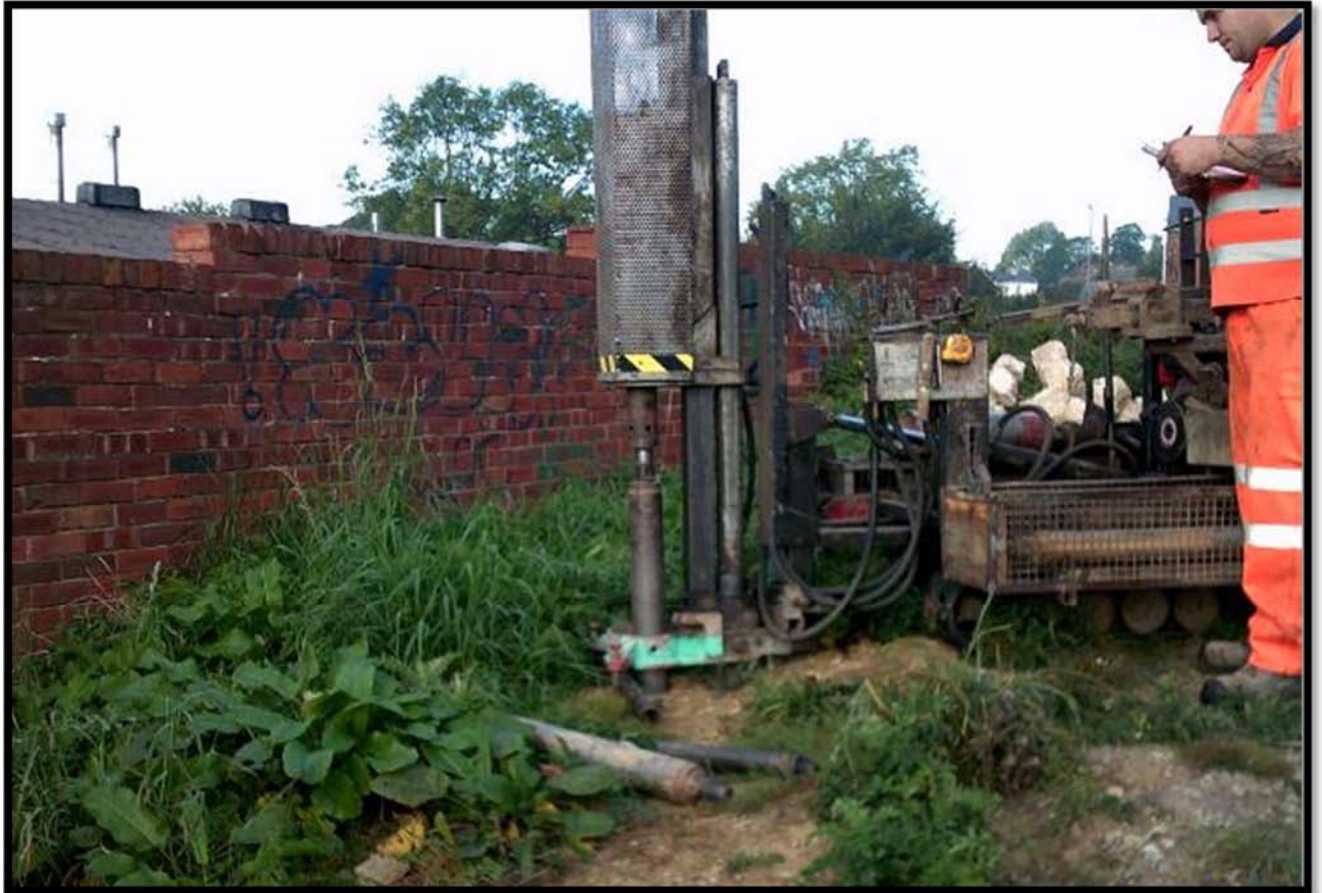
A: Window sample borehole WS01 was located behind a retaining wall at the northeast corner of the site.

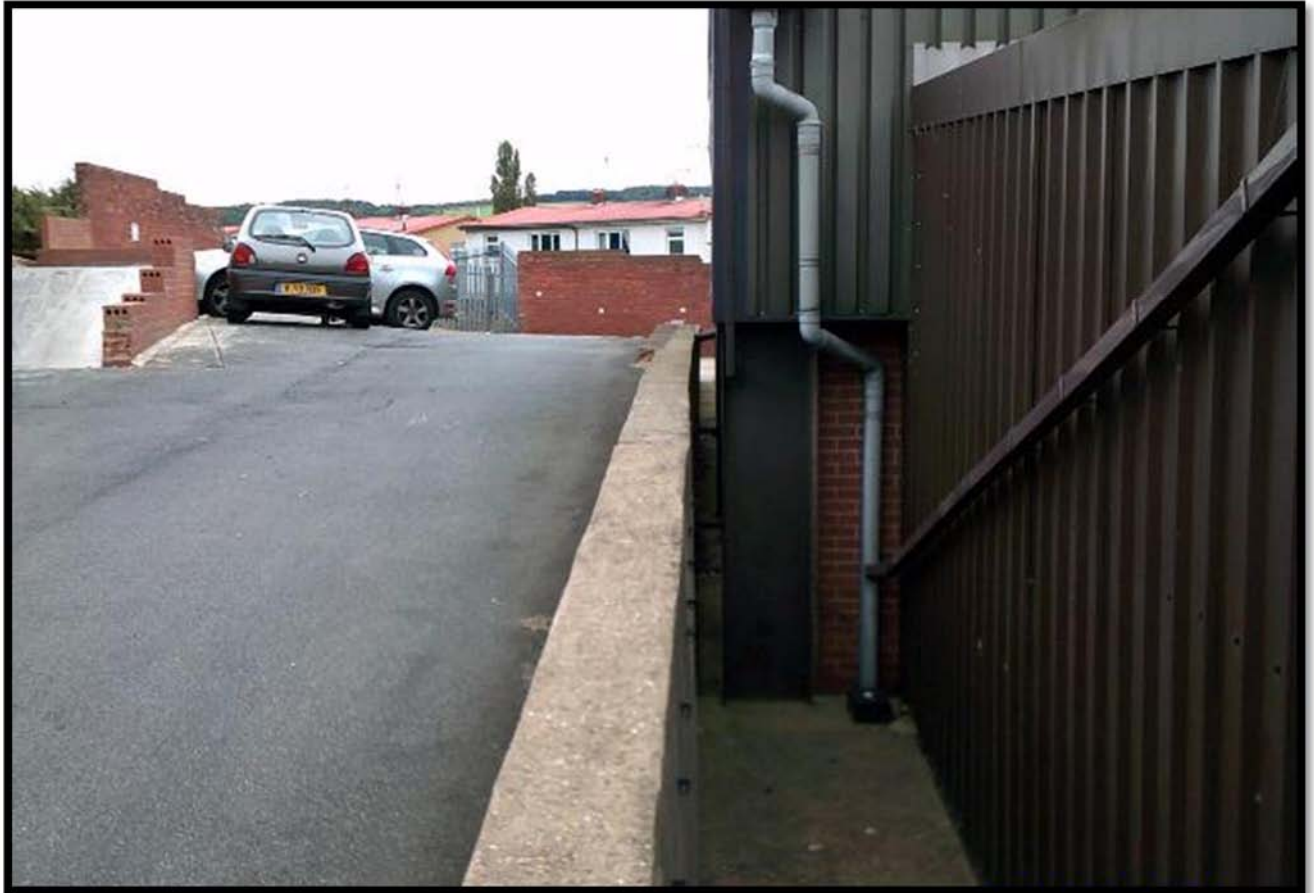
C: The access road behind the main building was set behind a retainment.

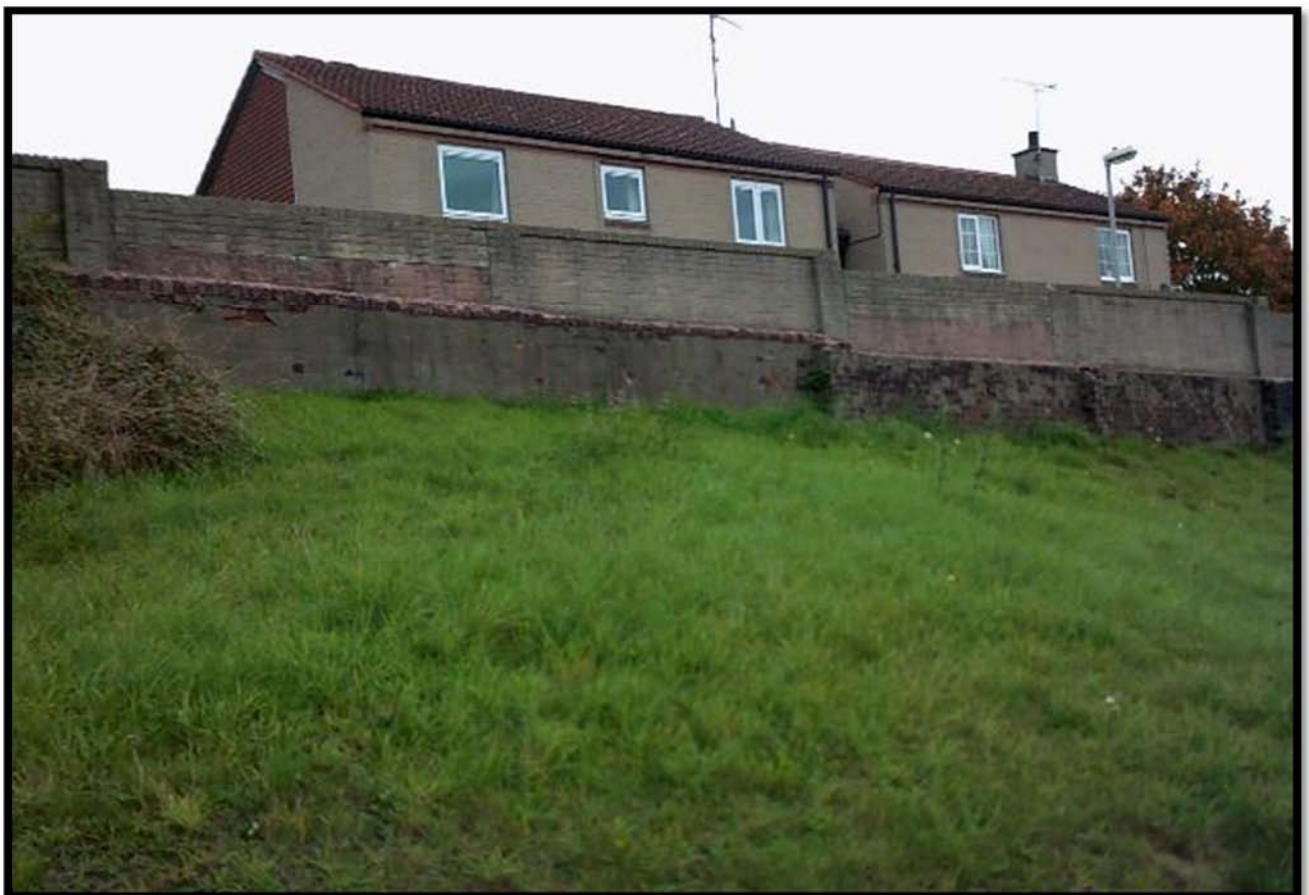
D: The site had been steeply banked at the north boundary.

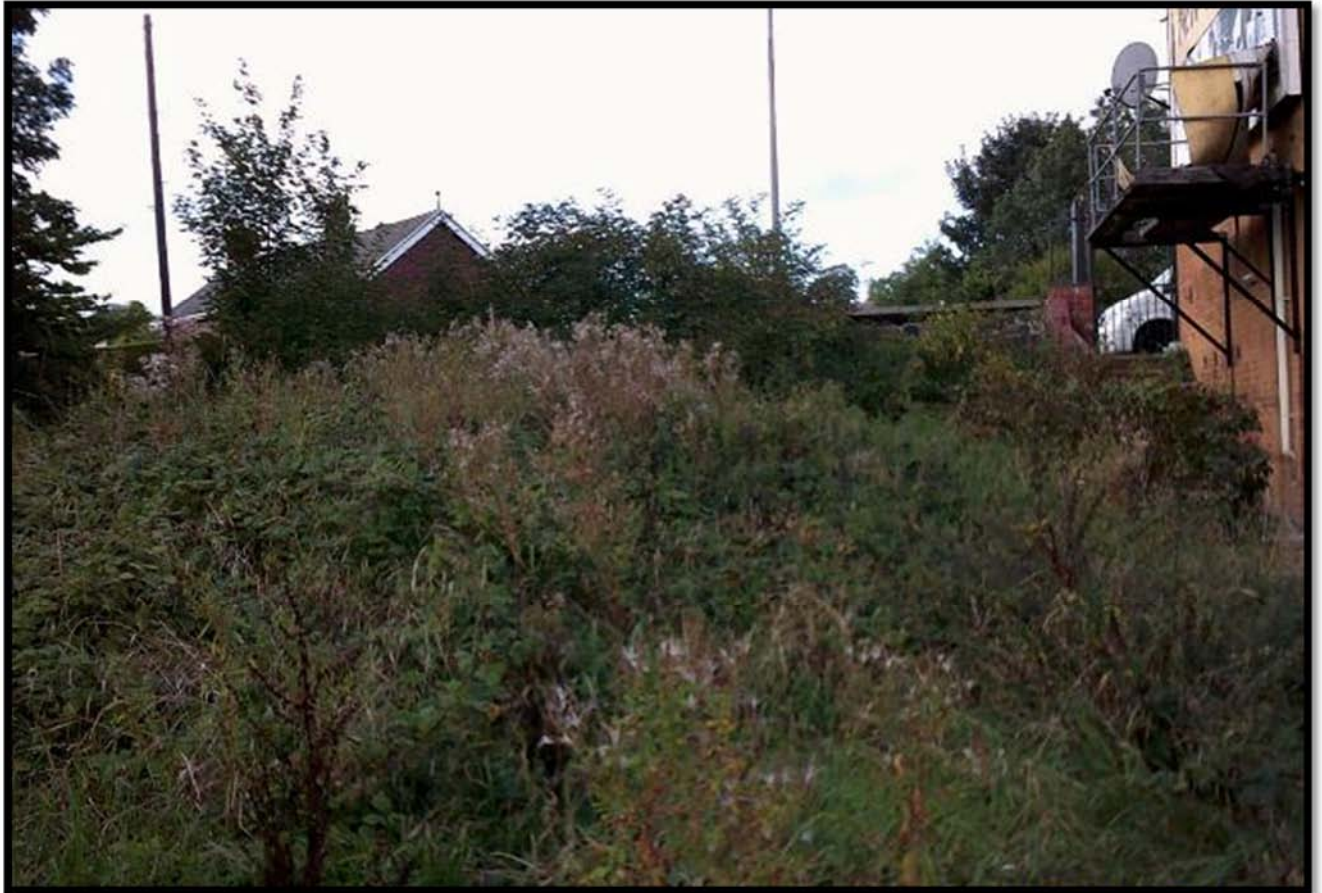
E: The extreme west of the site was inaccessible.

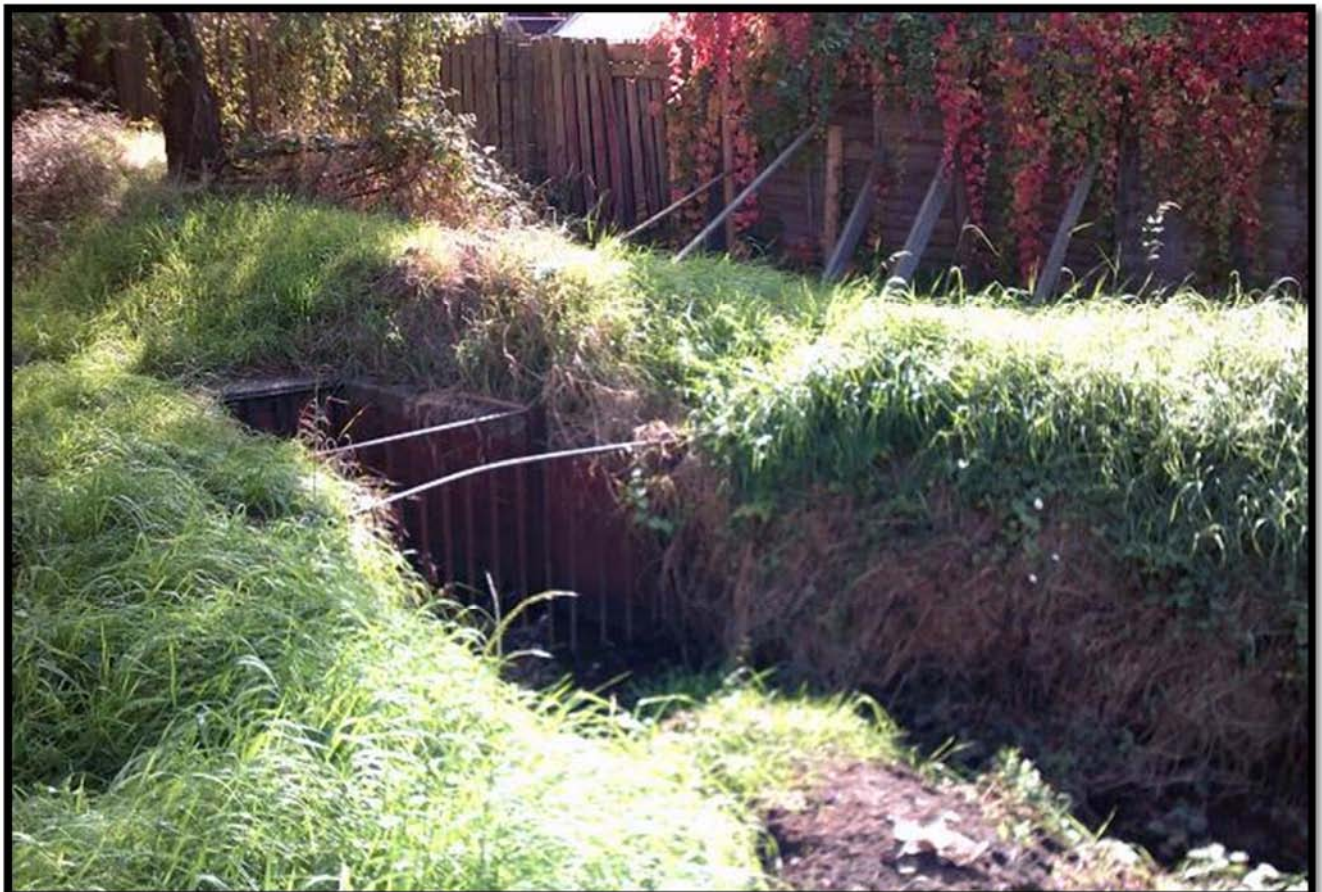
F: The site watercourse had been culverted in the southeast of the site.

We anticipate potential groundwater ingress into shallow excavations on lower ground at the south of the site and it is recommended that the scheduled restructuring of a semi-culverted watercourse at the site should be undertaken before the general site works. Compaction characteristics of the material that is likely to be excavated, provided a maximum dry density of 2.01Mg/m^3 at an optimum moisture content of 11 for a 4.5kg compaction.

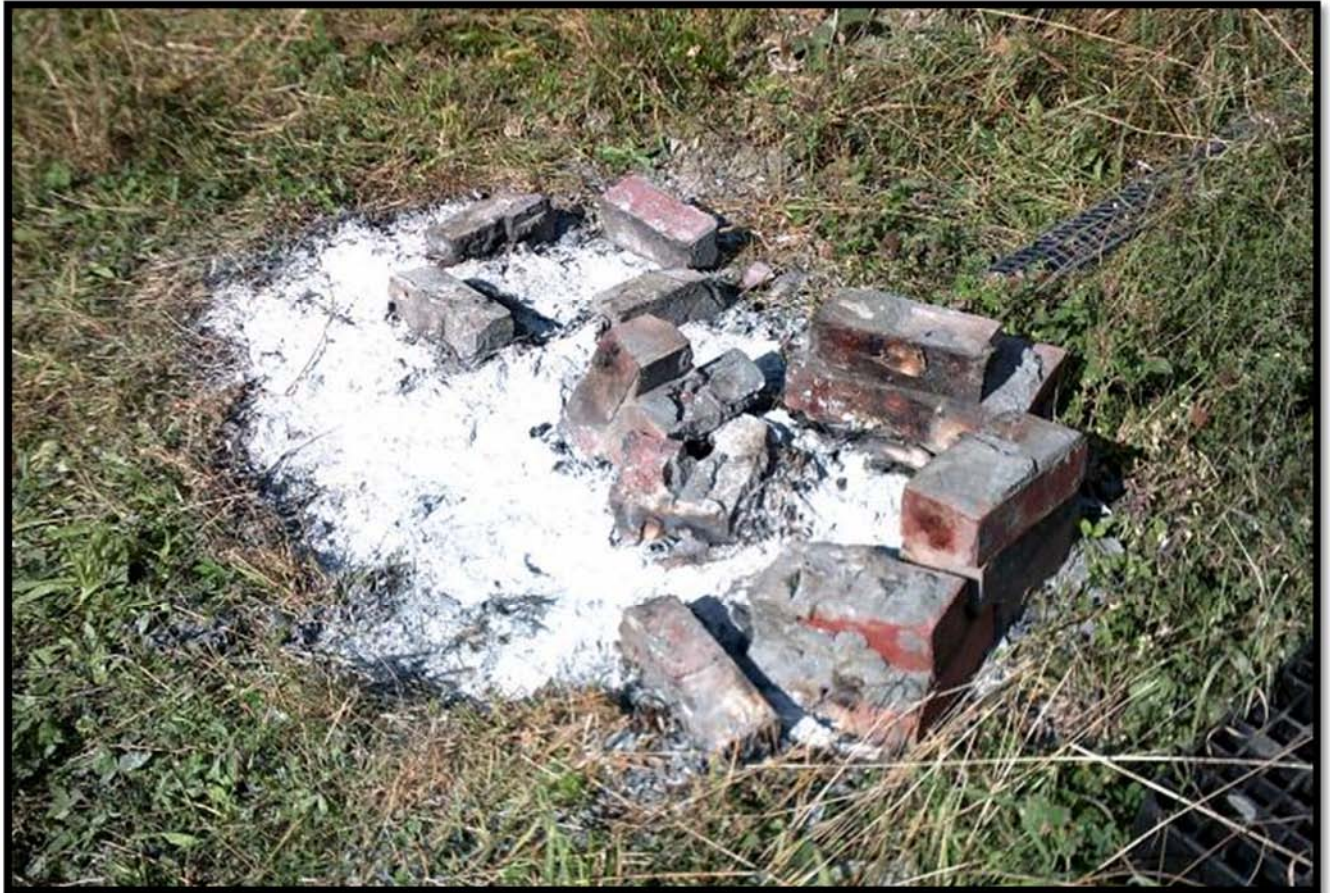
Window sample borehole WS07 was located in close proximity to the remains of a bonfire and it is wholly possible that arsenic had been locally concentrated by the process of burning.

G: There was evidence of bonfires and building waste at the site.

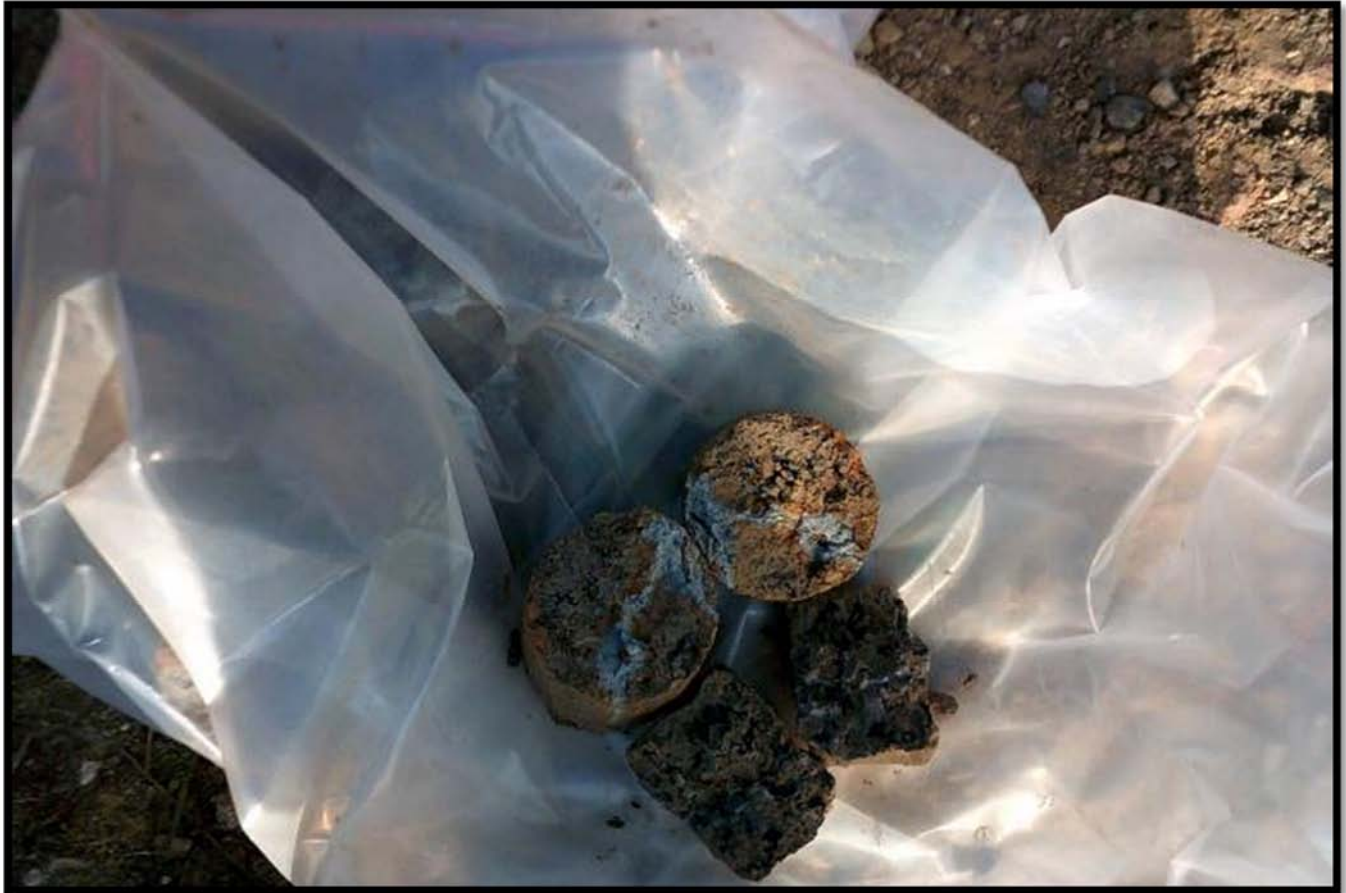
T: Sandy gravelly clay of completely weathered bedrock.

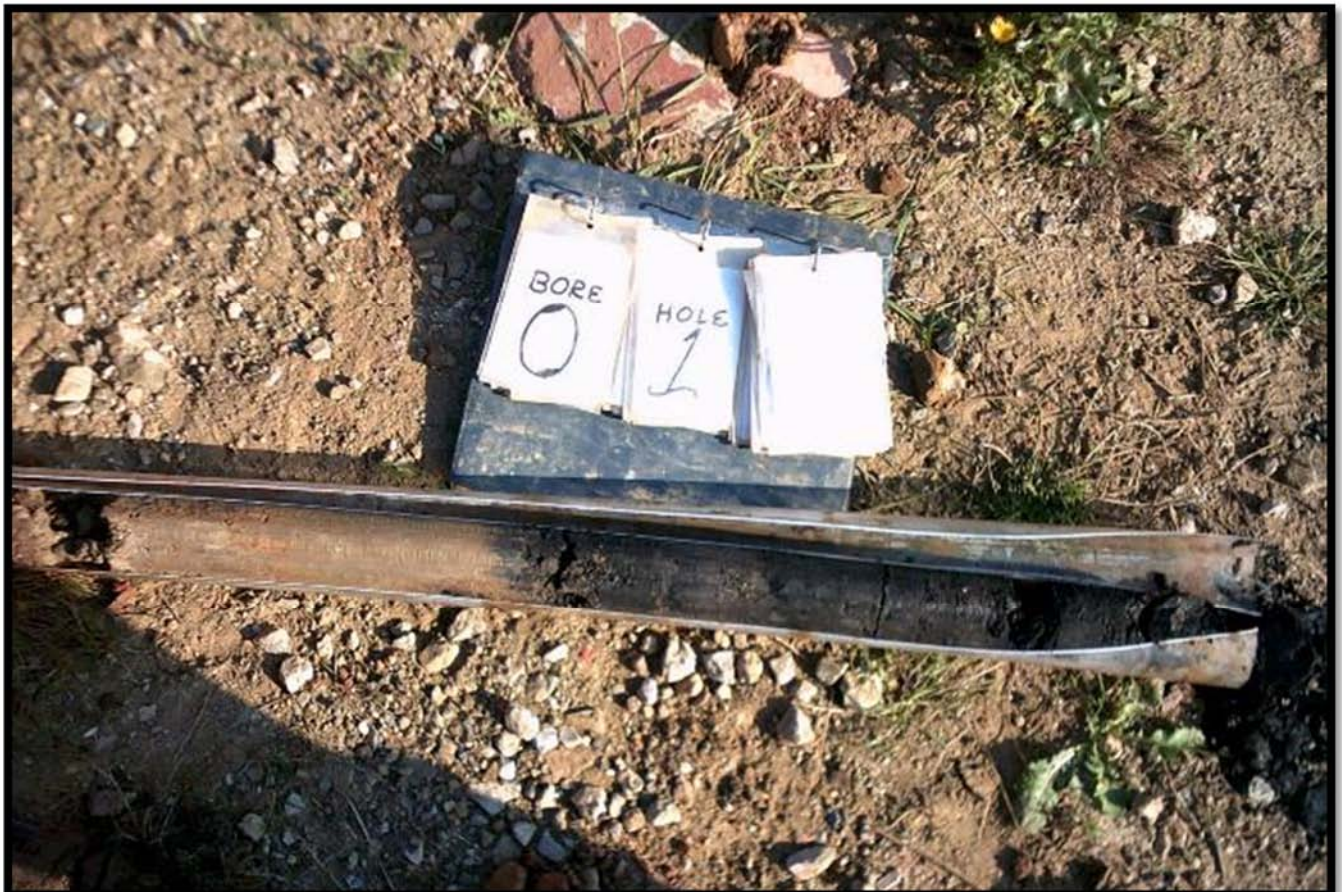
It is not acceptable to form a building foundation directly on to coal due to the elevated risk of combustion and or the potential migration of mine gasses or contaminants. In the event that

U: Dirty coal at the base of window sample borehole WS01.

coal were to be encountered at the founding depths this would require to be removed or suitably blinded by concrete in accordance with the coal authority’s specification. The resulting foundation design will also require inclusion of gas membranes and basic gas protection in order to conform to an NHBC approved design.

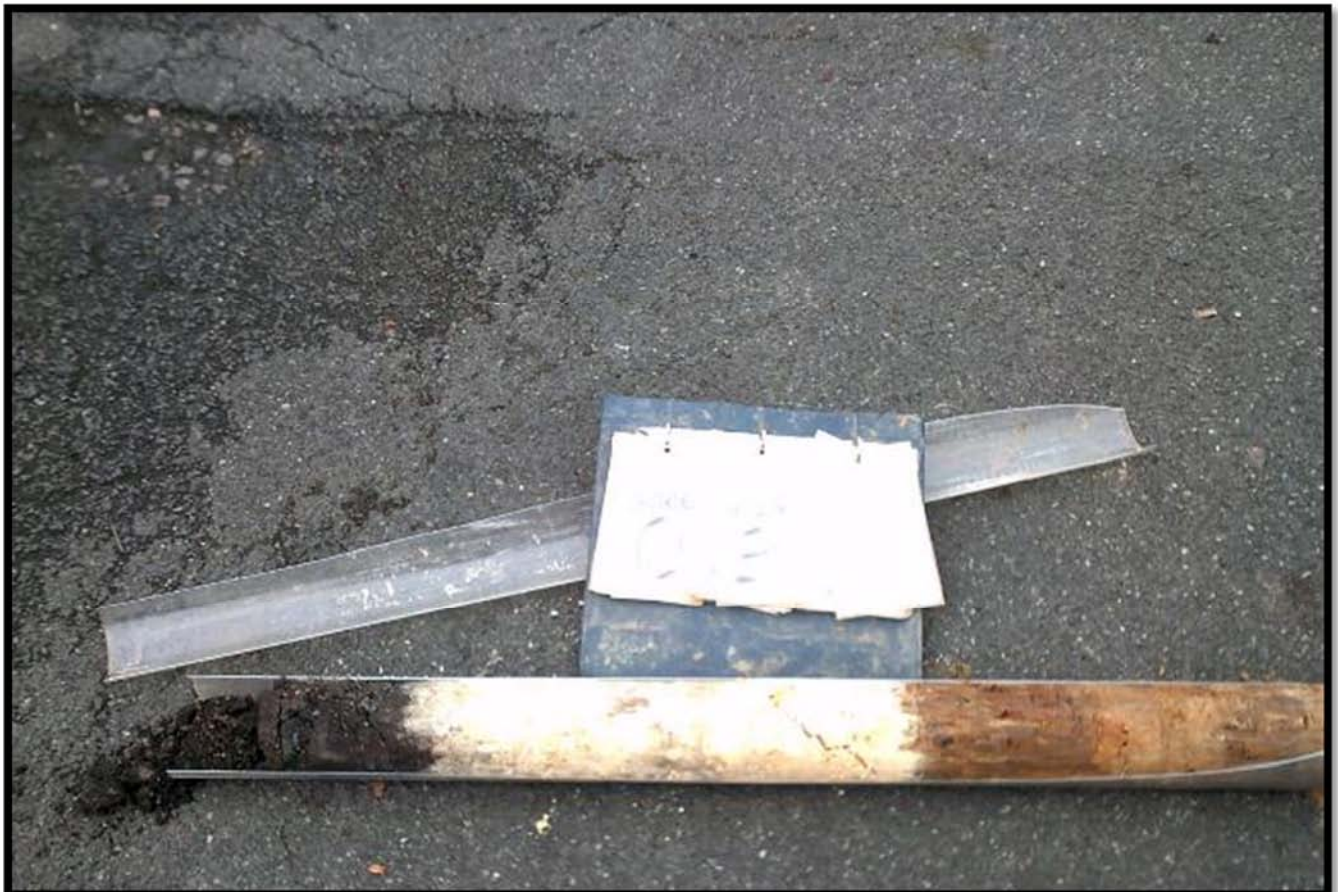
Tarmac was only encountered below window sample borehole WS03 where it was 0.03m in thickness above a mixed gravel of loose tarmac ash and concrete to a total thickness of 0.20m.

W: Ground level to 1.00m from WS03.

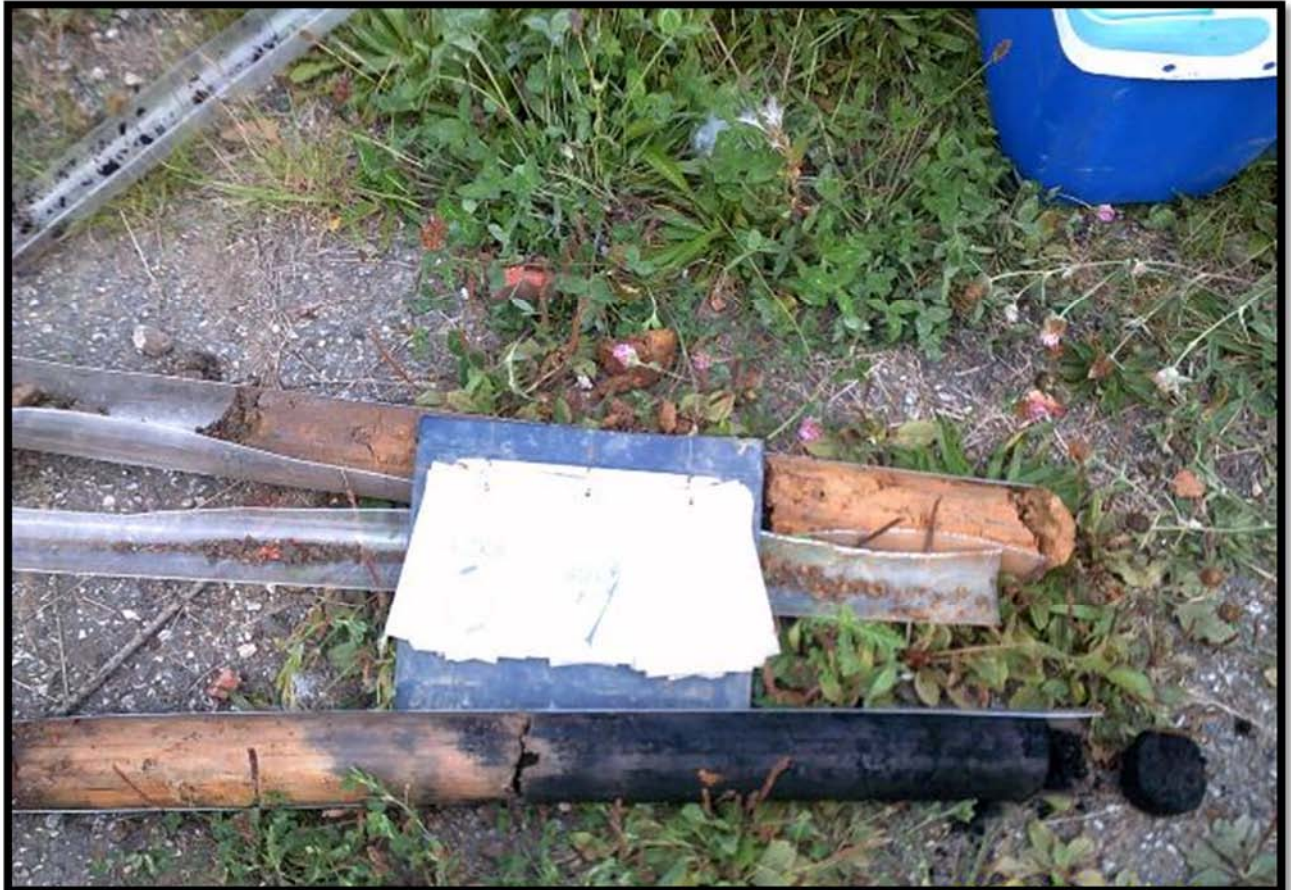
X: Cores from window sample borehole WS07.

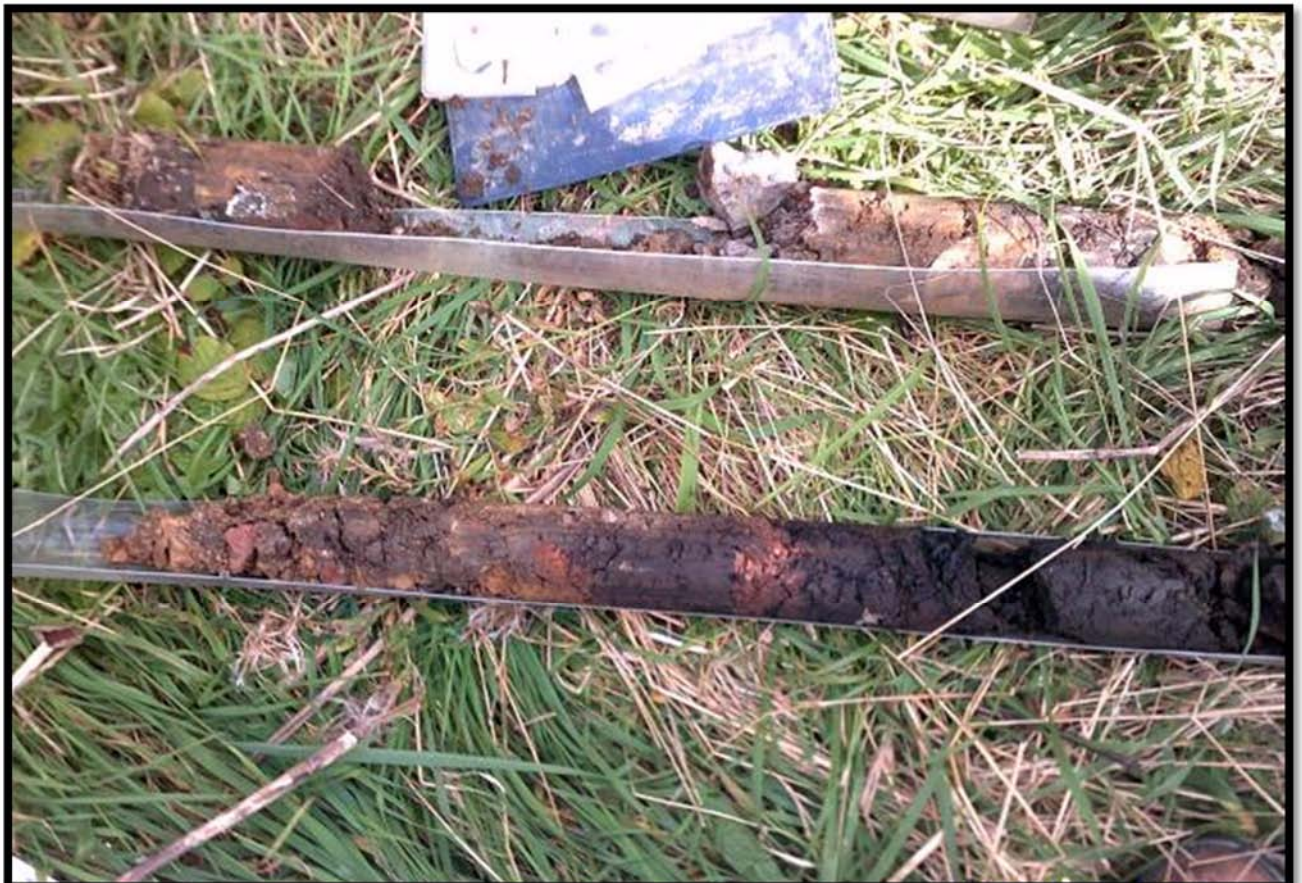
The exceptions to this was in WS05 and WS10. Window sample borehole WS05 was located on uneven ground at the western part of the site and found to be above 1.90m of dry made ground without odour that comprised predominantly of remnant building waste.

Y: Made ground below WS05

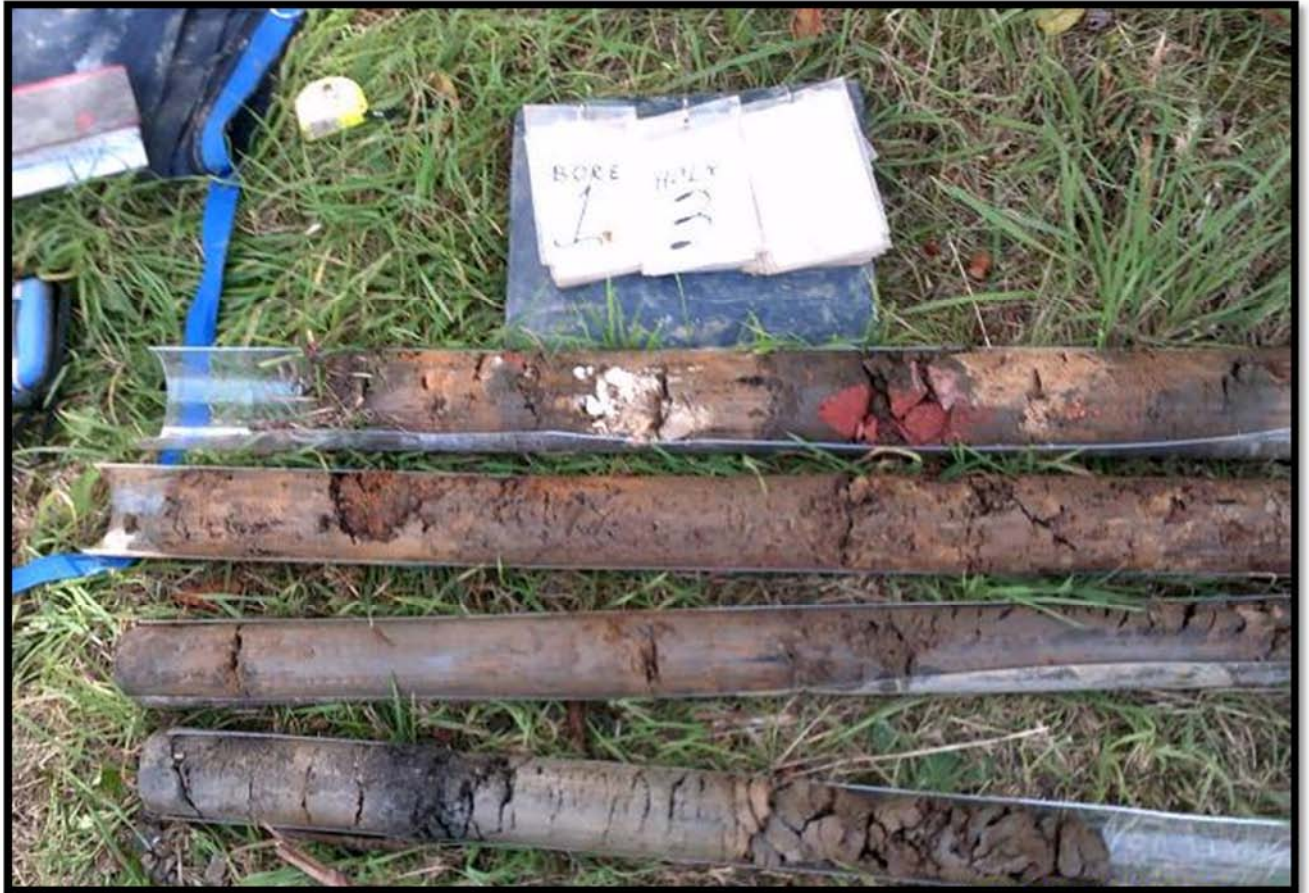
Z: Cores from WS13 showing a typical soil profile with clay grading to mudstone.
