**LAKESIDE VIEW, BLACKER GREEN LANE,  
SILKSTONE.**

**BAT SURVEY.**

**Ref No: 200614.**

**Date: 2<sup>nd</sup> June 2020.**

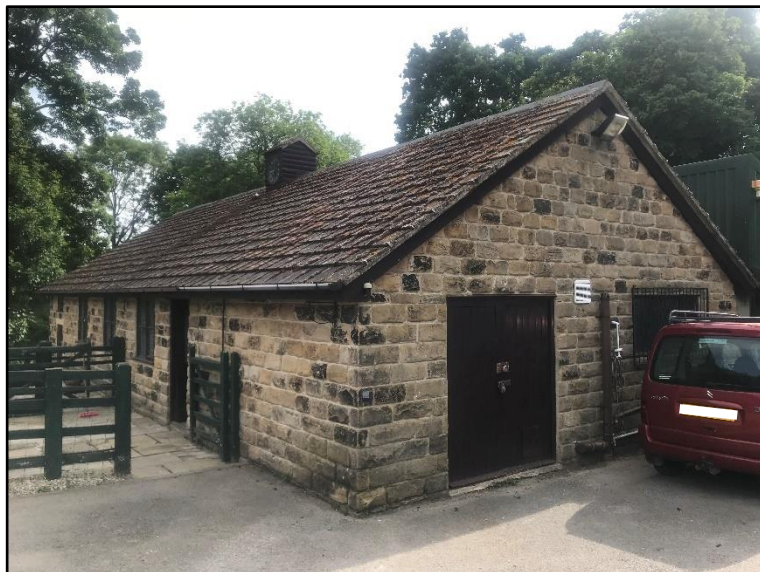
3.3.1. The outbuilding is a single storey outbuilding that is generally in very good condition. The building is shown in the photograph below.

3.3.2. The walls are cavity walls, with an outer skin of cut and dressed stone that is well pointed with no cracks or gaps suitable for roosting bats.

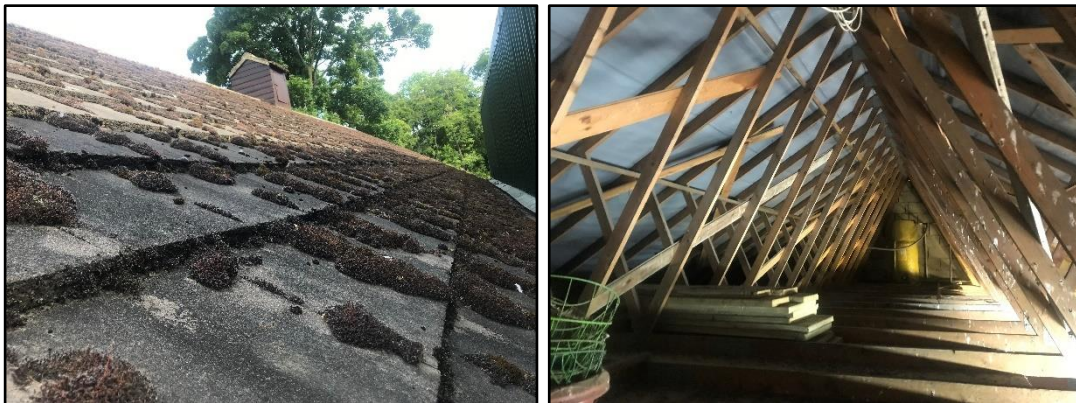
3.3.4. The roof is a pitched, stone tiled roof, underlined with a modern breathable membrane and supported by a trussed rafter construction as shown in the photographs below. A small clock tower sits on top of the roof pitch that comprises timber clad walls and a pitched stone tiled roof.

3.3.5. The roof is in very good condition with all the roof tiles closely fitting and no gaps under or missing mortar under ridge tiles suitable for roosting bats. The roof beams are all in excellent condition with no opportunities for roosting bats.

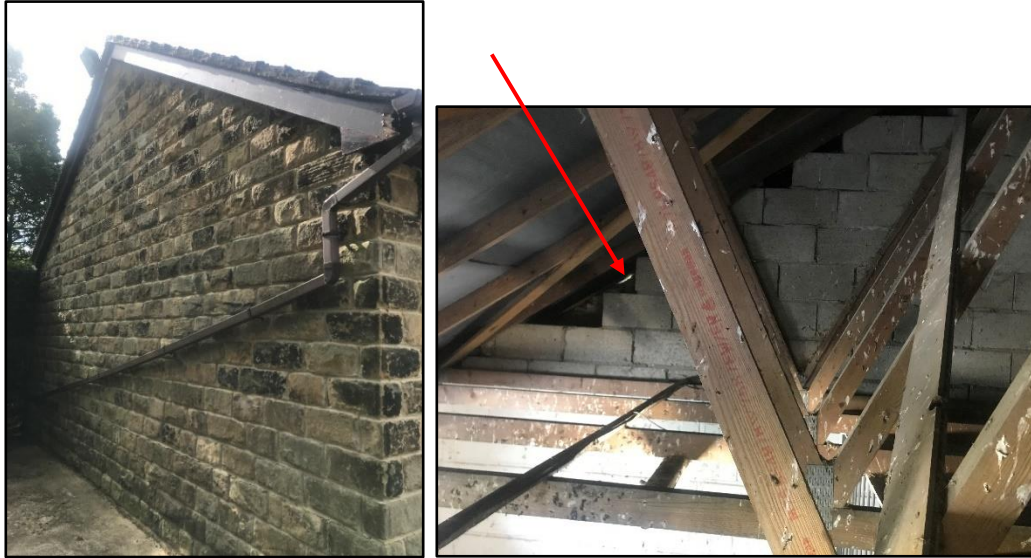
3.3.6. There are soffits around the entirety of the building. These are generally well sealed with the exception of on the north gable end where there are very occasional gaps behind due to the uneven nature of the external stone wall, although some of these are too narrow for bats to access. This leaves just one, potentially two gaps suitable for bats to use to gain entry inside the building or into the top of the wall cavity. These are visible from the inside of the building where daylight can be seen shining through.

3.3.7. No bat field signs were visible on the external wall around these gaps and the gap shown in the photograph above was closely inspected from inside the building and no bat field signs were identified around the gap or on top of the walls leading into the wall cavity at this location.

5.2. Firstly, it is recommended that the gaps behind the soffits on the north gable end are retained.

5.4. It is recommended that when plastering the internal gable end at the northern end of the building, care is taken to ensure that this does not prevent bats from accessing into the wall cavity from the external gaps under the soffit.

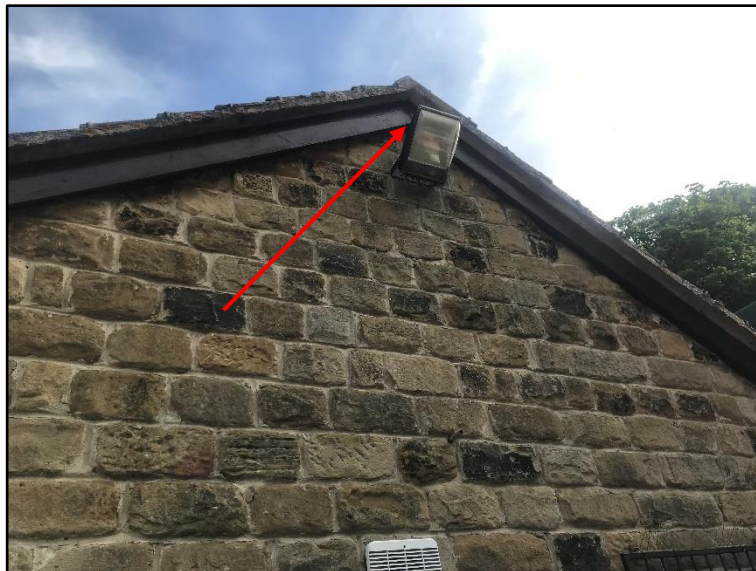
3.3.8. There is also a gap at the very apex of the southern gable end, but this is located behind a large security light and is therefore unsuitable for bats to use. This is demonstrated in the photograph below.

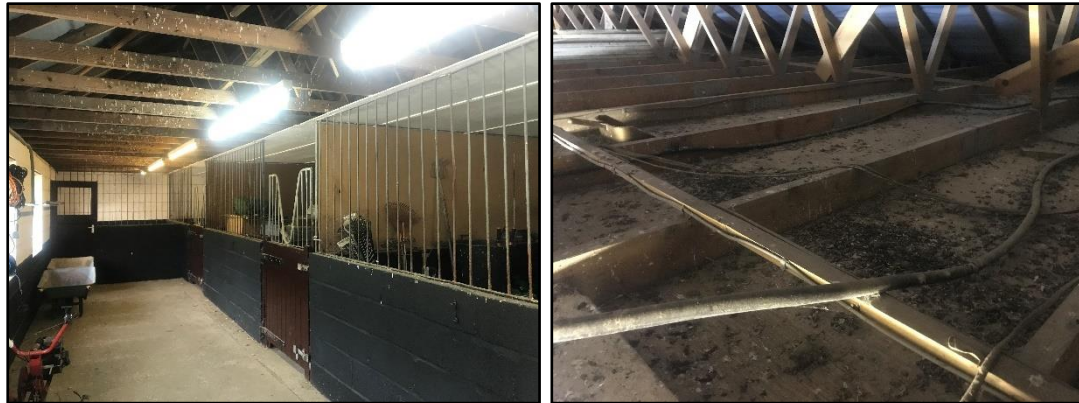
3.3.9. Internally the building is one open area that has been previously converted into stables with a dog kennel and small tac room. The building is no longer in use for these purposes and is used only for some storage and is accessed on a daily basis with

strip lighting throughout. A false ceiling has been installed above the stables and tack rooms creating a mezzanine floor. The photographs below show the general nature of the internal of the building.

3.3.10. The only available entry points for bats inside the building is via the one or two gaps on the north gable end of the building, although no bats or bat field signs were identified inside the building. Due to the nature of the building if any bats utilised the interior of the barn bat field signs would have been evident during this survey.
