**Scudder's daily dairy pictures record
Demolition of B & Q Builder's yard**

Beachcroft Rd Barnsley S70 3PA

Thursday 31-08-2017 first day on site

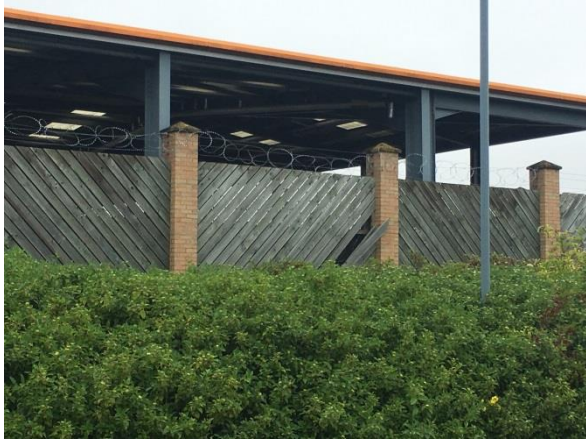
No1. Existing damage to timber fence

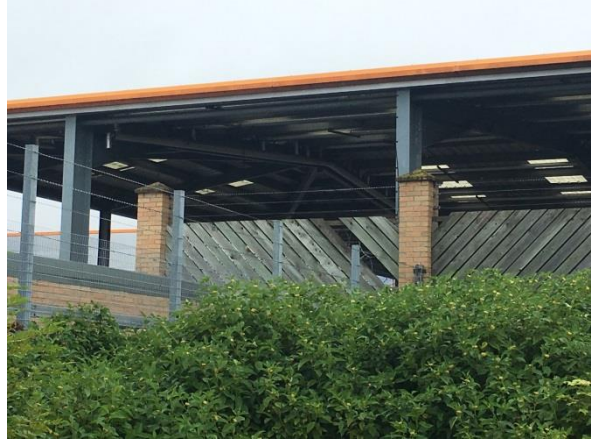
No2. Existing damage to timber fence

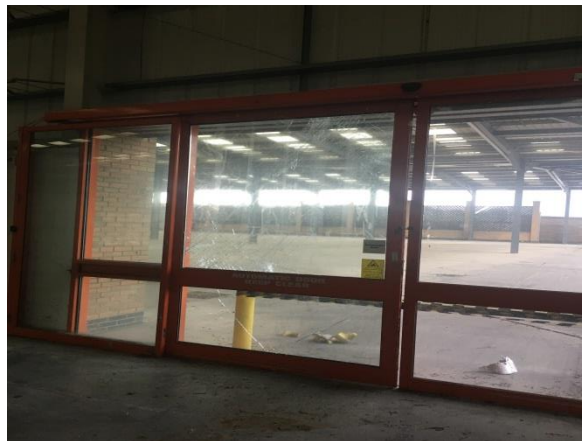
No.4 Glass doors previously damaged

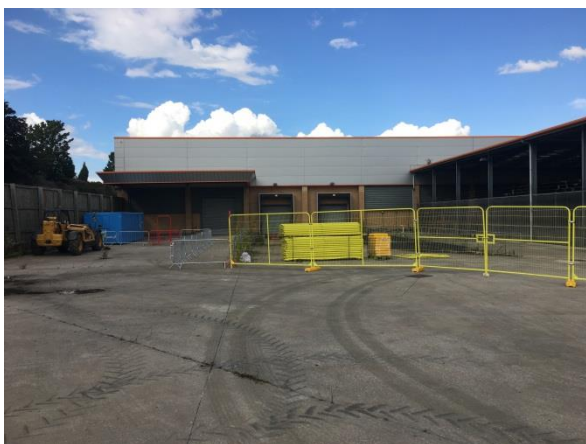
No.5 Got delivery the Welfare unit
& heras fence, then start to set up site

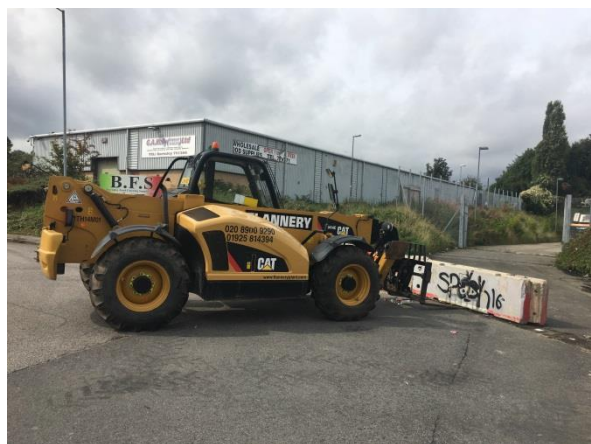
No.6 Telehandler moving the jersey barriers
every morning and put them back in place at the
end of every shift to keep site secure.

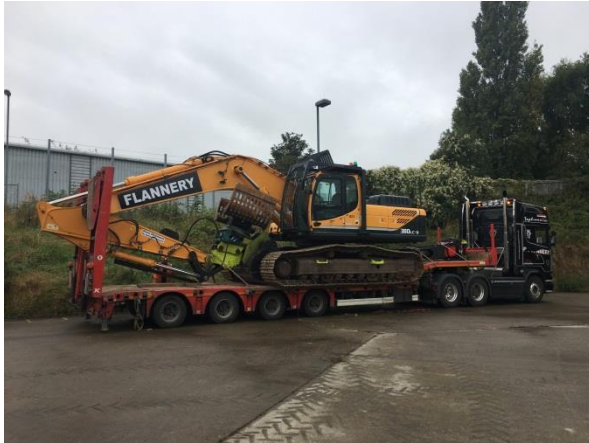
No.1 35t machine has been delivered to site.

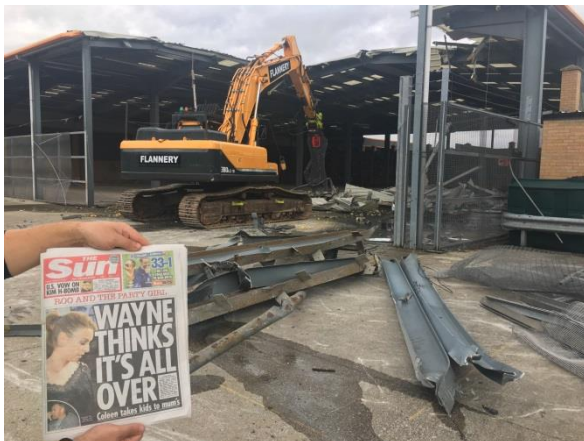
No.3 Start the demolition works with bay 1

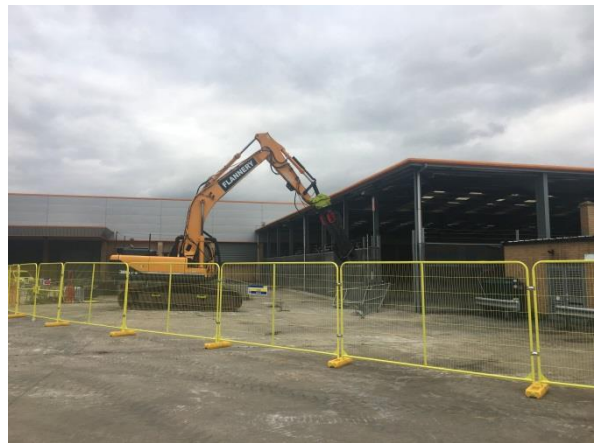
No.2 Demo area has been fenced off ready to start the demolition

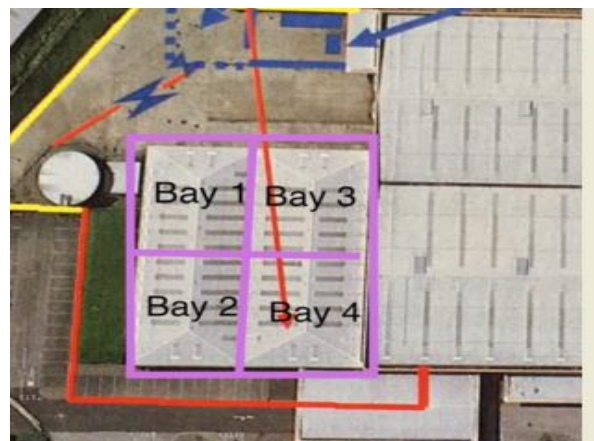
No.4 Plan showing bay 1,2,3 and 4 to builder's yard

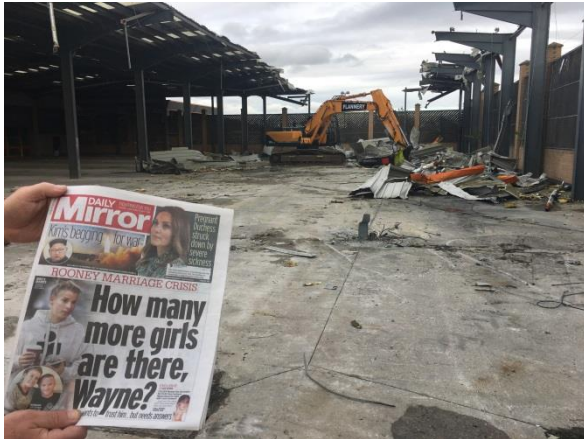
No.1 Continue with demo works with bay 2

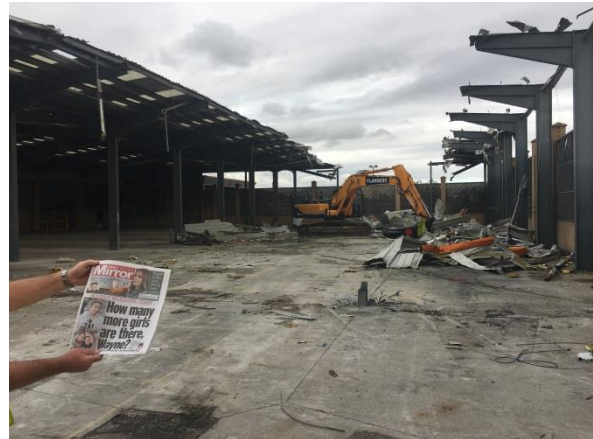
No.2 Excavator with shears attached cut the portal frame as close to the column as possible

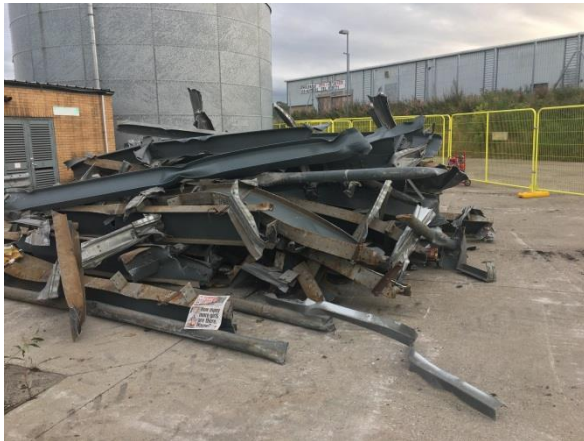
No.3 Cut the steel portal frame into smaller sizes ready to be removed from site.

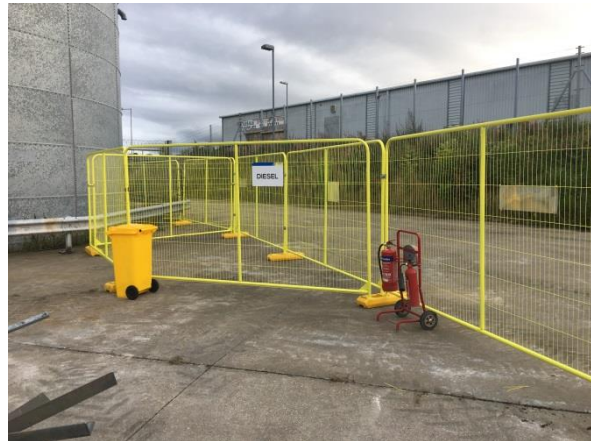
No.4 set up area for fuel

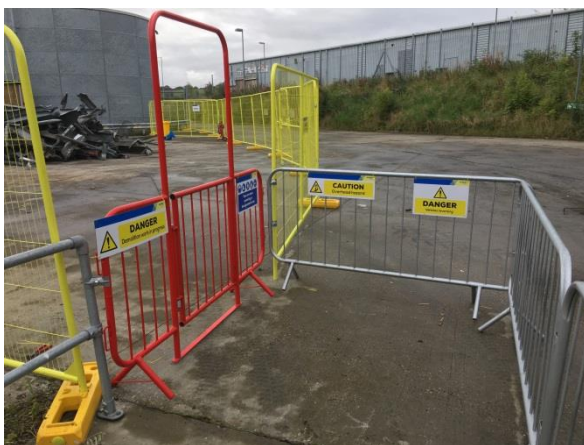
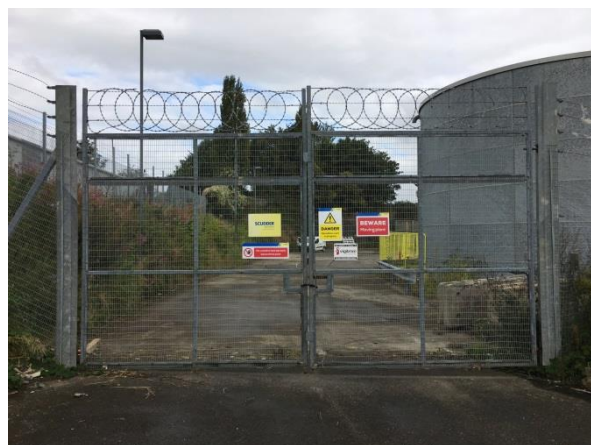
No.5 Access routes will be set up as needed with fencing and signs to segregate areas when working and moving/removing materials, demolition area fence off and display warning signage

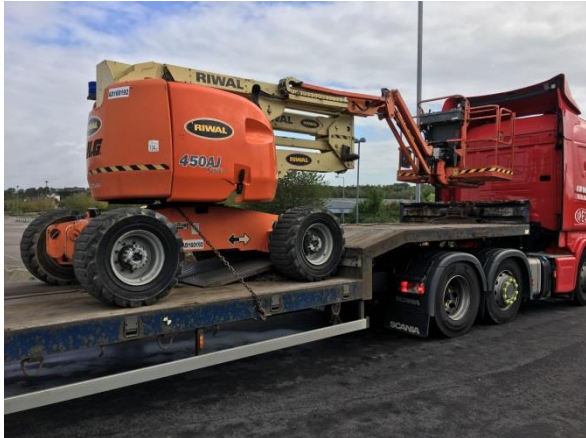
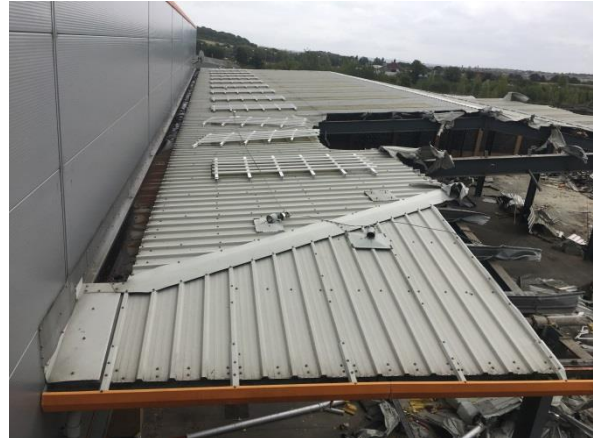
No.1 MEWP machine has been delivered to site. **No.2** Investigate on how to separate from main structure bay 3 & 4

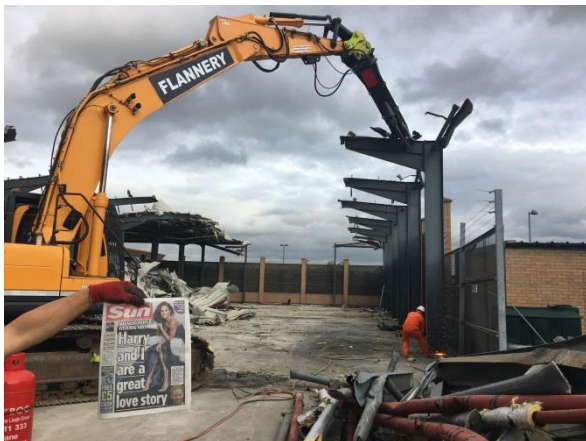
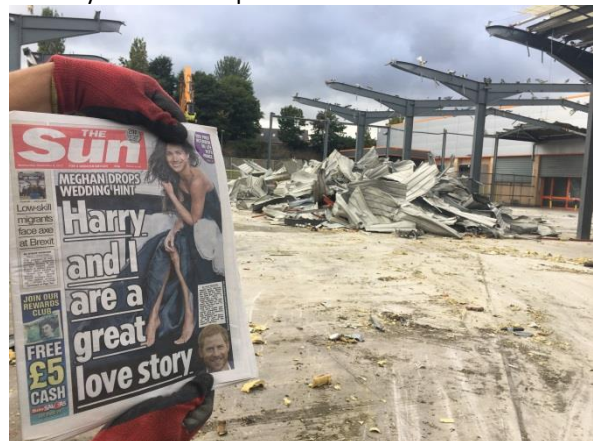
The excavator grabs hold of the last steel portal and pulls it backwards away from the adjacent wall. The excavator will then process the steel as described above and clear the area. A burner will then proceed to cut the steel columns at ground level utilising a gas axe (oxy propane) cutting equipmen

No.3 The excavator grabs hold of the steel column

No.4 placing the sheeting to one side for later loading into 40yd bins for disposal off site

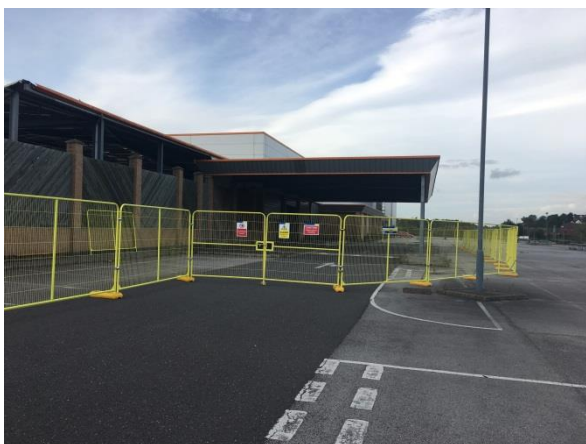
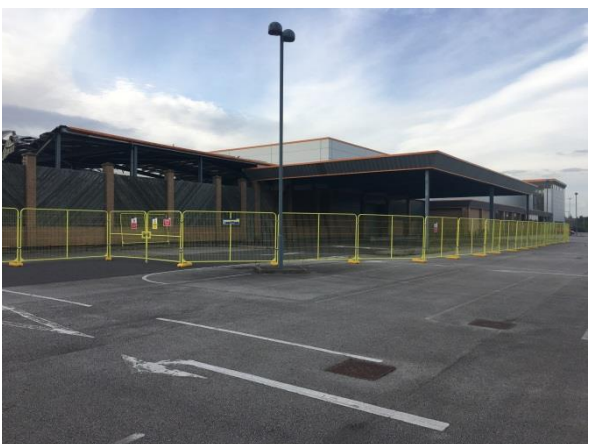
No.5 Canopy 2 fenced off

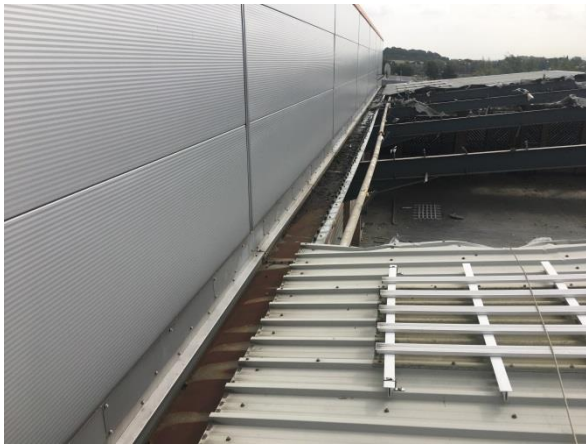
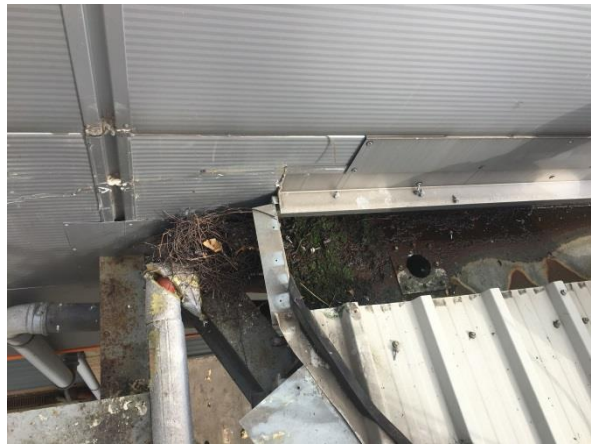
No.1 investigate how to separate from main structure

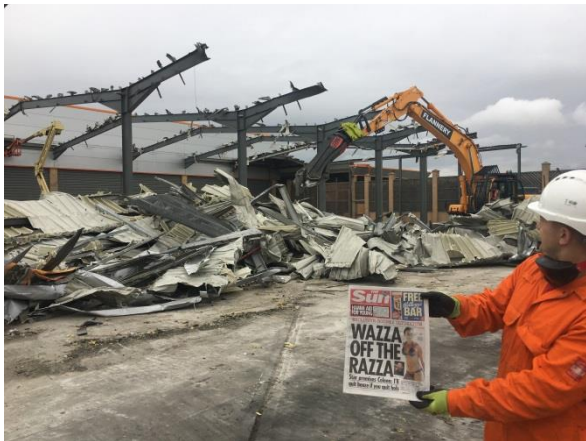
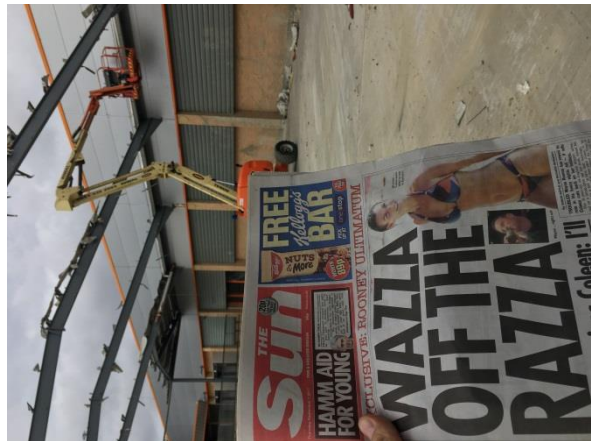
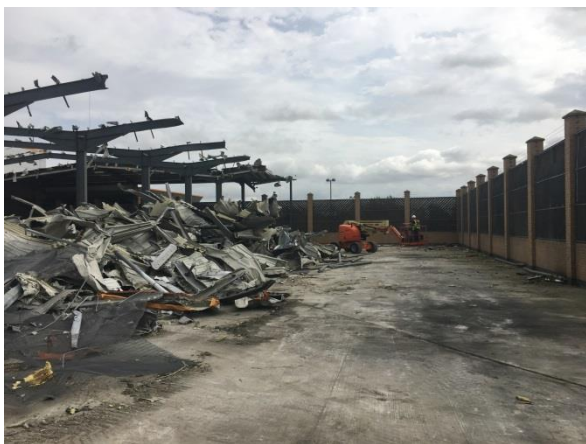
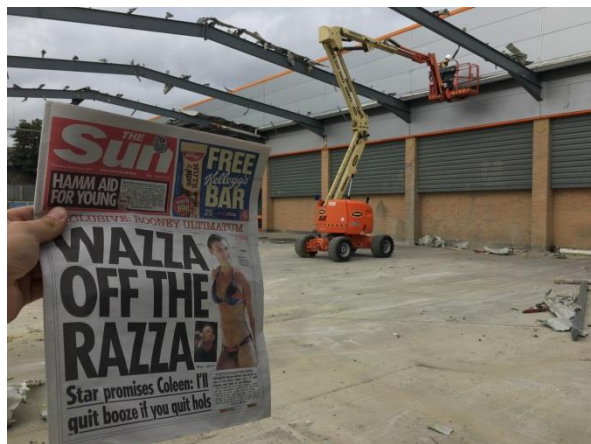
No3. Demolition continue with bay 3 & bay 4

No.4 undo the bolts and remove the rain gutter by hand

Roof removed on Bay 3 and bay 4
