**SITE ASSESSMENT  
PROPOSED AUTISTIC HOSPITAL**

**SHORTWOOD BUSINESS PARK  
HOYLAND  
BARNSELEY**

**REPORT NUMBER: 11061-R1 (01)**

**SITE ASSESSMENT  
PROPOSED AUTISTIC HOSPITAL  
SHORTWOOD BUSINESS PARK, HOYLAND, BARNSELEY**

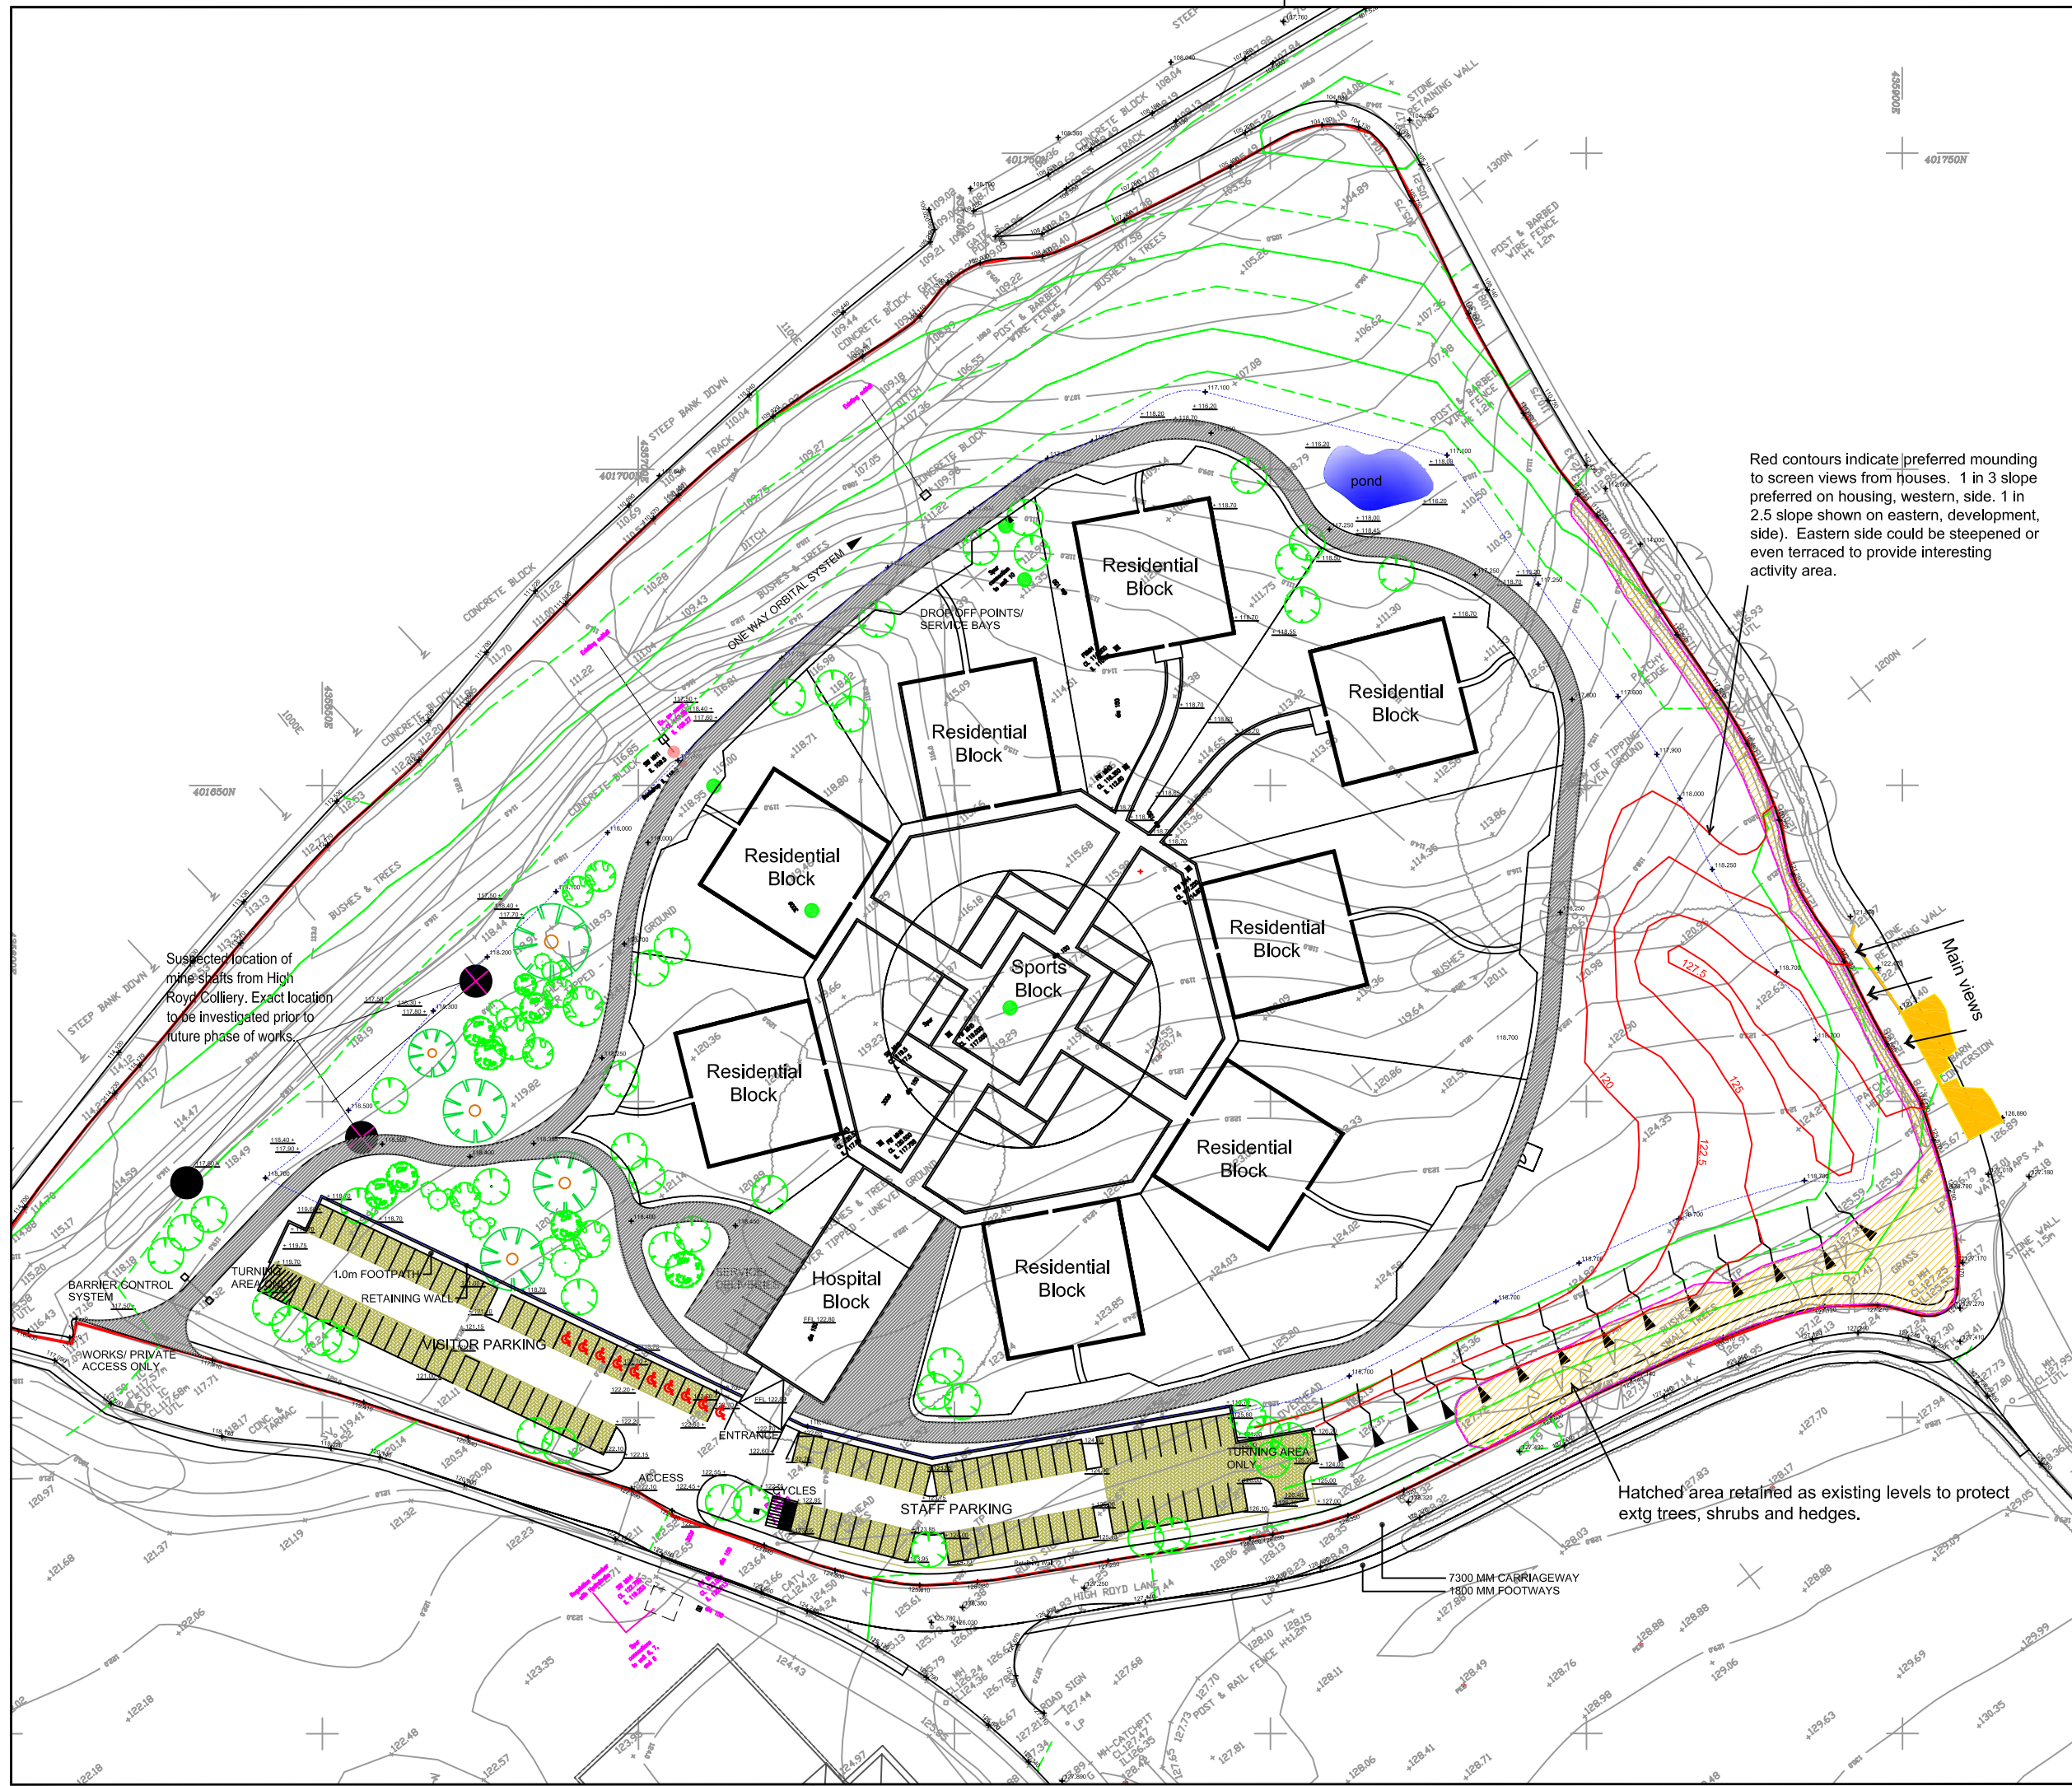
Red contours indicate preferred mounding to screen views from houses. 1 in 3 slope preferred on housing, western, side. 1 in 2.5 slope shown on eastern, development, side). Eastern side could be steepened or even terraced to provide interesting activity area.

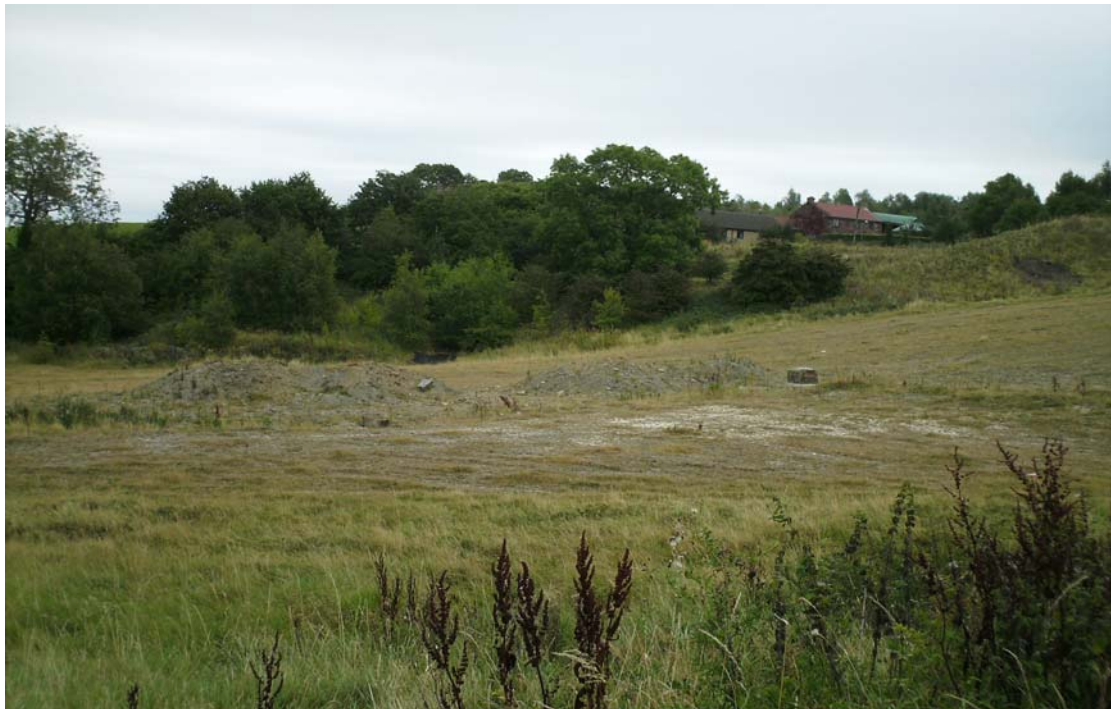
Photograph 1: Easterly View of Central Portion of Site and Mounded Soil in South Eastern corner of Site

In the south east corner of the site are two raised earth mounds. The surface of the mounds are densely vegetated. These were investigated with two trial pits in each (TP105 to TP108) and were generally found to contain mostly reworked natural soils comprising gravelly silt and clay soils, with some concrete and broken brick and pipe remains. At the base of the trial pits in these earth mounds, associated with the adjacent ground level, apparent natural silt and clay soils were encountered.

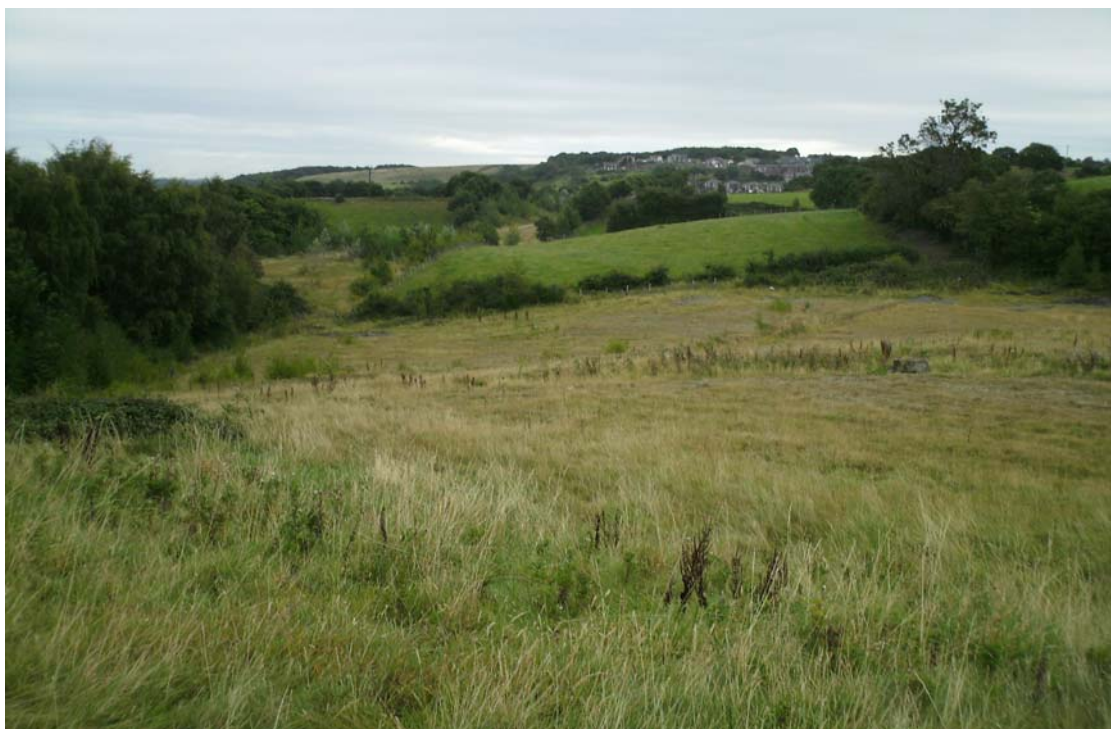
Photograph 2: North Easterly View of Northern Corner of Site and Adjacent Land to the North

In the northern corner of the site a horizon of made ground was encountered that was significantly different to that found across the remainder of the site. The material was typically black clay or sand of ash with metal, ceramic fragments, plastic, wood, and brick and concrete fragments with a hydrocarbon odour. This material was identified in trial pits TP114, TP115, TP117, TP118, TP119 and boreholes RBH104 and BH107. Trial pit TP115 was continued as a trench in a northerly direction as far as practicably possible, towards the site boundary (see Figure 10), and made ground with evidence of hydrocarbon contamination was present along its entire length. With the exception of trial pit TP119, where this made ground type was encountered at 0.2m below ground level, all other exploratory holes indicated a minimum cover of 0.9m above this layer. This material is considered likely to comprise materials associated with the former refuse tip in this area.
