**PHASE 2
GEOTECHNICAL AND GEO-ENVIRONMENTAL
SITE INVESTIGATION**

LOCKWOOD ROAD, GOLDTHORPE

GLEESON DEVELOPMENTS LIMITED

20 May 2021

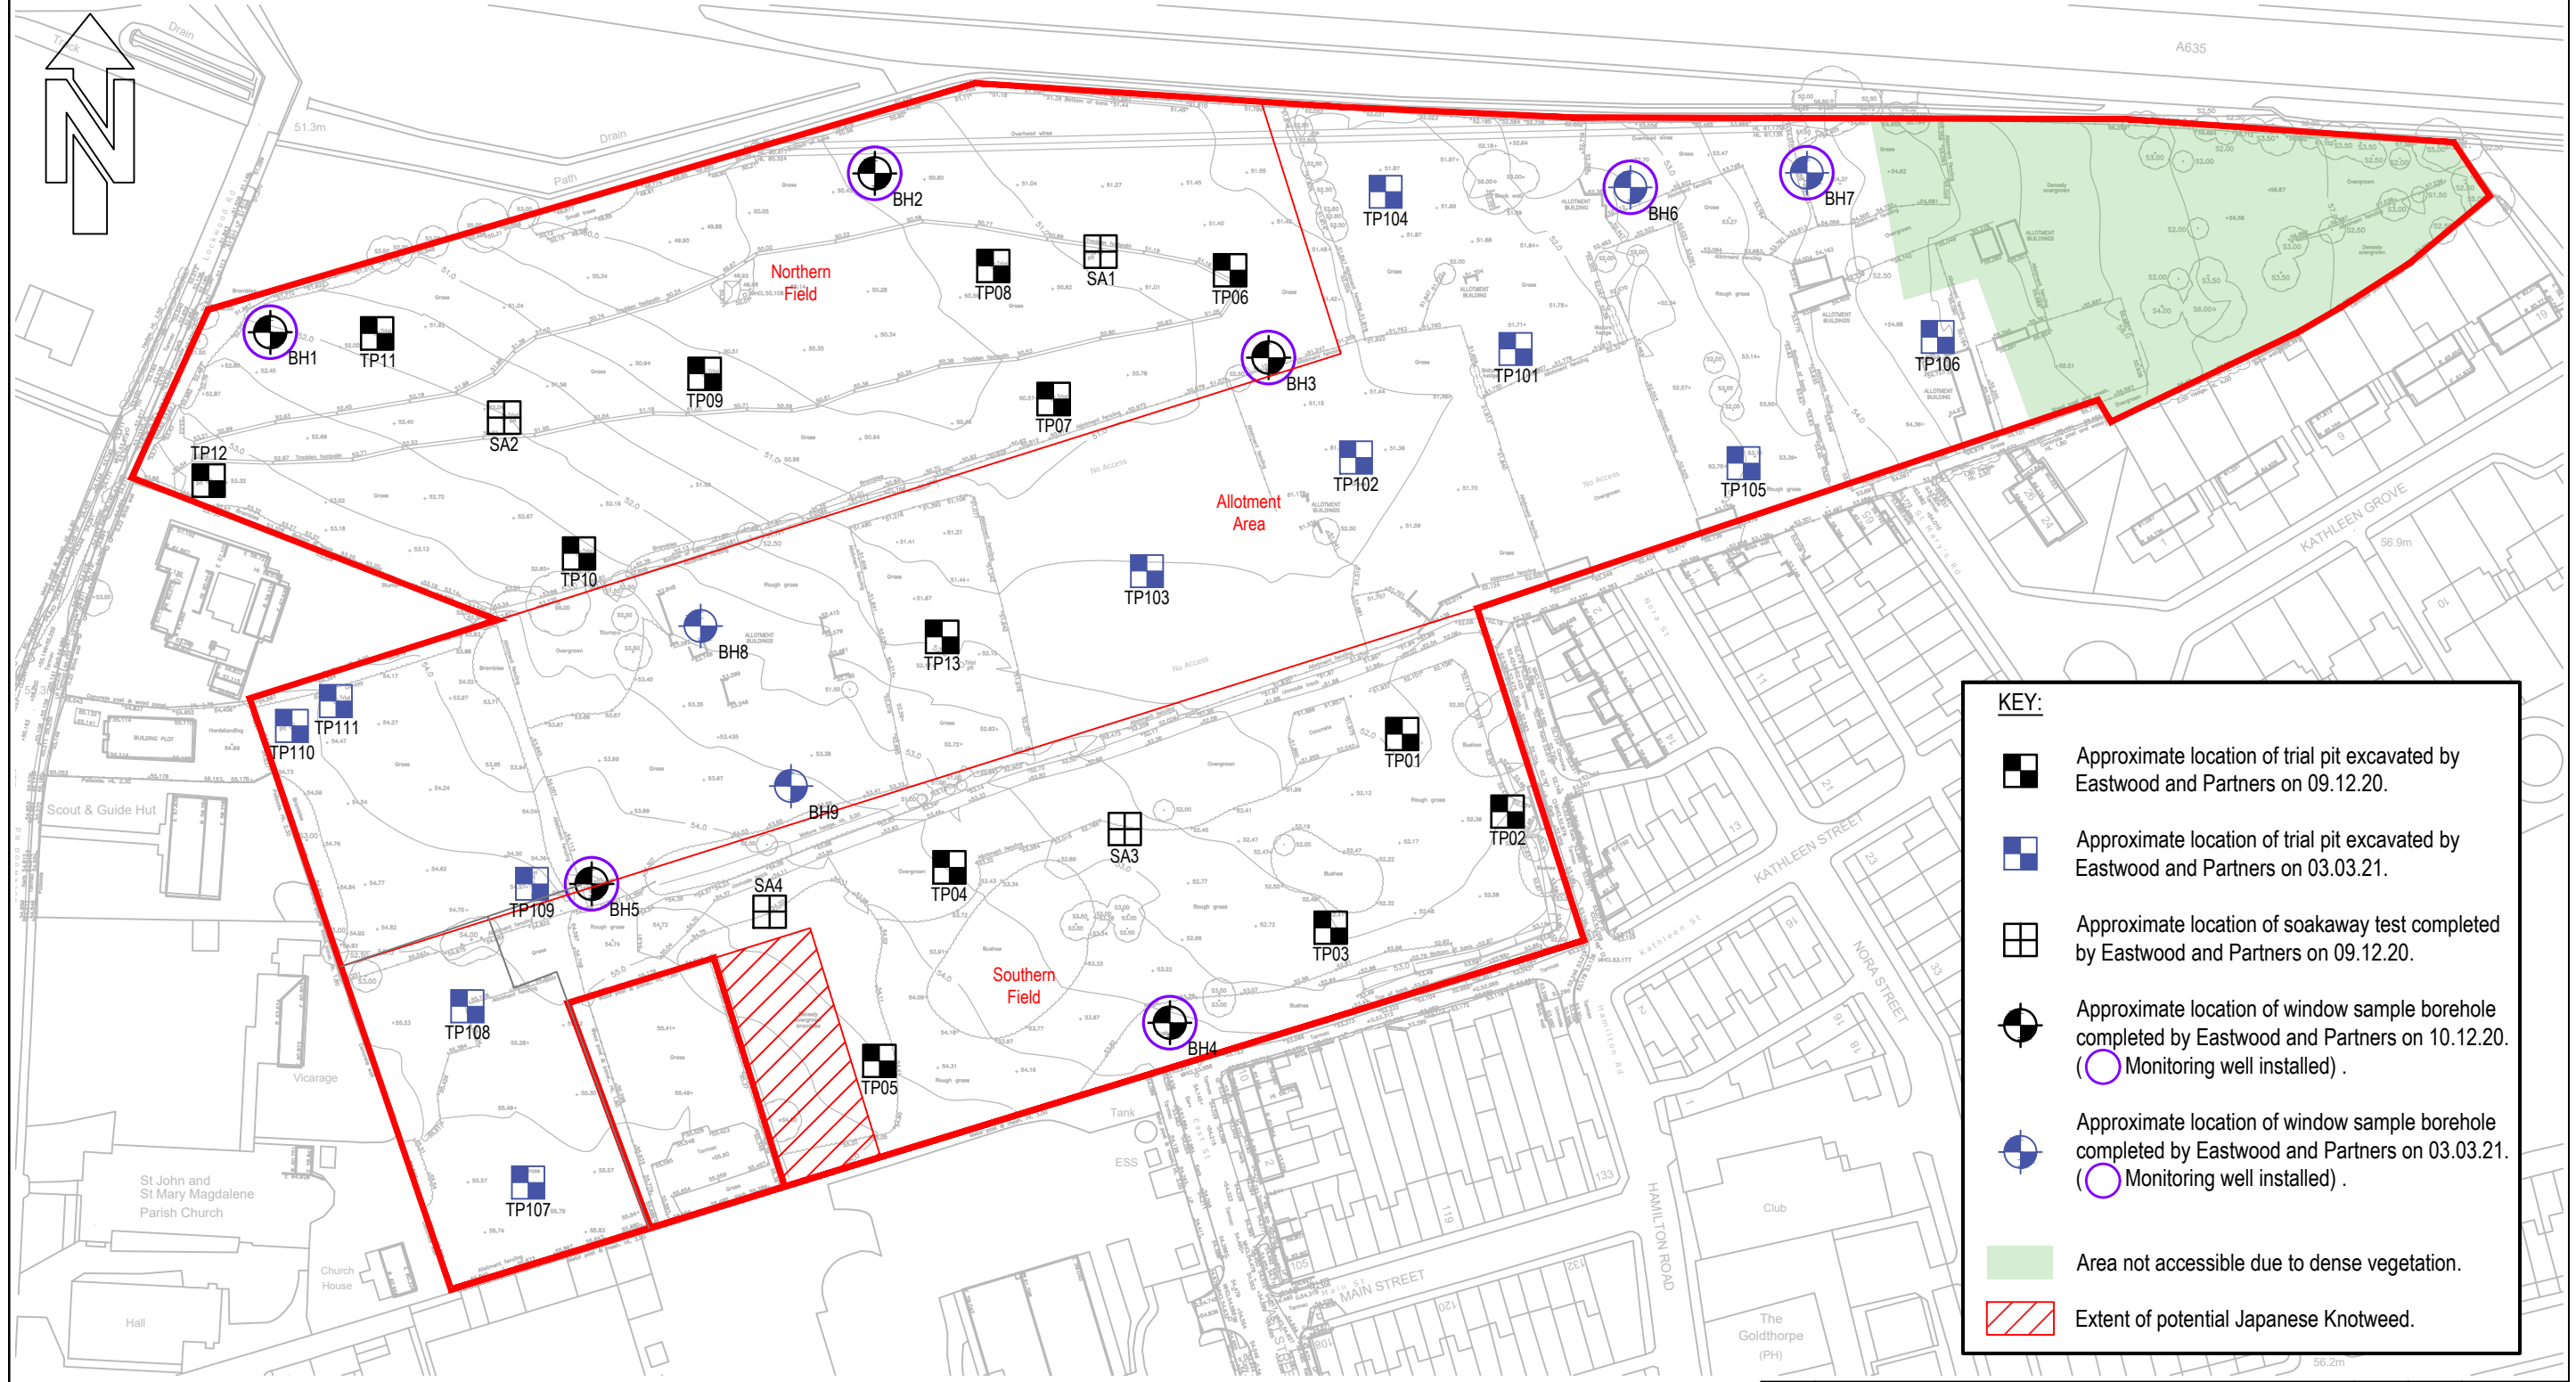
Exploratory Hole Location Plan, drawing [44271/001B](#)

- Approximate location of trial pit excavated by Eastwood and Partners on 09.12.20.
- Approximate location of trial pit excavated by Eastwood and Partners on 03.03.21.
- Approximate location of soakaway test completed by Eastwood and Partners on 09.12.20.
- Approximate location of window sample borehole completed by Eastwood and Partners on 10.12.20. (Monitoring well installed)
- Approximate location of window sample borehole completed by Eastwood and Partners on 03.03.21. (Monitoring well installed)
- Area not accessible due to dense vegetation.
- Extent of potential Japanese Knotweed.

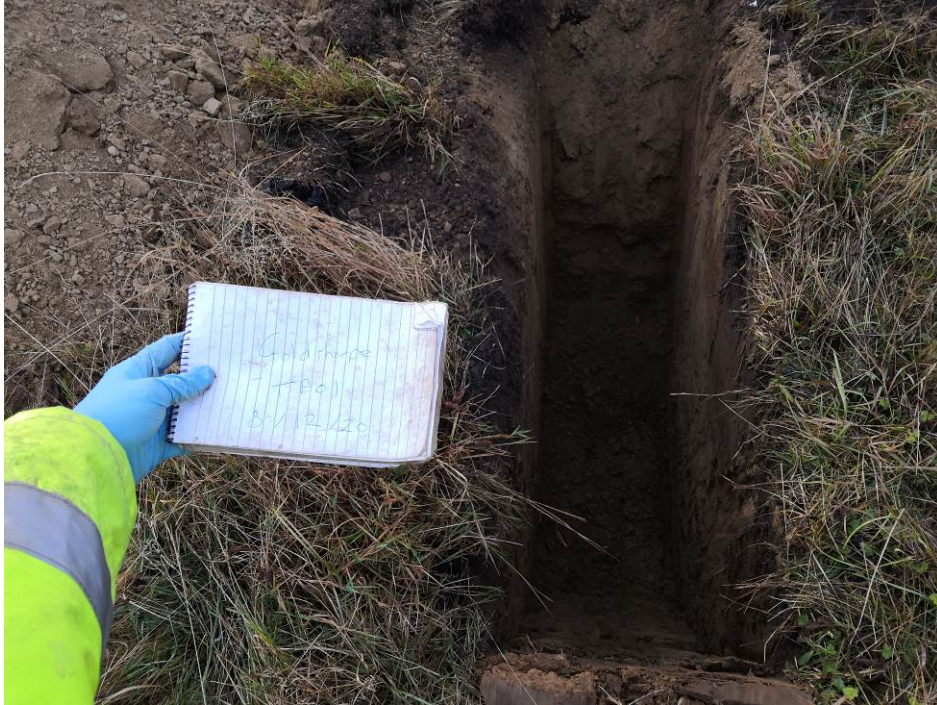
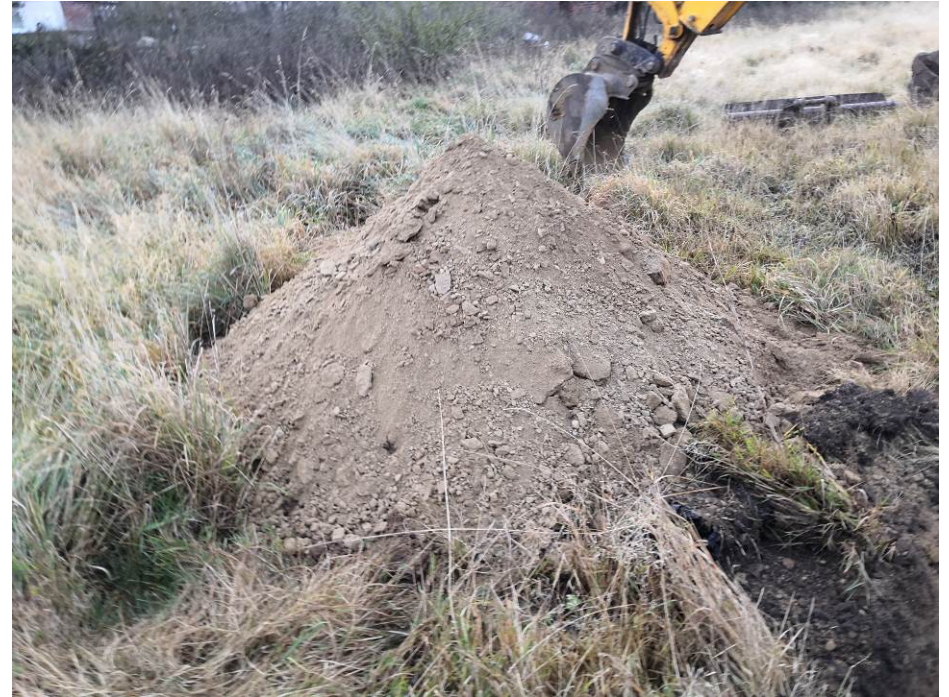
Prepared	LW	Checked	GCB	Date	08.12.2021	Photograph No	1 and 2
----------	----	---------	-----	------	------------	---------------	---------

TP01

Arisings from TP01

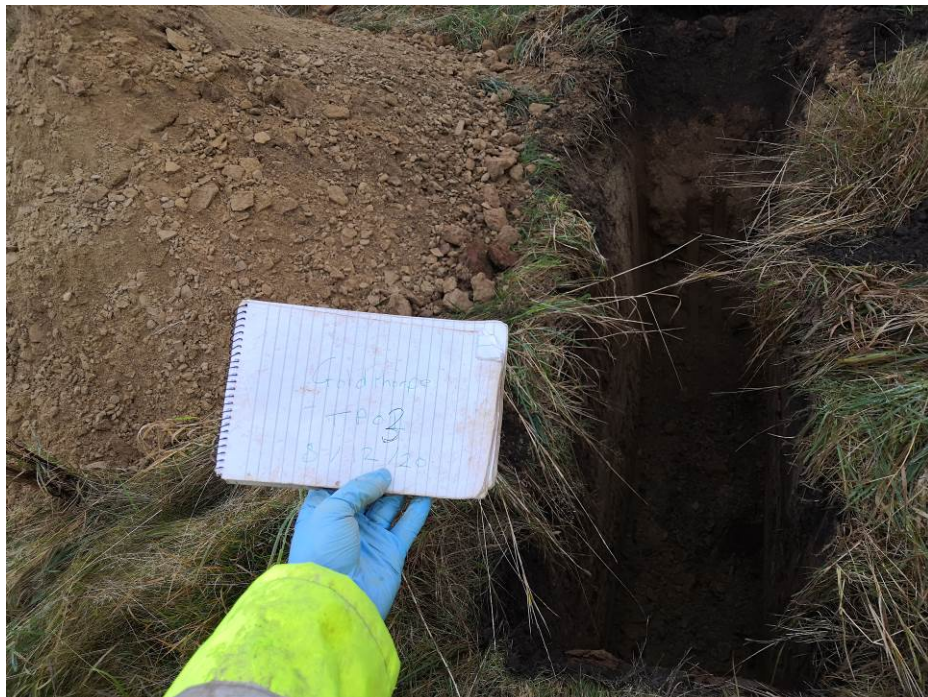
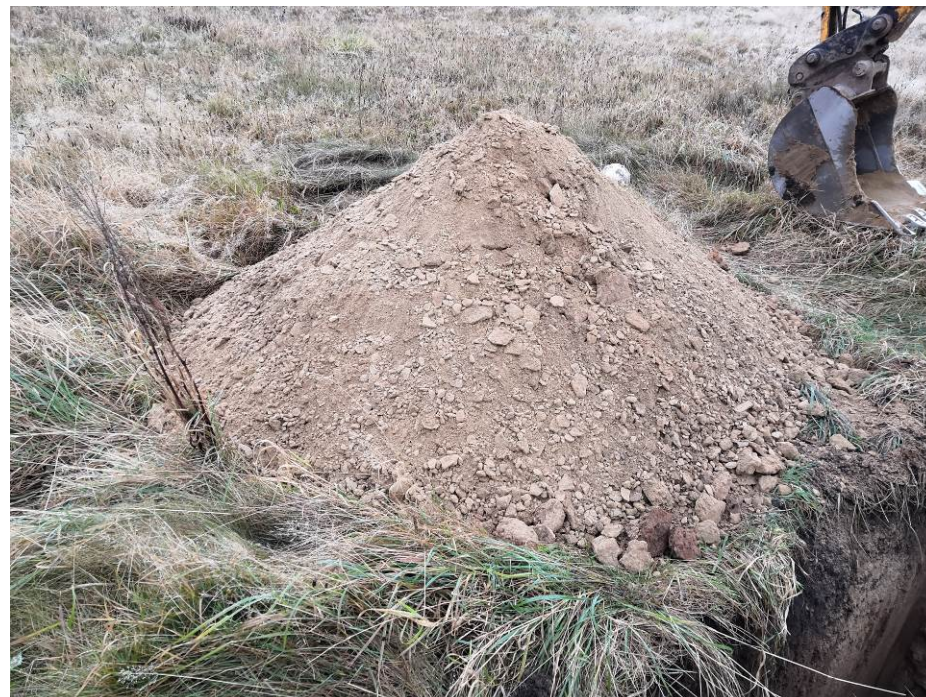
Prepared	LW	Checked	GCB	Date	08.12.2021	Photograph No	3 and 4
----------	----	---------	-----	------	------------	---------------	---------

TP03

Arisings from TP03

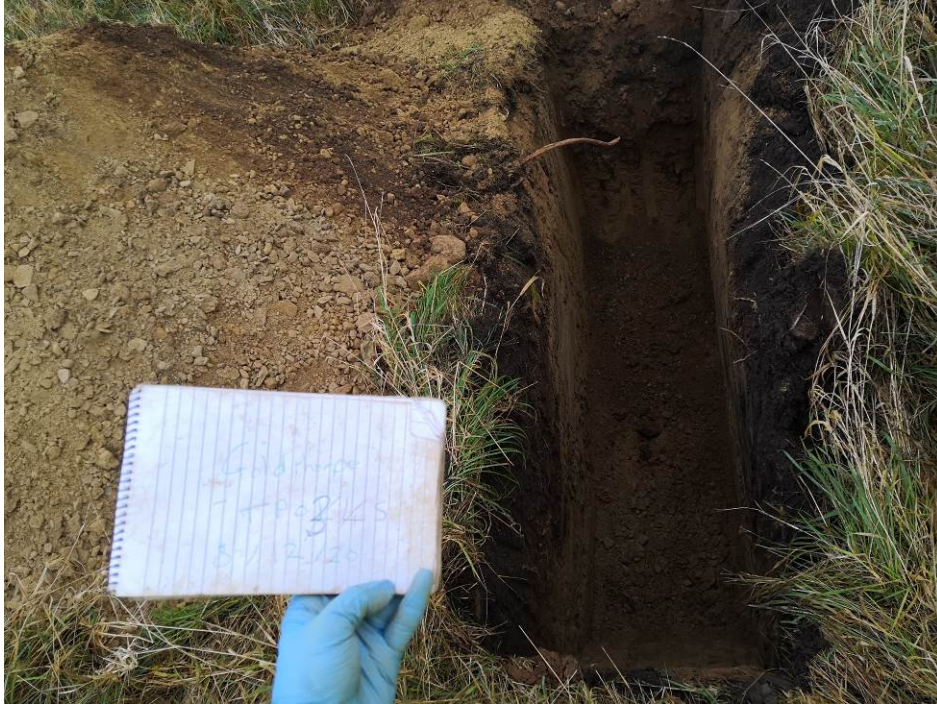
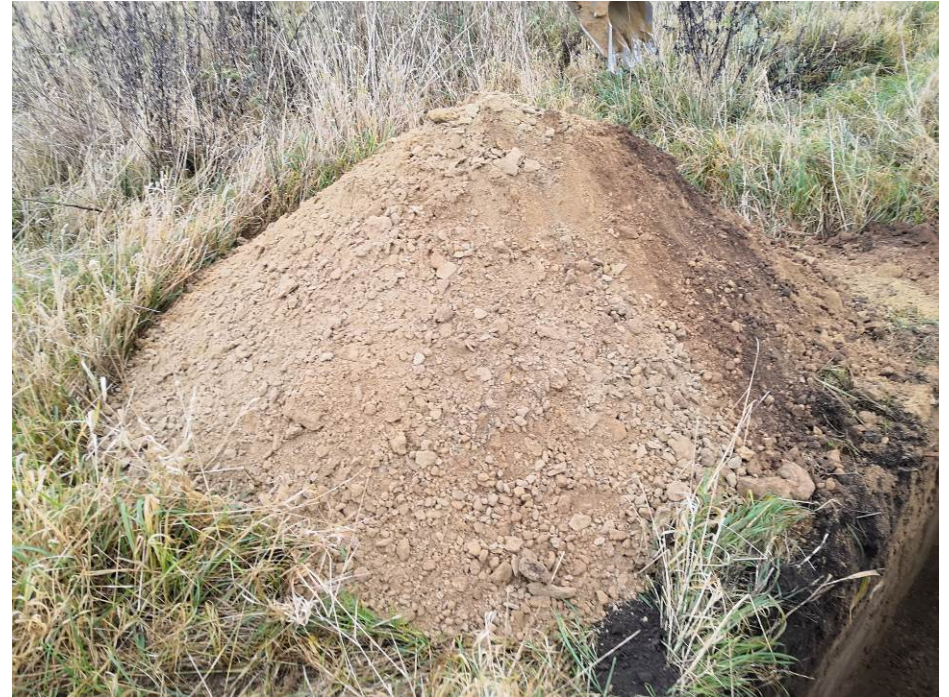
Prepared	LW	Checked	GCB	Date	08.12.2021	Photograph No	5 and 6
----------	----	---------	-----	------	------------	---------------	---------

TP05

Arisings from TP05

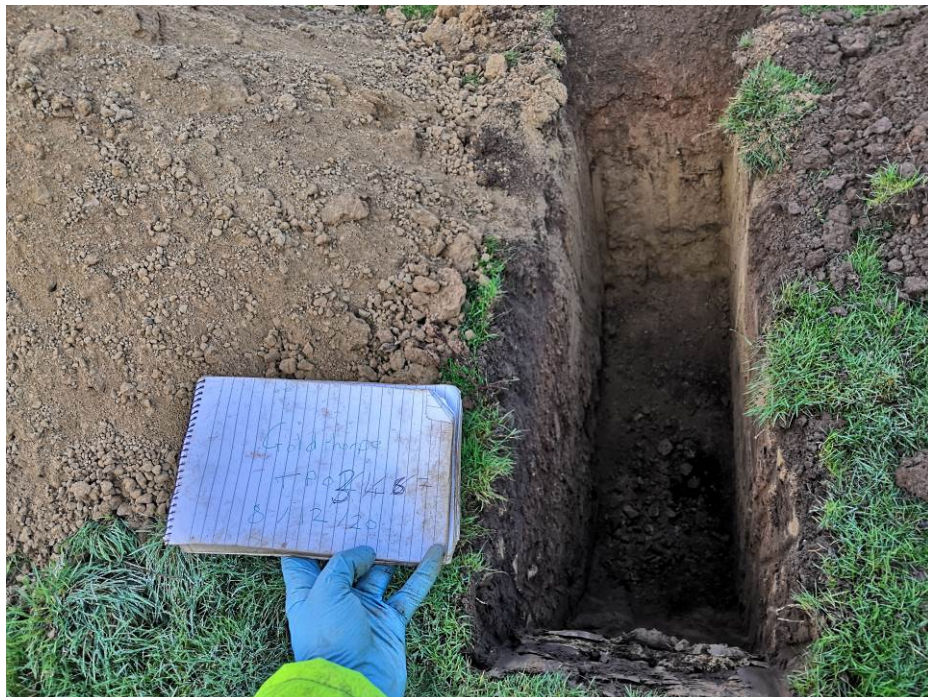
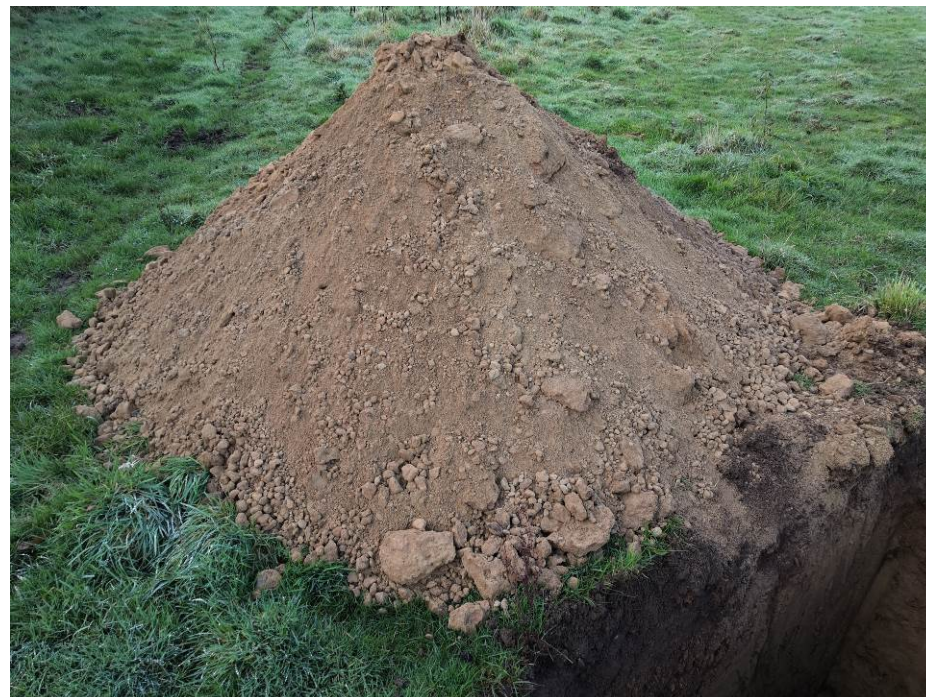
Prepared	LW	Checked	GCB	Date	08.12.2021	Photograph No	7 and 8
----------	----	---------	-----	------	------------	---------------	---------

TP07

Arisings from TP07

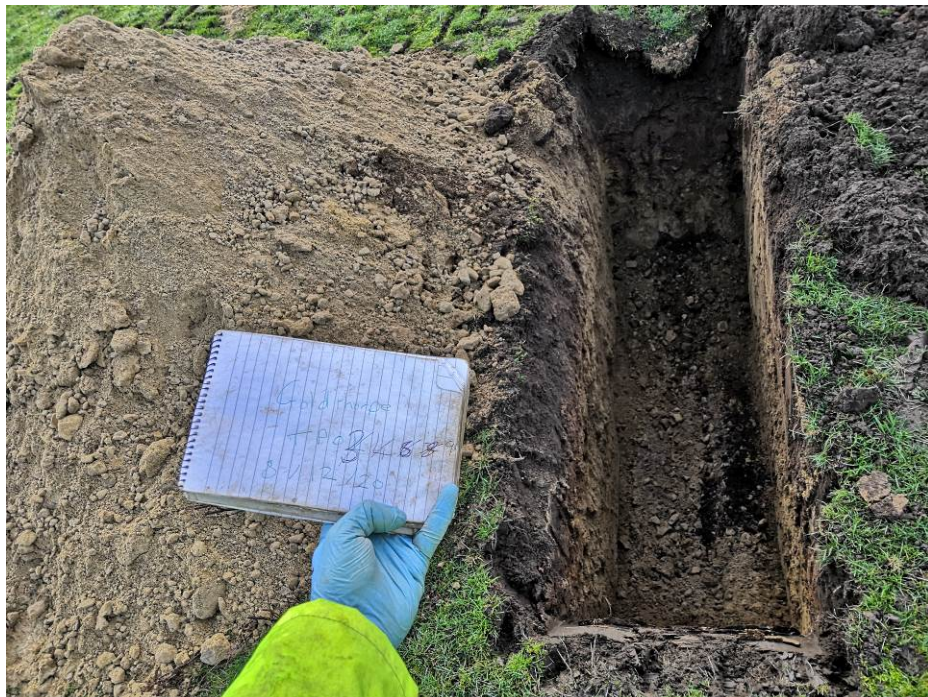
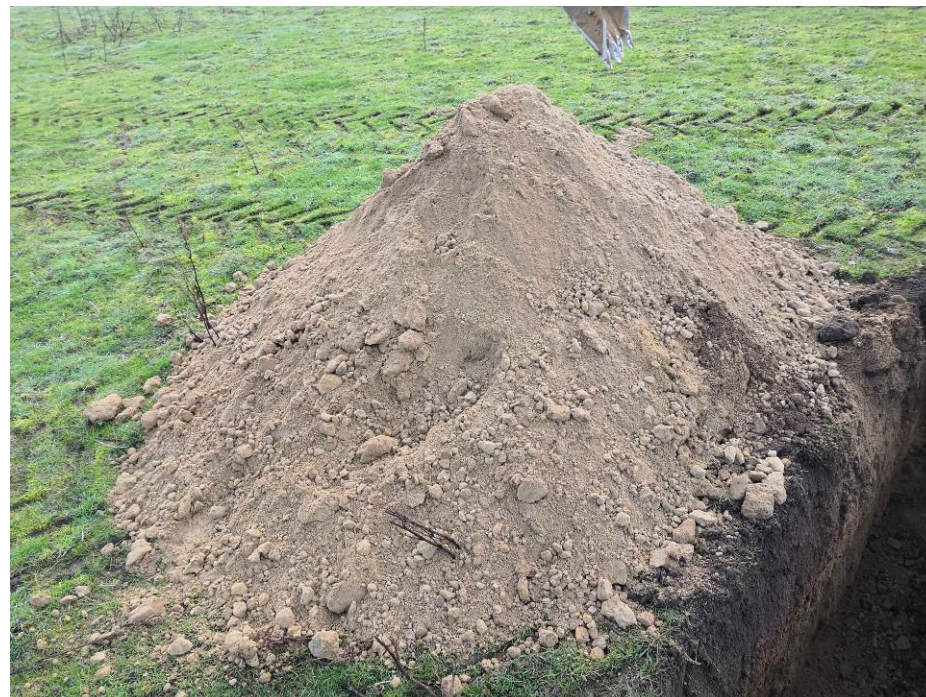
Prepared	LW	Checked	GCB	Date	08.12.2021	Photograph No	9 and 10
----------	----	---------	-----	------	------------	---------------	----------

TP08

Arisings from TP08

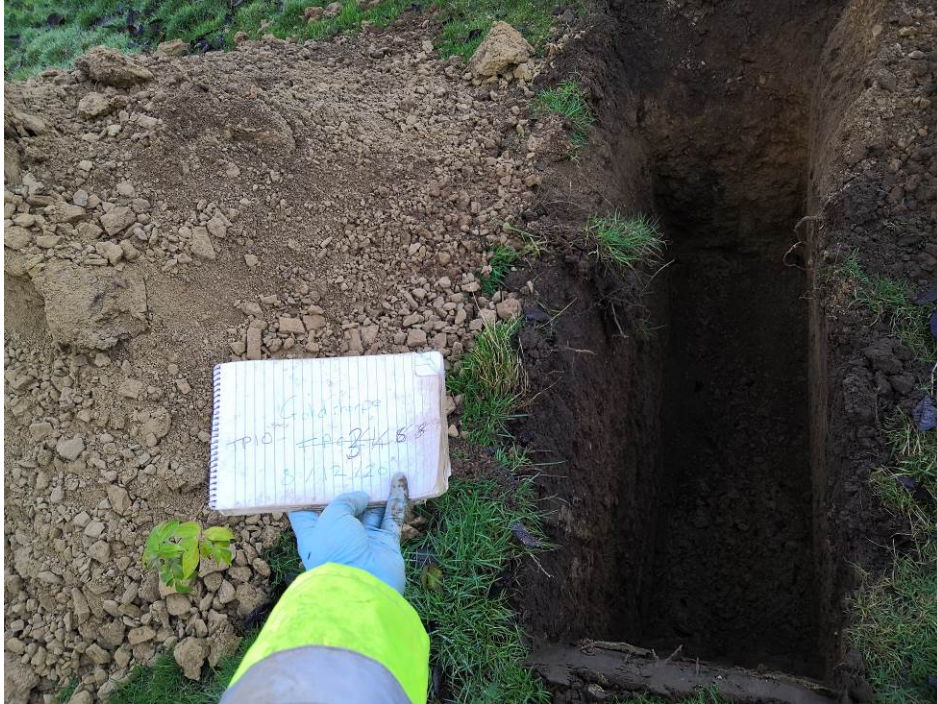
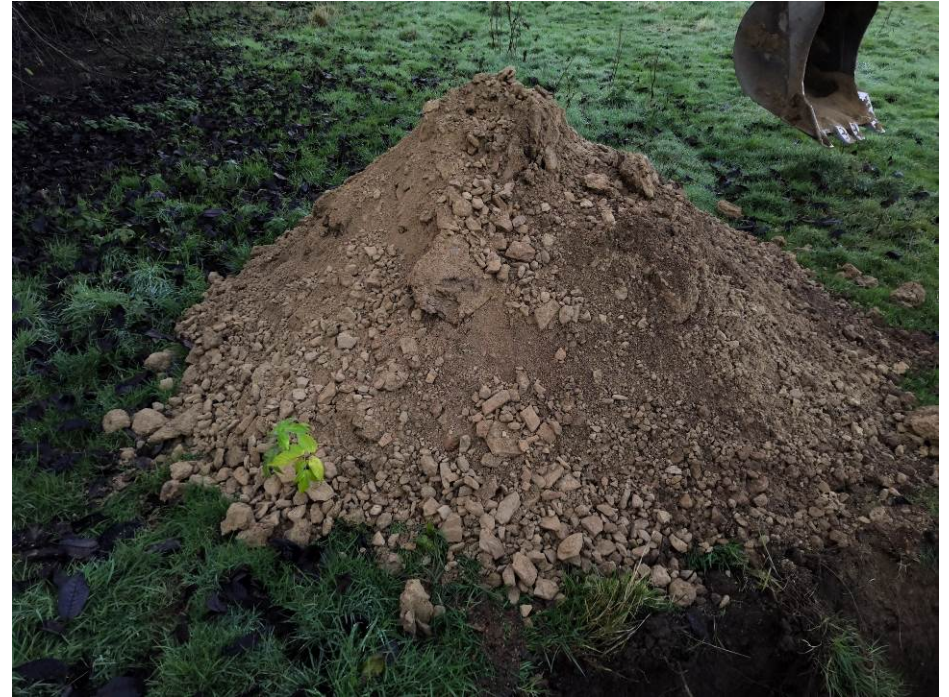
Prepared	LW	Checked	GCB	Date	08.12.2021	Photograph No	11 and 12
----------	----	---------	-----	------	------------	---------------	-----------

TP10

Arisings from TP10

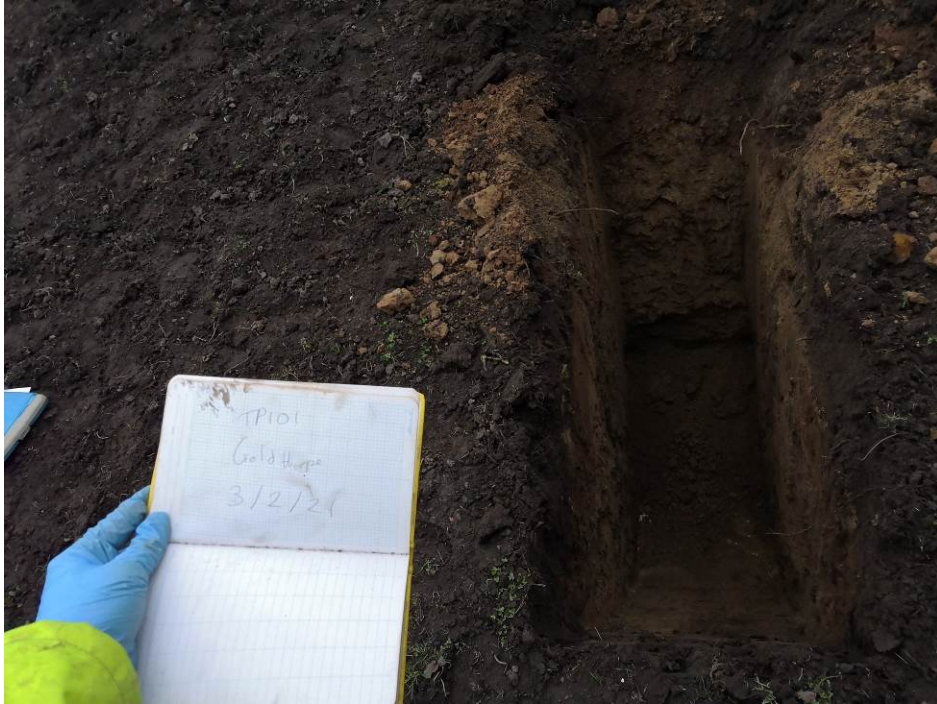
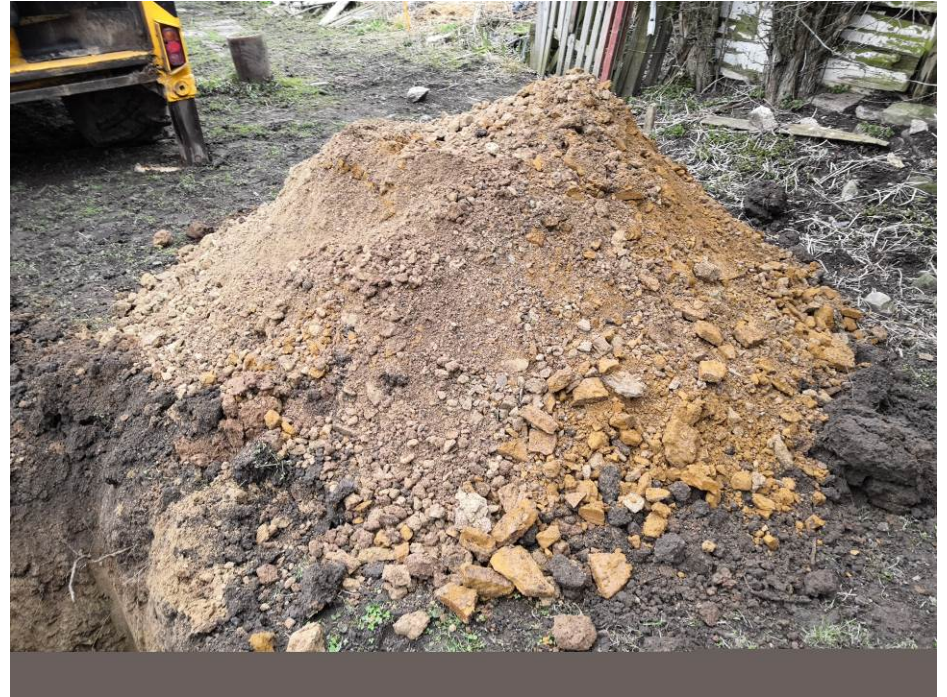
Prepared	LW	Checked	GCB	Date	03.03.2021	Photograph No	13 and 14
-----------------	----	----------------	-----	-------------	------------	----------------------	-----------

TP101

Arisings from TP101

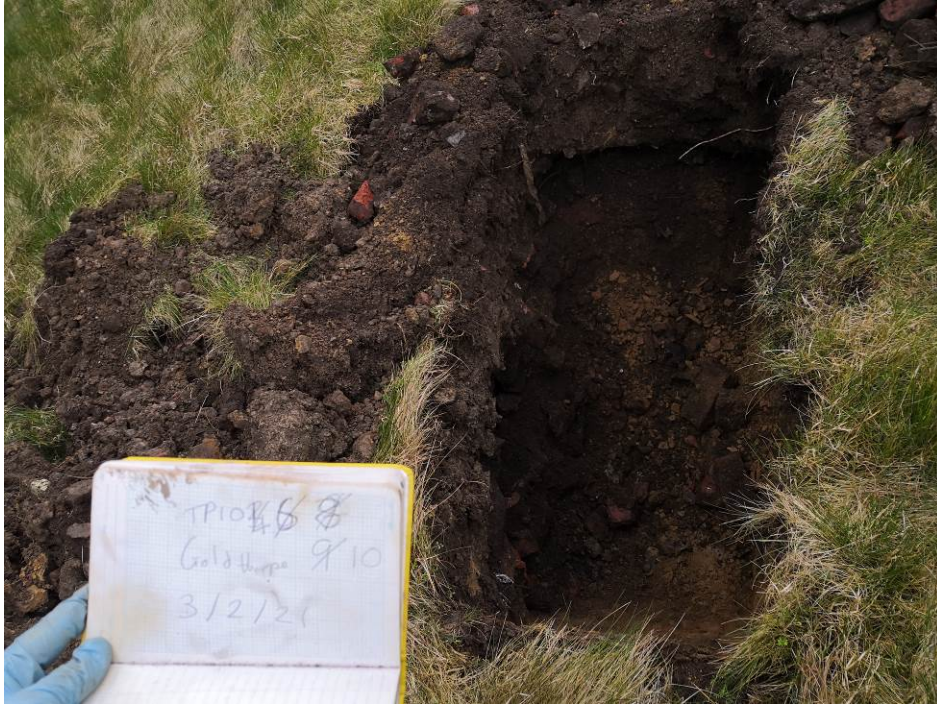
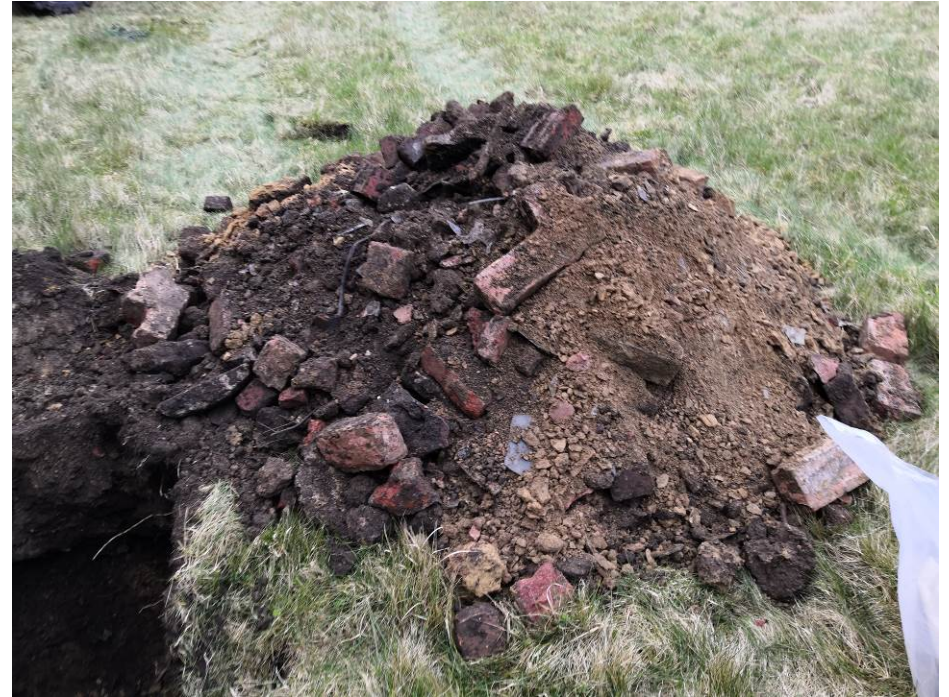
Prepared	LW	Checked	GCB	Date	03.03.2021	Photograph No	15 and 16
-----------------	----	----------------	-----	-------------	------------	----------------------	-----------

Two samples of made ground were tested. A SOM of 1% has been assumed as 'worst case'. One sample (TP110 at 0.4 m) recorded elevated concentrations of lead and two PAH determinants, with respect to human health. Lead was recorded at a concentration of 320 mg/kg, in excess of the assessment value of 200 mg/kg. Benzo[b]fluoranthene and dibenz[a,h]anthracene were found at

TP110

Arisings from TP110

Elevated concentrations of lead and polycyclic aromatic hydrocarbons were recorded within the made ground. The elevated levels may be considered representative for the made ground. Therefore, the made ground is not considered suitable to remain beneath gardens or soft landscaping. It is recommended that a 600 mm thick capping layer of clean soil (of which at least 100 mm should consist of topsoil) is placed over the made ground wherever it remains below private gardens or other areas of soft landscaping. Alternatively, the made ground can be removed from these areas and placed below hardstanding areas, such as driveways or parking areas.
