**Groom Design Services  
Ltd**

**The Three Horseshoes  
Brierley  
Barnsley  
S72 9JT**

**Phase I Desk Study**

Ref: 13187/5001  
June 17

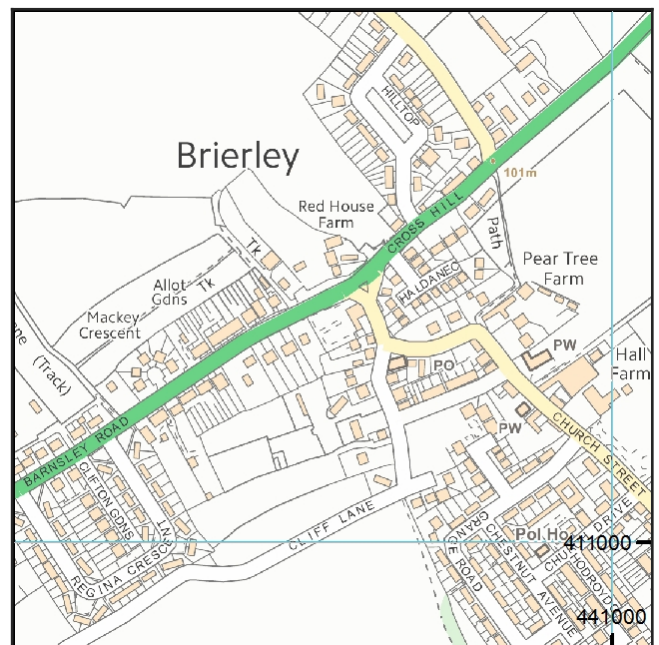
Approximate position of property

Coal seams are outcropping in the general locality of the site, and from the above discussion it is possible that underground coal seams are present beneath the site at depths less than 30m. There is a disused shaft to the west of the site and records of coal mining subsidence to the south of the site. The risk to the site from migration of crown holes towards the surface as a result of the collapse of unrecorded shallow coal workings is considered to be **MODERATE**. Further site investigation is recommended to check for any voids beneath the site and confirm that the shaft does not cross the site boundary.

The site is not within a development high risk area with regards to shallow depth coal mining, however a development high risk area does exist to the west of the site. The coal authority report has identified a disused mine shaft 5m west of the site and an area of coal mining related subsidence to the south. Based on the information presented within this report, it is considered that the risk from shallow depth mining works is Moderate and further site investigation comprising rotary open hole boreholes to 30m is recommended. Site investigation on the western boundary of the site adjacent to the recorded shaft is also recommended to confirm that the shaft does not cross the site boundary.
