**DESIGN & ACCESS STATEMENT**

**ROBIN HILL  
LANE HEAD ROAD, CAWTHORNE**

**Chris Carr Associates  
6a Eastgate  
BARNSLEY  
S70 2EP**

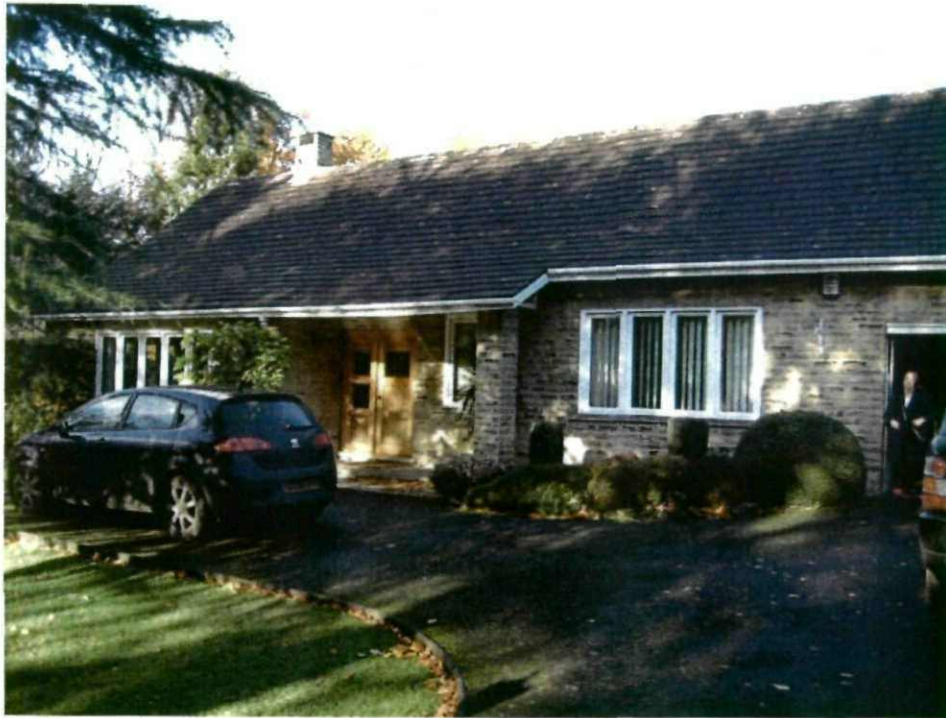
1. Front elevation viewed from the south east

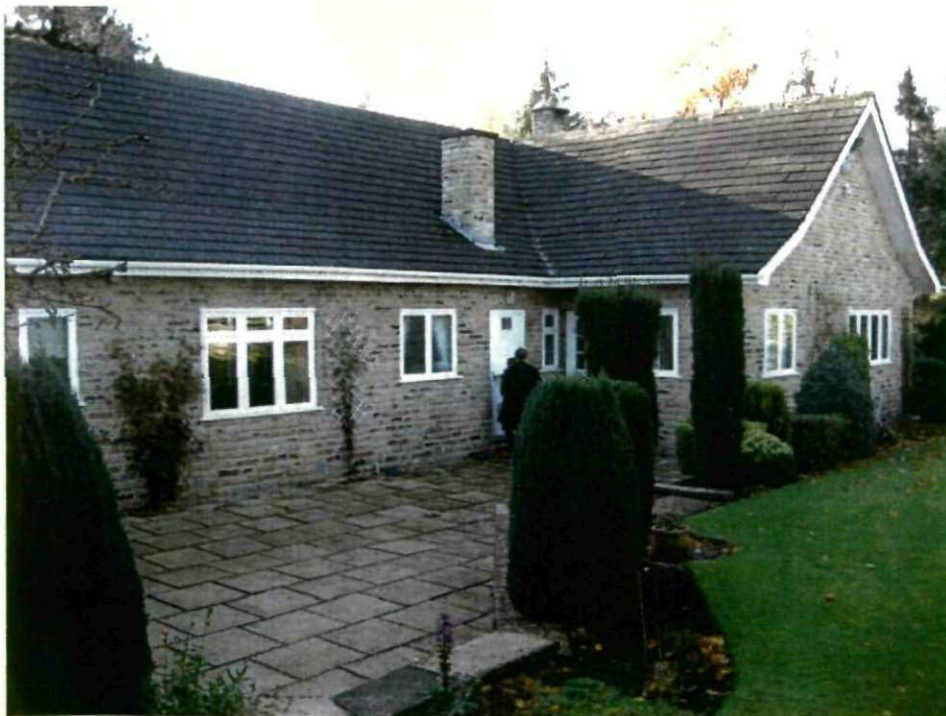
2. Rear elevation viewed from the north east

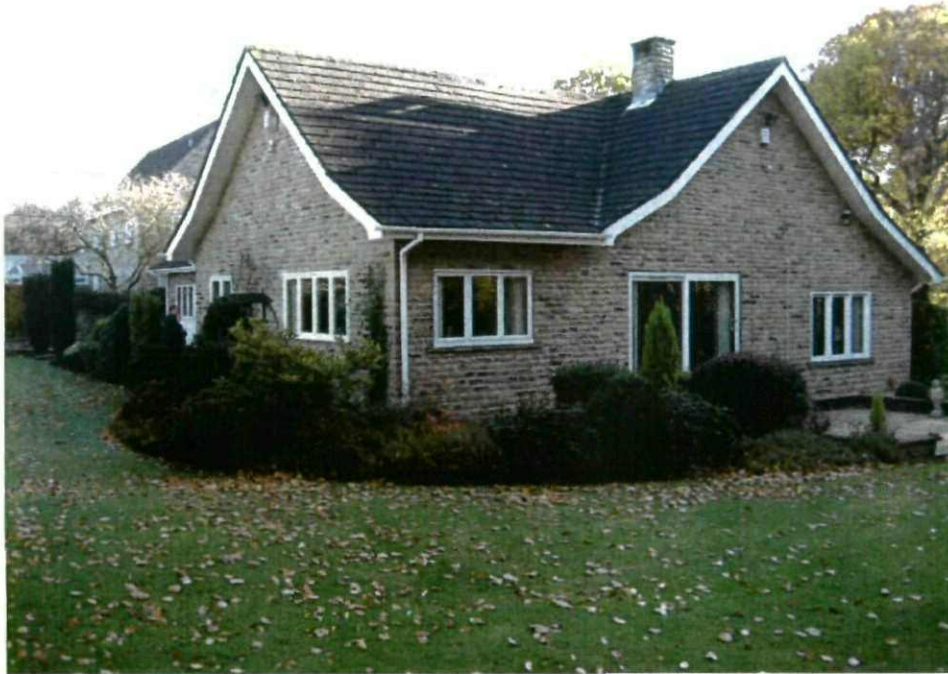
3. Side and rear view from the north west

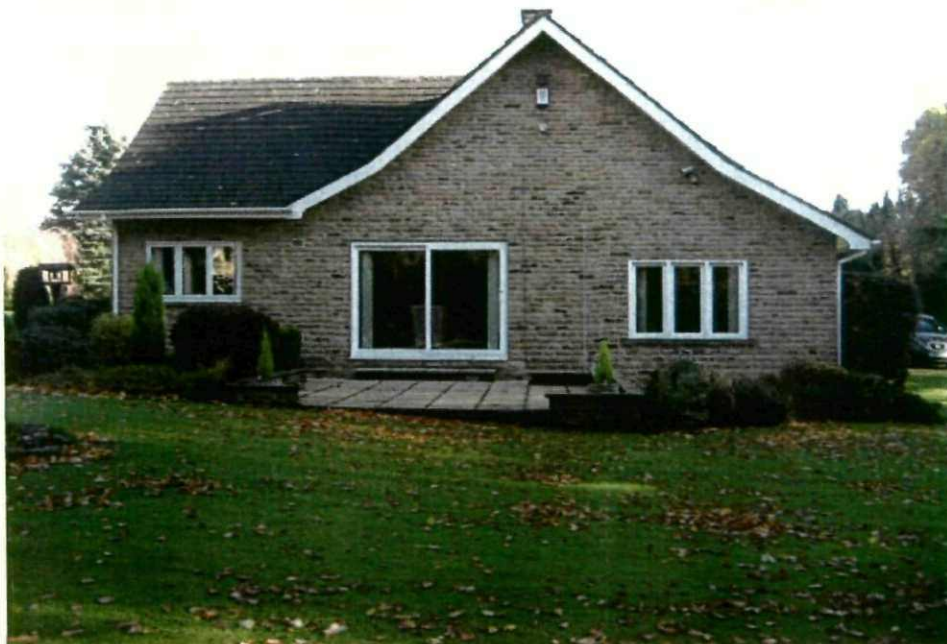
4. Side elevation viewed from the west

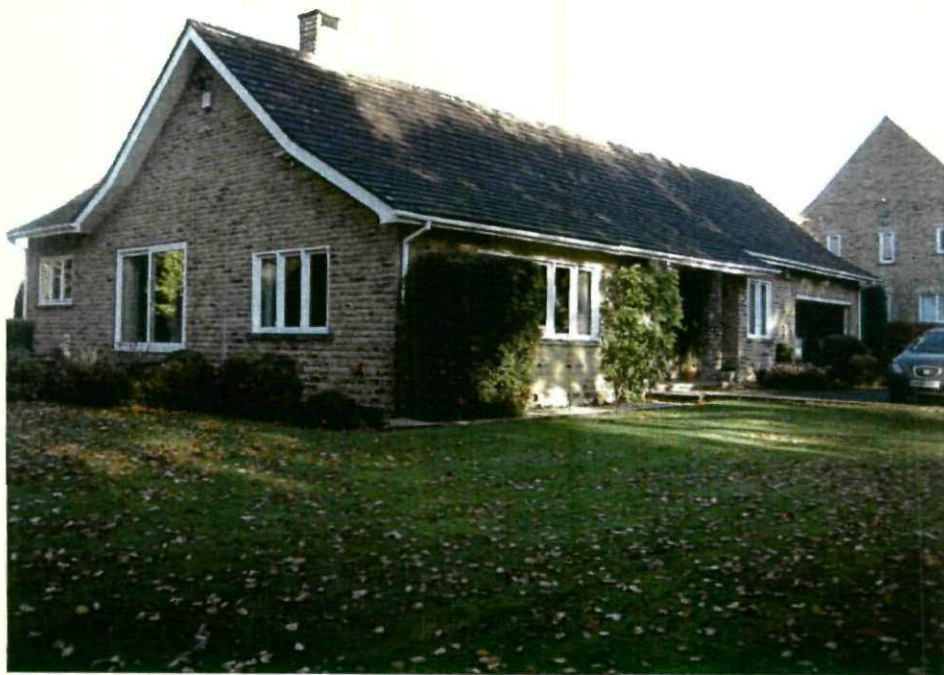
5. Front and side view from the south west

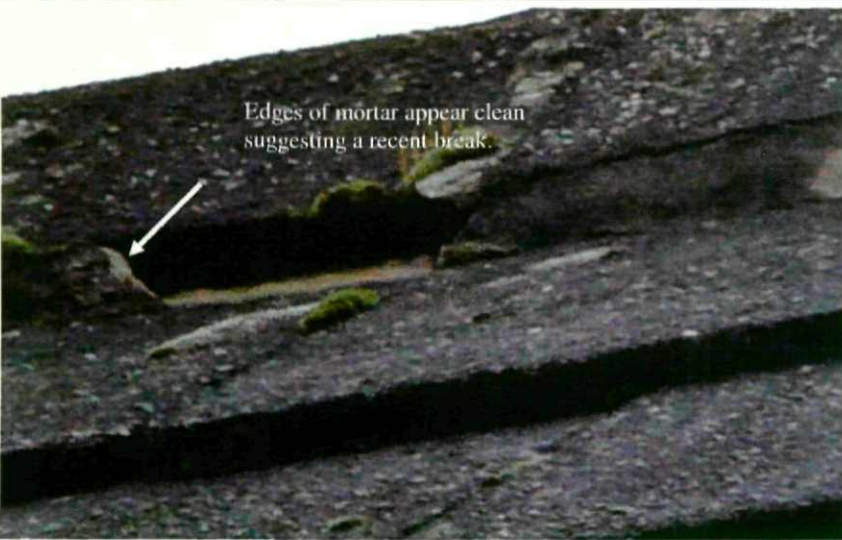
Edges of mortar appear clean  
suggesting a recent break.

- 7.3 There was a single brick chimney-stack close to the west gable. The flashing was examined with binoculars and there did not appear to be any suitable openings for bats. An opening under a ridge tile where pointing had come out was noted. The edges of the mortar in Fig 1 appear clean in comparison to the surface of the mortar suggesting the mortar had come out recently. On close examination with binoculars there was no evidence to suggest the opening has been used by bats.

flashing round the single chimney-stack appeared tight with no suitable openings for bats. An opening in the pointing below a ridge tile appeared to be quite recent judging by the colour of the mortar around the opening compared to the rest of the pointing and no indications of possible use by bats was noted.
