Tithe Laithe,

Hoyland

Phase 2 Pre-development Arboricultural Report

06 March 2018

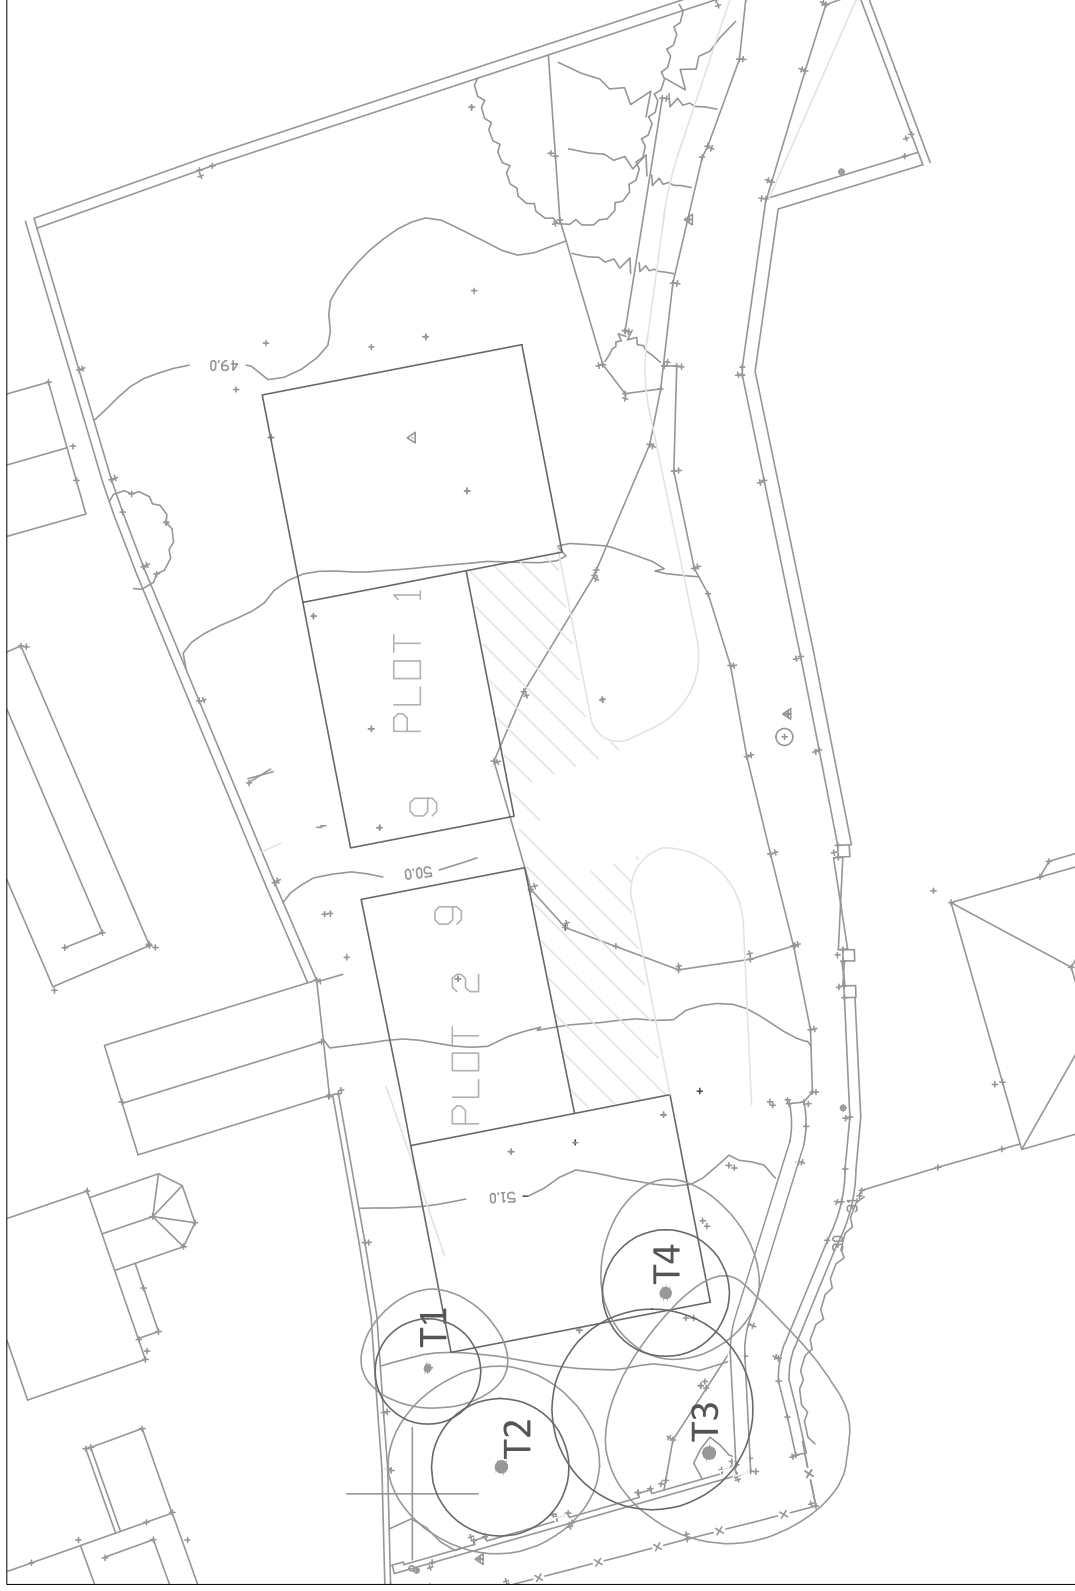
Plan 2: Tree Constraints Plan showing the proposed layout.

The proposed site layout shown in Plan 2 would involve the removal of Trees 1 and 4. Tree 1 would be too close to one of the dwellings and Tree 4 would be within the foot print of the dwelling. These trees are included in retention category C because of their young age. The development would remain outside the crown spreads and RPAs of all other trees on the site but they would occupy a large proportion of the garden.

Of the four significant trees currently on the site two trees, Trees 1 and 4, would need to be removed to facilitate the proposed layout. These are category C trees because of their young age.

The proposed layout would remain outside the root protection areas and crown spread of the remaining trees. However, the remaining trees, Trees 2 and 3 would occupy the entire garden area of plot 2.

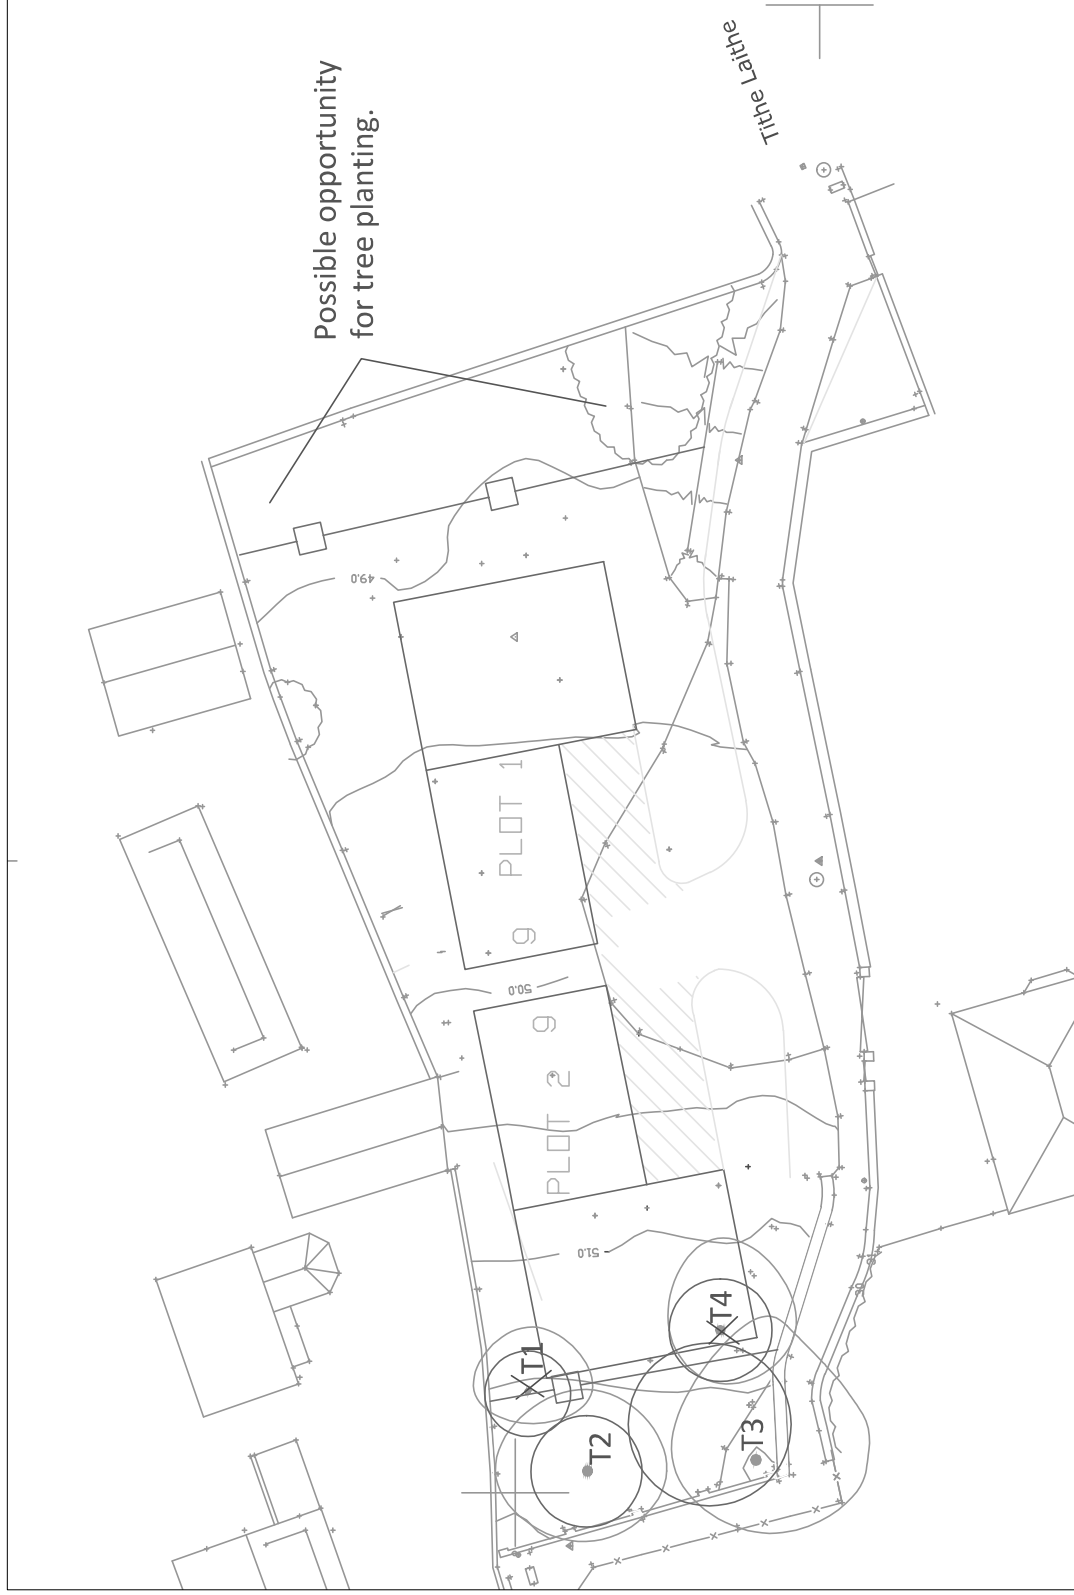
Plan 3: Tree Protection Plan showing the proposed layout.

Plan 3 is the tree protection plan that shows where temporary fencing should be installed to protect retained trees and to protect soil if trees are to be planted on the eastern boundary.

Temporary tree protection barriers will be erected at the positions shown in Plan 3. These will remain in place for the duration of the construction phase.

- a. Trees not to be retained as part of the consent will be felled. These are Trees 1 and 4. Tree 3 will need to be pruned on the east side if being retained.
- b. Erect temporary tree protection barriers around any trees to be retained and areas where new planting is to take place to protect the soil as shown on Plan 3 and described in appendix 4.
- c. Construct the new development.
- d. Plant replacement trees, if applicable.
- e. Remove temporary tree protection barriers.

Trees that must be removed to accommodate development shall be removed prior to any other works commencing on site. These are Trees 1 and 4. If Tree 3 is being retained it will need to be pruned on the east side of the crown.
