Report No: 2500/1  
Date: June 2002

**GEOENVIRONMENTAL REPORT**  
**for**  
**GOLDTHORPE COLLIERY,**  
**GOLDTHORPE**

**prepared for**  
**BEN BAILEY HOMES LIMITED**

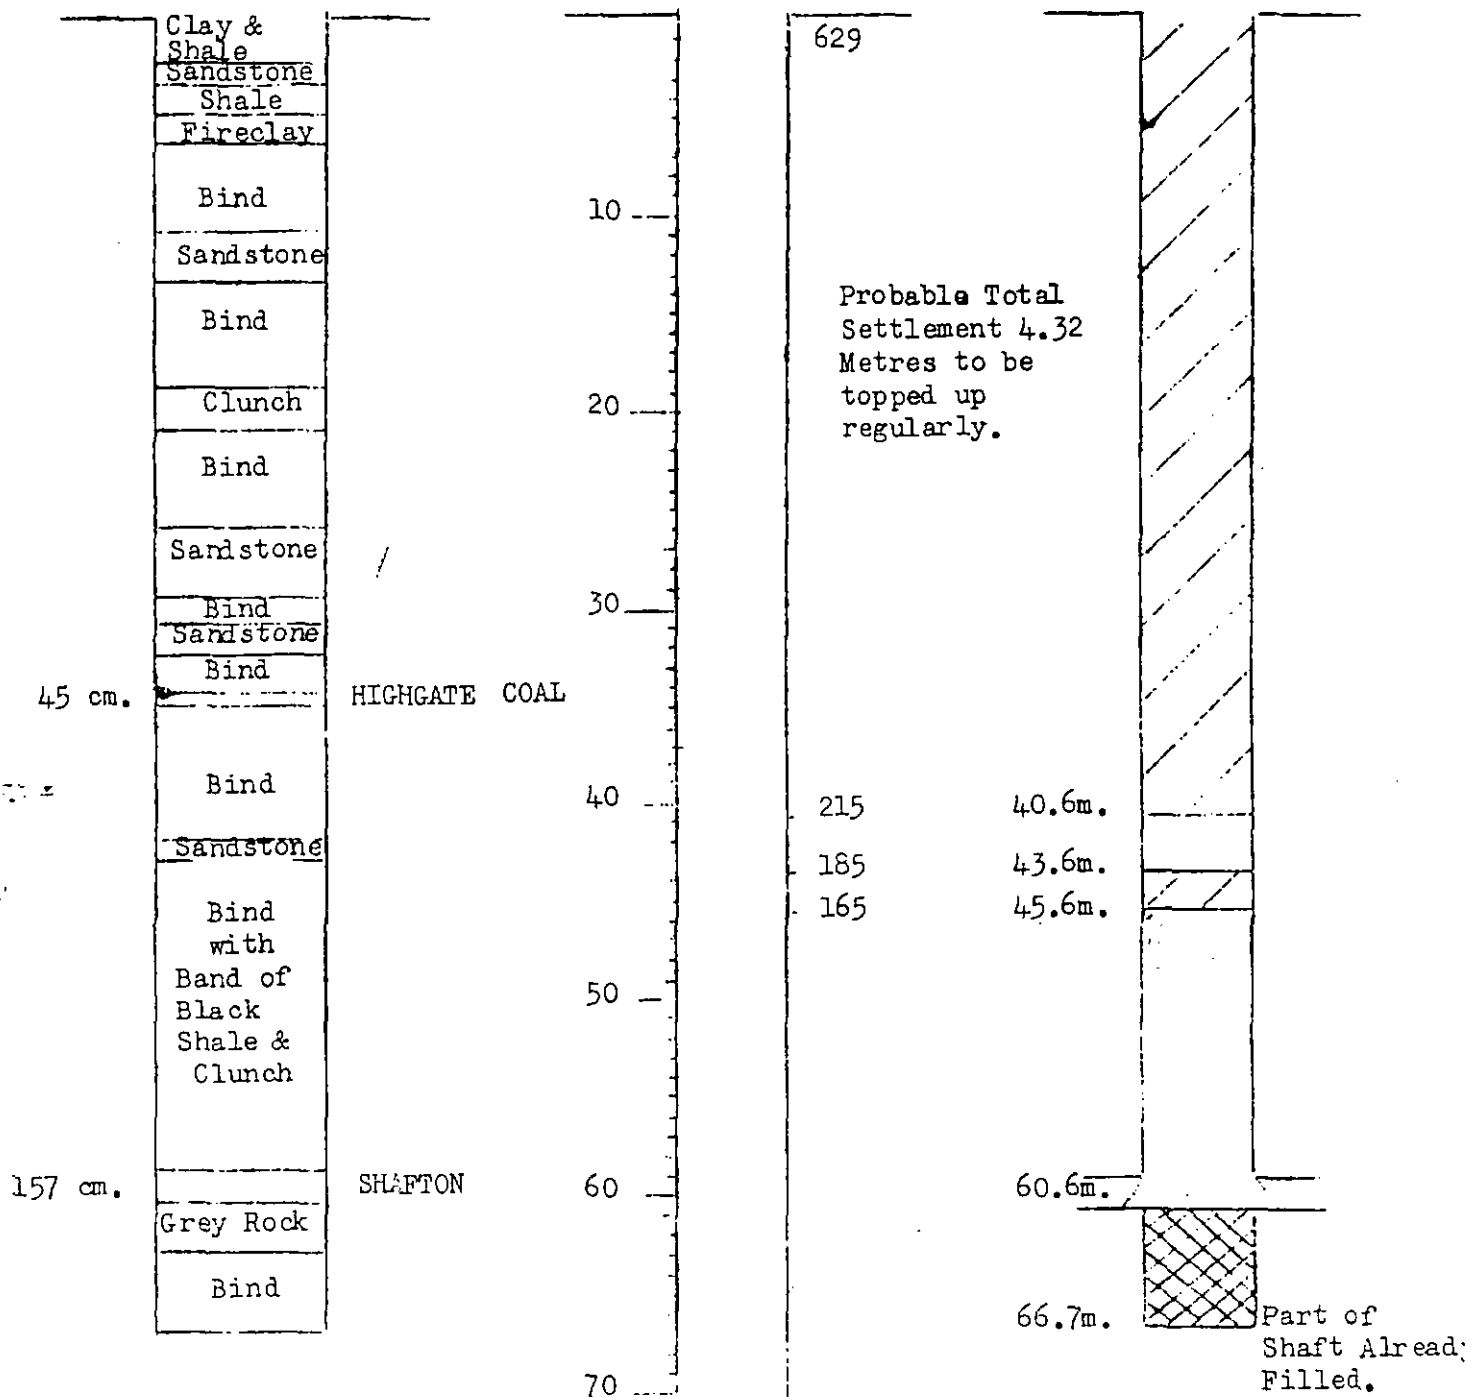
DETAILS OF FILL

FINES, UNPRESSED TAILINGS & CARBONACEOUS MATERIALS MUST NOT BE USED.

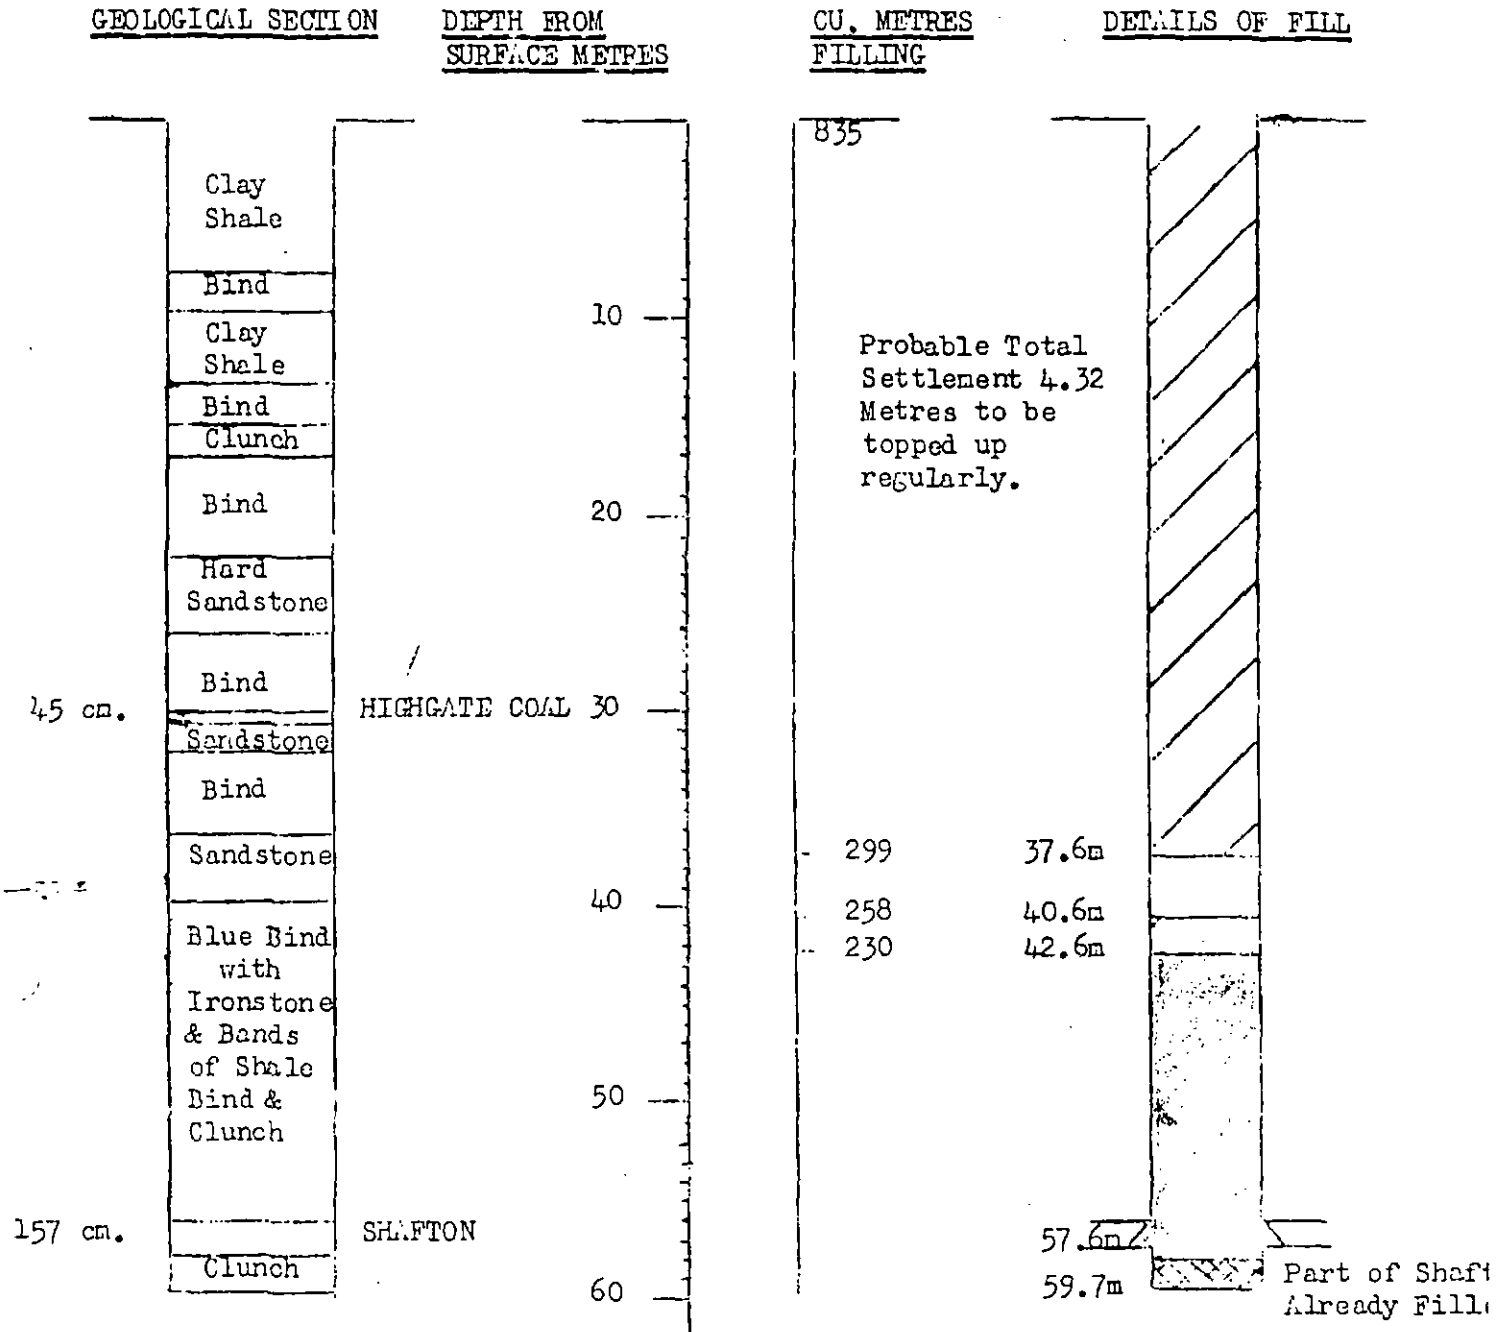
DIAMETER OF SHAFT 14' - 0"

FINES, UNPRESSED TAILINGS & CARBONACEOUS MATERIALS MUST NOT BE USED.

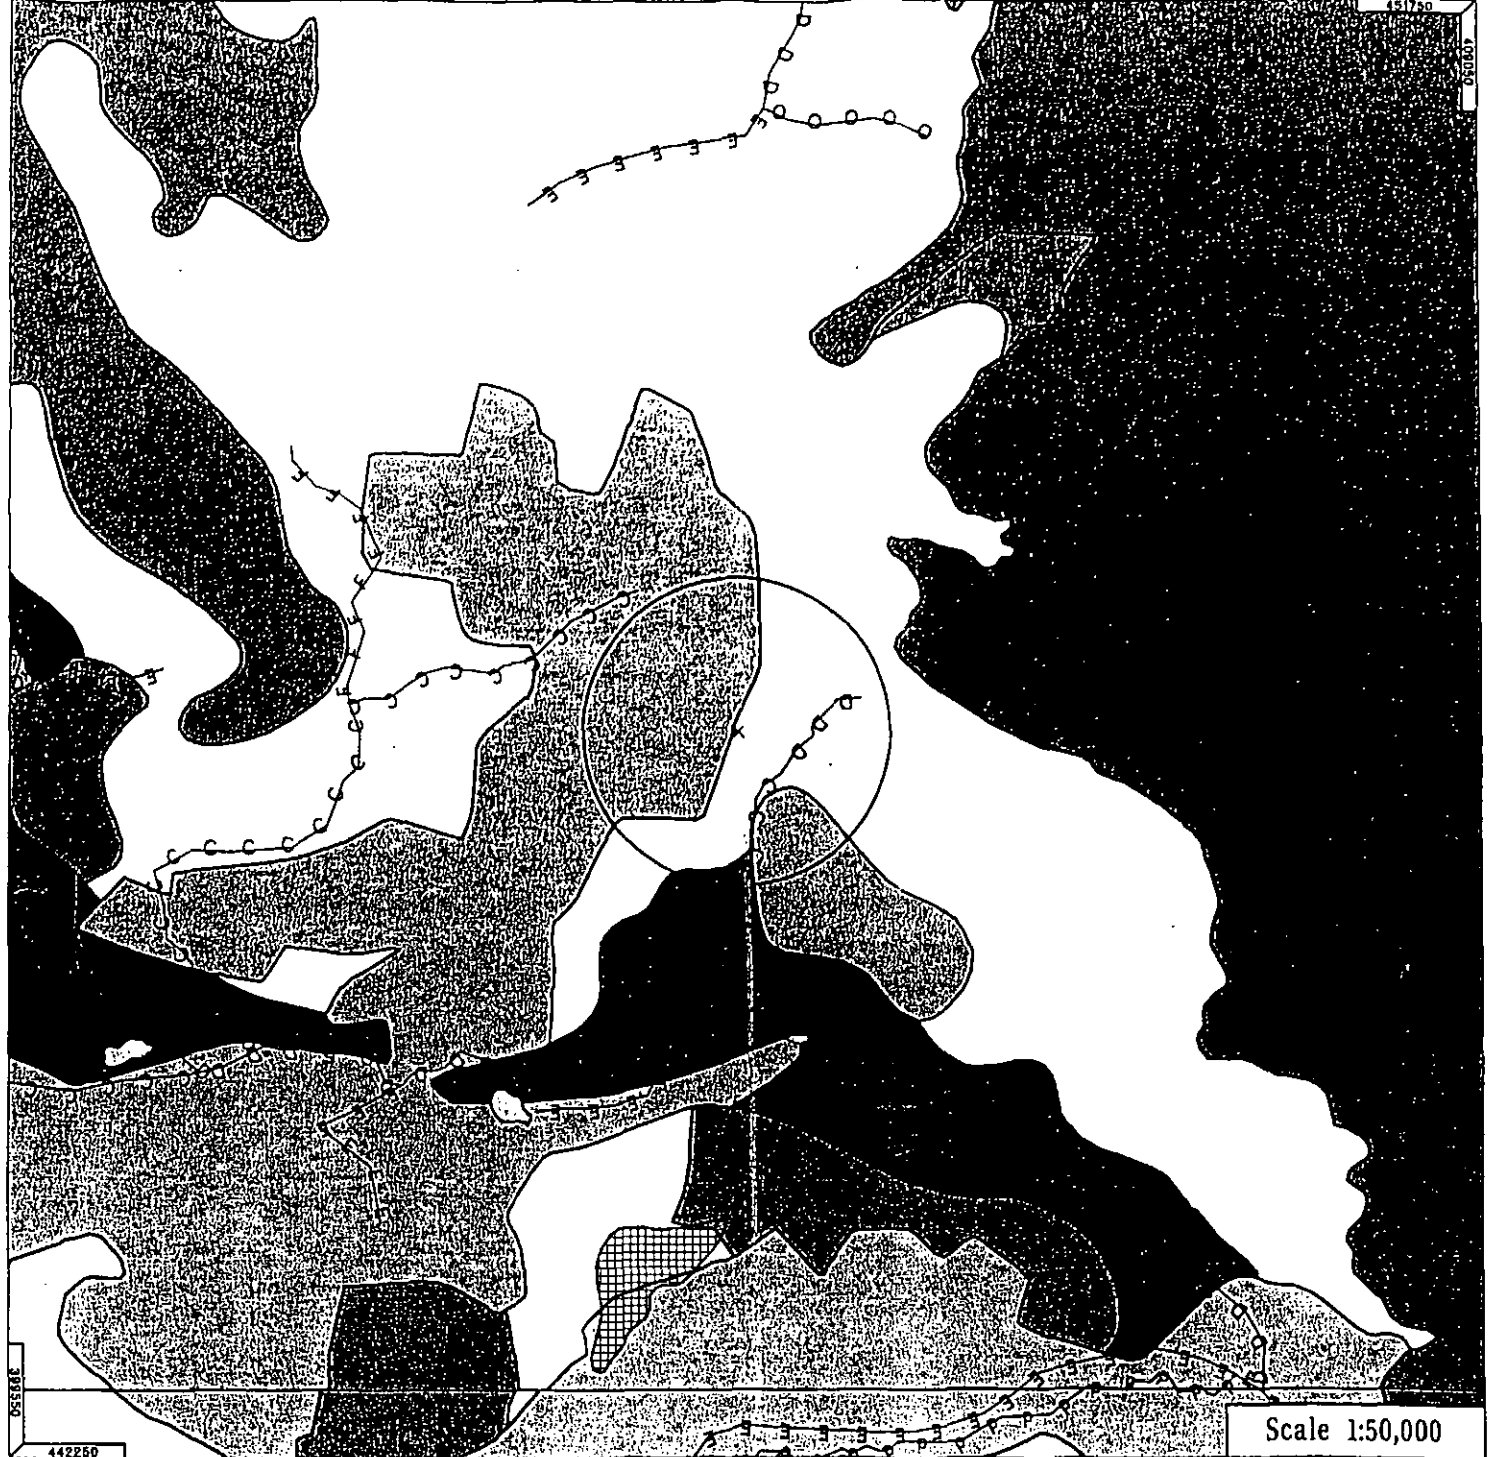
### Groundwater Vulnerability and River Quality Map

| Water | Minor Aquifer Low | Minor Aquifer High 3 | Minor Aquifer High U | Major Aquifer High 3 |

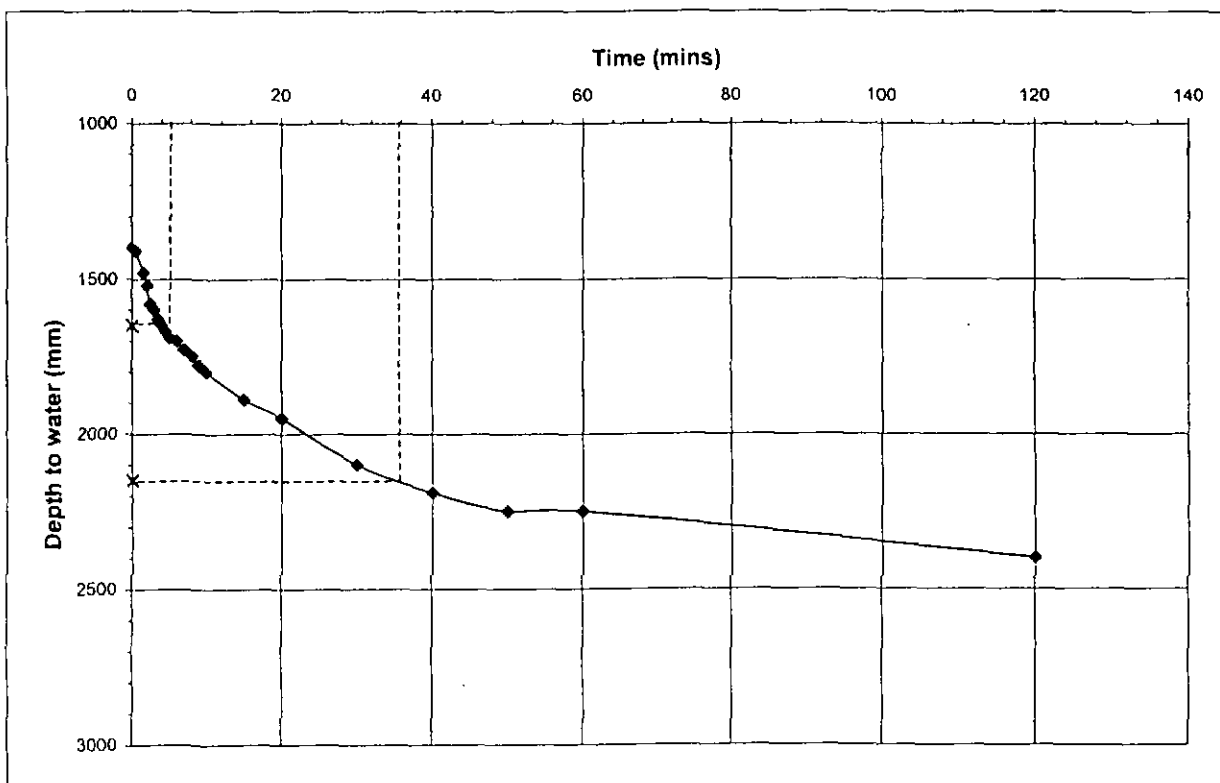
Soil infiltration rate,  $f$ , (m/s) = 5.43908E-05 (normal test)

Soil infiltration rate,  $f$ , (m/s) = 1.63E-05 (pit filled with stone)

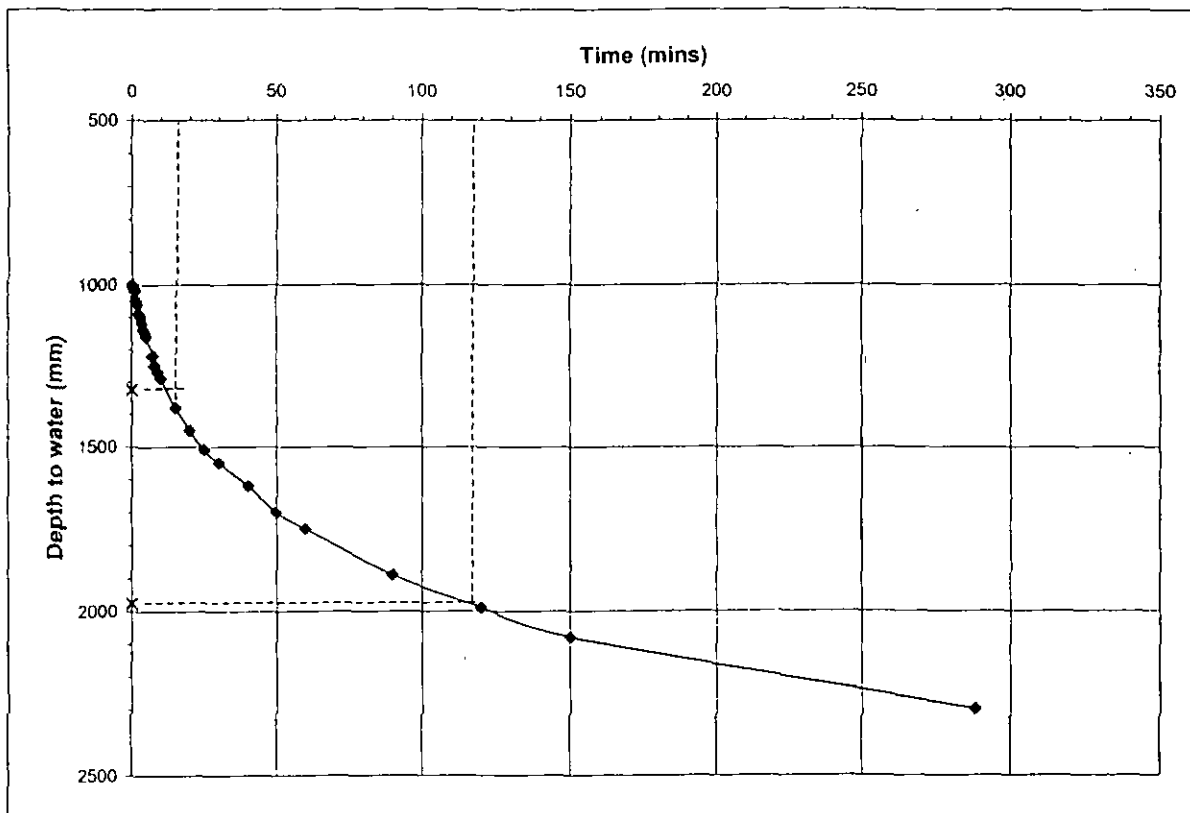
Soil infiltration rate,  $f$ , (m/s) = 1.76E-05 (normal test)

Soil infiltration rate,  $f$ , (m/s) = 5.27E-06 (pit filled with stone)

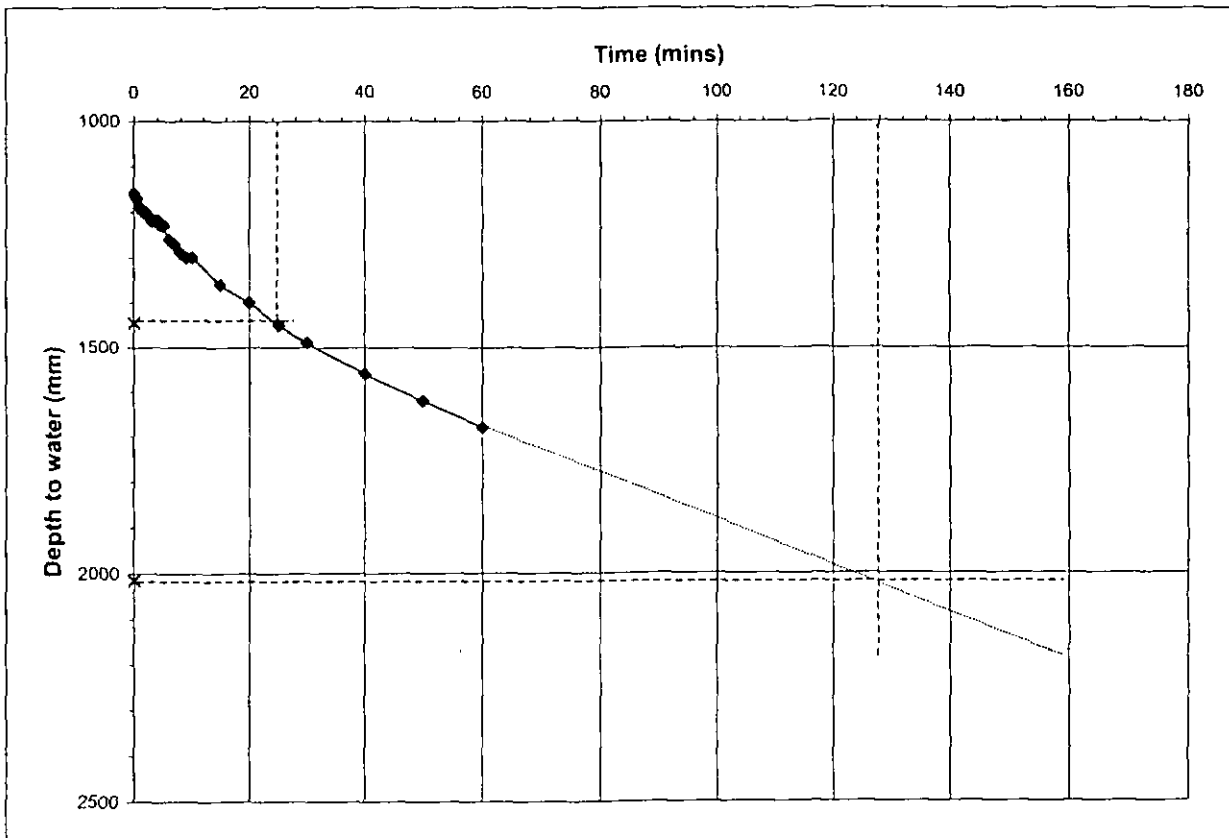
Soil infiltration rate,  $f$ , (m/s) =  $1.75E-05$  (normal test)  
 Note:  $t_{p25}$  not reached, value extrapolated from graph.  
 Soil infiltration rate,  $f$ , (m/s) =  $5.25E-06$  (pit filled with stone)

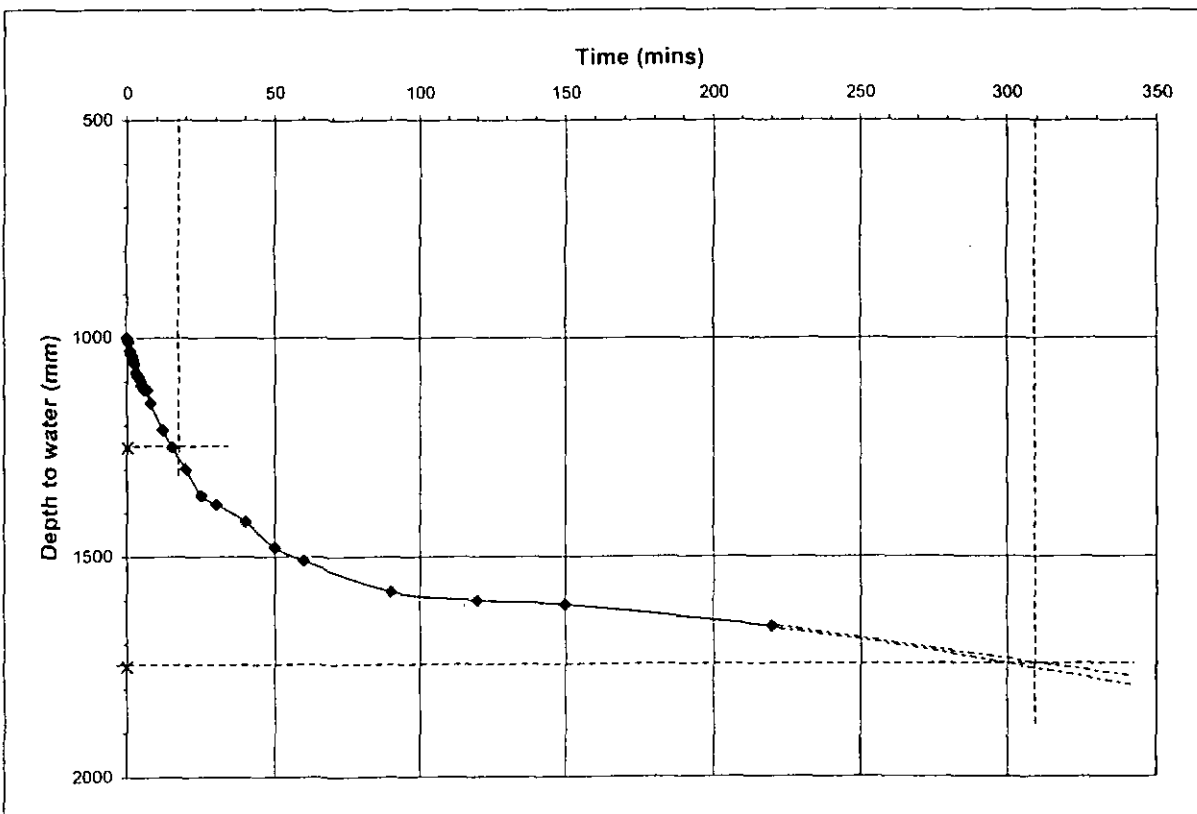
| Soil infiltration rate, $f$ , (m/s) = | 5.81E-06 | (normal test) |
| Note: $t_{p25}$ not reached, value extrapolated from graph. | | |

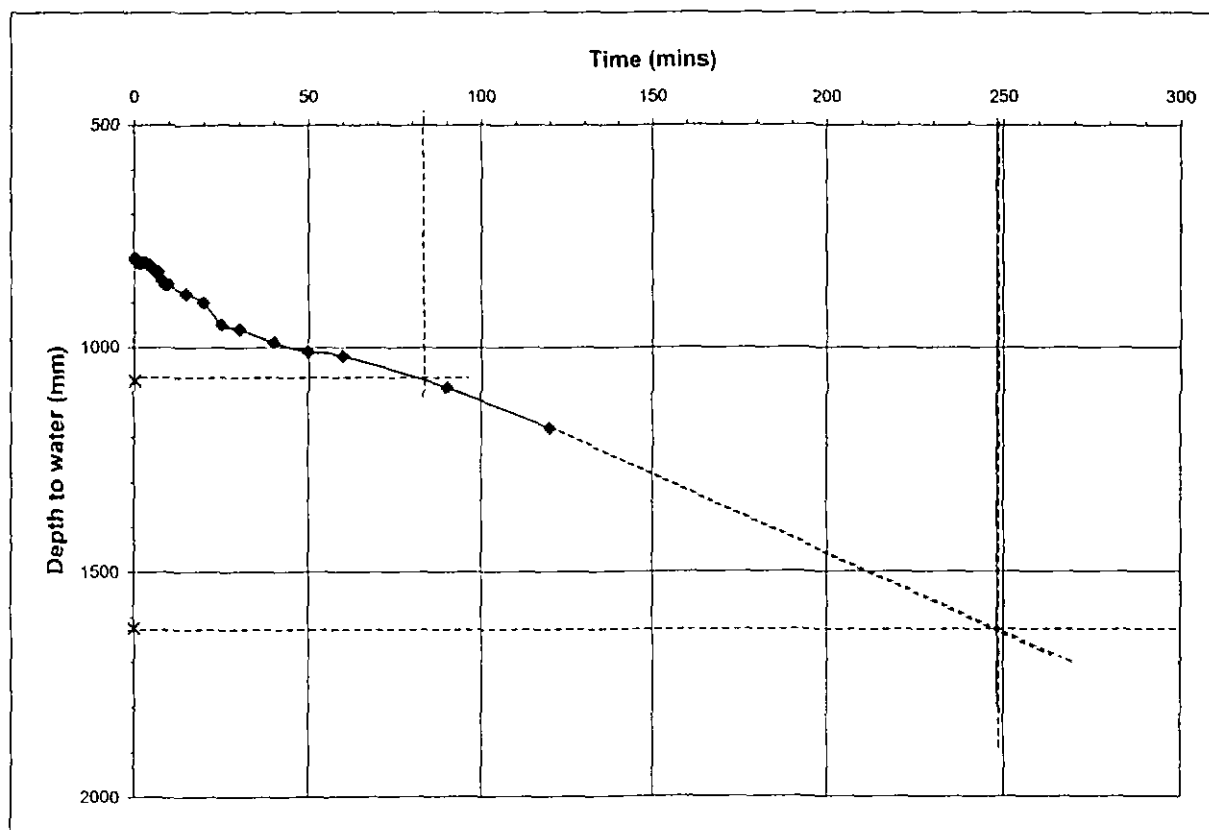
Soil infiltration rate,  $f$ , (m/s) = **1.08E-05** (normal test)  
 Note:  $t_{p25}$  not reached, value extrapolated from graph  
 Soil infiltration rate,  $f$ , (m/s) = **3.24E-06** (pit filled with stone)

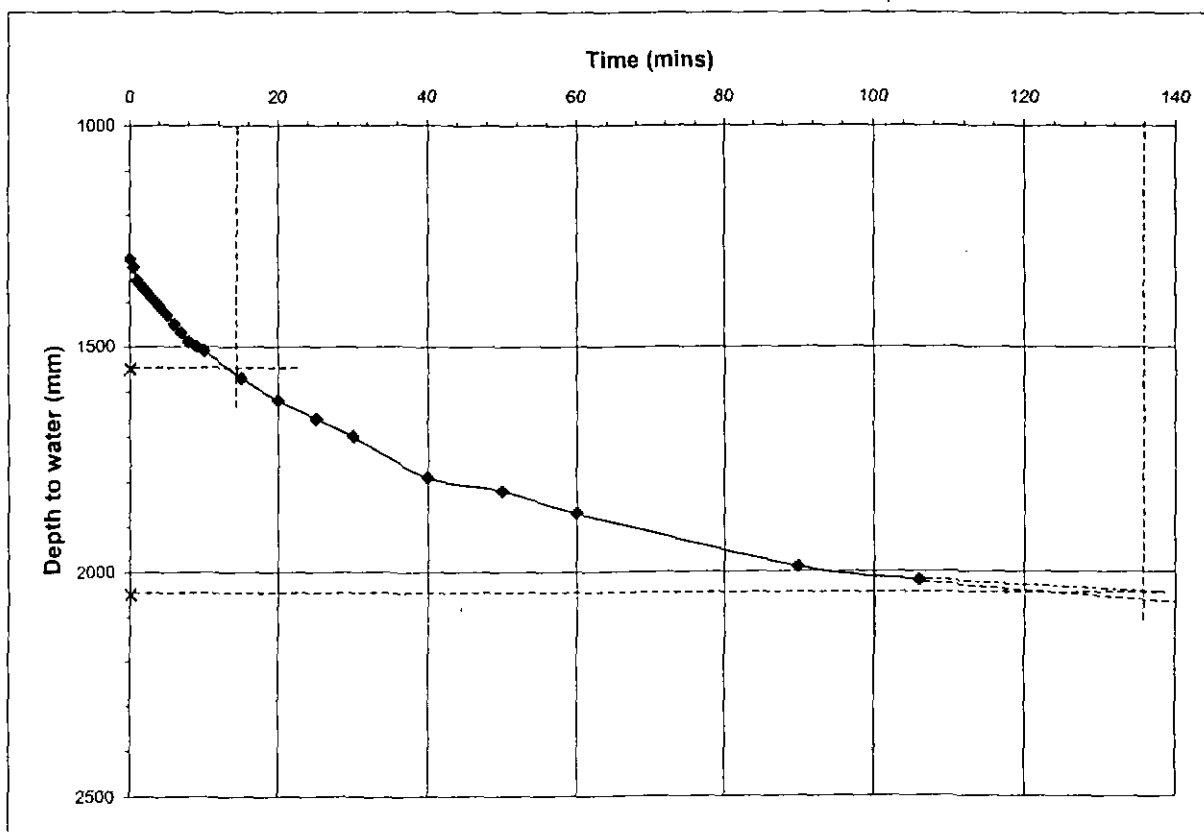
Soil infiltration rate,  $f$ , (m/s) =  $1.43E-05$  (normal test)  
 Note:  $t_{p25}$  not reached, value extrapolated from graph  
 Soil infiltration rate,  $f$ , (m/s) =  $4.30E-06$  (pit filled with stone)

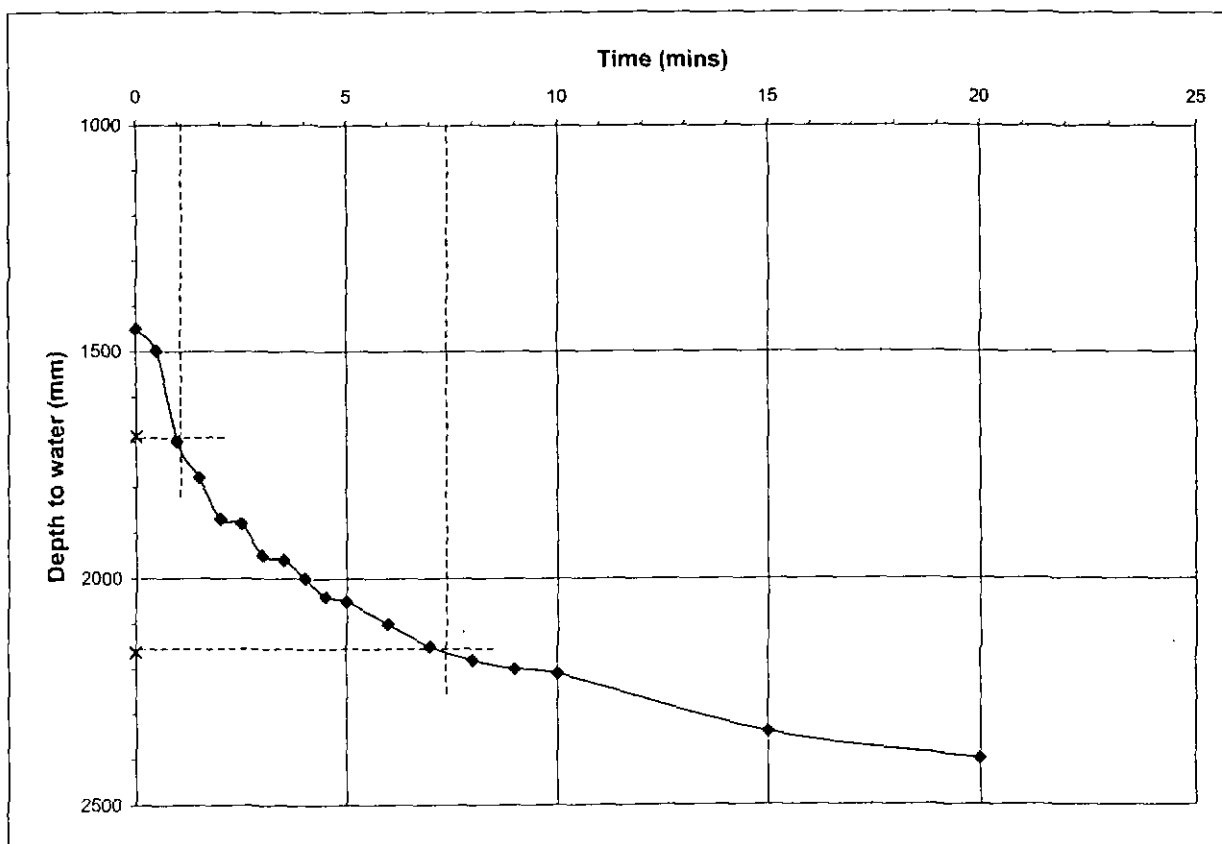
Soil infiltration rate,  $f$ , (m/s) =  $2.84E-04$  (normal test)

Soil infiltration rate,  $f$ , (m/s) =  $8.53E-05$  (pit filled with stone)

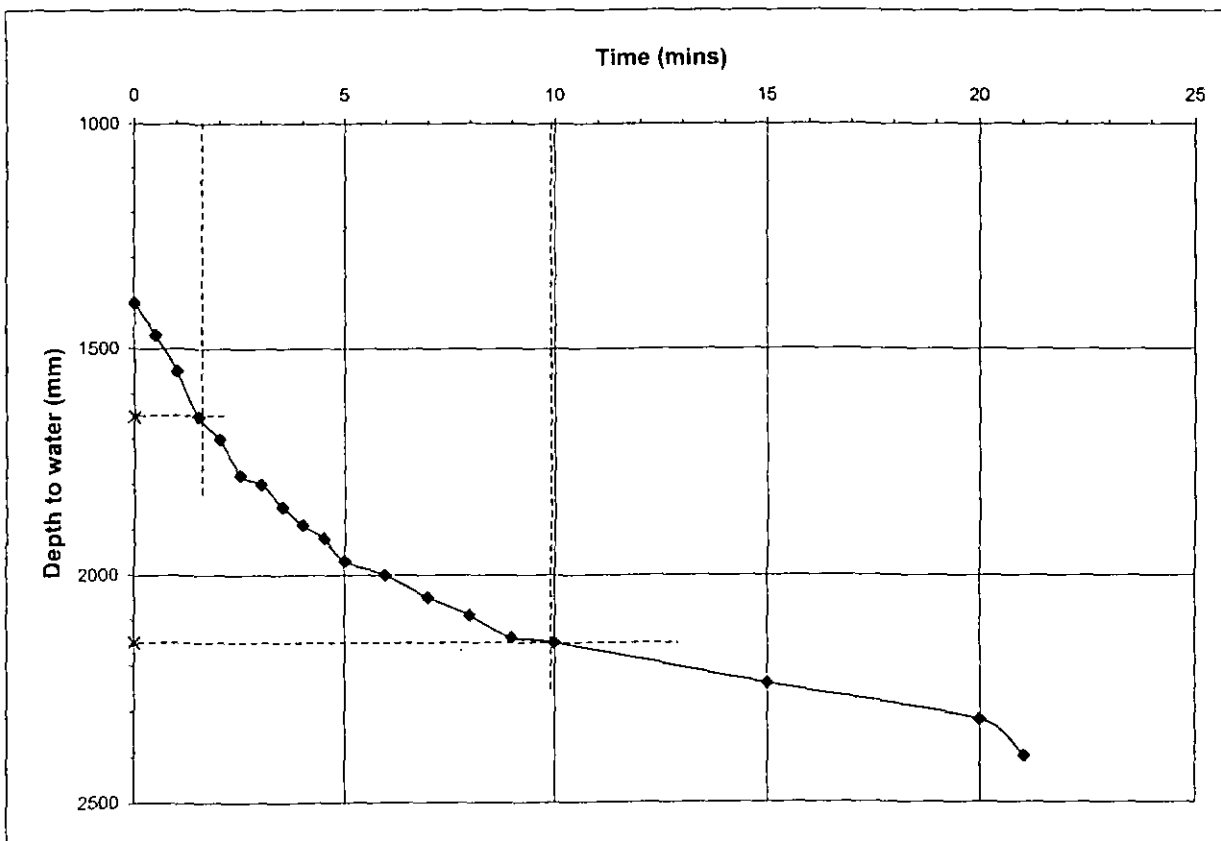
Soil infiltration rate,  $f$ , (m/s) = 2.03E-04 (normal test)

Soil infiltration rate,  $f$ , (m/s) = 6.09E-05 (pit filled with stone)

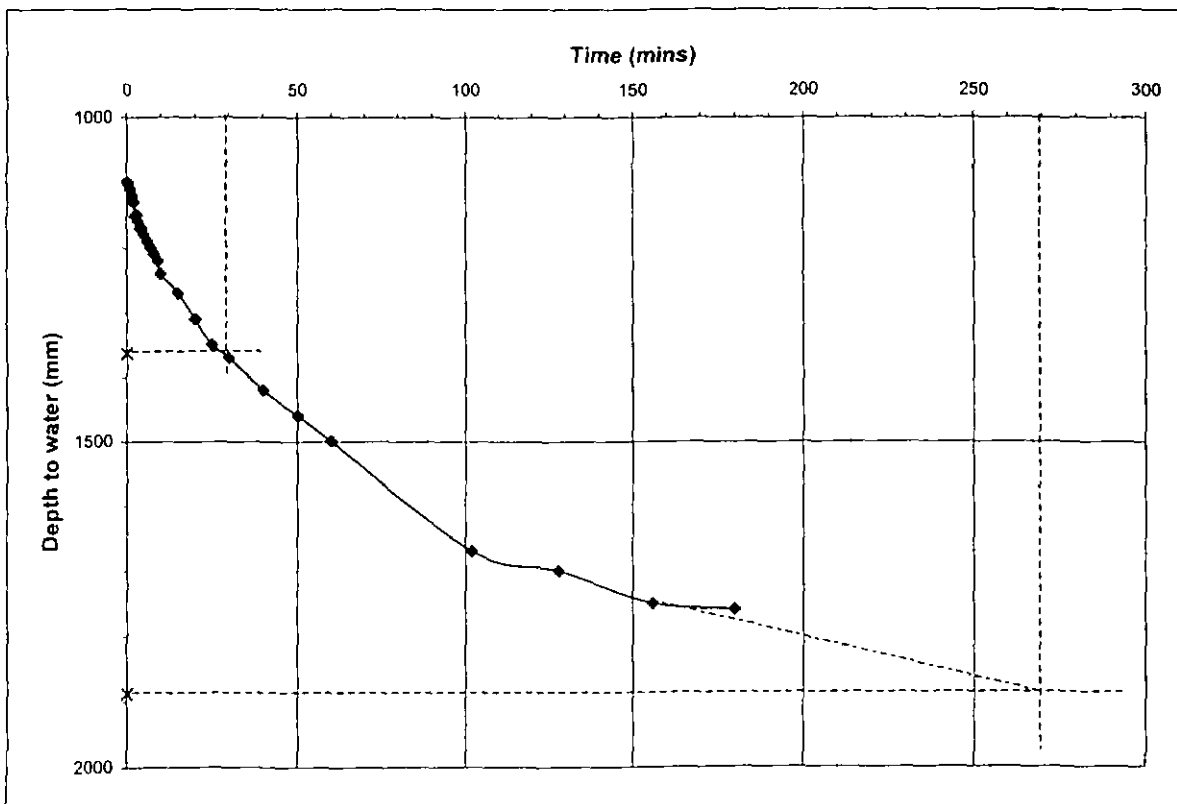
Soil infiltration rate,  $f$ , (m/s) =  $7.09E-06$  (normal test)

Note:  $t_{p25}$  not reached, value extrapolated from curve.

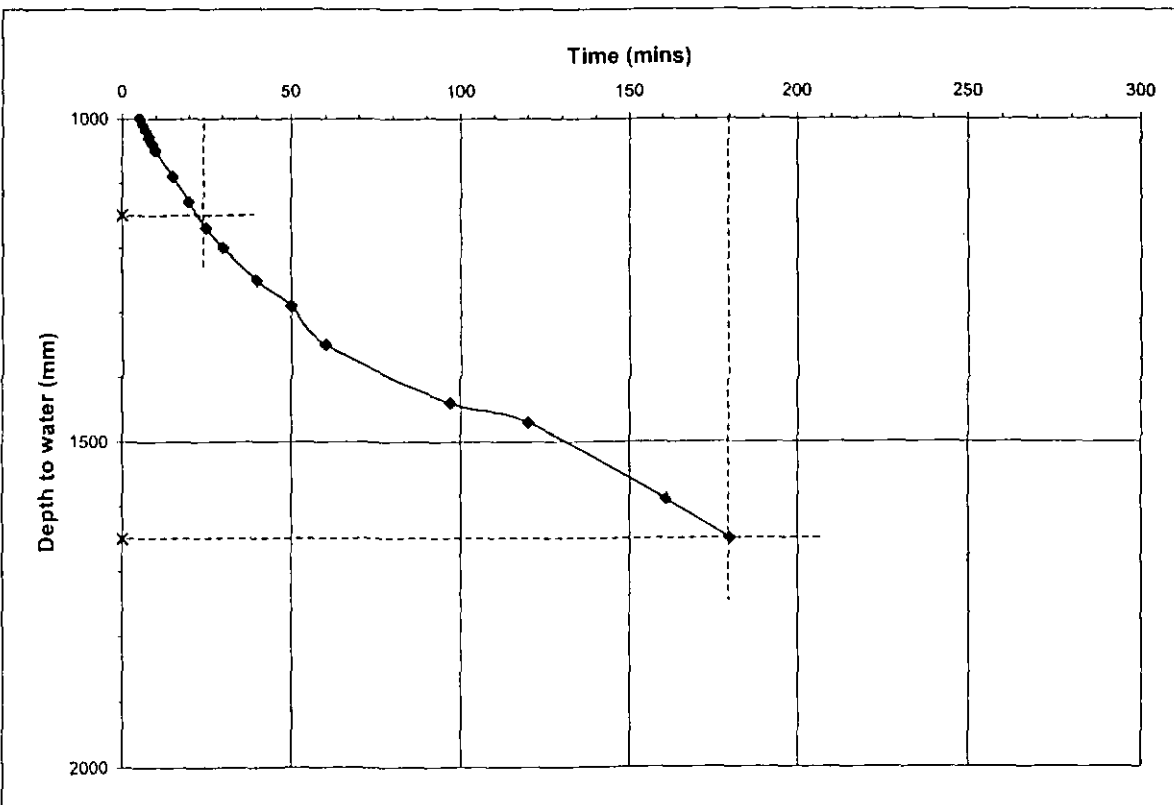
| Soil infiltration rate, $f$ , (m/s) = | <u>1.09E-05</u> | (normal test) |
| Soil infiltration rate, $f$ , (m/s) = | <u>3.27E-06</u> | (pit filled with stone) |

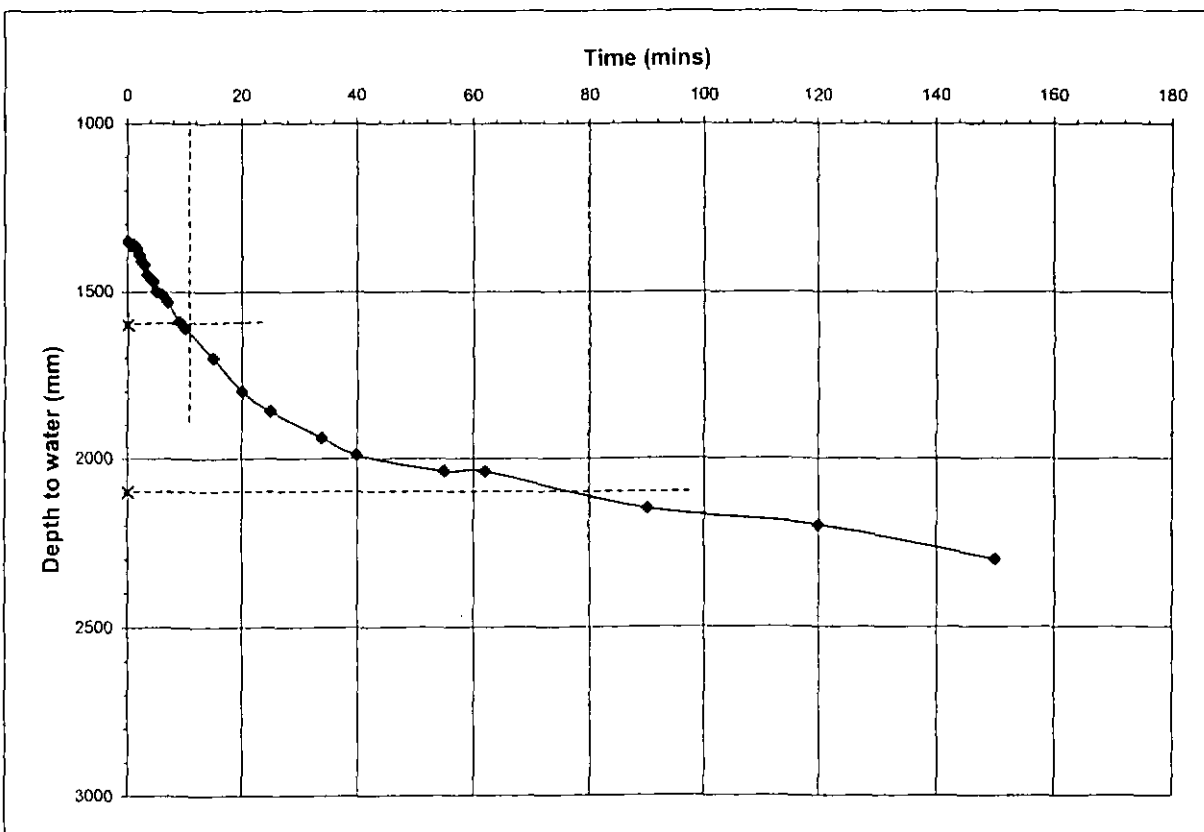
| Soil infiltration rate, $f$ , (m/s) = | 2.42E-05 | (normal test) |
| Soil infiltration rate, $f$ , (m/s) = | 7.26E-06 | (pit filled with stone) |

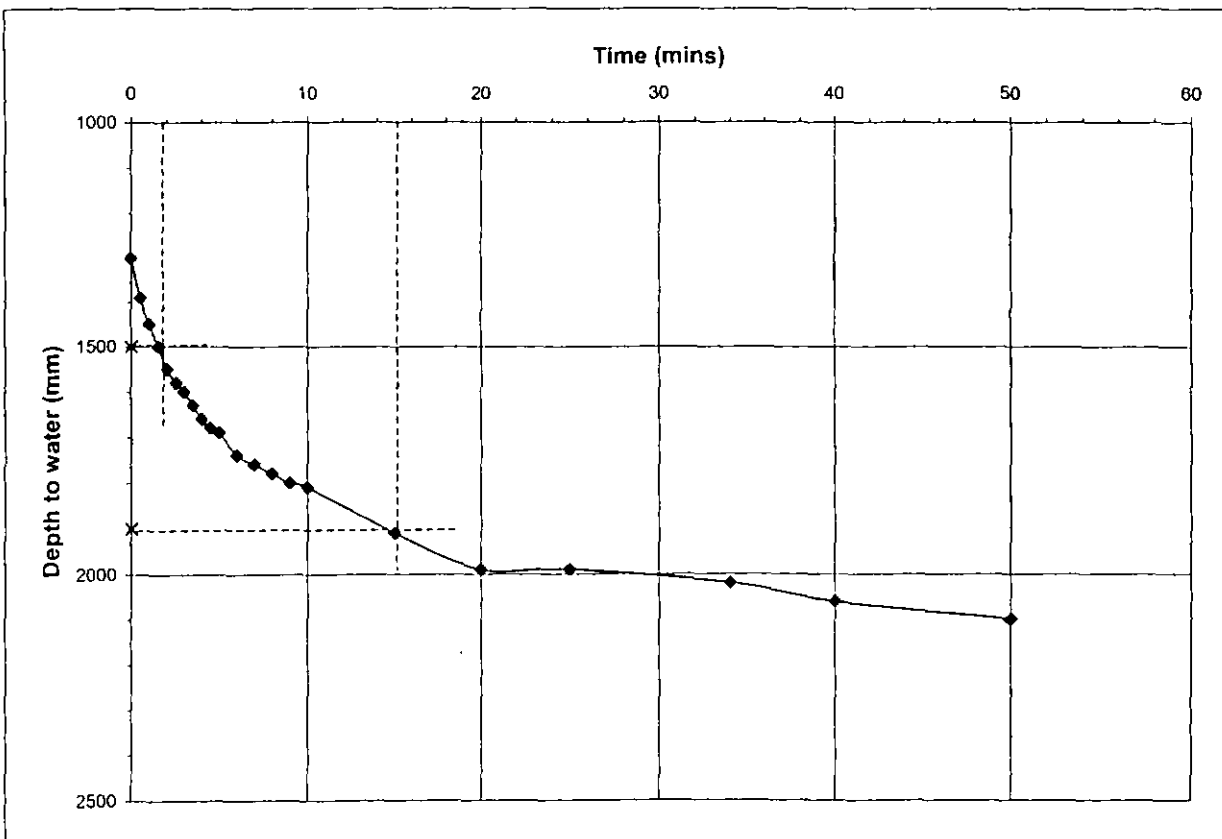
Soil infiltration rate,  $f$ , (m/s) = 1.27E-04 (normal test)

Soil infiltration rate,  $f$ , (m/s) = 3.80E-05 (pit filled with stone)

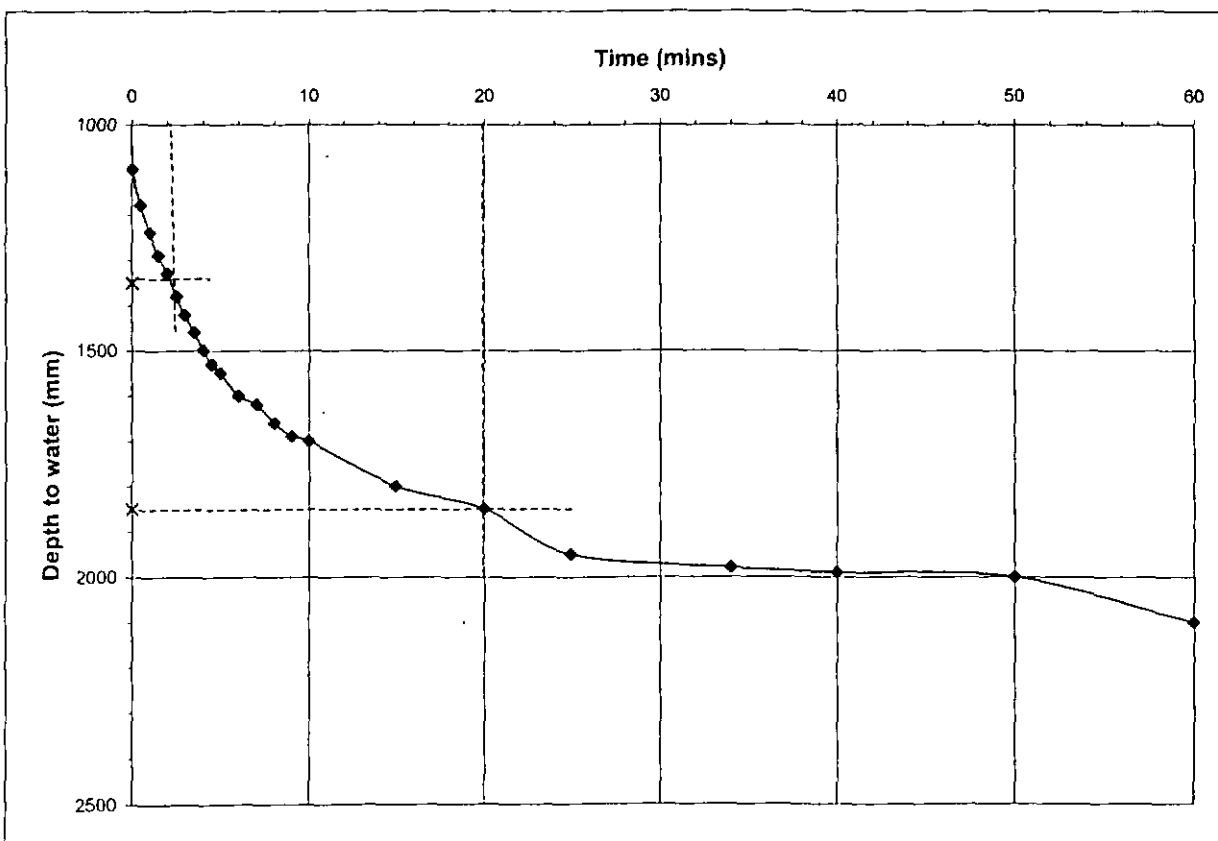
| Soil infiltration rate, $f$ , (m/s) = | 9.63E-05 | (normal test) |
| Soil infiltration rate, $f$ , (m/s) = | 2.89E-05 | (pit filled with stone) |

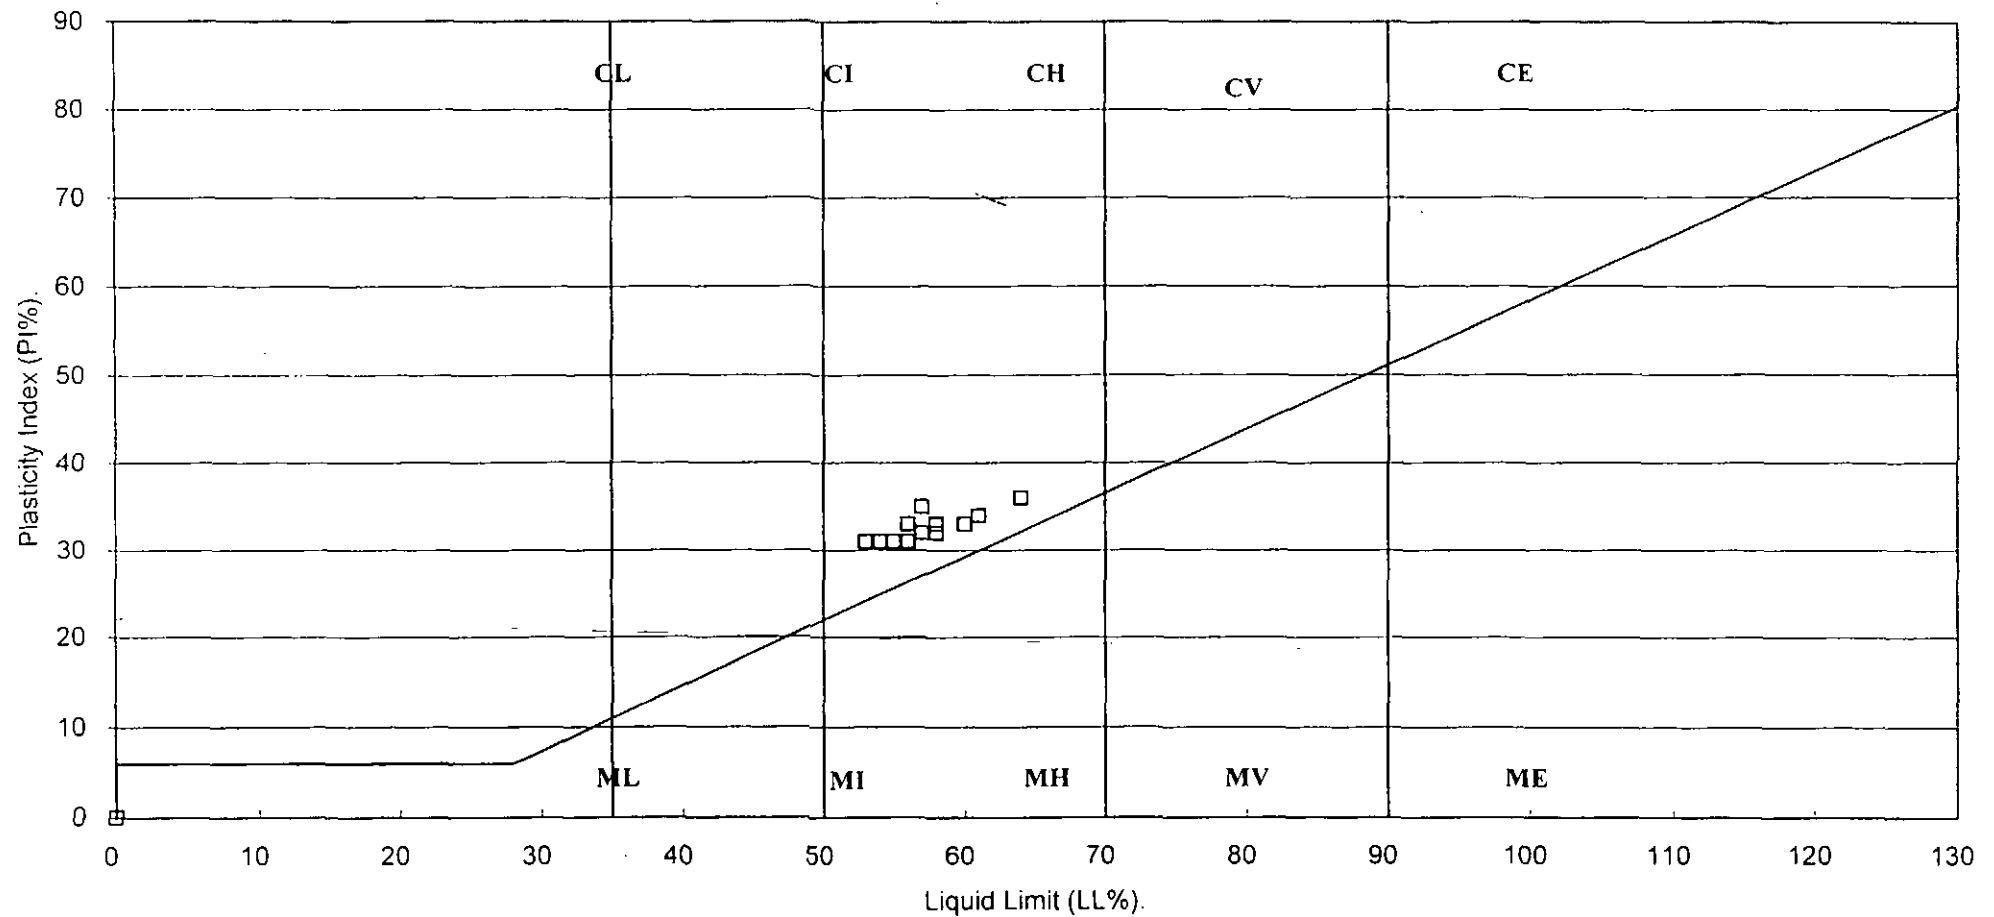
# PLASTICITY CHART FOR CASAGRANDE CLASSIFICATION.

(B.S.5930 : 1999)
