Bat Scoping Survey to
Kexbrough Hall Farm
Churchfield Lane
Kexbrough
S75 5DU

30th September 2020

Revised and updated 26th May 2021

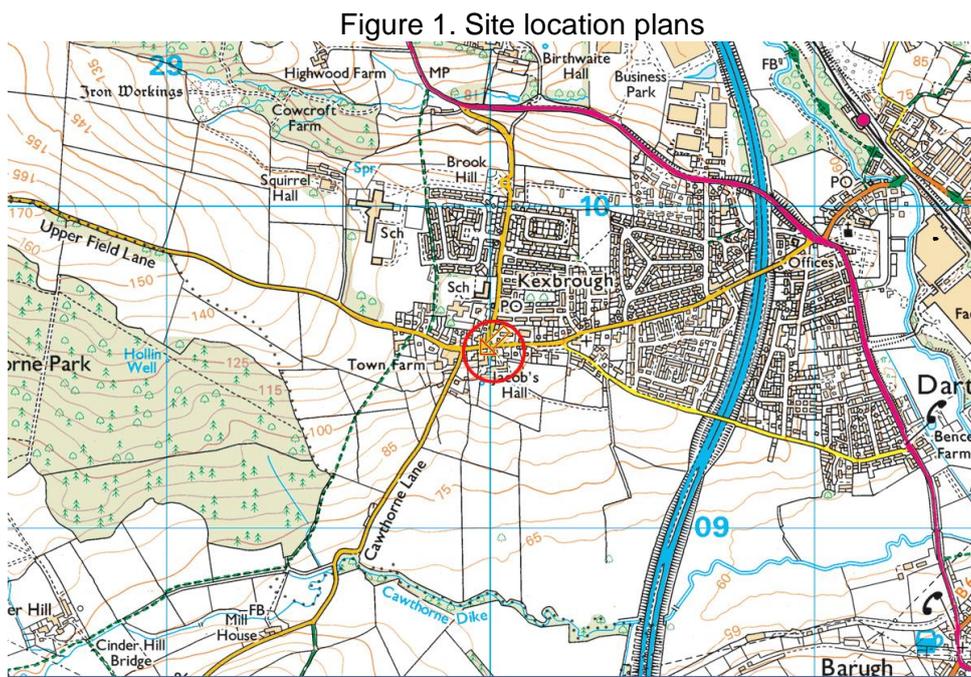
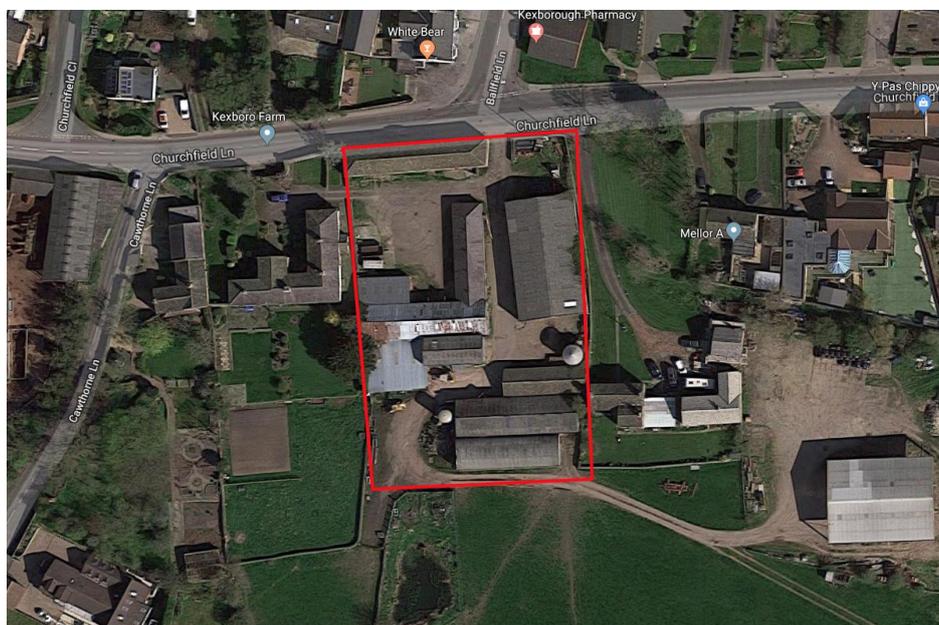
Figure 2 Aerial view of the site, surrounds and buildings surveyed

5.1 This site is comprised of a number of barns with three large stone barns set around a large open farmyard. There are modern agricultural barns adjacent to these and some smaller outbuildings too. The site has residential dwellings to the north side of the site and these will also offer roosting potential. Linear features connect the site to the wider landscape.

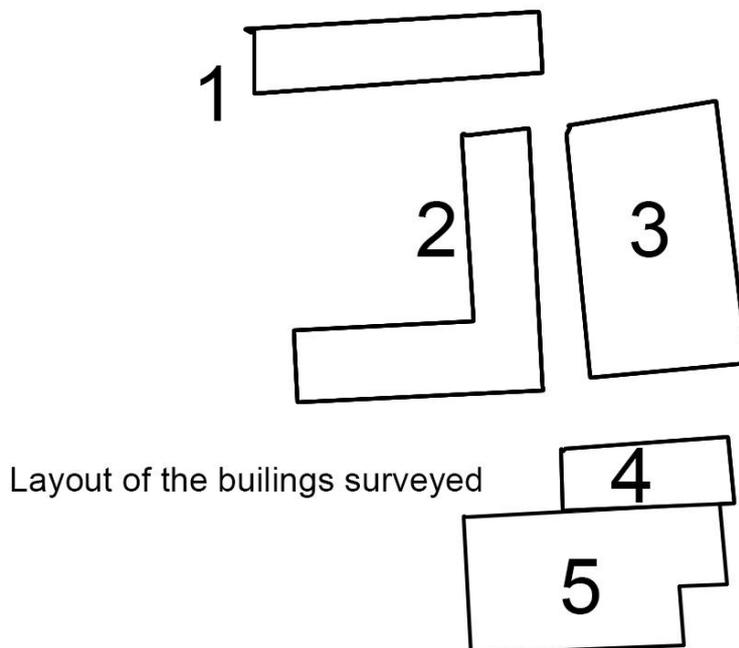
Figure 3. layout of buildings for reference

The site consists of three stone barns arranged around an open farmyard with two of the barns joined to form an L-shape (building 2). Along the outer edge of the site are a series of large, modern agricultural units and a small, open fronted building (building 4).

Buildings numbered 3 and 5 above are large agricultural units constructed around a steel frame with breeze block to the lower wall sections and corrugated tin or cement fibre to the sides and roof. These buildings are not considered to be of any interest to bats in terms of providing roost sites, though they will be used by bats as foraging areas, especially by any bats emerging locally. Both common pipistrelle and whiskered bats seem to favour hunting in this kind of units

just after emerging, but the buildings do not have the cavity walls or roof voids that bats require for roosting. These units are classed as being of negligible interest to roosting bats.

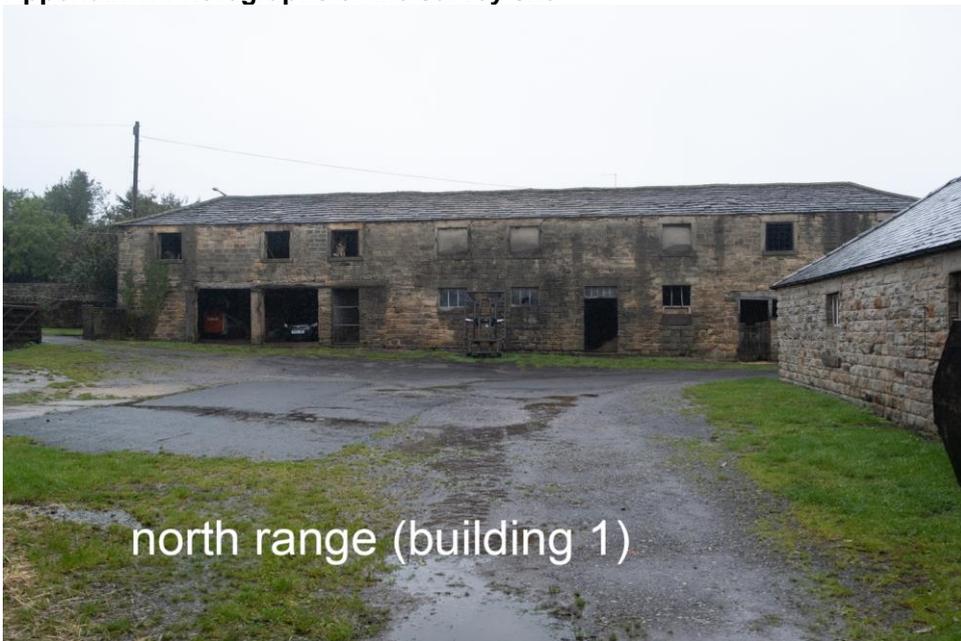
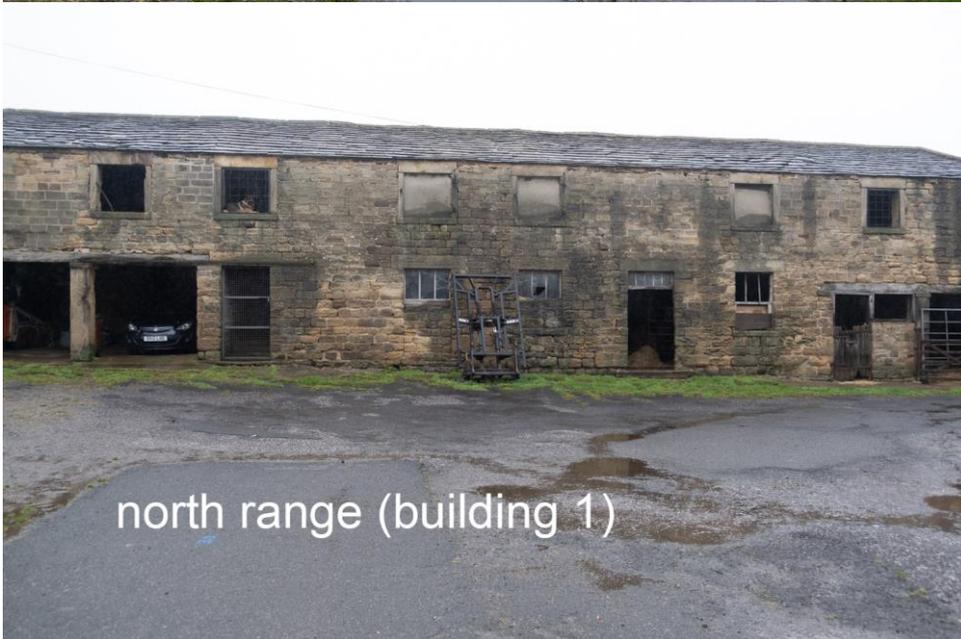
The buildings with the most potential interest to roosting bats are the stone buildings arranged around the farmyard. Building 1 is a long, two-storey building with stone roof tiles. The roof is unlined and for the most part has a heavy build-up of dirt and cobwebs on the ridge beams. The ridge tiles are all present and have had some remedial works carried out and appear to be well bedded and could be of interest to ridge dwelling species. The gable walls have also had some repointing works undertaken and have limited access points. The gable walls have a stone cap and do not have any kind of fascia other features that bats could roost beneath. The walls have some structural gaps and other minor cavities that may be used by small numbers or individual bats. Although there was no evidence to suggest use by bats, the building has some potential and is classified as being of low importance to bats.

- 9.3 The large range of the stone barn on the north boundary which was thought to have the most roost potential turned out to have the least potential due to the heavy build-up of cobwebs and dust along the ridges. No bats were seen inside this building or seen to emerge from it.

north range (building 1)

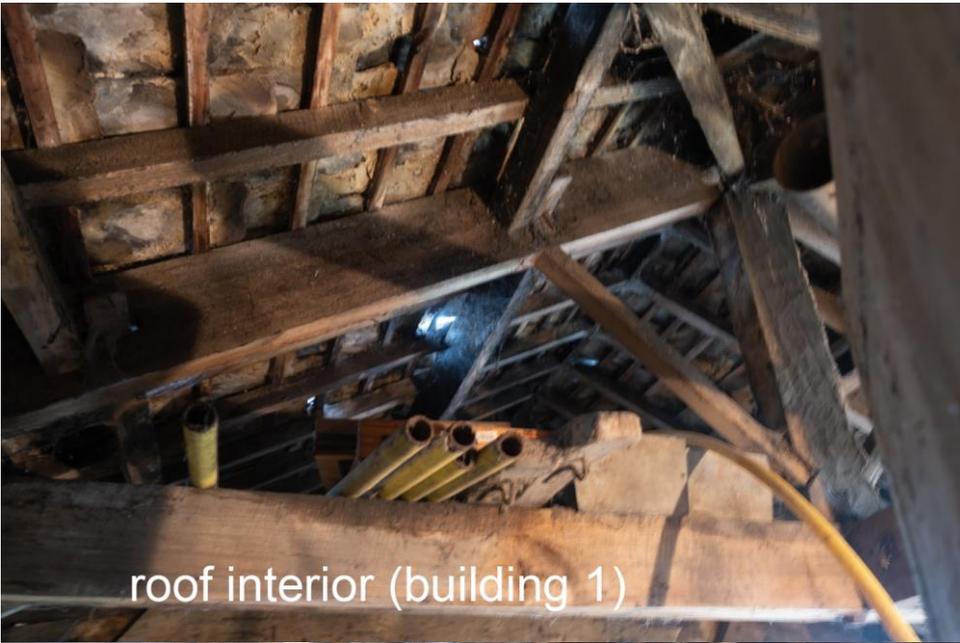
Frequent forays were made inside buildings 1 and 2 to establish if ridge or void dwellings species were present. Building 1 has an exceptionally dirty ridge section and no bats were ever seen or recorded inside this building bats are not considered to be using this to roost. A single

roof interior (building 1)

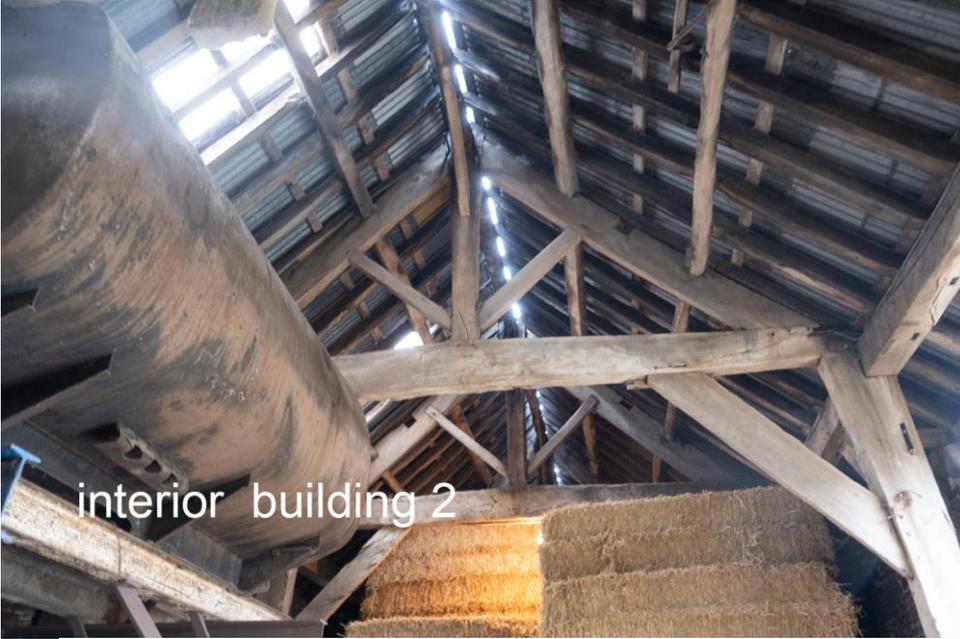
Building 2 is an L-shaped barn consisting of a single storey unit with slate roof connected to the larger, Grade 2 listed barn which has a corrugated tin roof. The single storey section appears to be modern and has a sound slate roof which is lined with felt. It is hipped on the exposed gable and all hip and ridge tiles are present and well bedded and without gaps. The stone walls are well pointed and do not have gaps. The larger section of this barn is two storey and is a stone shell built around the original (medieval) timbers but without being connected to them. The stone roof has long been taken away and replaced with a corrugated tin roof which has gaps the whole length of the ridge. The roof is of no interest to ridge dwelling species and does not provide any kind of potential roosting site. The interior of the barn is incredibly dusty due to the presence of a milling machine that is used daily to grind fodder for the cattle. The amount of dust is likely to make this barn very unattractive to bats. It is, nevertheless, categorised as being of low interest.

brown long-eared bat was recorded flying in building 2 and, whilst at this time of year, a brown long-eared bat may use any crack or crevice as a transitional roost, no roosting activity was recorded on site.

interior building 2

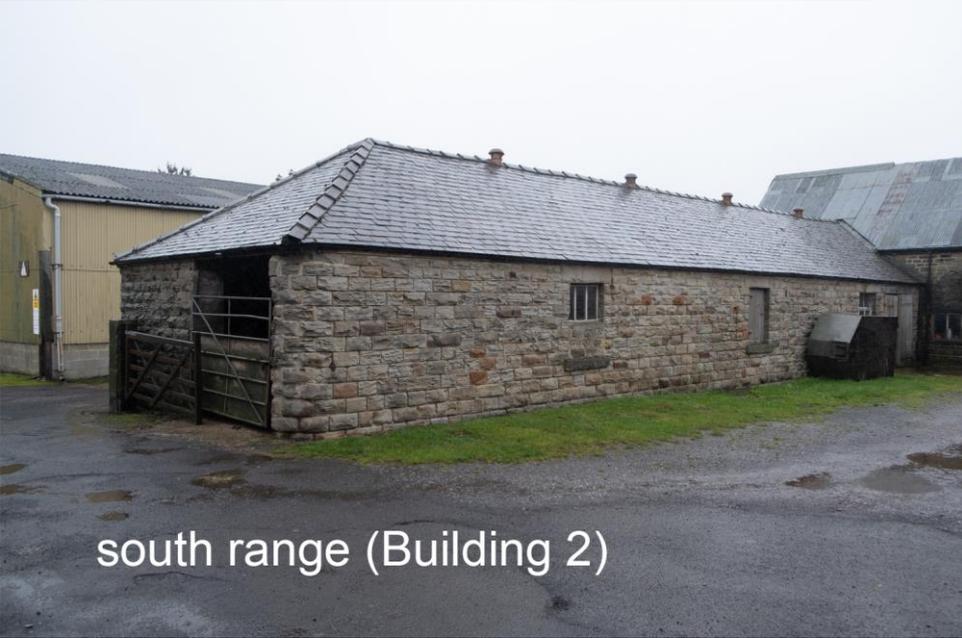
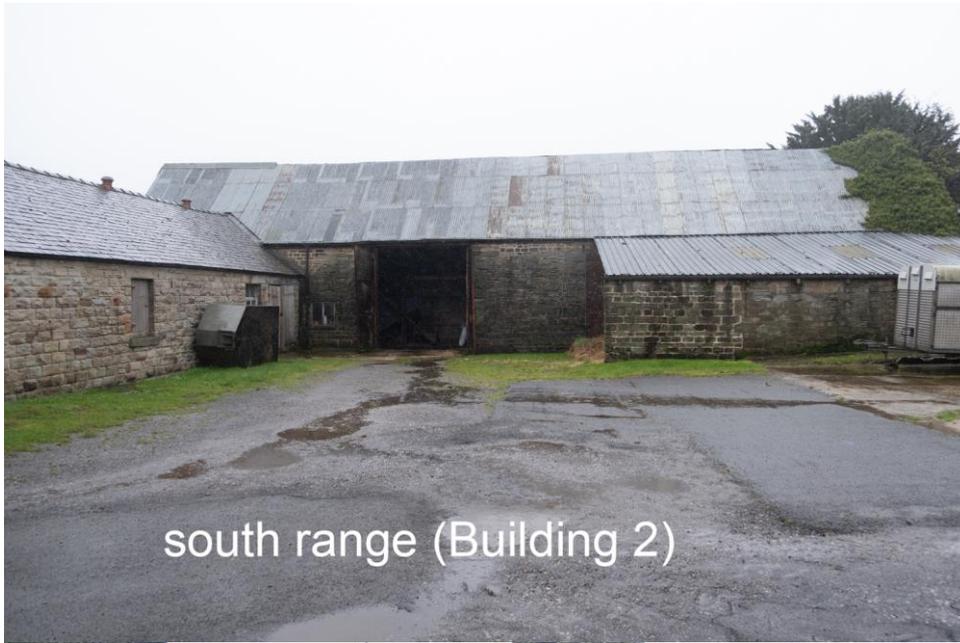
- 9.2 The large Grade 2 listed barn has limited roost potential due to the tin roof with large ridge gaps and the huge amounts of dust in the interior section caused by the grinding machine are likely to penetrate roost areas. Whilst any crack or crevice may be used by an individual or transient bat from time to time, all activity surveys suggested that the original assessment was accurate and no bats were seen to emerge from this building. A single brown long-eared bat recorded inside the building briefly some 45 mins after sunset and considered likely to have entered the barn from elsewhere and, given the record was very late in the season and of a single bat, it is likely that this was a transient record. The single storey building that adjoins this barn had some potential for bats to roost behind the gutter boards but no bats emerged from this area or were seen in the roof void.

south range (Building 2)

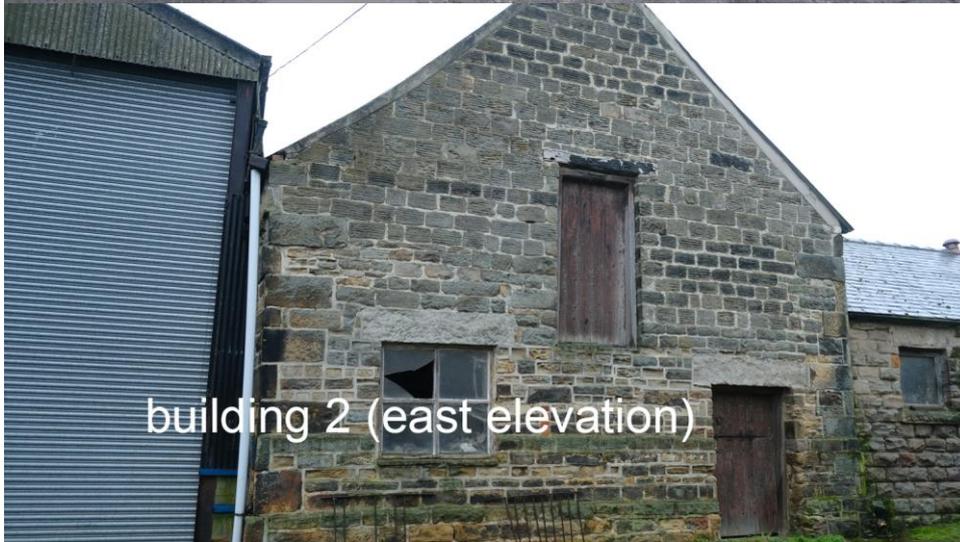
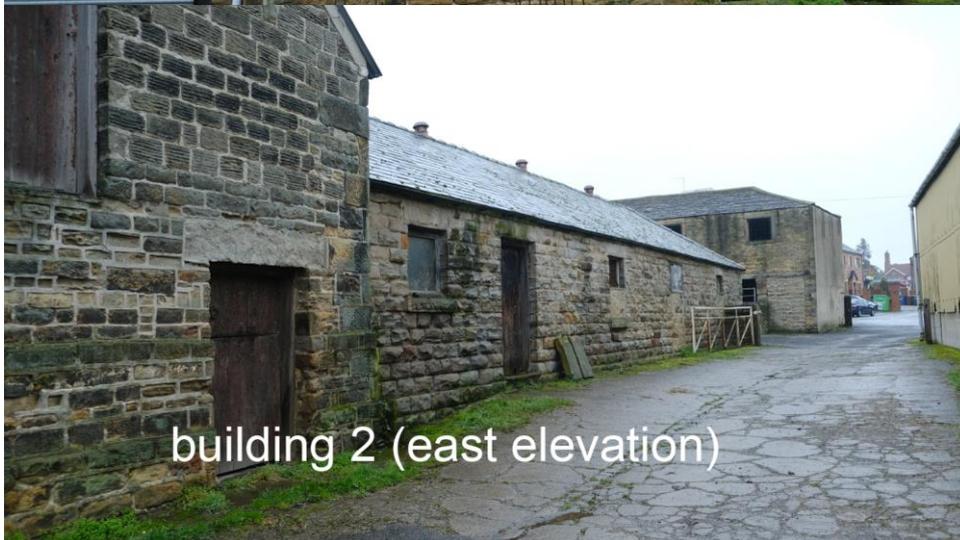
building 2 (east elevation)

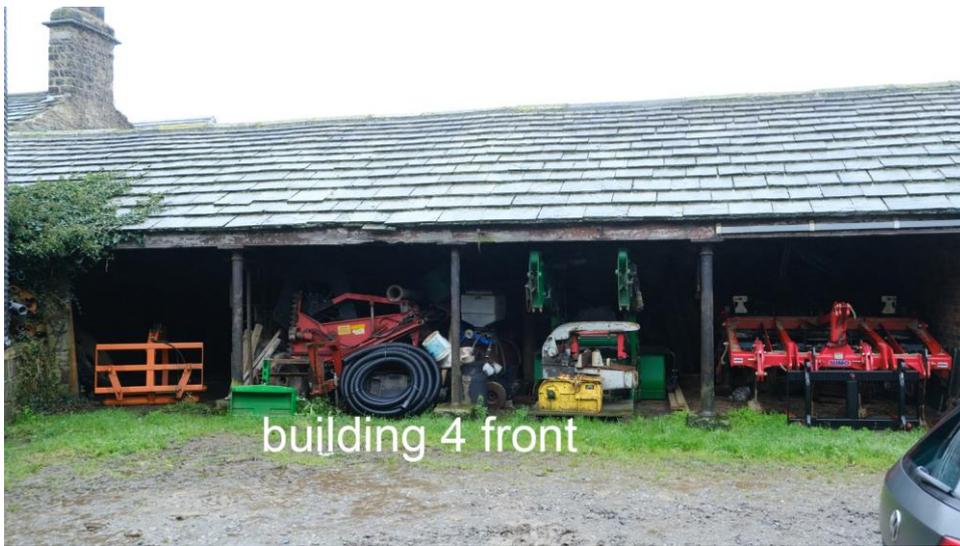
To the rear of the farmyard is a small, open-fronted, single storey building used for storing farm machinery (building 4). This has a stone roof which appears to be relatively new and is lined and may provide either roosting potential or could be used as a feeding perch by brown long-eared bats. An activity survey would establish if the building is being used by bats.

building 4 front
