PROJECT  
Alhambra Shopping Centre

TITLE  
Existing Elevations

| PROJECT REF<br>07-01-1100 | DRAWING REFERENCE<br>001 | REV<br>P1 |

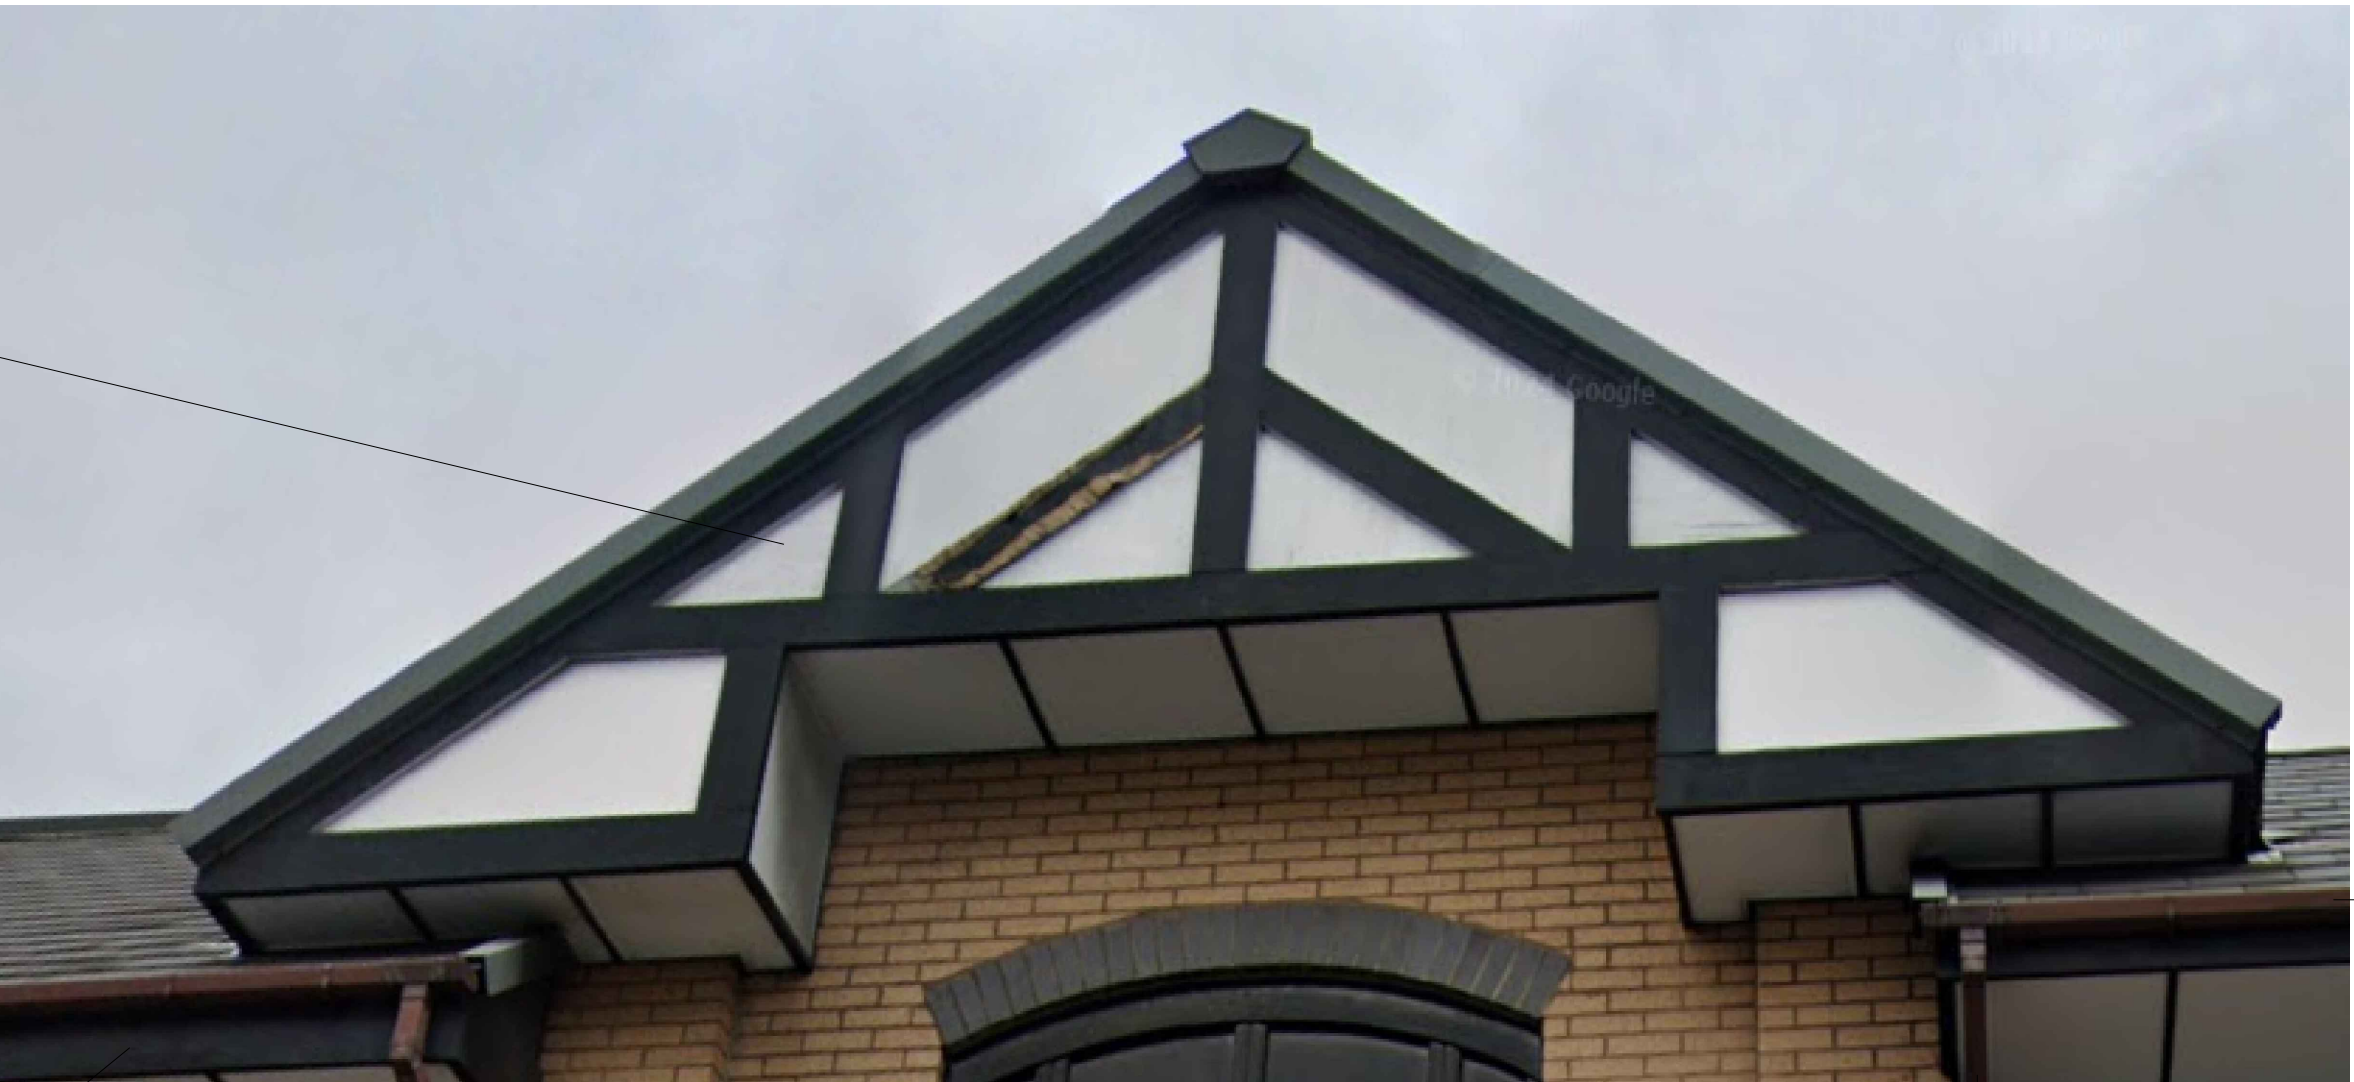
Existing Mock Tudor Gable (NTS)

Existing mock tudor panelling and all rotten timbers to be removed. New 18mm OSB smart plywood over, with a breather membrane over. New anthracite shiplap cladding to be installed.

New UPVC Anthracite fascia cover board

Rain water downpipes to be replaced with circular Anthracite grey downpipes

Rain water gutters to be replaced with deep flow semi circular Anthracite grey gutters

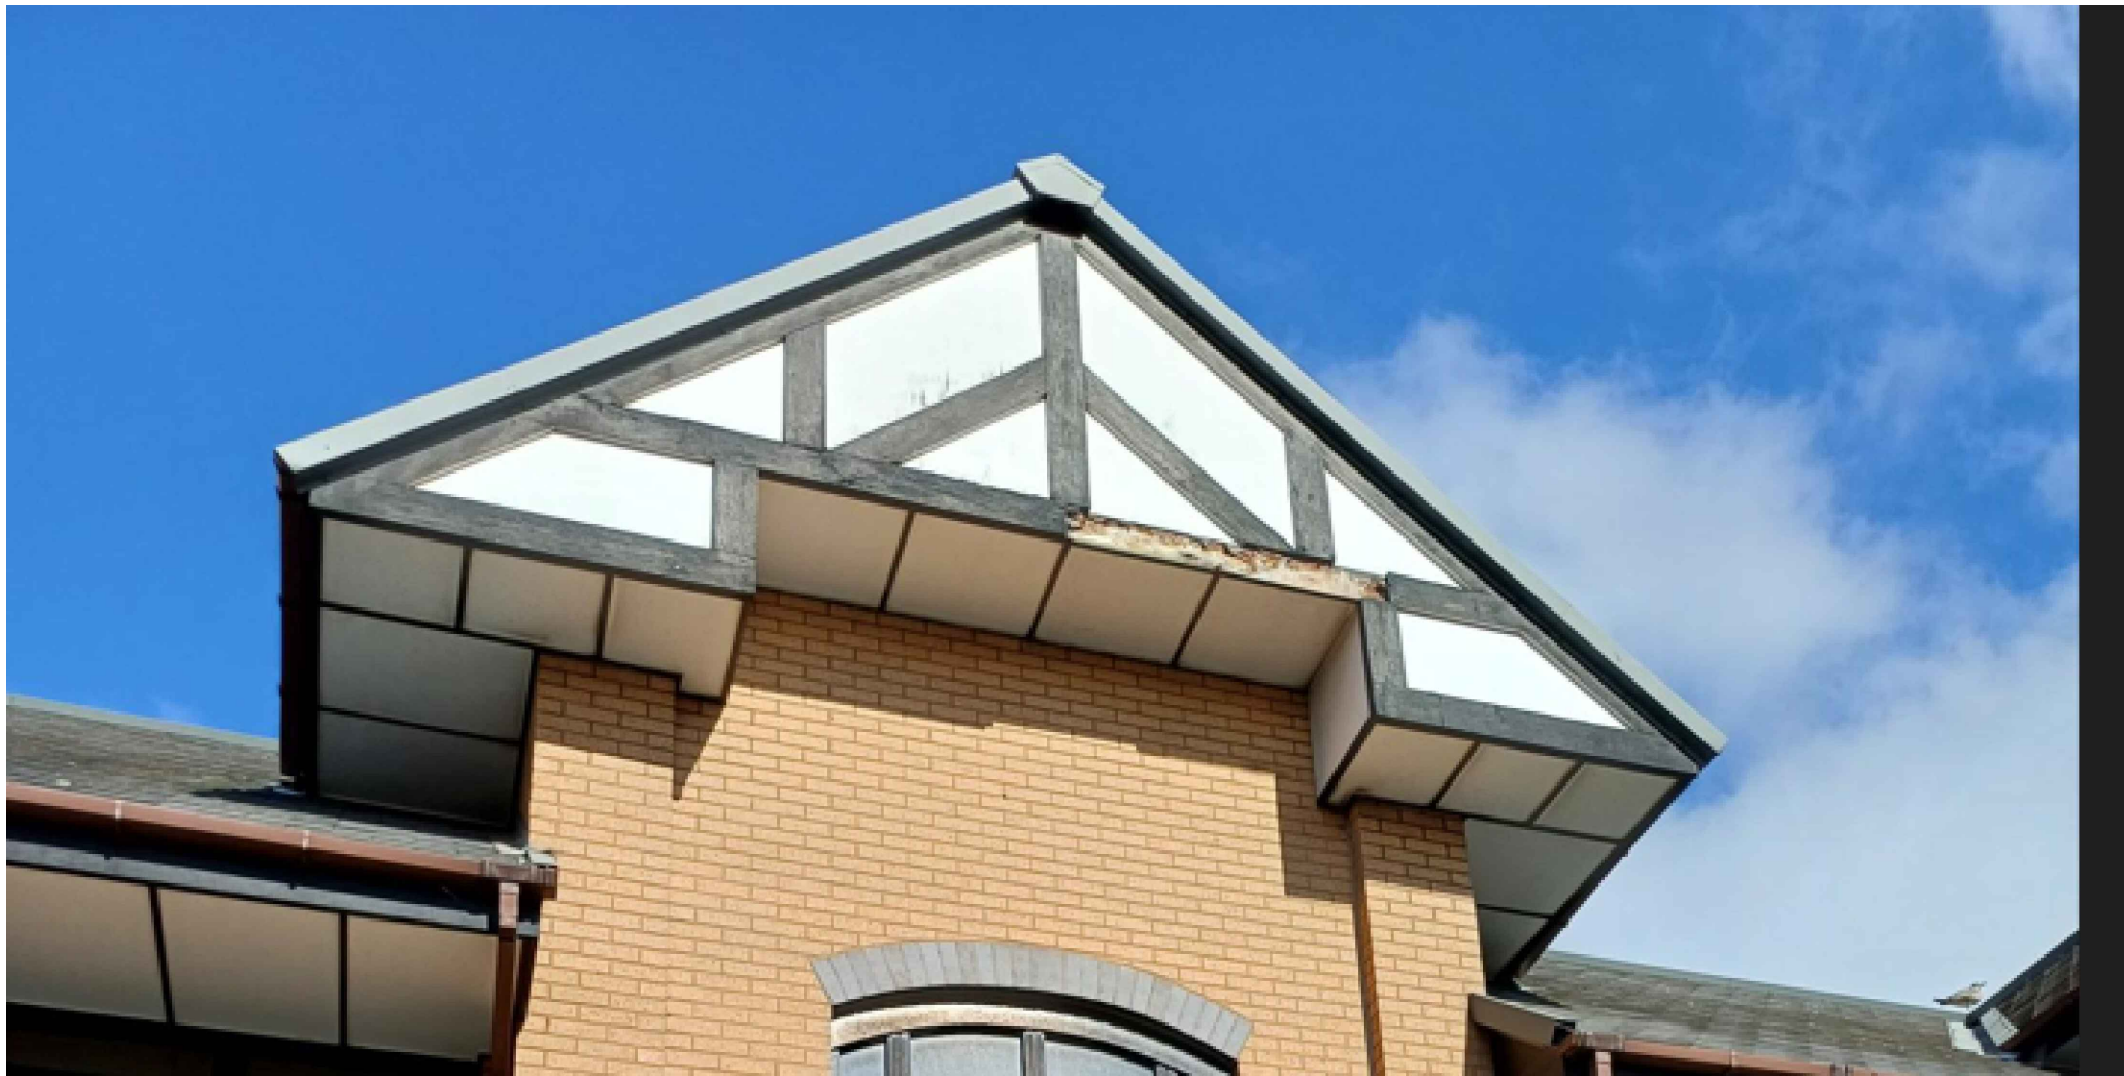
Example of damaged existing gables
