**Whitcher Wildlife Ltd.
Wildlife Consultants.**

EASTFIELD FARM, THURGOLAND.

BAT SURVEY.

Ref No:- 120945. REV1.

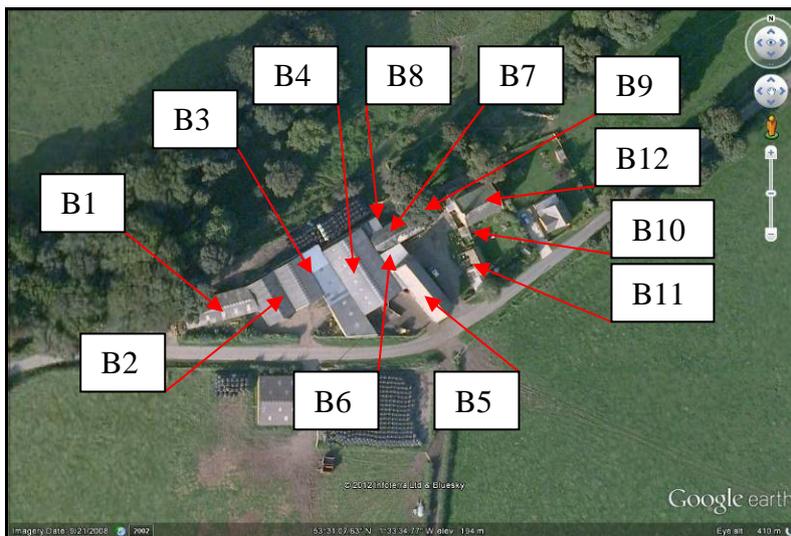
Below is an aerial photograph showing the surveyed buildings and the reference they have been given for the purpose of this report.

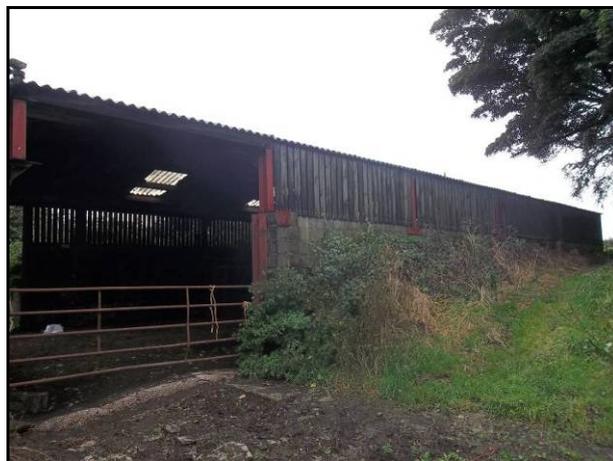
3.4.1.2. The photograph below shows Building 1 from the north looking to the west.

3.4.1.1. Building 1 comprises a two storey metal and wood framed cattle shed. The lower section of the wall comprises breeze blocks with vertical wooden boards on the upper section. The roof comprises a single pitch covered with corrugated cement sheets and cement sheet ridge tiles.

3.4.1.3. There were no bat field signs identified internally or externally in this building during this survey. This building will not provide a suitable habitat for roosting bats.

3.4.1.4. This building is to remain after works are complete.

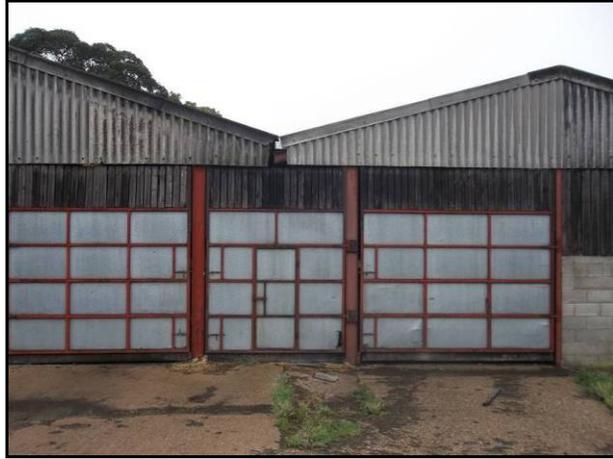
3.4.2.2. The photograph below shows Buildings 2 looking from the south.

3.4.2.1. Building 2 comprises a two storey metal and wood framed cattle shed. The lower section of the wall comprises breeze blocks with vertical wooden boards on the upper section. The roof comprises two pitches covered with corrugated cement sheets and cement sheet ridge tiles.

3.4.2.3. There were no bat field signs identified internally or externally in this building during this survey. This building will not provide a suitable habitat for roosting bats.

3.4.2.4. This building is to remain after works are complete.

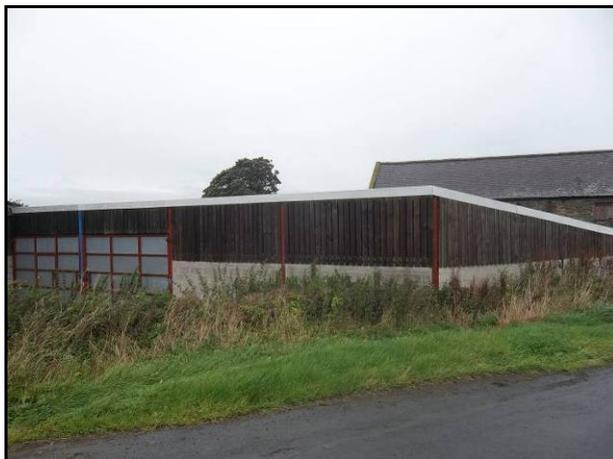
3.4.3.2. The photograph below shows Building 3 looking from the south.

3.4.3.1. Building 3 comprises a two storey metal and wood framed cattle shed. The lower section of the wall comprises breeze blocks with vertical wooden boards on the upper section. The roof comprises a lean to which is covered with corrugated metal and cement sheets.

3.4.3.3. There were no bat field signs identified internally or externally in this building during this survey. This building will not provide a suitable habitat for roosting bats.

3.4.3.4. This building is to be removed as part of the works.

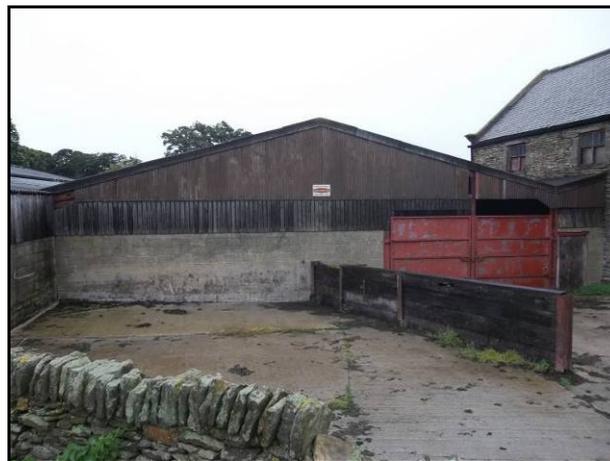
3.4.4.2. The photograph below shows Building 4 looking from the south.

3.4.4.1. Building 4 comprises a two storey metal and wood framed cattle shed. The lower section of the wall comprises breeze blocks on three elevations with a pointed stone wall on the northern elevation. The upper section is then covered with vertical wooden boards. The roof comprises a single pitch covered with corrugated cement sheets and cement sheet ridge tiles.

3.4.4.3. There were no bat field signs identified internally or externally in this building during this survey. This building will not provide a suitable habitat for roosting bats.

3.4.4.4. This building is to be removed as part of the works.

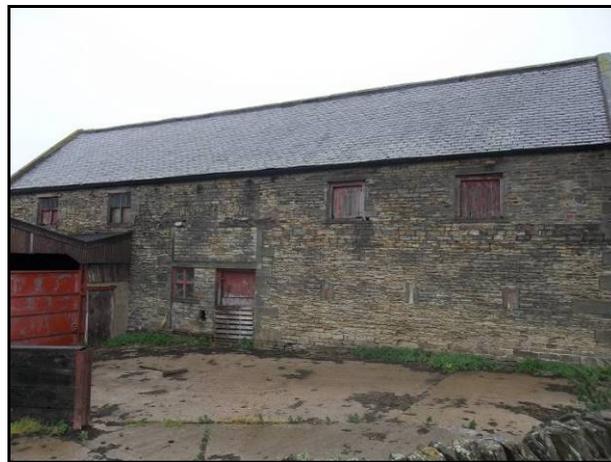
3.4.5.2. The photograph below shows Building 5 looking from the west.

3.4.5.1. Building 5 is a stone built, two storey barn with a mezzanine floor in the northern elevation. There are areas of missing mortar between the stonework and some areas of deteriorating stone. The roof is a single pitch with a king post timber roof structure with wooden rafters, which is not lined and is covered with tight fitting blue slate. The roof has stone ridge tiles with some areas of missing mortar on both sides. The gable ends are finished with stone coping stones on the northern and southern elevations.

3.4.5.3. There were no bat field signs identified internally or externally in this building during this survey. There is a low probability that this building will provide a suitable habitat for roosting bats.

4.5. Building 5 presents low level of potential for roosting bats as the stone work and pointing is deteriorating providing gaps and crevices for bats to roost.

5.1. Building 5 should have a bat dusk emergence survey carried out between May and September, weather dependant. This survey should be carried out prior to works commencing on this building.

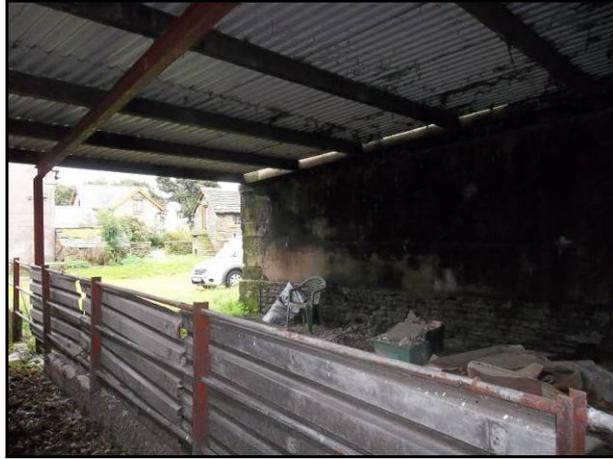
3.4.6.2. The photograph below shows Building 6 looking internally from the west.

3.4.6.1. Building 6 comprises a single storey metal and wood framed shelter. The shelter spans from the northern elevation of Building 5 and the western elevation of Building 7. The roof comprises a lean to which is covered with corrugated metal sheets.

3.4.6.3. There were no bat field signs identified internally or externally in this building during this survey. This building will not provide a suitable habitat for roosting bats.

3.4.6.4. This building is to be removed as part of the works.

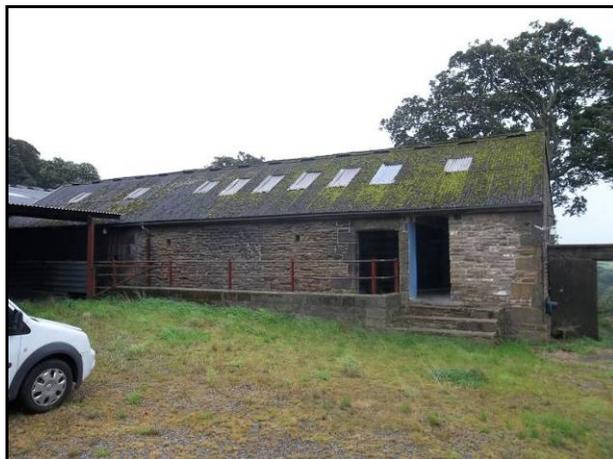
3.4.7.2. The photograph below shows Building 7 looking from the south.

3.4.7.1. Building 7 is a stone built single storey building. There are areas of missing mortar between the stonework and some areas of deteriorating stone. The roof comprises a single pitch and is lined with plastic sheeting and covered with corrugated cement sheets and cement sheet ridge tiles.

3.4.7.3. There were no bat field signs identified internally or externally in this building during this survey. This building will not provide a suitable habitat for roosting bats.

3.4.7.4. This building is to remain after works are complete.

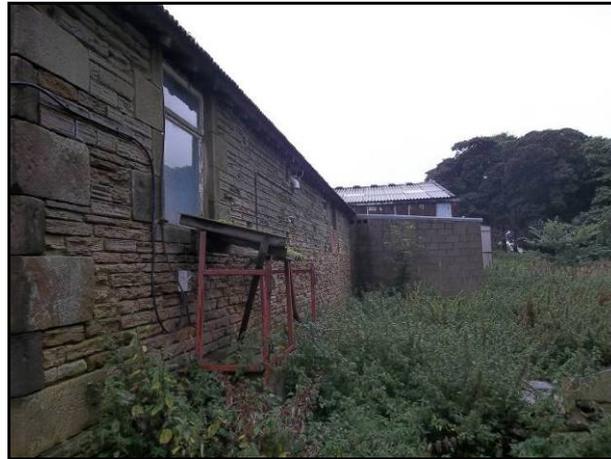
3.4.8.2. The photograph below shows Building 8 from the east.

3.4.8.1. Building 8 comprises a single storey building with breeze block walls. The shelter extends from the northern elevation of Building 7. The roof comprises a wood framed lean to which is covered with corrugated metal sheets.

3.4.8.3. There were no bat field signs identified internally or externally in this building during this survey. This building will not provide a suitable habitat for roosting bats.

3.4.8.4. This building is to be removed as part of the works.

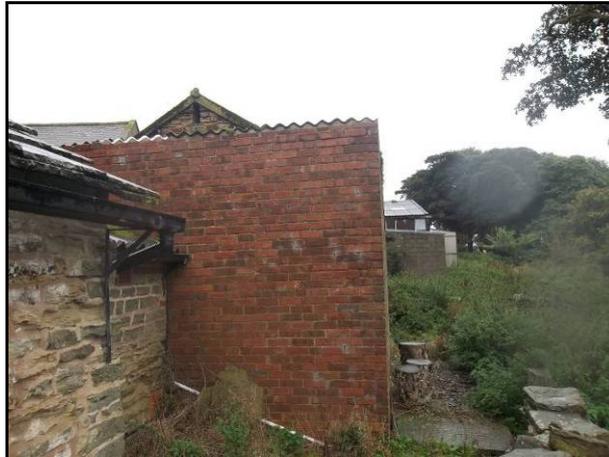
3.4.9.2. The photograph below shows Building 9 from the east.

3.4.9.1. Building 9 comprises a single storey building with red brick walls. The pointing is all intact between the brickwork and around the edge of the roof covering. The roof comprises a wood framed, lean to, which is covered with corrugated cement sheets.

3.4.9.3. There were no bat field signs identified internally or externally in this building during this survey. This building will not provide a suitable habitat for roosting bats.

3.4.9.4. This building is to be removed as part of the works.

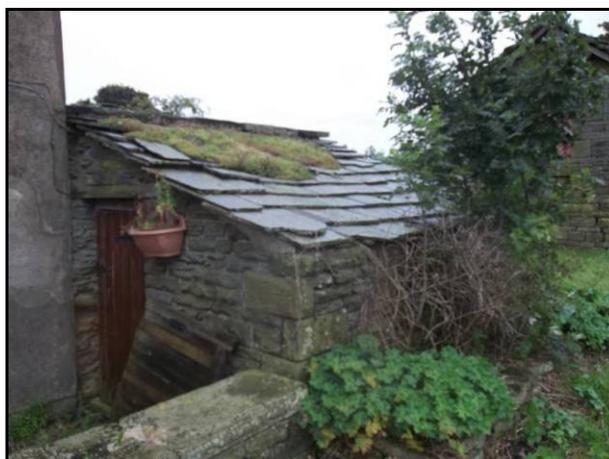
3.4.10.2. The photograph below shows Building 10 looking from the north.

3.4.10.1. Building 10 is a stone and brick built single storey building. The walls are pointed and in a reasonable condition. The roof comprises a single pitch which is not lined and is covered with stone roof tiles which have gaps between due to the shape and fit of the tiles with stone ridge tiles, which have missing mortar on both elevations.

3.4.10.3. There were no bat field signs identified internally or externally in this building during this survey. This building will not provide a suitable habitat for roosting bats.

4.3. Building 10 and 11 are both deteriorating with missing pointing in the stone walls. However, these gaps could be examined and will not provide a suitable habitat for roosting bats.

3.4.10.4. This building is to remain after works are complete.

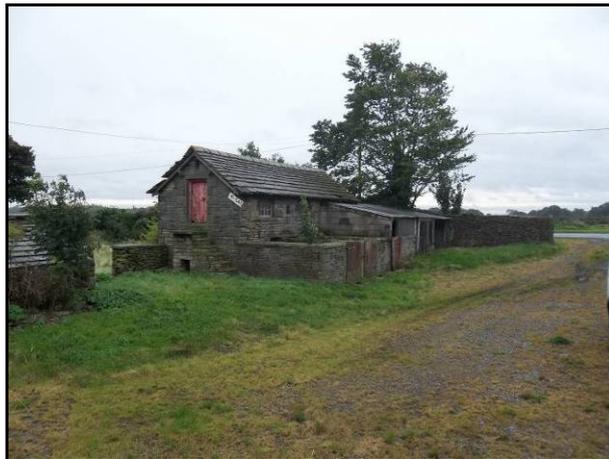
3.4.11.2. The photograph below shows Building 11 looking from the north.

3.4.11.1. Building 11 is a two storey stone building. The walls are pointed and in a reasonable condition. The roof comprises a pitched roof, which is not lined and is covered with stone roof tiles, which have gaps between due to the shape and fit of the tiles with stone ridge tiles and which have missing mortar on both elevations.

3.4.11.3. There were no bat field signs identified internally or externally in this building during this survey. This building will not provide a suitable habitat for roosting bats.

3.4.11.4. This building is to remain after works are complete.

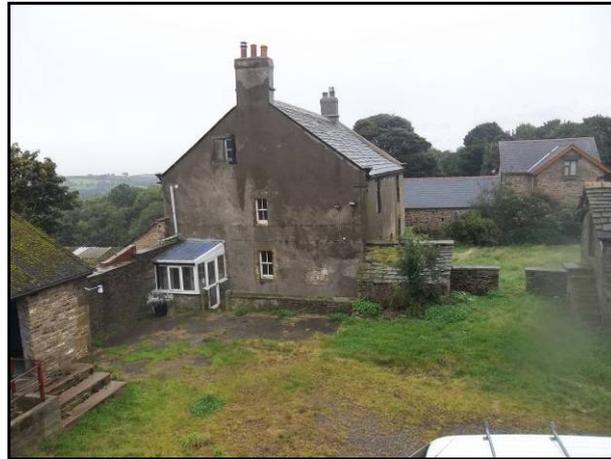
3.4.12.2. The photograph below shows Building 12 from the west.

3.4.12.1. Building 12 is a two storey farm house with rendered walls on all elevations and a pitched roof with a chimney on both the eastern and western gable end. The roof of the building is a wooden queen post design with wooden rafters. The roof is

not lined and is covered with blue slate, which is pointed internally. There are stone coping stones on both gable ends and stone ridge tiles, which are all recently pointed with no gaps or crevices.

3.4.12.7. There were no bat field signs identified internally or externally in this building during this survey. This building will not provide a suitable habitat for roosting bats.

3.4.12.8. This building is to be removed as part of the works.

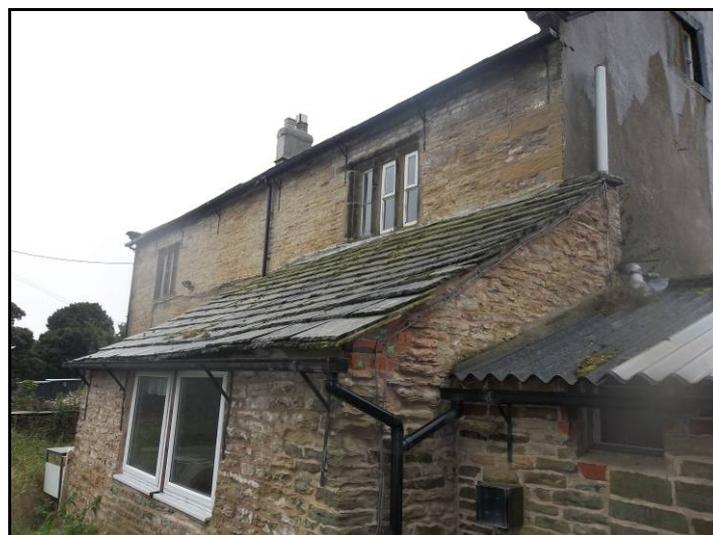
3.4.12.4. Below is a photograph of the single storey extension on the northern elevation of the building.

3.4.12.3. On the northern elevation of Building 12 there is a single storey extension with a lean to roof open to the rafters internally. The walls comprise stone which has been recently pointed leaving no gaps or crevices. The roof is covered with stone roof tiles with gaps between due to the shape and fit of the tiles. There is a small window at both the western and eastern gable end which provides large amounts of light into the loft space.

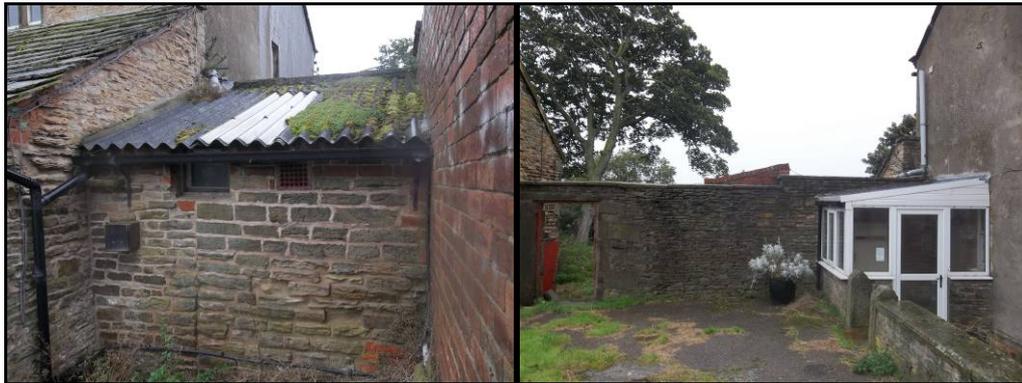
3.4.12.6. The photograph below on the left shows the northern elevation of the porch. The photograph on the right shows the southern elevation of the porch.

3.4.12.5. There is a single storey porch connecting Building 12 on the western elevation and Building 9 on the eastern elevation. The walls comprise stone, which has been recently pointed leaving no gaps or crevices. The roof of the building is covered with corrugated cement sheets on the northern elevation and polycarbonate on the southern aspect.
