Bat Survey

Furlong Road Methodist Church, Bolton

Survey site:
Furlong Road Methodist Church
Bolton upon Dearne
Barnsley.

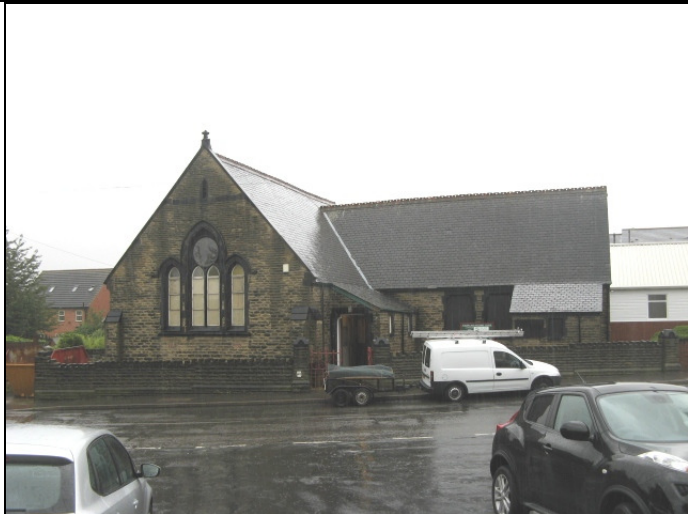
Front of the church.

Right of the red line indicates the
section of the building that is to
be demolished.

It is therefore recommended that a further examination is made by a suitably qualified ecologist just prior to the removal of the interior sections of the roof and when scaffold is erected to remove the roof tiles. If bats are not found then work can then proceed with care. Roof tiles are to be removed carefully by hand. Builders carrying out this work must be made fully aware of their responsibility if they encounter roosting bats. It is always stressed that in the event that bat/s are found within the structure of the building while work is in progress, work should stop immediately in that area and advice sought from an ecological consultant or Natural England.

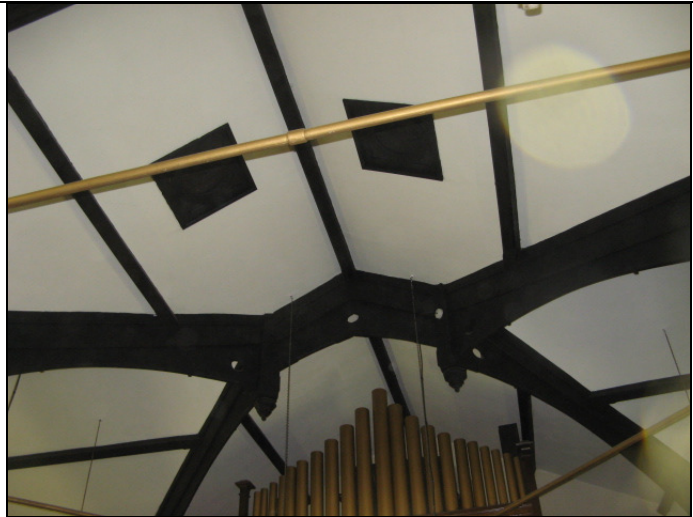
Interior of the room to be demolished.

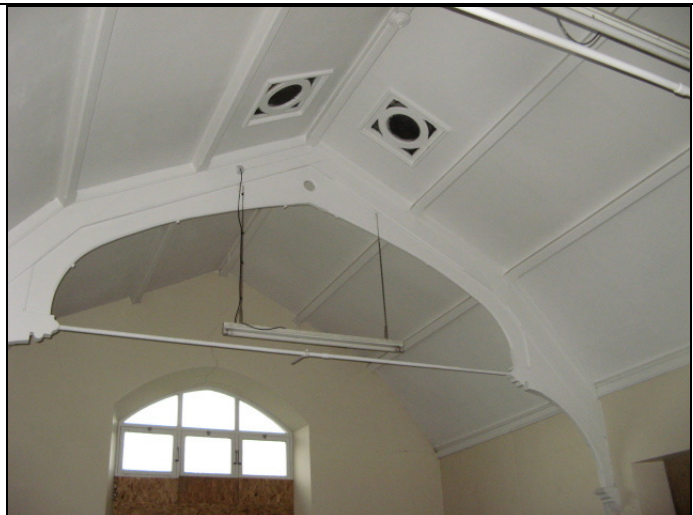
Very high ceilings in the room to be demolished.

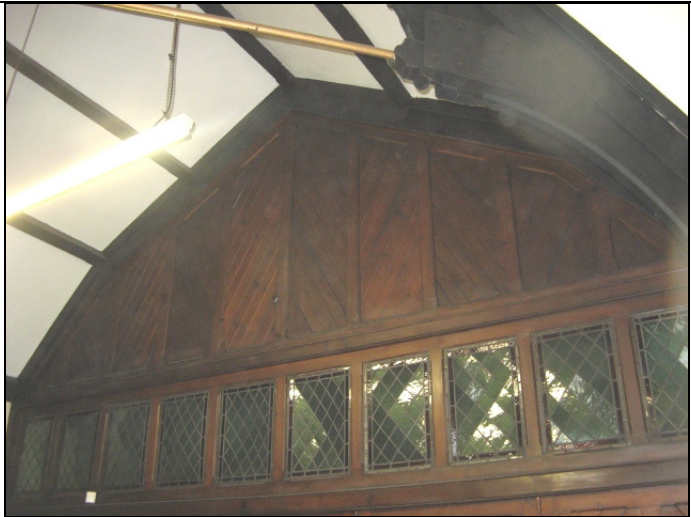
Small access hatch into the roof space.
There was no access into the roof space due to the height of the access hatch above the ground level.

The high ceiling indicates that there is only a small area of roof space.

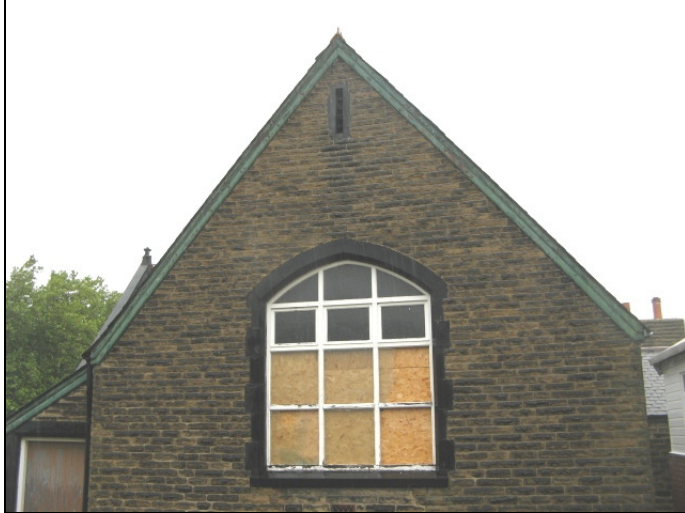
Rear of the church.
This section of the church is to remain intact.

This area of the church roof cannot be altered in any way without a Natural England mitigation bat license.

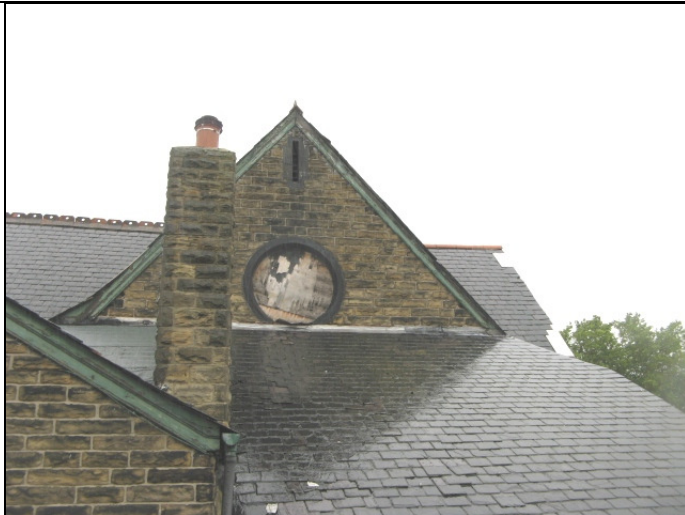
Rear of the church.
Yellow arrows pointing to areas where bats were seen to leave or enter the building (information received from Karen Larkin).

Information received from Karen Larkin. Bat survey carried out on 21st August 2012. Four common pipistrelle (*Pipistrellus pipistrellus*) were seen flying around the church. One of these was seen to emerge from the rear of the church via a fascia and another was observed entering the building at the rear of the church via a slit opening at the top of the building.

After the section of the church has been demolished there are plans to sell the rest of the church so it can be used as a living accommodation. The rear of the church is a recognized bat roost.
