Former Carlton Colliery Barnsley

Enabling Works Remedial Implementation Plan

Document Ref: 173367/RIP/001

**Former Carlton Colliery,
Shaw Lane,
Carlton,
Barnsley
S71 3HJ**

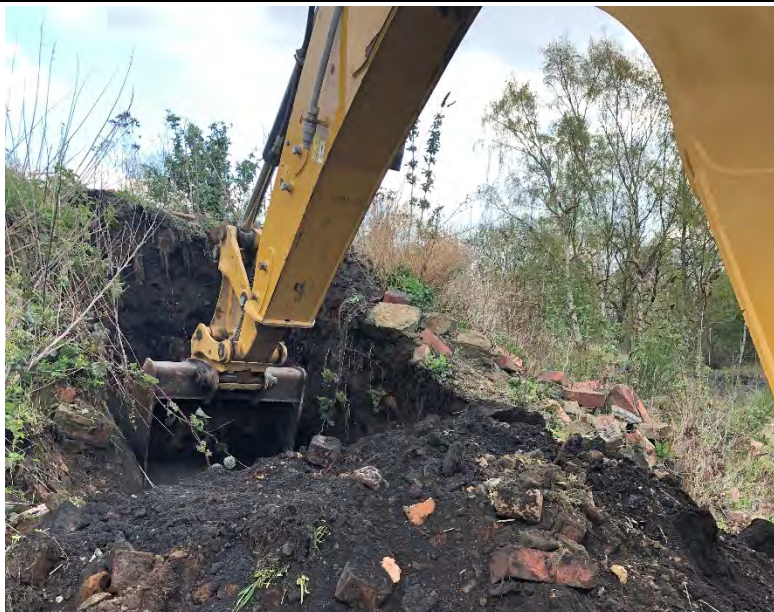
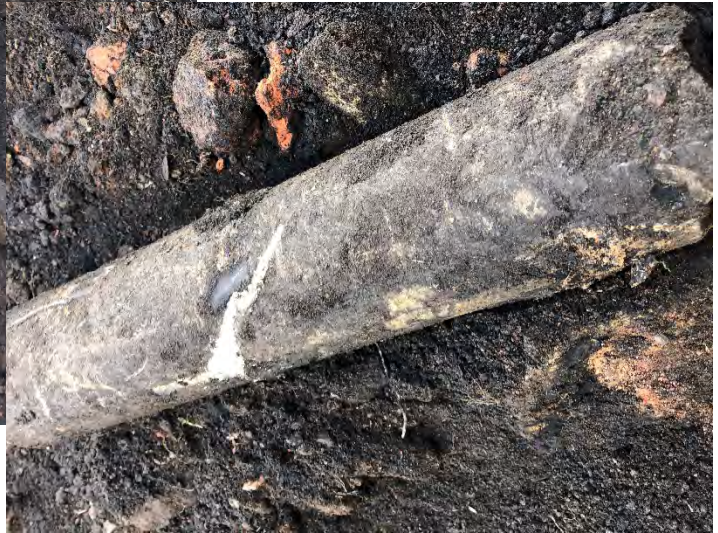
Stockpile SP1
 Mixed ash and brick and pipe
 Potential ACM noted within matrix

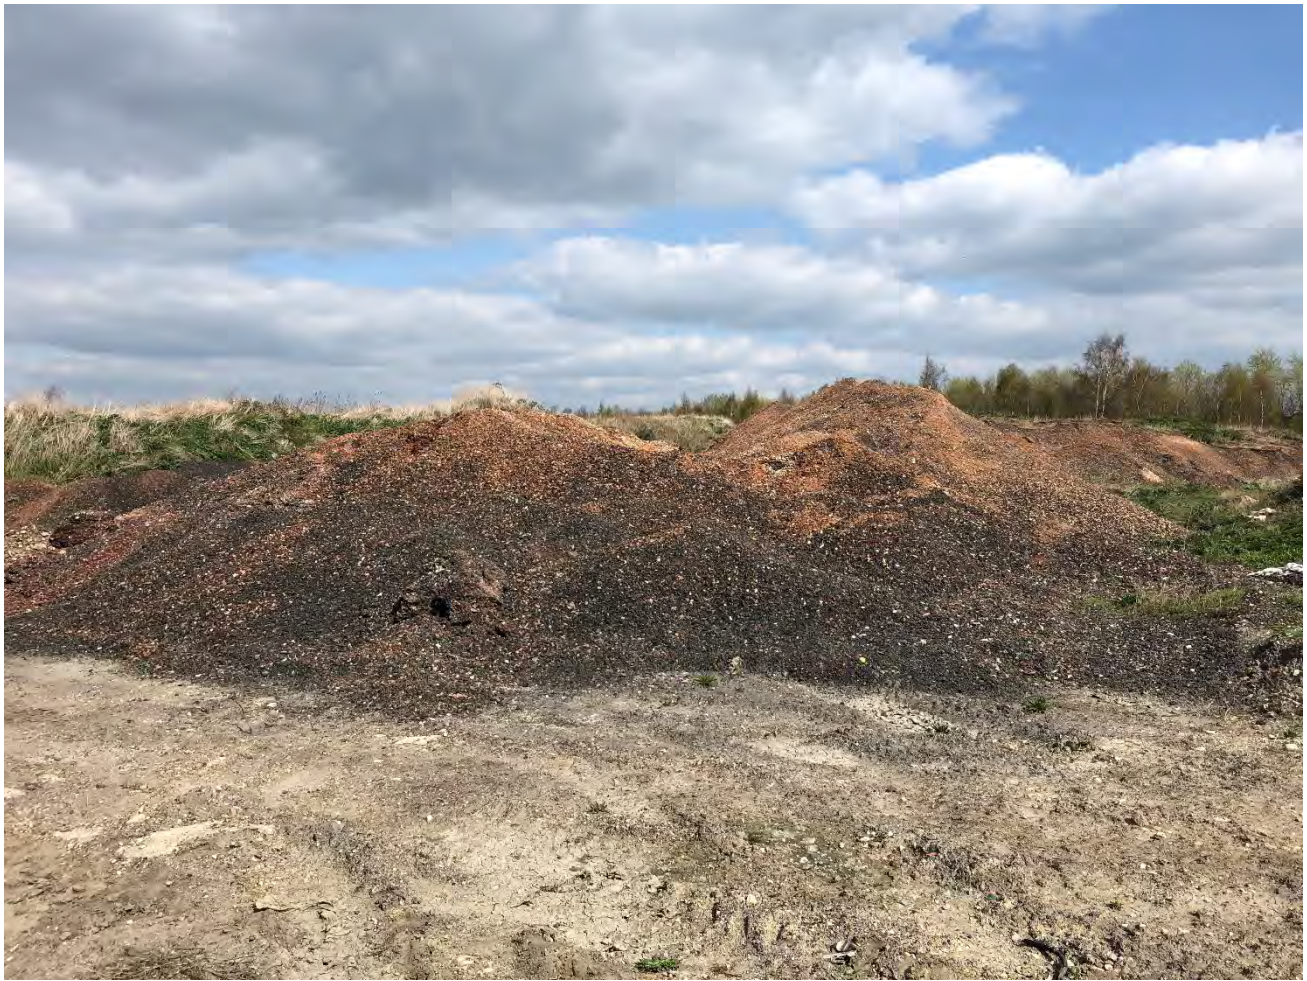
Comment
Mixed clinker and burnt shale

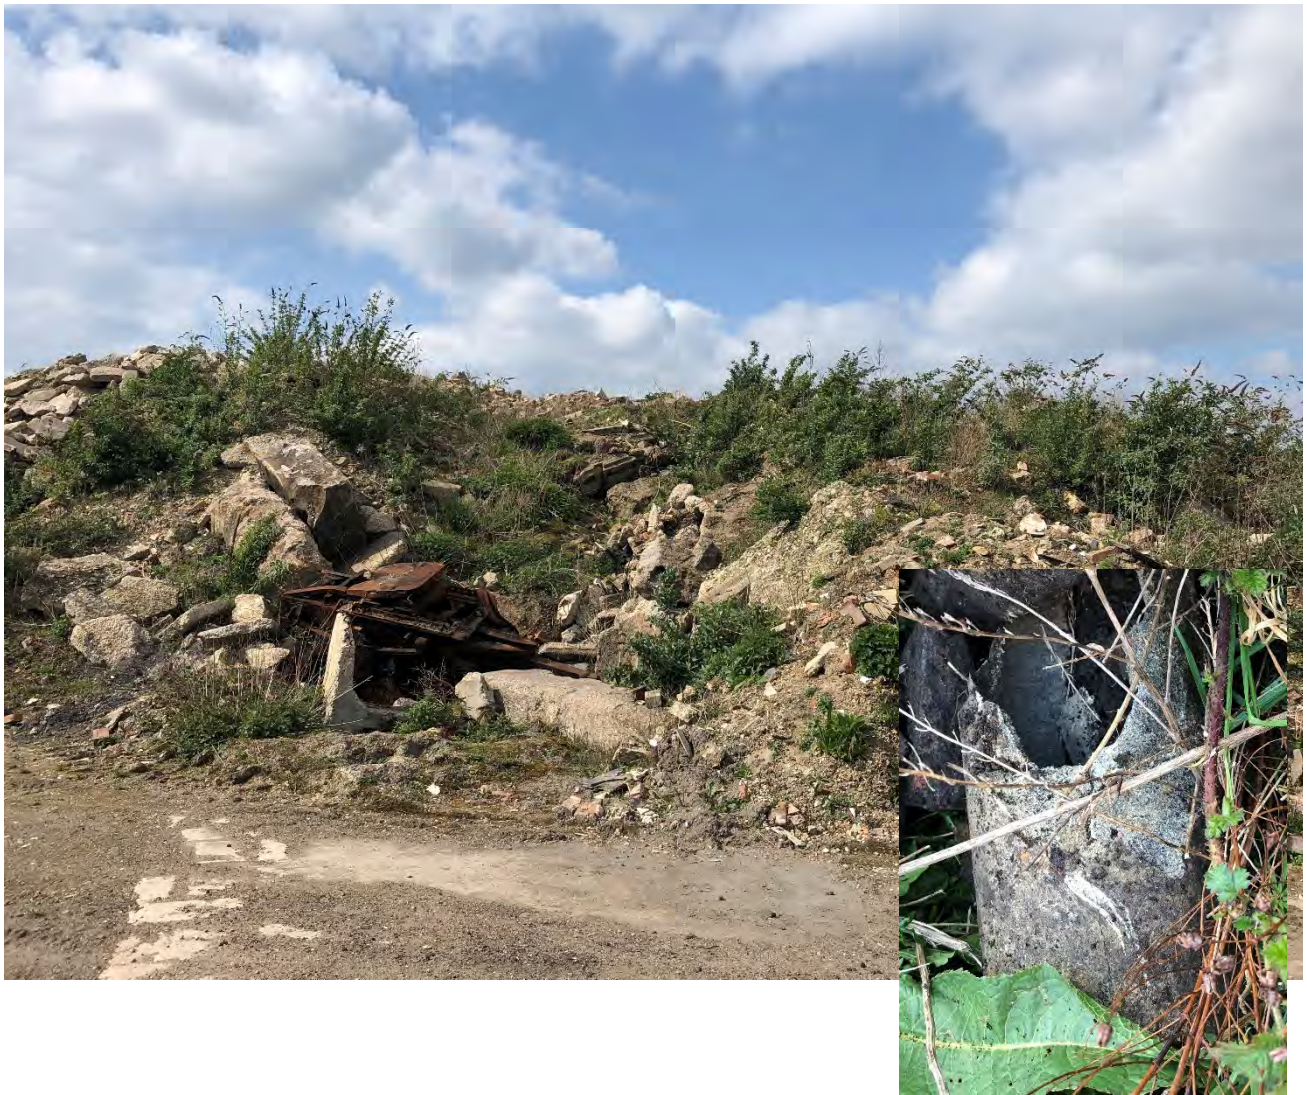
Demolition arisings
Identified potential ACM

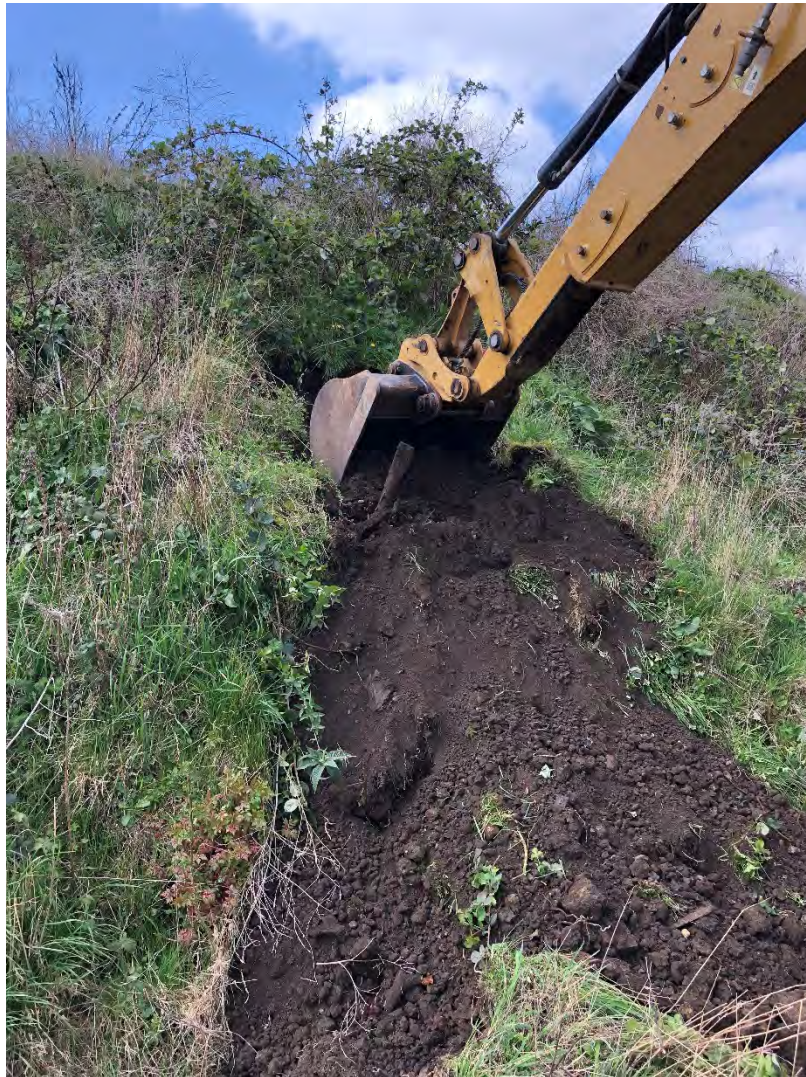
Material appears to be top and sub-soil with some Made Ground

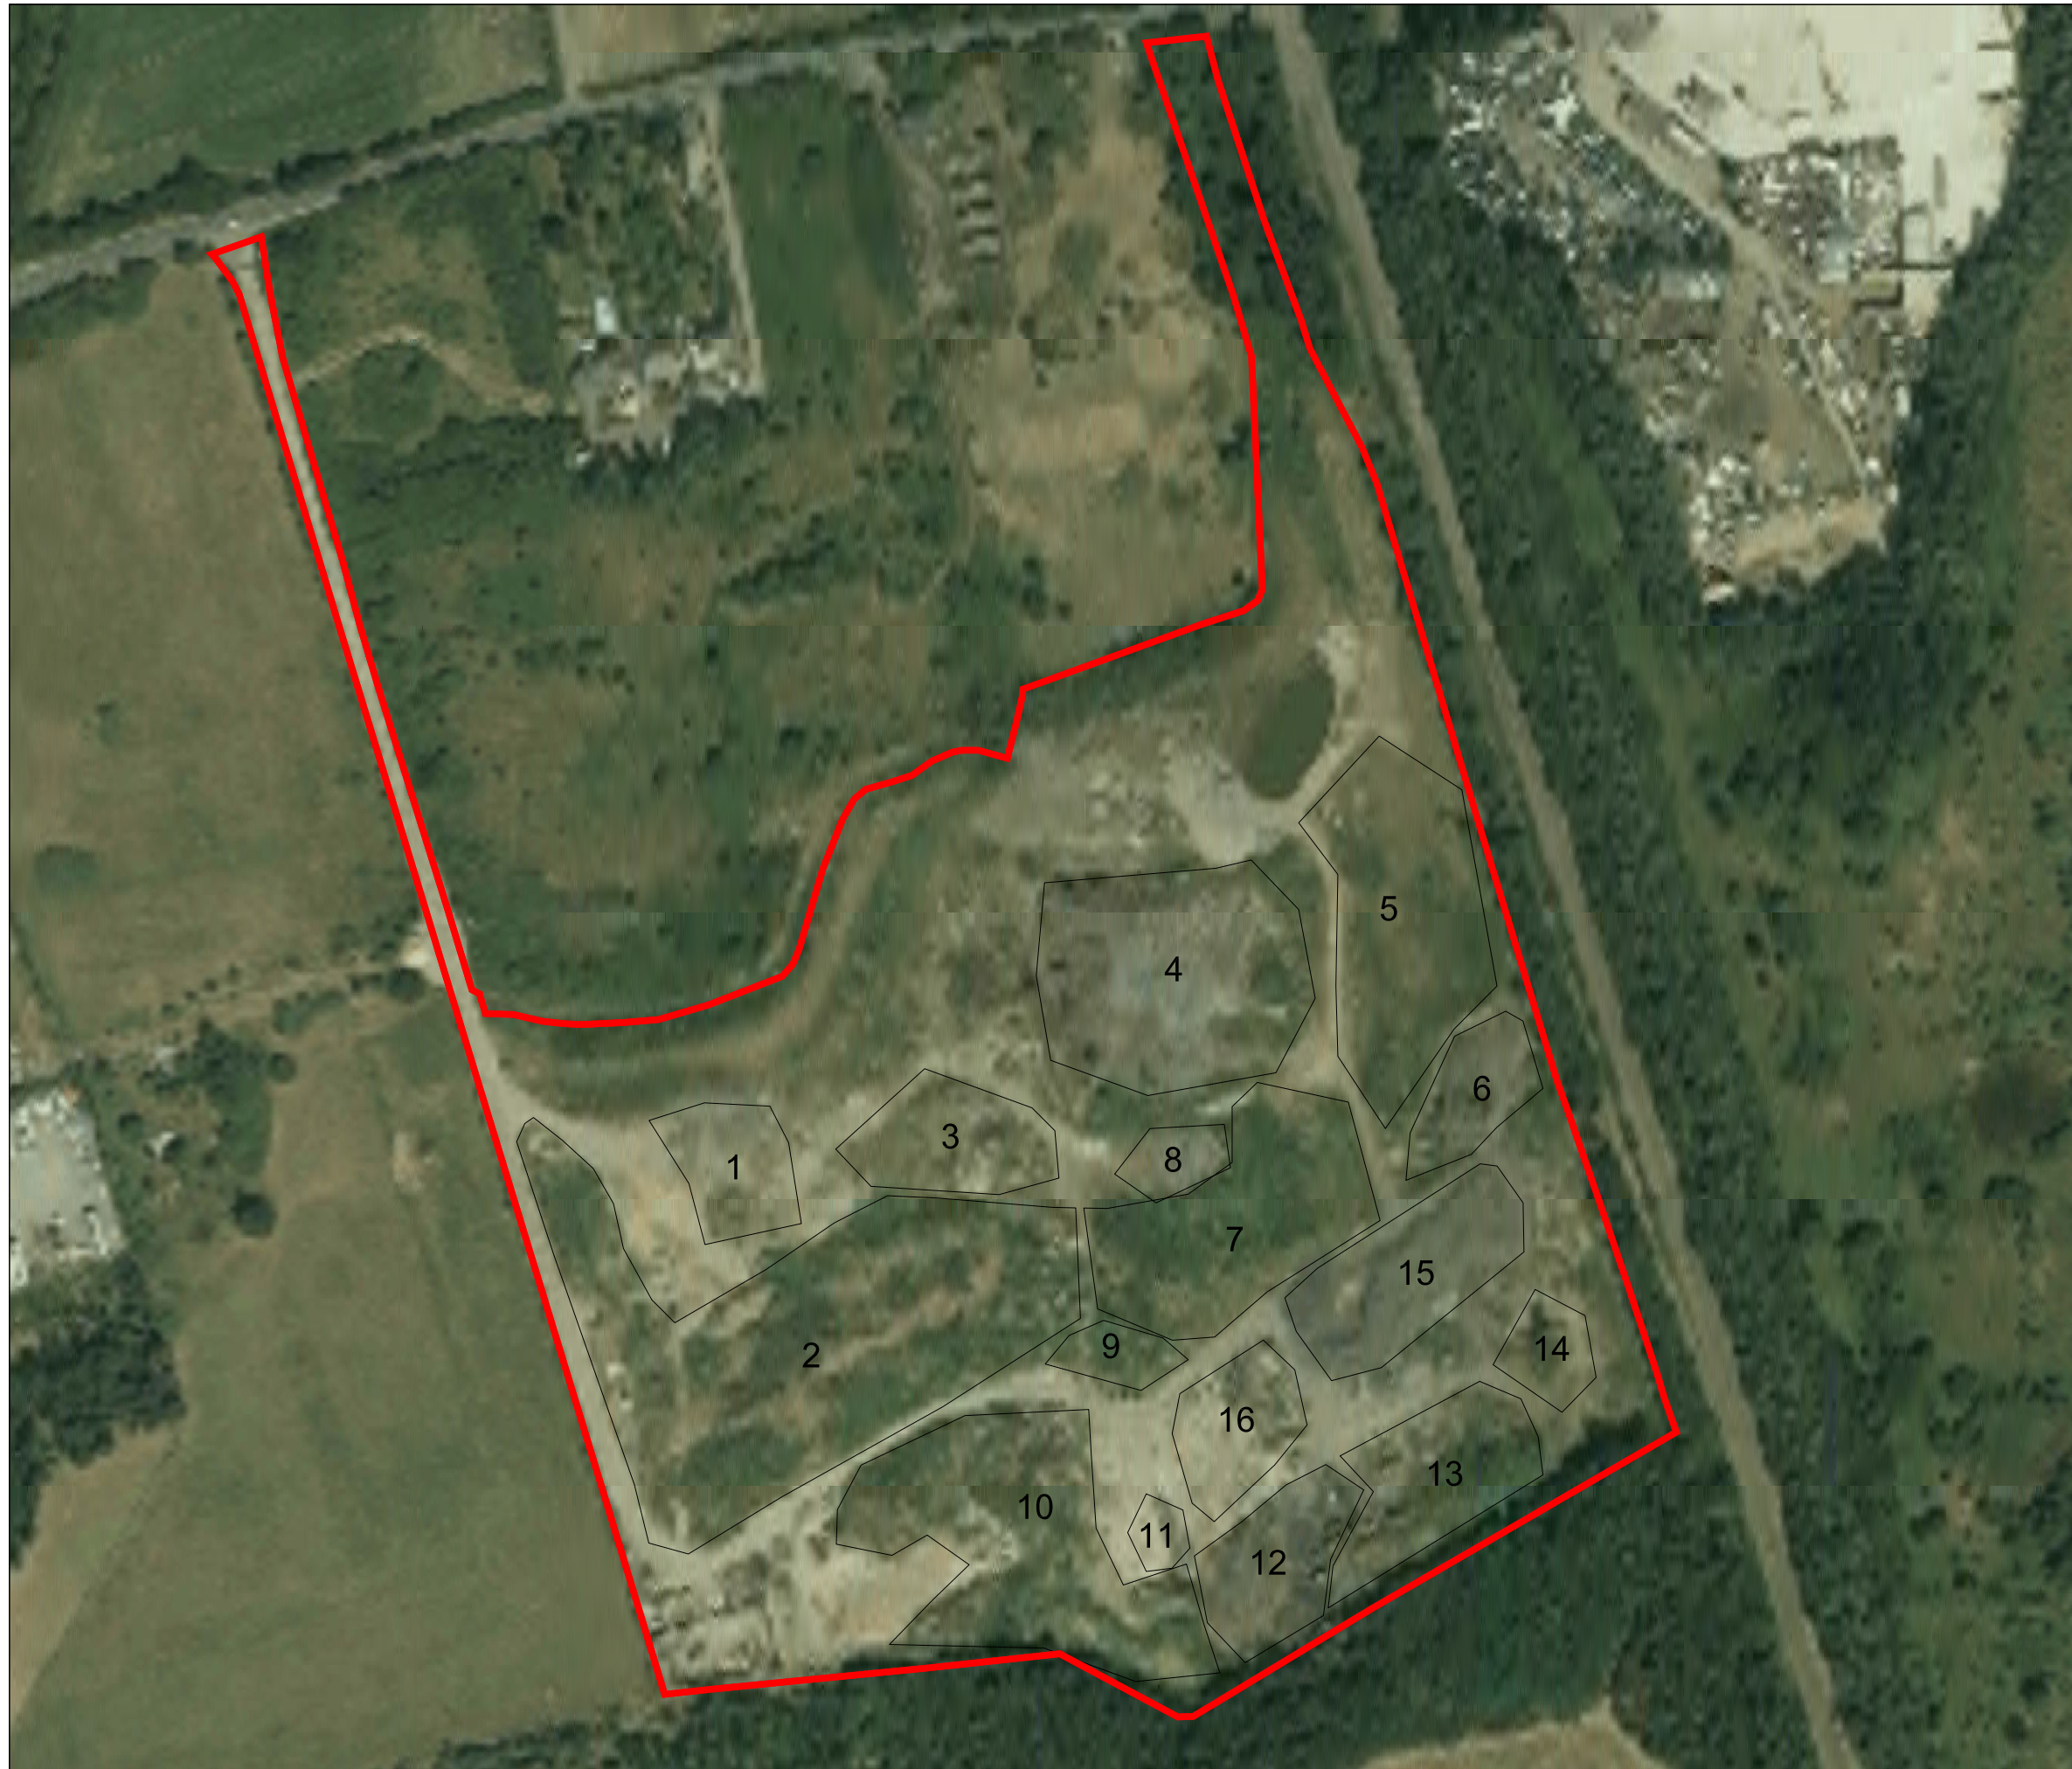
- Planning application boundary
- 1. Stockpile of brick and concrete.
- 2. Stockpile of Made Ground including brick, concrete and soil.
- 3. Stockpile of brick and concrete.
- 4. Black coal and clinker stockpile.
- 5. Stockpile of Made Ground from the remediation of the northern portion of the site prior to 2019.
- 6. Stockpile Made Ground from the remediation of the northern portion of the site prior to 2019.
- 7. Stockpile of Made Ground including brick, concrete and soil.
- 8. Stockpile of concrete and brick.
- 9. Stockpile of Made Ground including brick, concrete and soil.
- 10. Demolition Arisings.
- 11. Stockpile of Made Ground.
- 12. Demolition Arisings.
- 13. Demolition Arisings.
- 14. Demolition Arisings.
- 15. Stockpile of mixed clinker and burnt shale.
- 16. Stockpile of concrete and brick.
