**GEO-ENVIRONMENTAL INVESTIGATION  
REPORT  
For  
THE HABIB BANK  
On a Site at  
FORMER WILLIAM FREEMANS FACTORY,  
WAKEFIELD ROAD, MAPPLEWELL, BARNSELY**

# THE HABIB BANK

**FORMER WILLIAM FREEMANS FACTORY,  
WAKEFIELD ROAD, MAPPLEWELL, BARNSELY**

| <b>JOB NUMBER: 12070197</b> | | <b>DOCUMENT REF: NLM/DRS/12070197.20070986</b> | | |

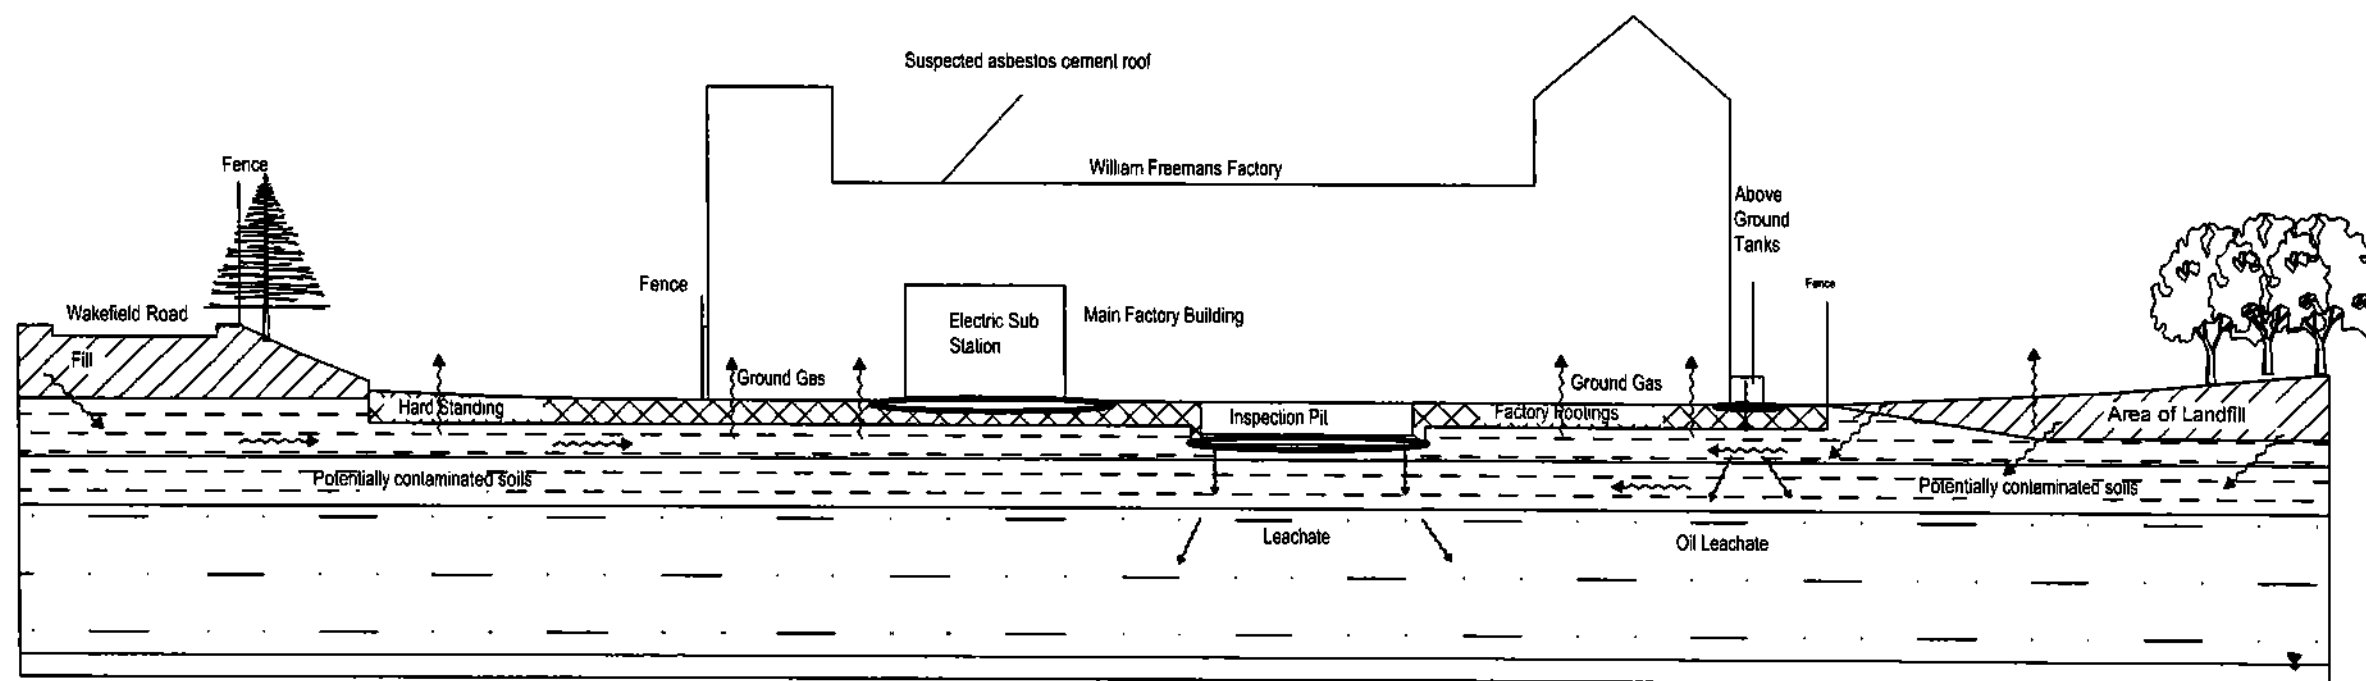
Existing Site Layout Showing Line of Section

Leachate

- 4.1.2 No potential **off site** sources of ground contamination have been identified.
- 4.1.3 A preliminary pre-development conceptual site model has been produced based on the suspected ground conditions from the desk study information only, which is presented on Drawing No. 12070197-504.

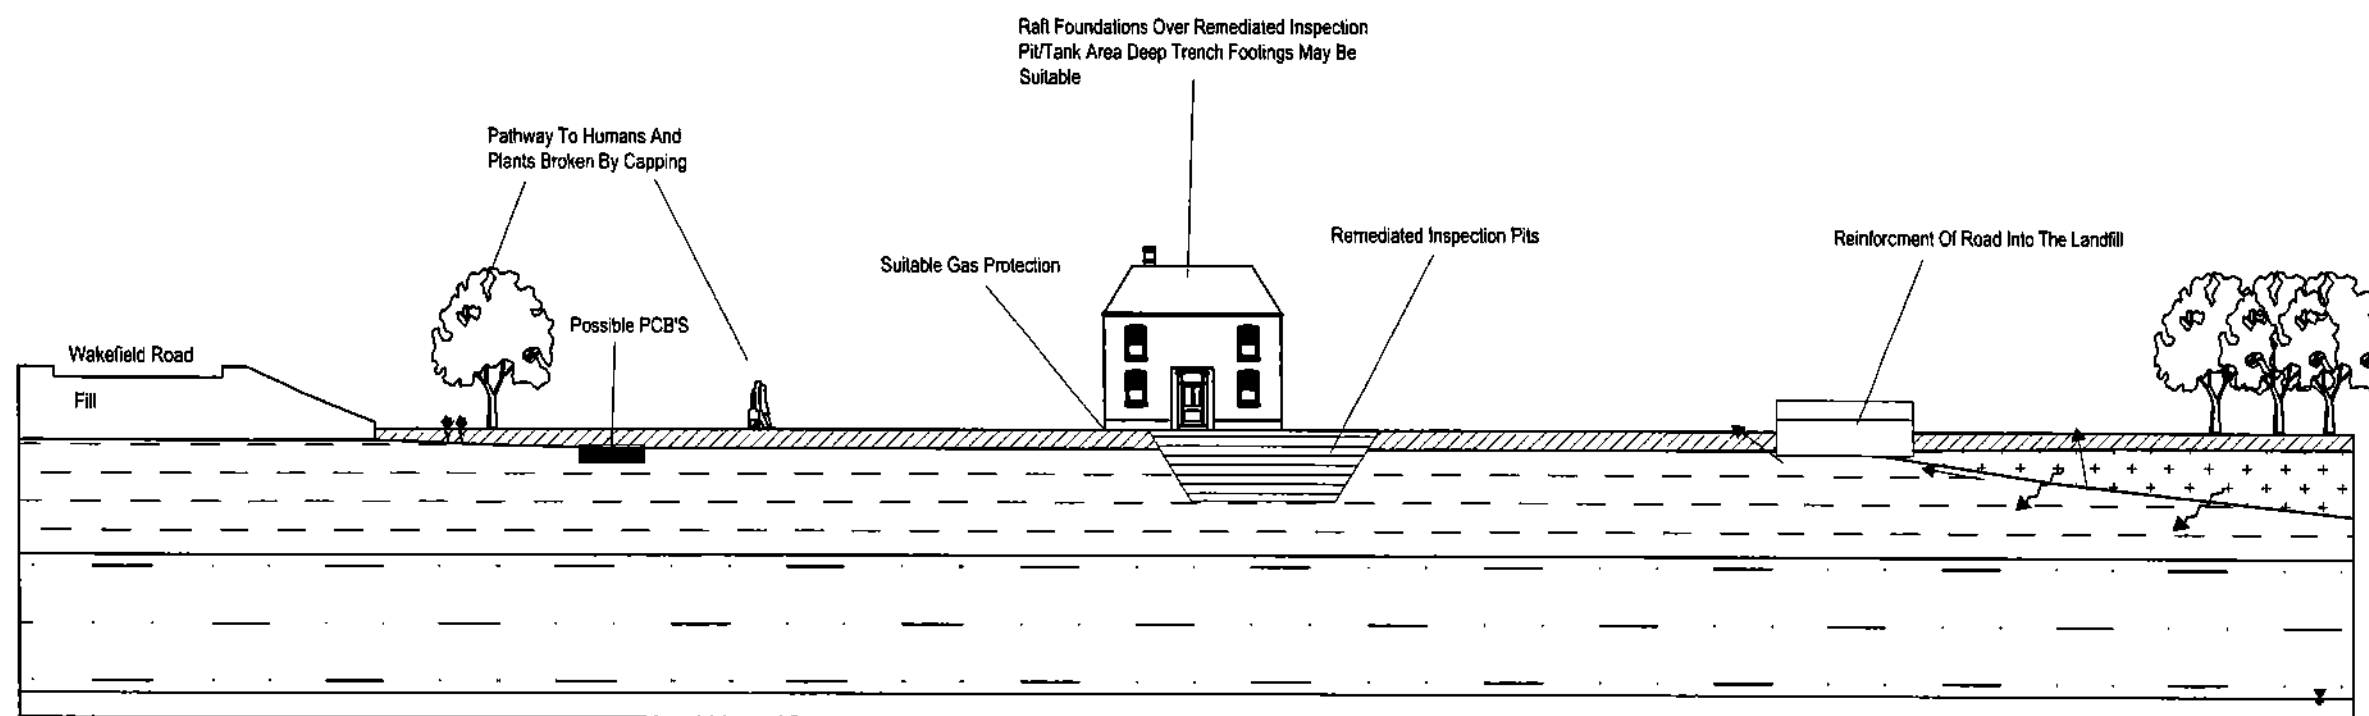
Existing Site Layout Showing Line of Section

Ground Gas
