## Proposed Drainage Strategy

PERSEVERANCE STREET, BARNSELY

CAIRNWELL DEVELOPMENTS LTD

**48063-ECE-XX-XX-RP-C-0001**

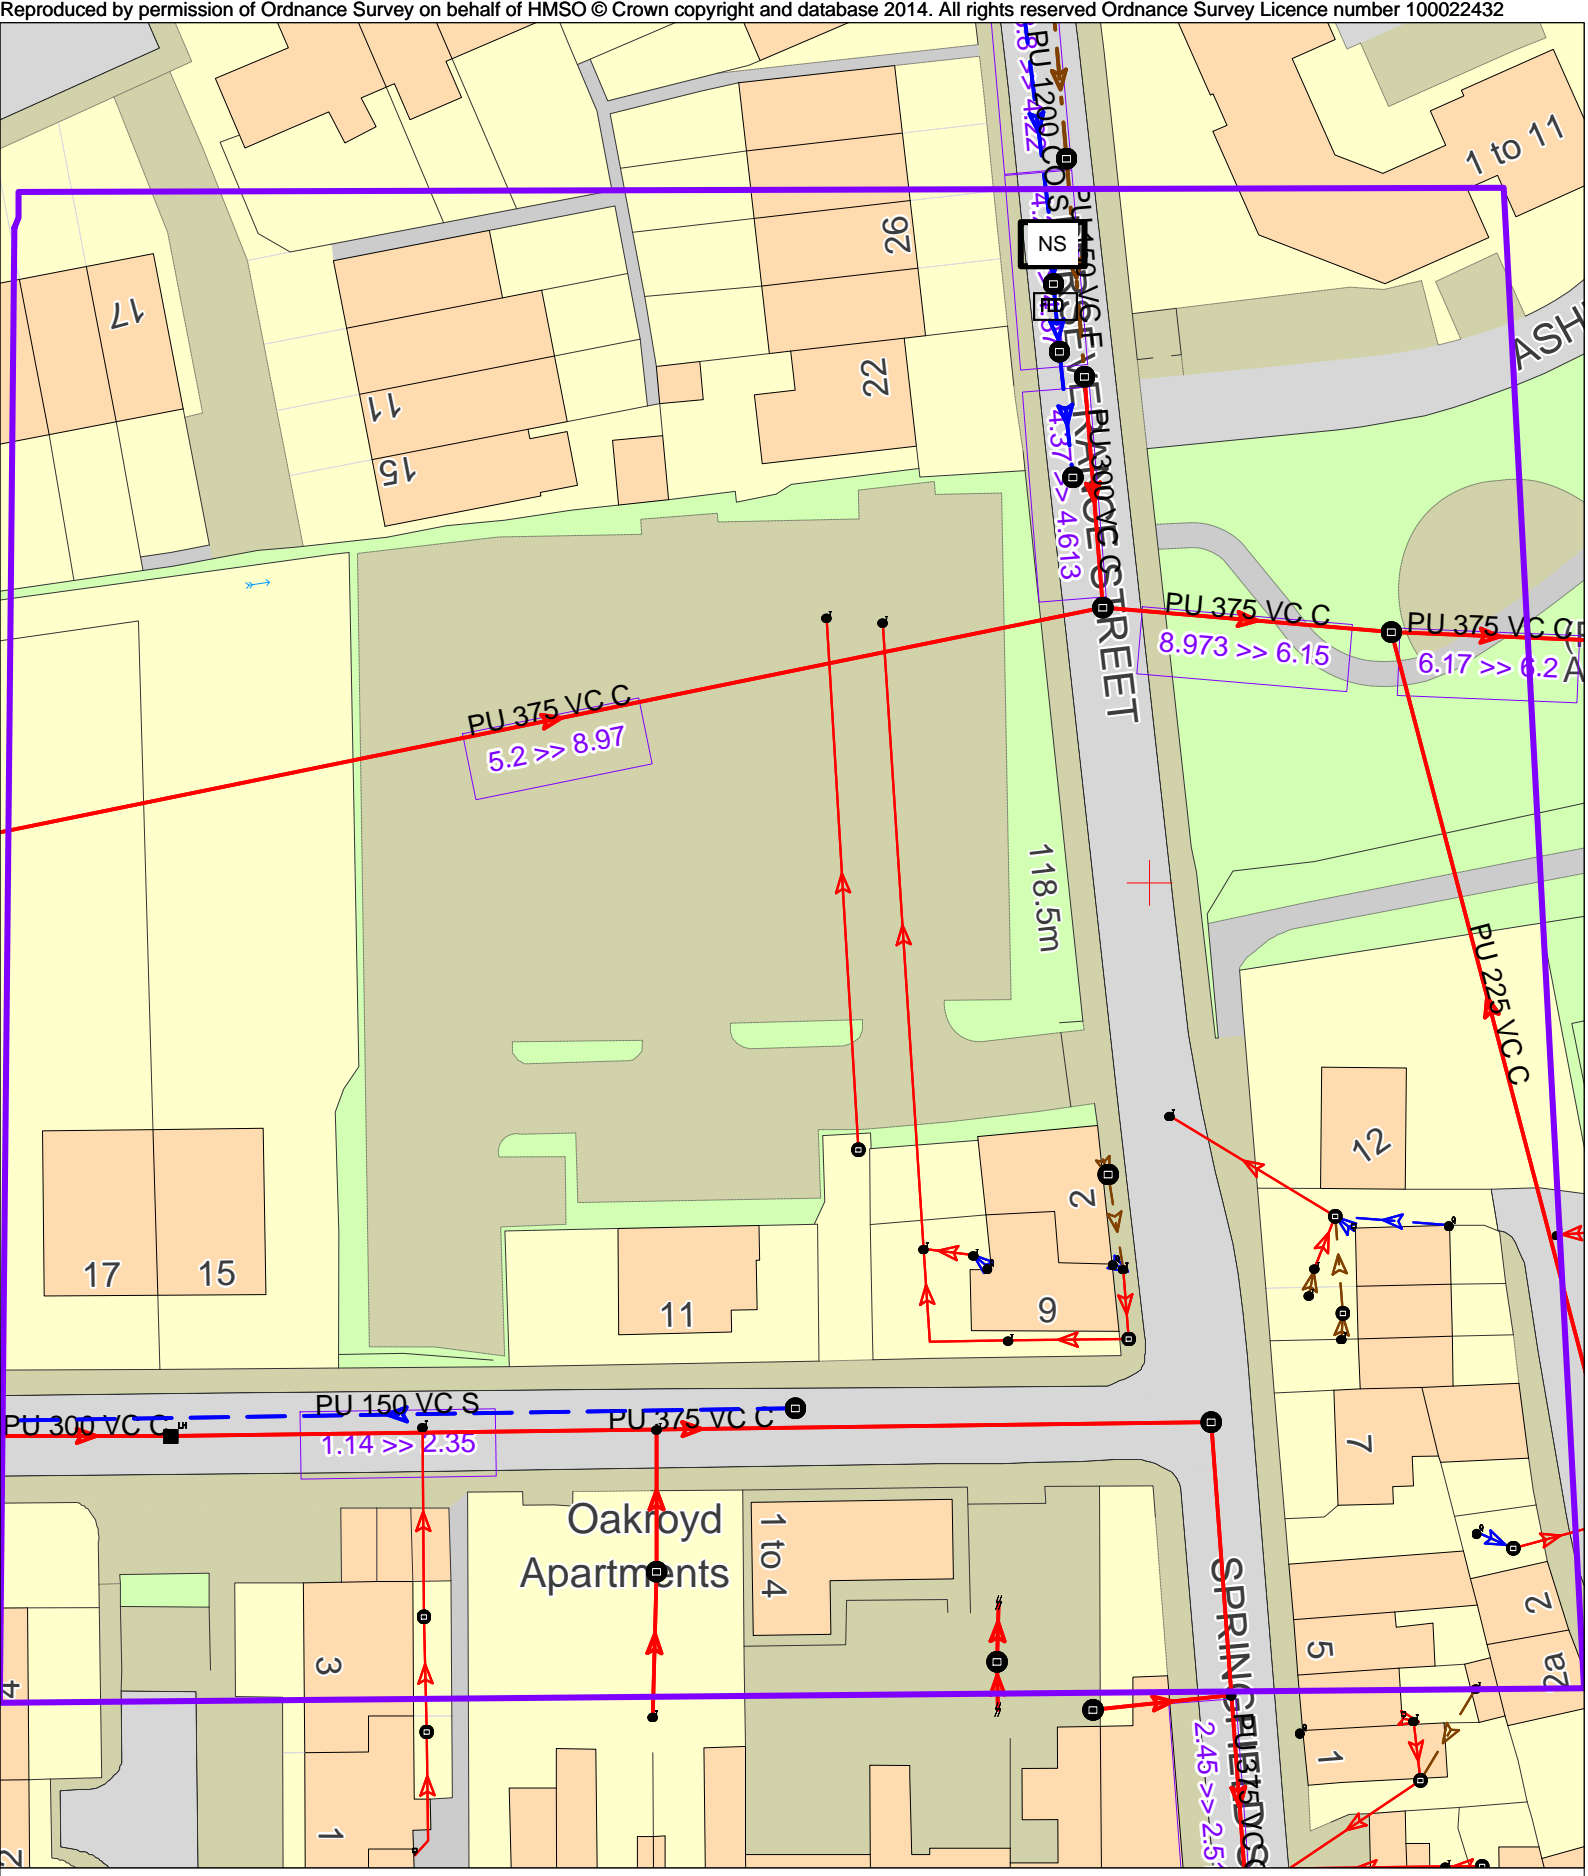
## APPENDIX 3

The appended Yorkshire Water record plan (Appendix 3) shows there to be combined sewers within the site as well as surface water and combined sewers within Perseverance Street to the east and Springfield Street to the south. The sewers within the site are a 375 dia. combined running west to east across the site and two combined sewers of an unknown size entering from the south and thought to discharge to the 375 dia. combined sewer.

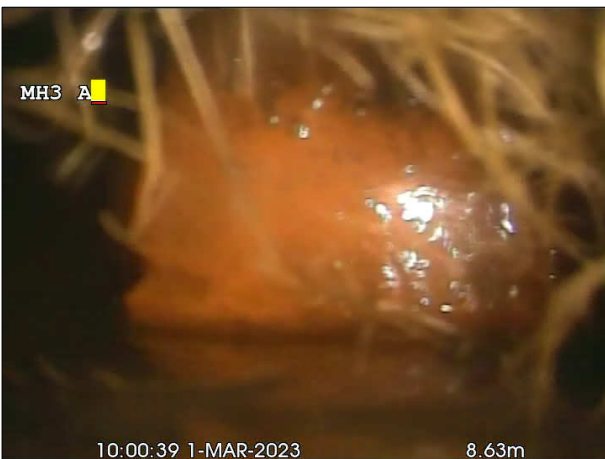
Photo: 3\_6a, 00:00:00  
7.5m, Obstruction, 80 % height/diameter loss

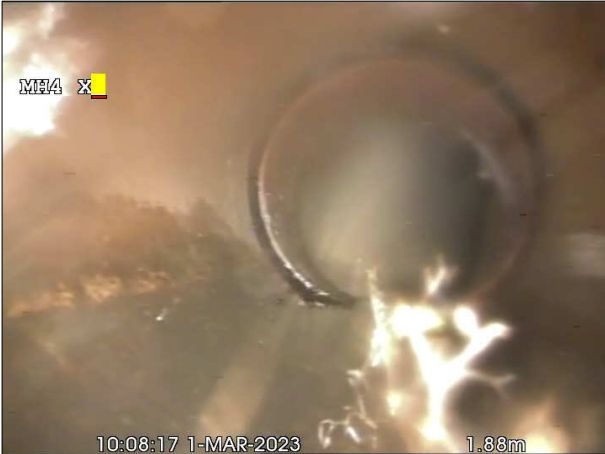
Photo: 42\_4a, 00:00:00  
1.9m, Joint displaced. Medium

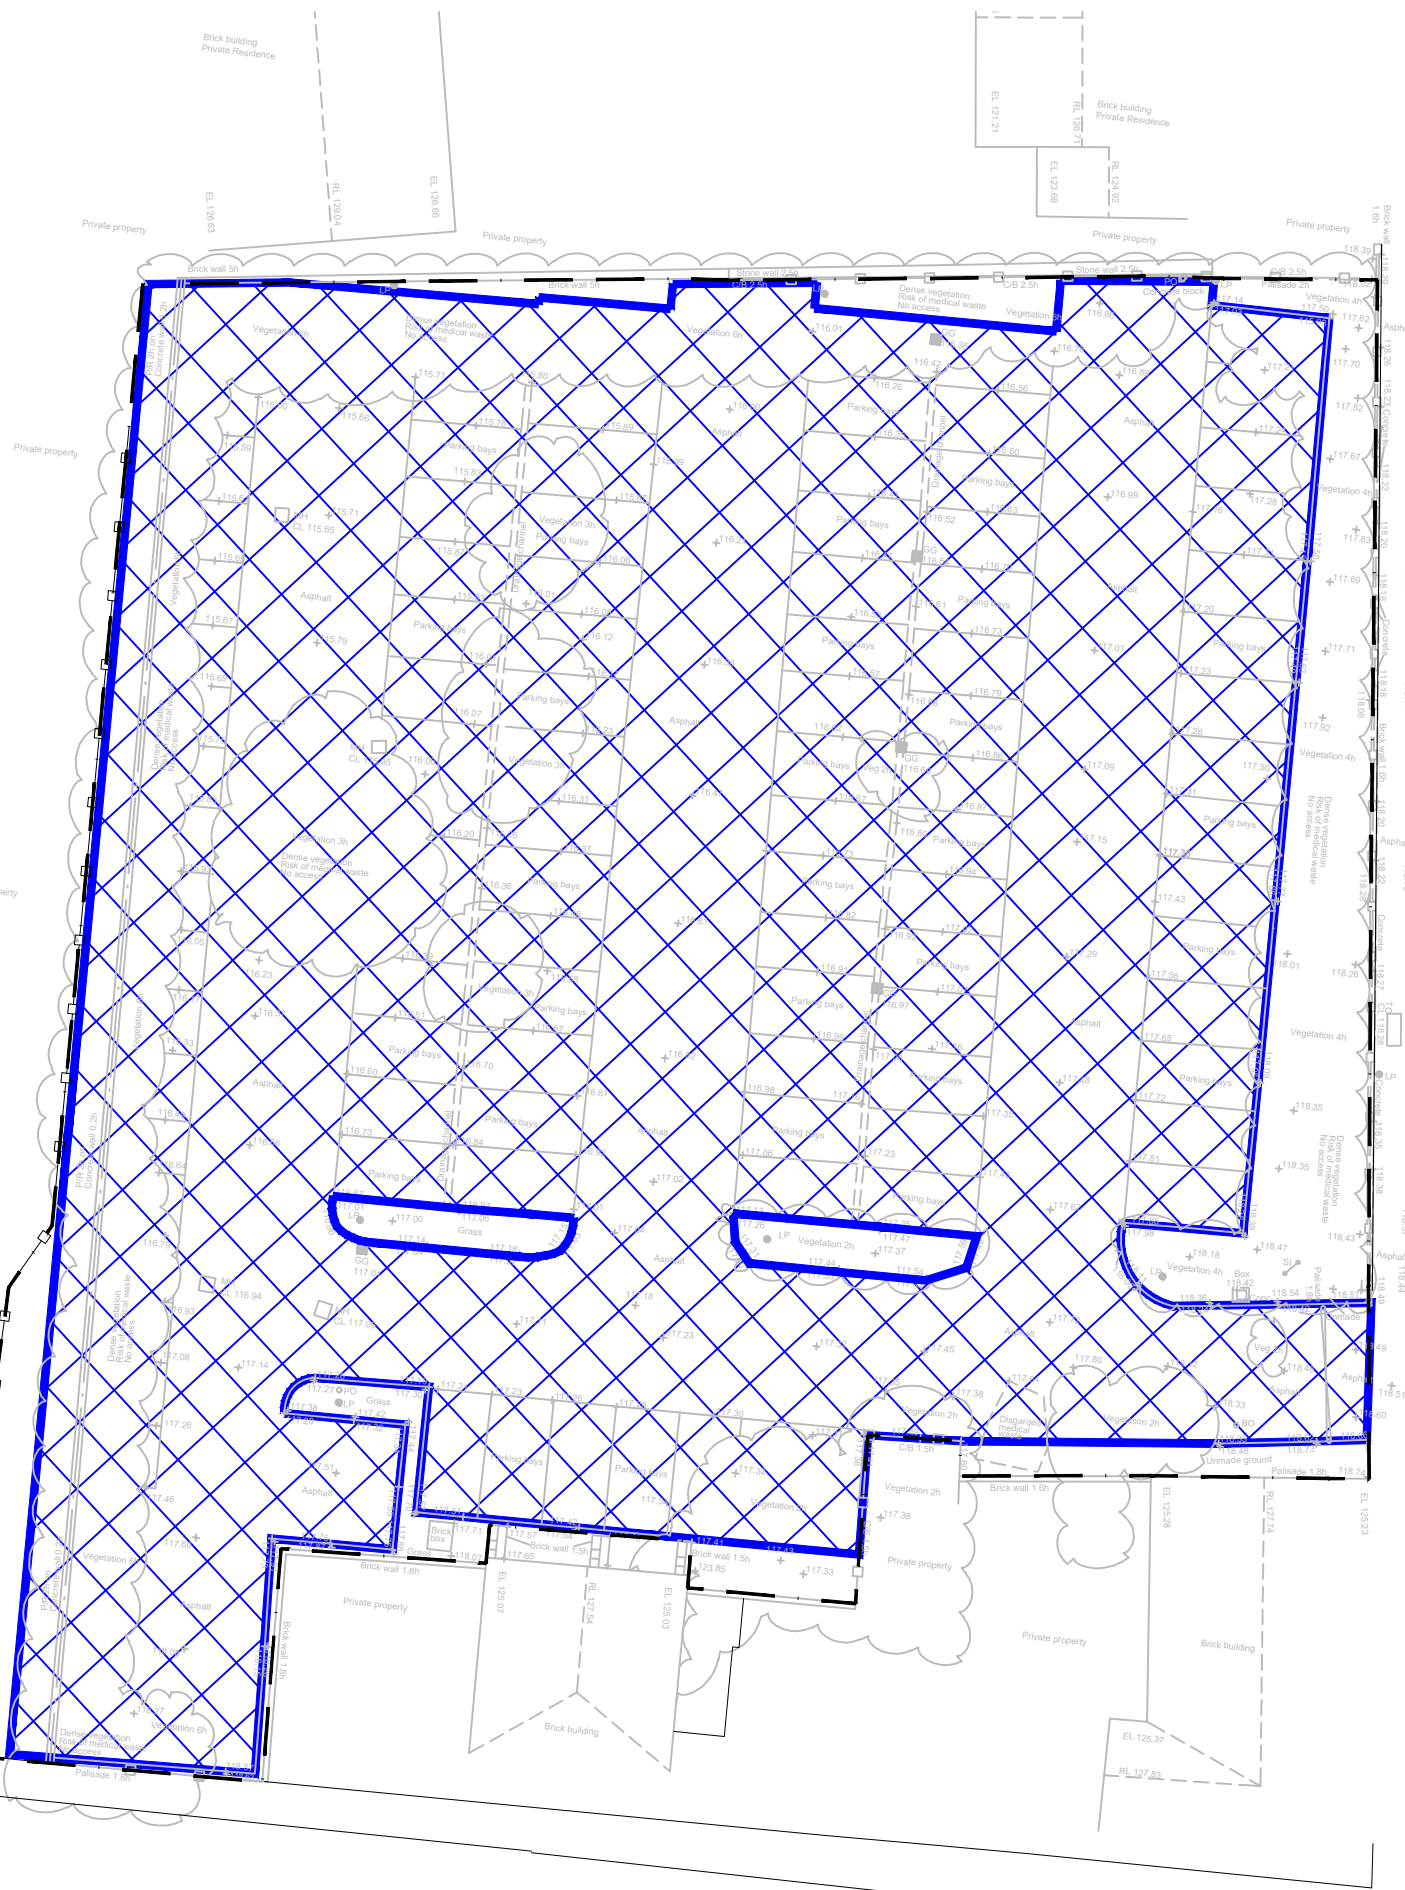
EXISTING IMPERMEABLE AREA  
POSITIVELY DRAINED  
**2,320m<sup>2</sup>**

As shown on sheet SW1 (Appendix 5), the existing impermeable area which is positively drained to the watercourse is taken to be 2,320 m<sup>2</sup>. Assuming a rainfall intensity of 50 mm/hour, the unrestricted discharge rate from the site would be approximately 32 litres/second.
