## **CONTAMINATION REMEDIATION STATEMENT**

**HALIFAX ROAD  
THURGOLAND**

PROJECT: HALIFAX ROAD, THURGOLAND

REPORT TYPE: CONTAMINATION REMEDIATION STATEMENT

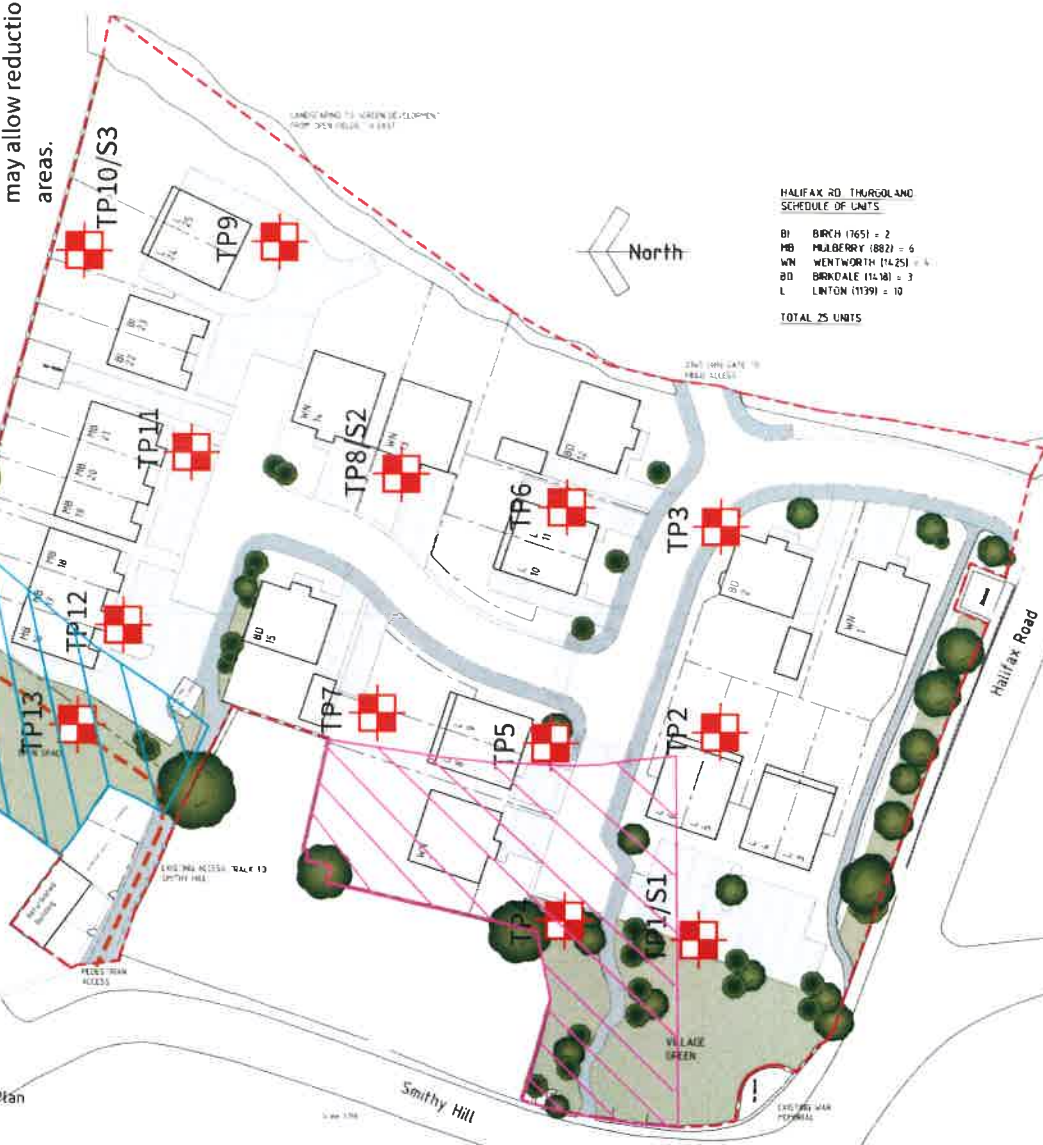
REMEDICATION PLAN

Worst case extent of topsoil at/around TP13 with elevated PAHs. Take off site

Worst case extent of topsoil at/around TP4 with elevated lead. Take off site or use on POS

NOTE: Further sampling and testing may allow reductions of the affected areas.

- 3.1 Based on current results, the topsoil at/around TP4, which contains elevated lead, can be used in Public Open Space (POS) areas, or taken off site. The approximate extent (based on assuming the affected material continues up to the nearest uncontaminated trial pit), is indicated on the attached plan.

- 3.2 The topsoil at/around TP13 should not be used on POS, as some PAH concentrations were above screening values for POS. The affected material will need to be taken off site. The approximate extent (based on assuming the affected material continues up to the nearest uncontaminated trial pit), is indicated on the attached plan.
