# Bat Survey to Cardigan Works

Foundry Lane  
Elsecar  
S74 8EQ

5<sup>th</sup> August 2022

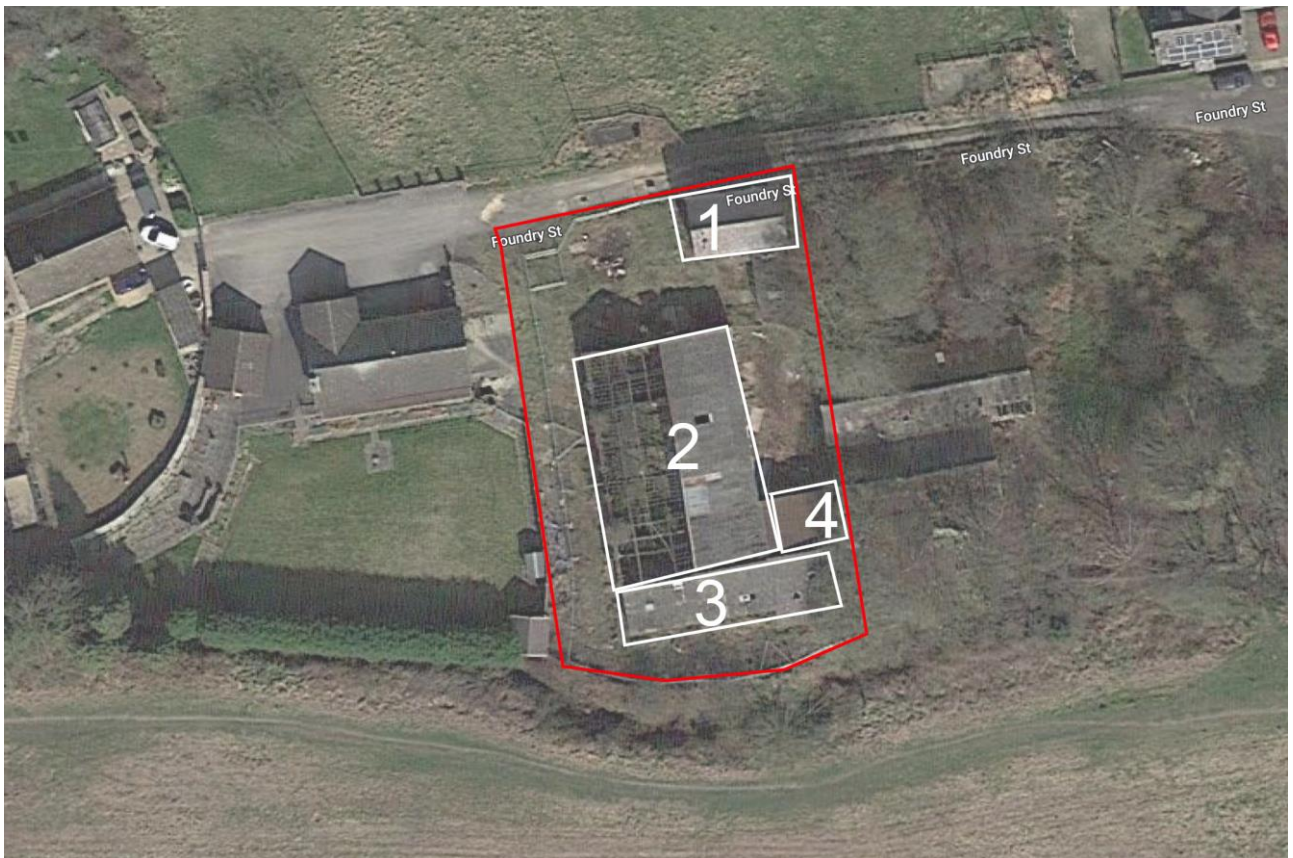
The site has a number of buildings which have been identified in figure 3 below

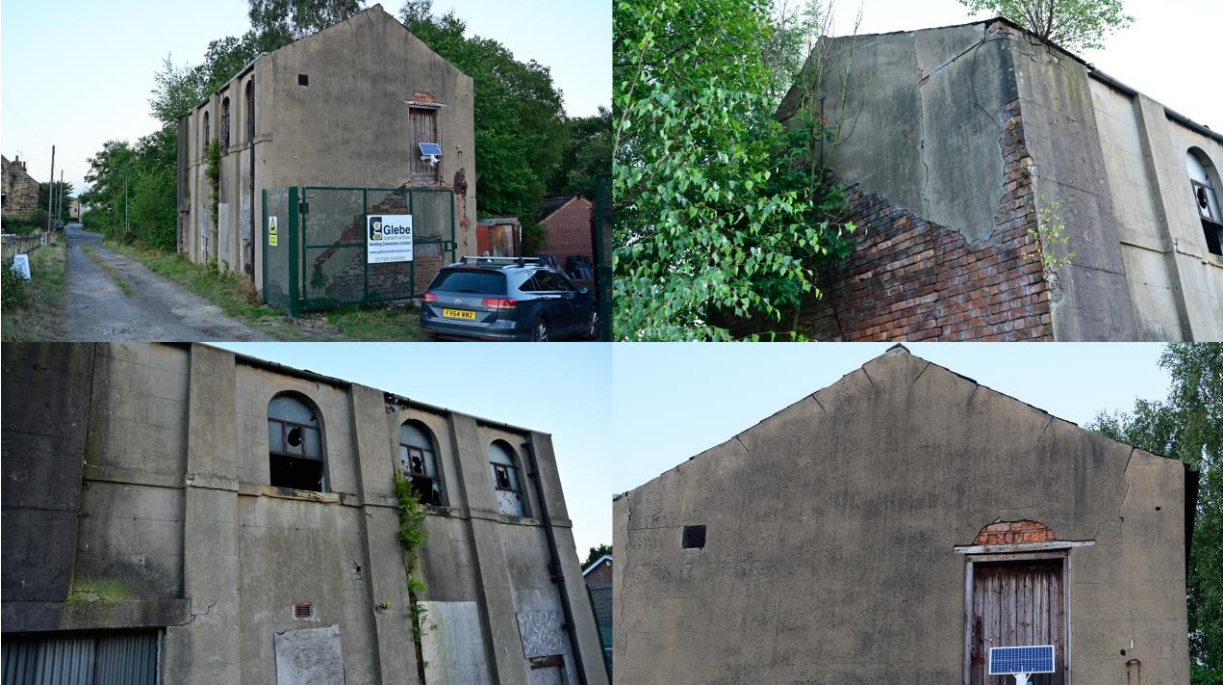
Photo 1 Various aspects of building 1

A former office block constructed of brick with blue slate roof. The interior has been extensively fire damaged and access into the roof void was not possible but it can be viewed from ground level and the roof is partially missing but still has a good section of ridge tile present. The ridge is a double beam and appears clean but there is a gap between the two ridge beams which was carefully scanned but no bats were seen. The roof is extensively used by feral pigeons. Externally, the roof has blue slates and is unlined and has extensive gaps where tiles have slipped, been stripped or cracked in the fire. Bats are unable to roost beneath these single tiles and the tiles at the verges sit flat to the rendered wall tops. It is possible that individual bats could roost beneath the tiles at the wall tops.

The walls are brick but have no wall cavity and most are covered by a cement render. There are some structural gaps, many of which are too big to be of interest to bats, and some sections where mortar has failed but these may be too shallow for bats. There are no decorative wooden fixtures to the walls (facia, soffits etc) and any gutter present is simply sitting on the brick buttresses.

This building exhibits some minor roost potential and is assessed as being of 'low' interest to bats.

- Contractors to be made aware of the small potential for bats to be present and to act with vigilance when disturbing roof tiles.

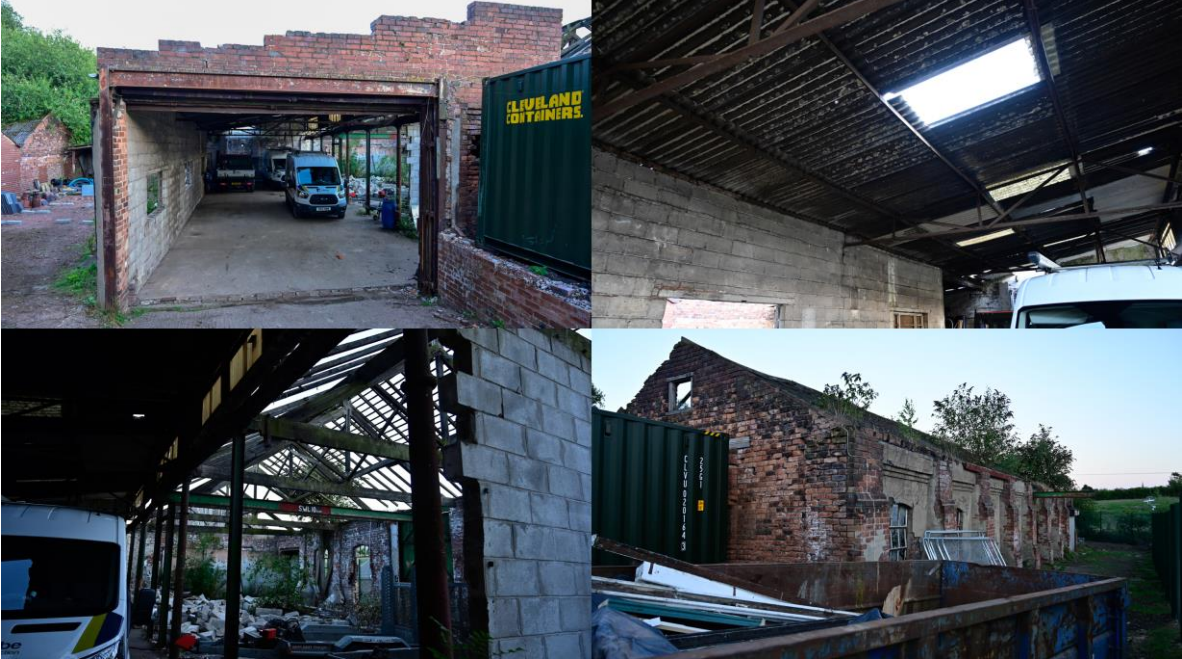
Photo 2: Various aspects of building 2

A large former foundry building in an advanced state of disrepair having most of the roof stripped of covering with the remaining roof covering being single sheet asbestos which is not regarded as being of bat roost potential. The walls are single thickness blockwork or brick with no wall cavity. There are no fixtures or features that would allow bats to roost and the likelihood of bats being present is very low. The building has 'negligible' potential to support roosting bats.

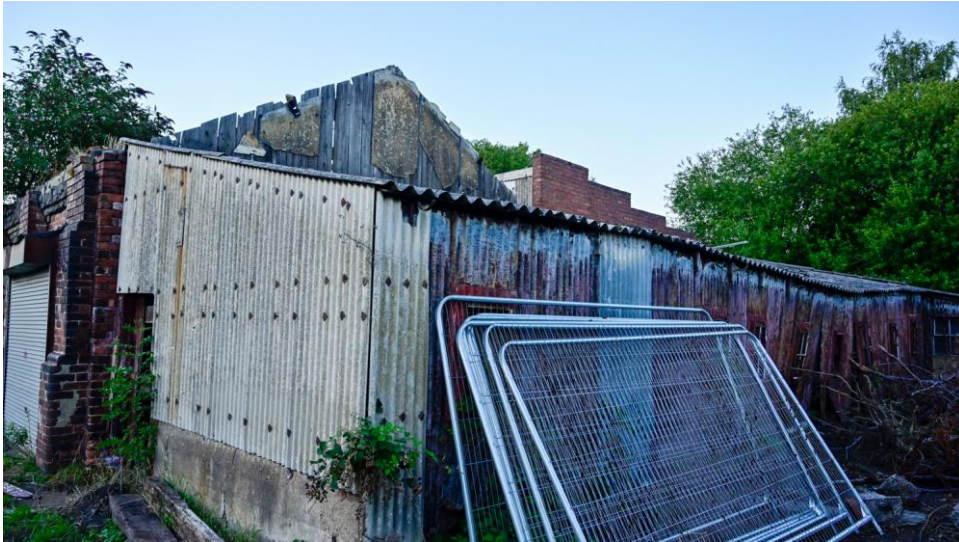
Photo 3. Building 3 at south end of the site

A low lean-to shed built entirely of corrugated asbestos or cement fibre sheets sat on top of a low blockwork wall. This building is regarded as being of 'negligible' interest to bats.

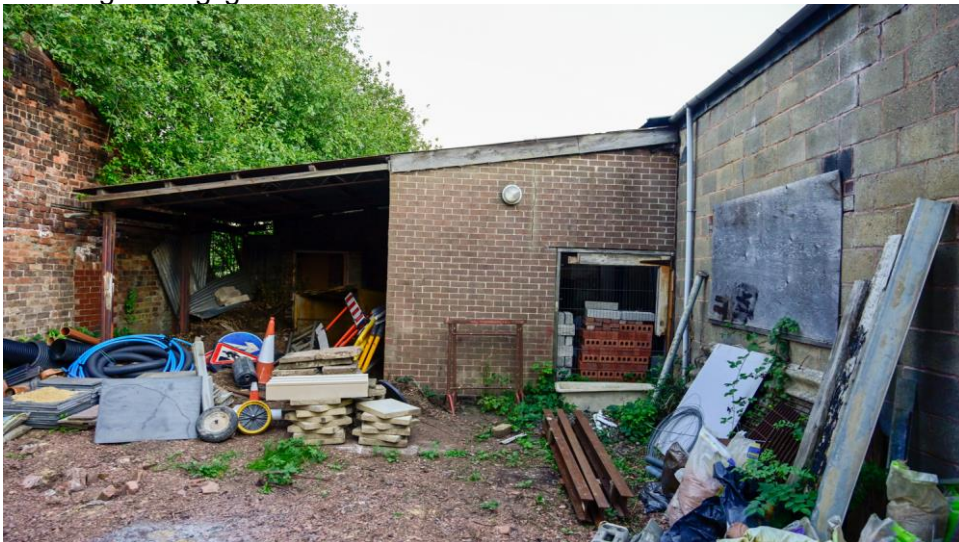
Photo 4 Lean to shed identified as building 4

A single storey lean-to set against the east elevation of building 2. The walls are constructed of brick with wall cavity and the roof is a single sheet corrugated cement fibre board over a steel portal frame. There are wooden fascia along the north and south sides of this building and these were inspected with a high-powered lamp and found to be free of bats. This building is regarded as being of 'negligible' interest to bats.
