**PHASE 2 GEOTECHNICAL AND  
GEO-ENVIRONMENTAL SITE INVESTIGATION REPORT**

**LAND SOUTH OF NEW SMITHY AVENUE  
THURLSTONE**

**MR P. MULLINS**

**40630-003**

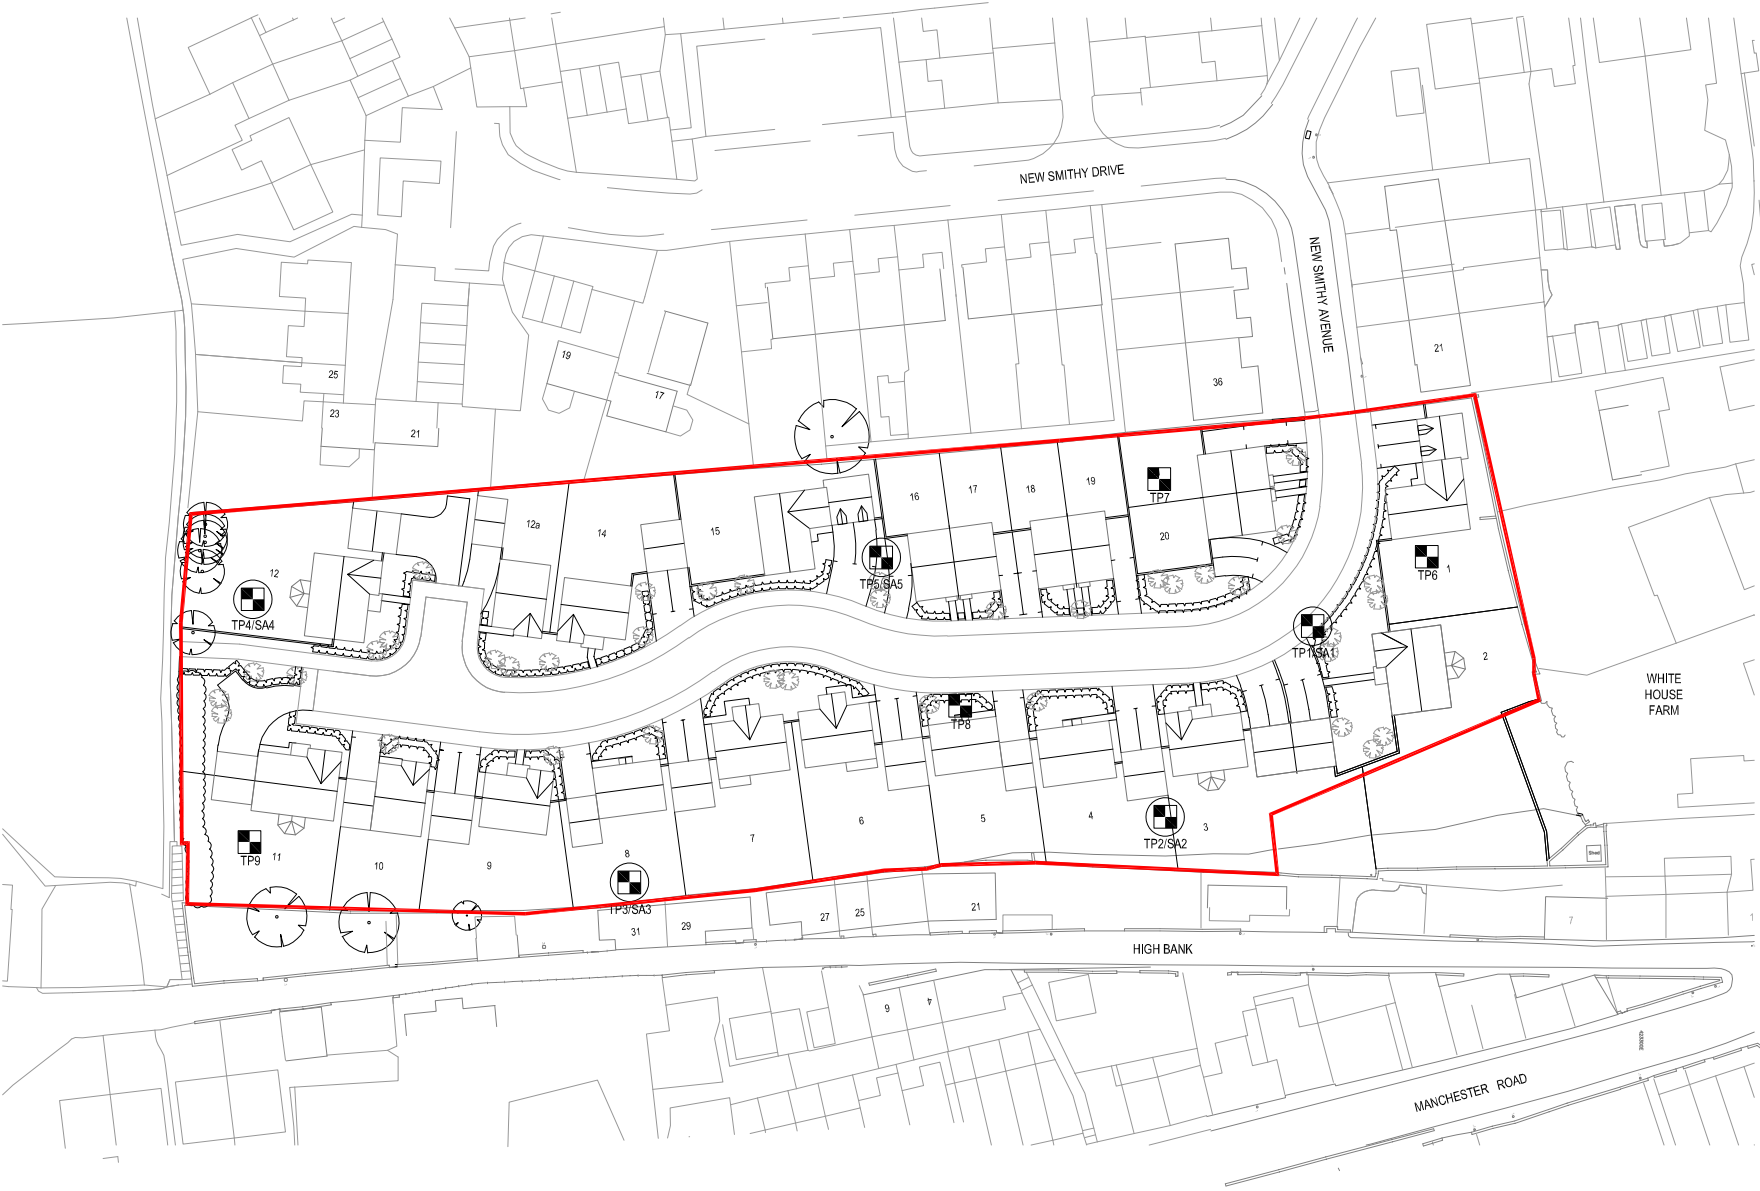
Exploratory Hole Location Plan – Drawing 40041/001A

The site works were undertaken on 6 December 2016. Nine trial pits, referenced TP1 to TP9, were excavated across the site in order to determine the underlying ground conditions. The trial pits reached depths of between 1.7 m and 2.1 m bgl. Five of these trial pits were also used for infiltration testing (referenced SA1 to SA5).
