# Small Lanes Farm, Cawthorne

## Bat and Bird Survey Report

1<sup>st</sup> July 2022

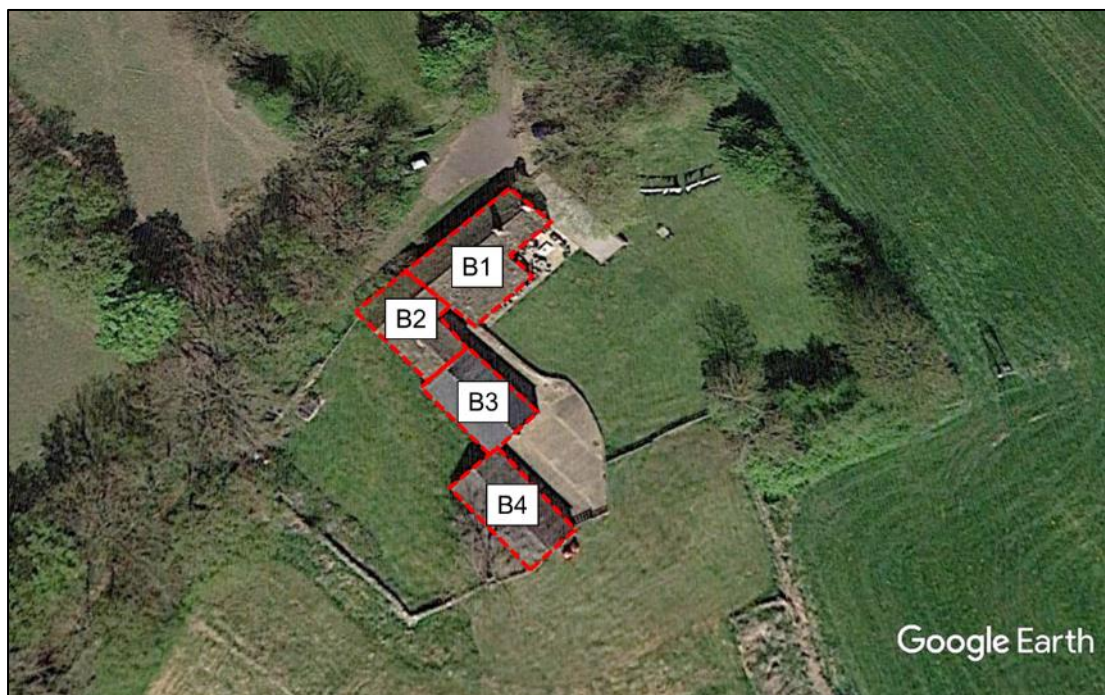
**Figure 1. Building numbering plan**

- 5.2.1 For the purpose of aiding description, the surveyed buildings have been numbered, with their locations shown in Figure 1.
- 5.2.2 No evidence of bat roosting was recorded from any site building. Buildings 1, 2 & 4 are considered to display a moderate level of bat roost potential, with Building 3 displaying low bat roost potential.
- 5.2.3 An active swallow *Hirundo rustica* nest was recorded from B4.

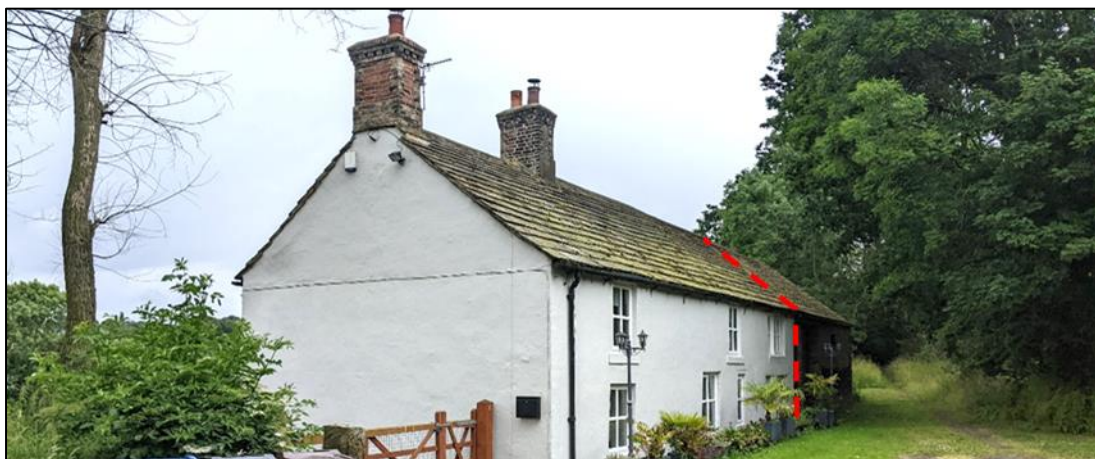
- 5.2.4 Building 1 comprises a quite recently renovated (within last 20 years) traditional two-storey farmhouse (Plates 1 & 2). The building dates back to either the 18<sup>th</sup> or 19<sup>th</sup> Century. External walls are cement rendered and the house has a pitched stone-slate covered roof with a cat-slide section on the southeast elevation. Two brick-built chimneys are present. This building has uPVC-framed double-glazed windows and uPVC gutters. Flashing is present at the base of chimneys.
- 5.2.5 On the exterior of the building potential bat roosting features appear mainly limited to crevices present between the stone slates of the roof, with these slates of slightly uneven widths as is typical of this type of roof.

### **Plate 1. North corner of B1, with B2 to right of image (beyond dotted red line)**

- 6.3.1 It is understood that the proposed scheme does not involve alterations to the exterior of the dwelling (B1), with bat roost potential limited to the roof on this building. As a result, no further survey of this building is considered necessary.
- 6.3.2 In accordance with the accepted bat survey guidelines (Collins, 2016) two further nocturnal surveys of Buildings 2 – 4 should be undertaken to determine bat roost presence/absence. These surveys should comprise dusk emergence or dawn return surveys, to be led by a licensed bat worker, with survey visits to be separated by at least 14 days.
- 6.3.3 The need for bat mitigation licensing and roost mitigation/compensation will be determined following nocturnal survey works.

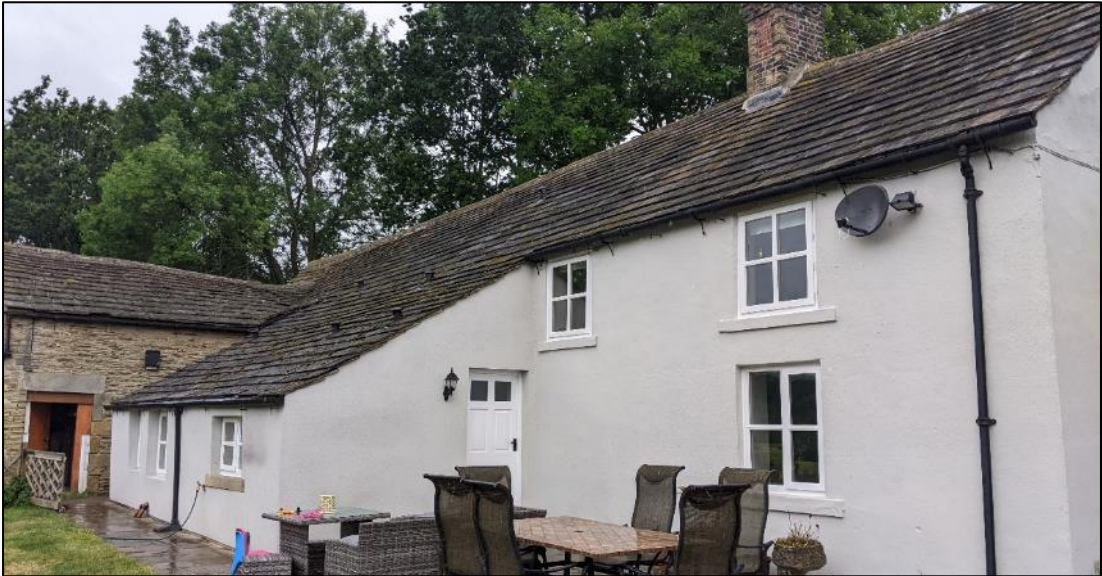
**Plate 2. Southwest elevation of B1**

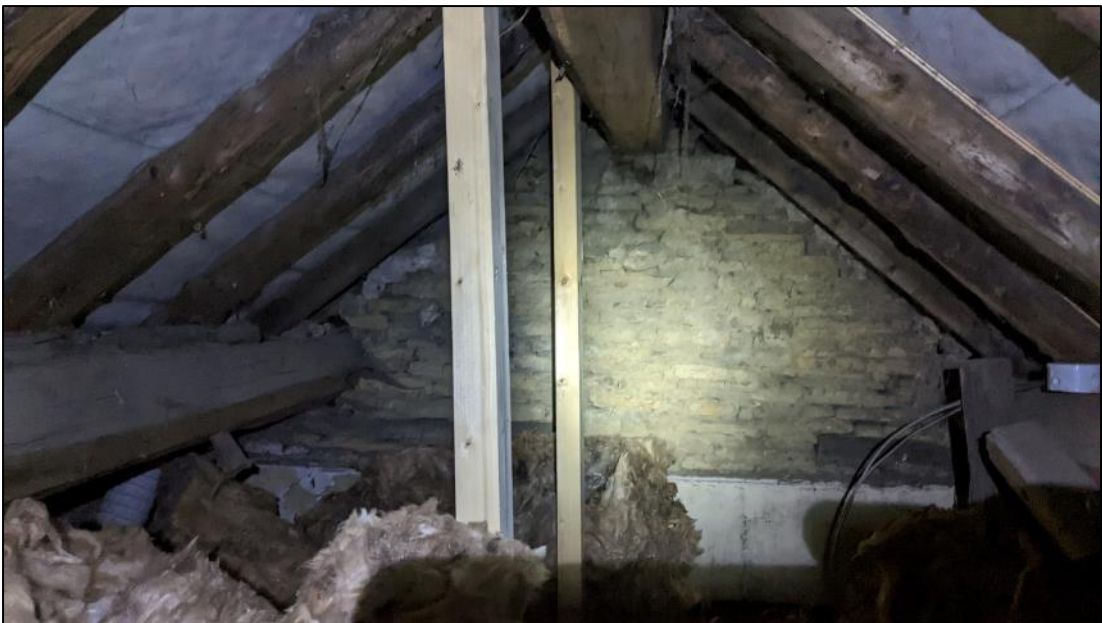
- 5.2.6 The central roof void was accessed, with the roof found to be lined with a breathable roofing membrane and suspended on a ridge beam, purlins, rafters and laths (Plate 3). The void was 1.5m high with the internal rooms partially vaulted. Within the void there was 200mm of insulation on the ceiling. No potential bat access points into the void were noted. Mouse *Mus musculus* and rat *Rattus norvegicus* droppings were however recorded from this void.
- 5.2.7 Building 1 is considered to display a moderate level of bat roost suitability.

**Plate 3. Roof void within B1**

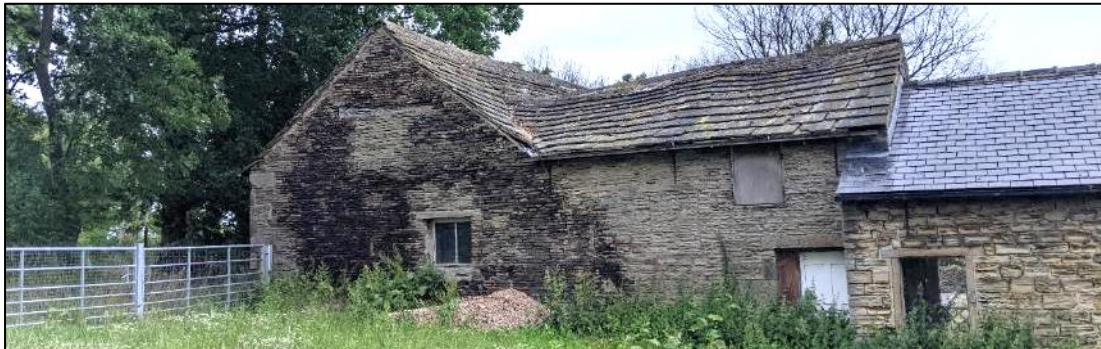
- 5.2.8 Building 2 comprises an L-shaped stone-built traditional barn dating back to either the 18<sup>th</sup> or 19<sup>th</sup> Century. The barn has a pitched stone-slate covered roof. The northeast wall of the barn adjoins the dwelling (B1), whilst the southeast wall adjoins another outbuilding (B3). Wooden double doors are present in the northwest elevation with single doors in the northeast and southwest elevations. A wood-framed single glazed window and a second wood panel covered window is present in the southwest elevation. The building has a mixture of wooden and uPVC gutters.

5.2.10 On the exterior of B2 bats may roost either between the stone slates of the roof, or within the many open masonry joints, particularly in the largely un-pointed southwest gable. Occasional crevices are also present between external timbers and adjacent stonework.

**Plate 4. Southwest elevation of B2**

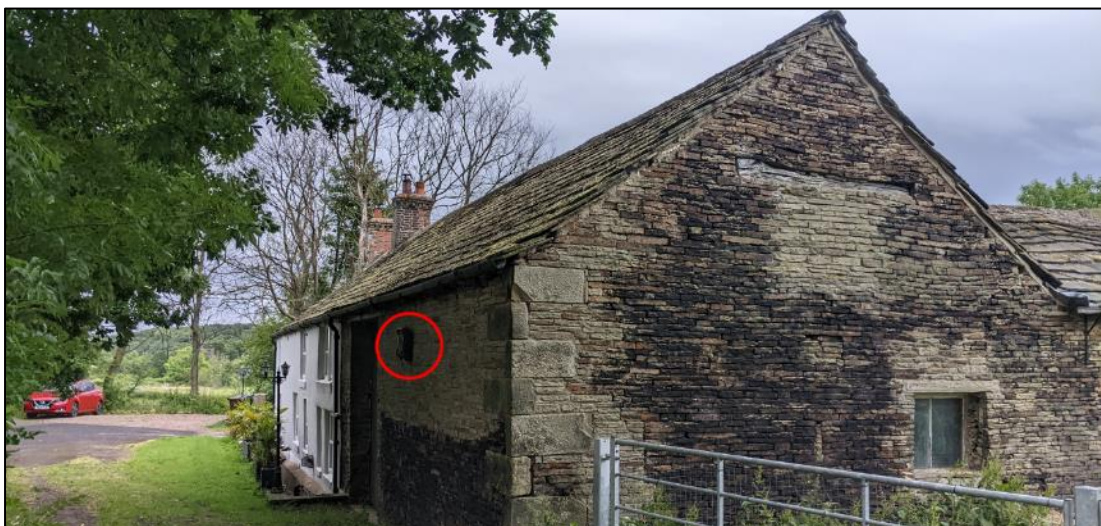
5.2.9 Two Schwegler 1FF bat boxes are present on the exterior of B2, with one on the northeast elevation and a second on the northwest elevation. Both boxes were inspected with no signs of bats noted. A blue tit *Cyanistes caeruleus* had been roosting in the box on the northeast elevation.

**Plate 5. Western corner of B2. Schwegler 1FF bat box is circled in red**

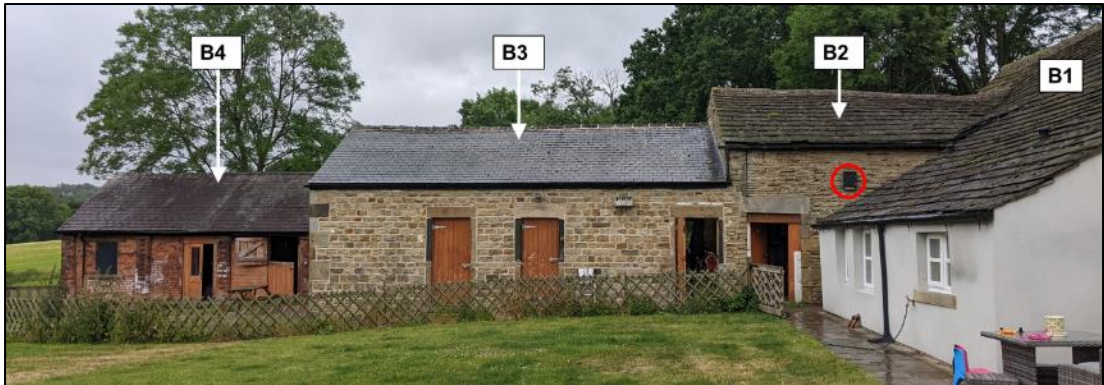
**Plate 6. Northeast elevation of barns and outbuildings. Second Schwegler 1FF bat box is circled in red**

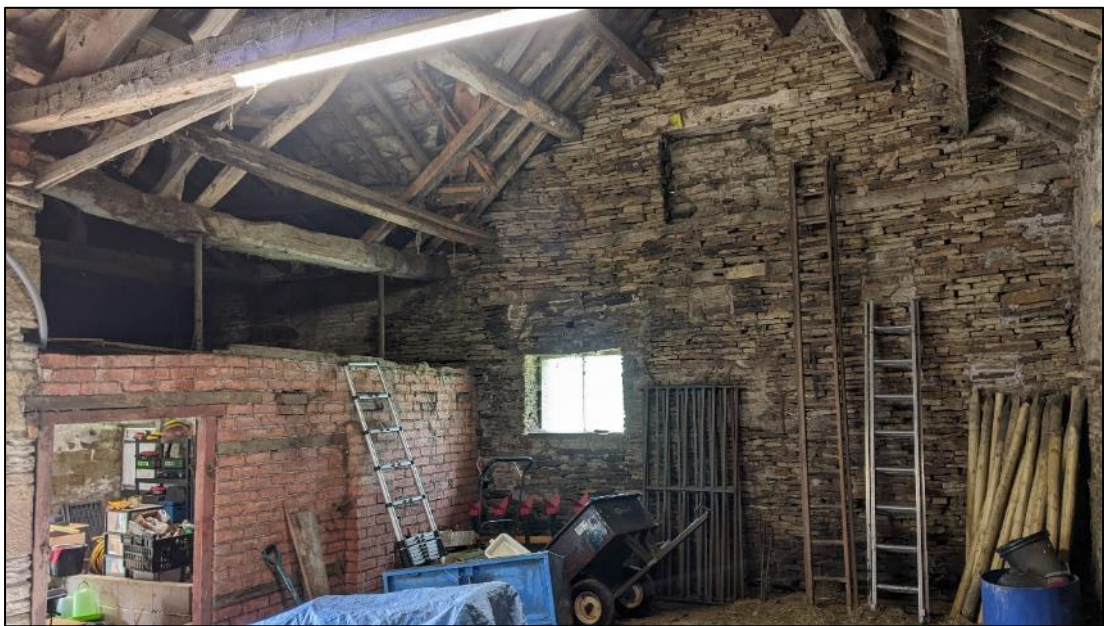
5.2.11 The unlined roof of B2 is suspended on hand-cut king-post trusses, purlins, rafters, a ridge beam and laths. The southeast end of the building is two-storey with the roof held up by Acrow-props in this area. Building 2 is actively used for storage.

5.2.12 No signs of bat presence were noted from the interior of B2. Open mortice joints in roof trusses were inspected and found to display good potential to support bat roosts, as do the numerous openings in the internal face of the un-pointed southwest gable. A crevice is also present between two timber window lintels.

**Plate 7. Interior of B2**

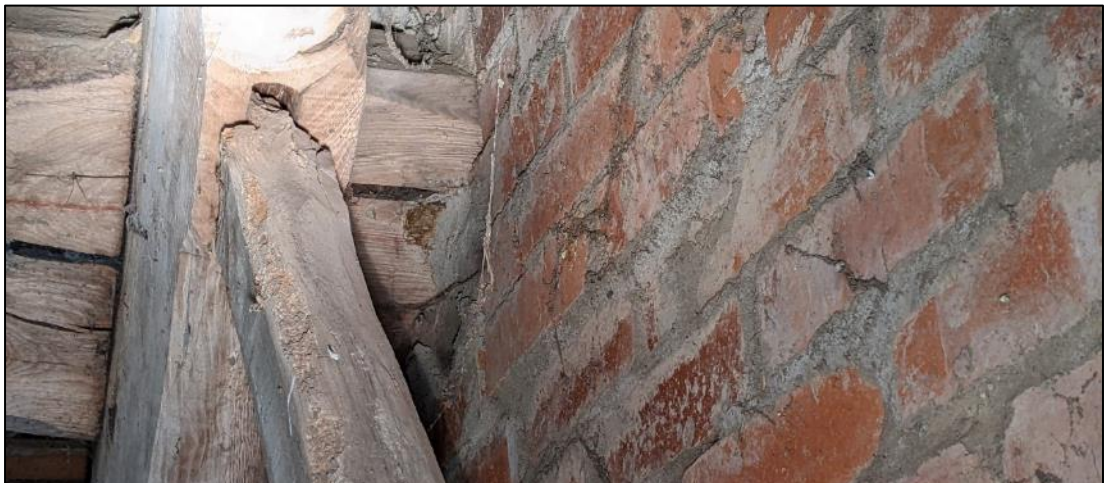
**Plate 8. Open mortice joint in king-post truss in B2**

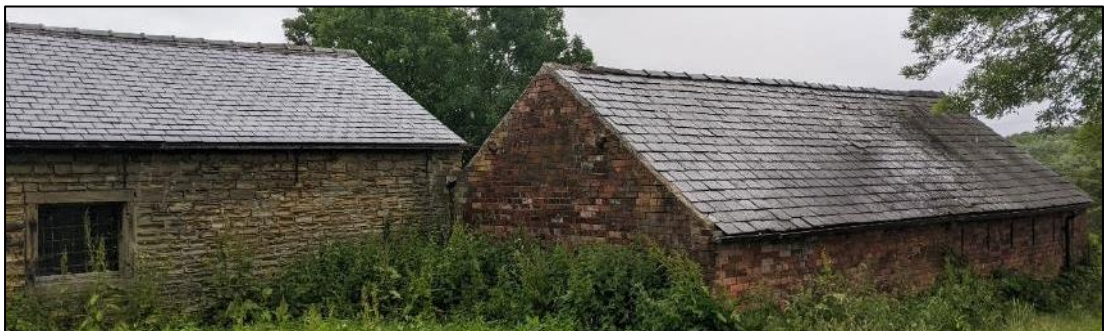
- 5.2.14 Building 3 comprises a recently largely re-built single storey outbuilding with a pitched Welsh slate covered roof with clay ridge tiles (Plates 5 & 9). The northeast elevation is stone faced with a concrete block inner skin, whilst the southwest elevation and gables comprise solid stone walls. A wooden fascia board is present on the northeast elevation. Two single-paned wood-framed windows are present in the southwest elevation with three wooden doors in the northeast elevation. Gutters are a mix of wood and uPVC.
- 5.2.15 On the exterior of B3 bats may potentially roost within eroded open joints in the exterior of the southwest elevation. There is also a crevice behind the fascia board on the northeast elevation (Plate 10), although this is largely cobwebbed. A Schwegler sparrow terrace is also present on the northeast elevation.

**Plate 9. Southwest elevations of B3 (left) and B4 (right)**

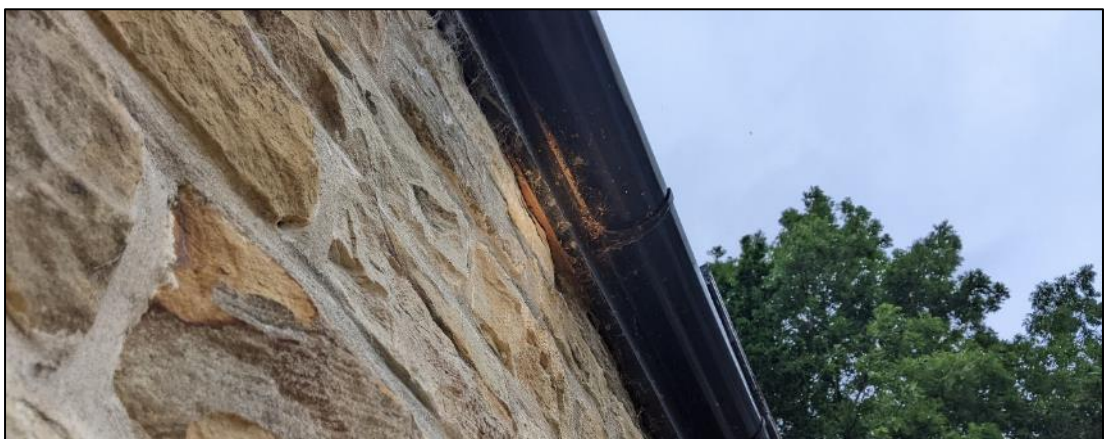
**Plate 10. Gap behind fascia board on B3**

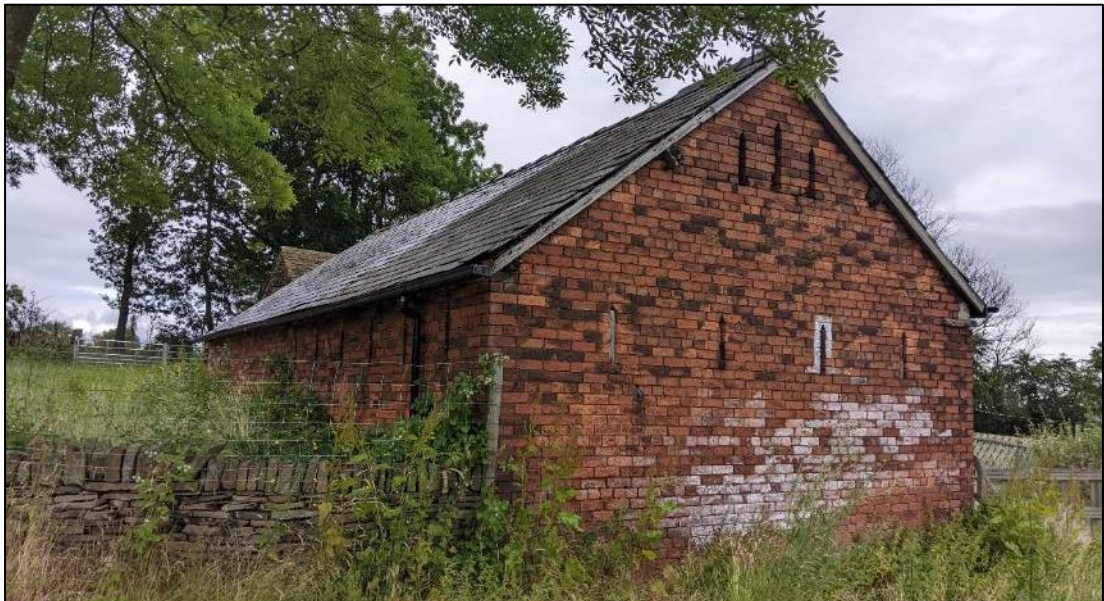
- 5.2.18 Building 4 comprises an 1800s brick-built single-storey outbuilding with a pitched Welsh slate covered roof with clay ridge tiles and eaves (Plates 5, 9 & 11). Arrow style ventilation slots are present in the southeast gable and southwest elevation, with these slots sealed within the inner face of the brick walls. This building appears to have formerly been partly open sided on the northeast elevation, with these openings now boarded up with two doors present (Plate 6). A mix of wood and uPVC gutters are present.

- 5.2.19 Within the exterior of B4 there are sections of missing mortar within the ridge bedding and gaps beneath slates, particularly on the southeast gable. There is potential bat access to the interior of the building via either the open stable door or across a gap above the wall plate. The ventilation slots do not lead into the interior of the building but do provide potential bat access into crevices within the walls.

**Plate 11. South corner of B4**

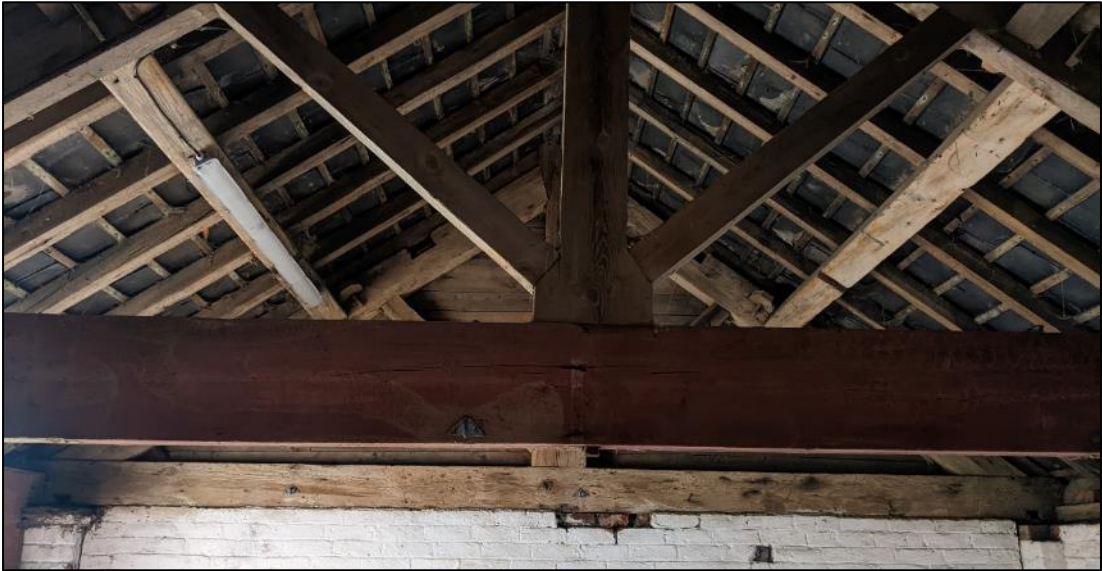
- 5.2.20 The interior of B4 is open to the underside of the slates with the roof suspended on king post trusses, purlins, a ridge beam, rafters and laths (Plate 12). The interior is divided into two compartments. The building is actively used for storage and in common with Building 3 is quite regularly swept. No signs of bats were recorded but an active swallow nest was observed (Plate 13).
- 5.2.21 Building 4 is considered to display a moderate level of bat roosting potential.

**Plate 12. Interior of B4**

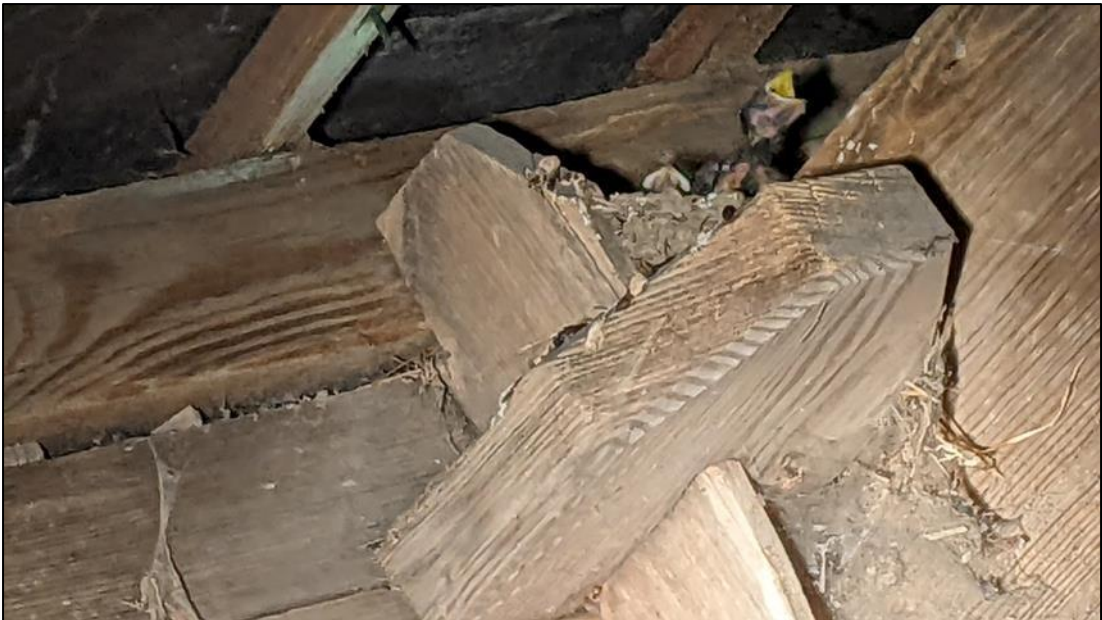
**Plate 13. Swallow nest and chicks in B4**

- 6.3.4 Building renovation works should commence either outside the bird nesting period (March to September inclusive), or the works will need to be preceded by a nesting bird check.
- 6.3.5 Conversion of B4 will result in the loss of a confirmed swallow nesting site. It is advised that this loss should be compensated for. Swallows typically nest internally within buildings. Assuming it is not possible to retain/create any access for swallows into existing buildings then it is recommended that an open-sided structure (i.e. a log store or bin store) be included in the scheme, within which a swallow nest cup may be installed.
- 6.3.6 The sparrow terrace on B3 should be retained.
