PHASE I
SITE INVESTIGATION

PLOT 2, LAND OFF WEST ROAD
POGMOOR, BARNSLEY

TREVOR SIMPSON

NOVEMBER 2010

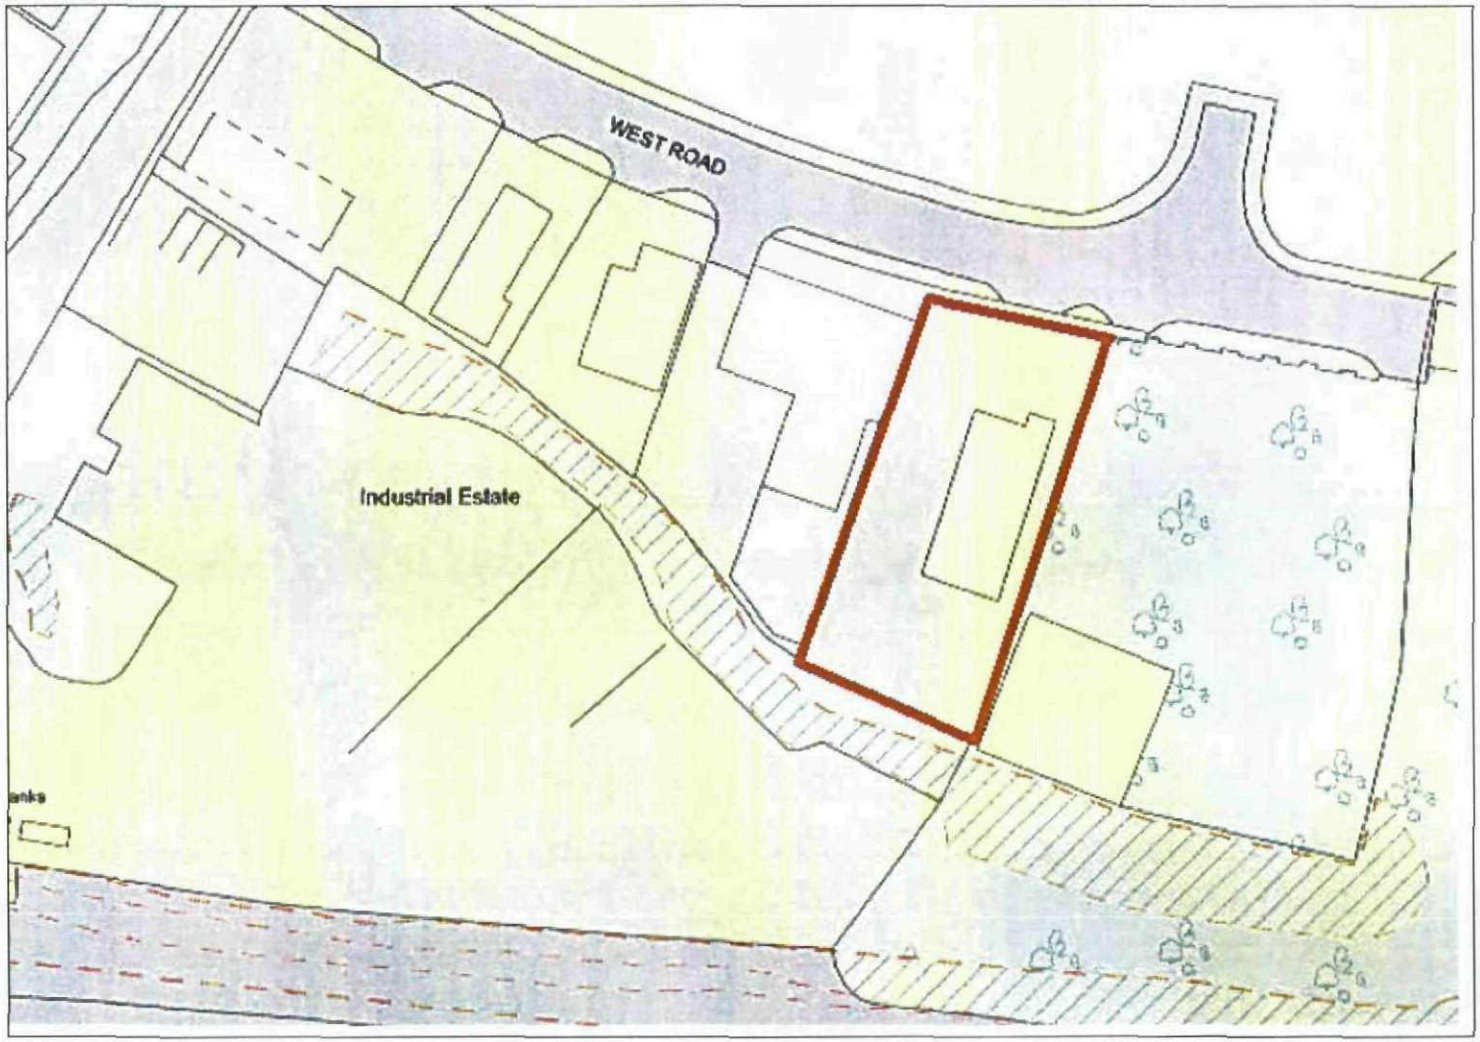
Plot 2, Land off West Road, Pogmoor, Barnsley– SITE PLAN

- West: Walls of adjoining corrugated steel building and concrete block building.
- South: Bush and scrub vegetation (note ground slopes very steeply downwards beyond boundary).
- East: Circa 1m high brick and concrete block retaining wall with chain link fence on top (retained side to the east); semi mature coniferous trees (note ground slopes very steeply downwards beyond boundary).
- North: 2m high wire mesh fence and steel gates.

The site was occupied by a disused brick built light industrial building with pitched asbestos roof, associated concrete hard standing around the building and along the western and southern boundaries and a small concrete block extension to the main building. The buildings were disused and locked with no access available at the time of the walk over. The remainder of the site was covered with hard core which in turn was covered by a significant amount of fly-tipped material and building waste. Points of note on the site include:

- A compressed oxygen gas cylinder located next to the western wall of the building.
- A discarded "Castrol" oil drum and un-marked blue drum adjacent to the western boundary.
- A number of discarded butane and propane gas cylinders next to the south west corner of the main building.
- A number of discarded liquid skips located along the western and southern boundaries of the site.
- A number of discarded blue drums located near the eastern boundary of the site. The majority of the drums were un-marked, however the following labels were noted:
  - "Grotanol"
  - "Parmetol"
- A dismantled concrete block structure now filled with tipped waste building materials was present in the south east corner of the site.

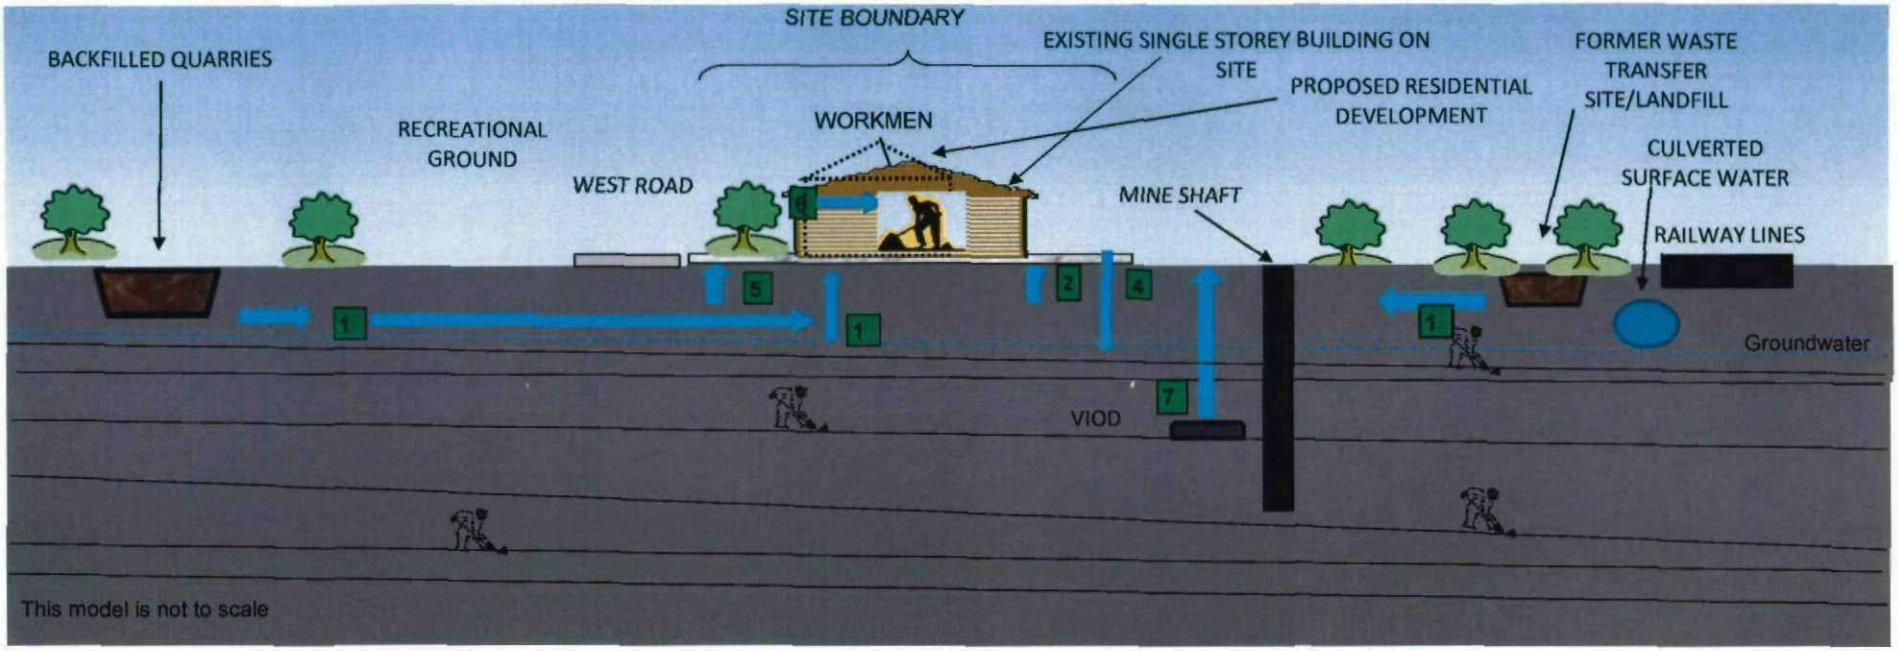
SOURCES	PATHWAYS	RECEPTORS	RISK
HISTORICAL USE AS INFILLED GROUND BUILDINGS REFUSE DESTRUCTOR NEIGHBOURING ACTIVITIES LANDFILL INDUSTRY QUARRYING MINING	1 Inhalation of vapours	Workmen/future occupants of residential house Neighbouring land use	High. Ground gas from backfilled quarries, underground mining and made ground.
	2 Ingestion and or skin contact	Workmen/future occupants of residential houses	High. Possible soil and groundwater contamination.
	3 Ingestion of drinking water	Potable borehole 722m from the site	Low to medium - due to distance from potable boreholes
	4 Leaching to surface/groundwater	Groundwater and surface water	Low to medium - due to distance to surface water.
	5 Ingestion of plants/ animals/ veg	Future site occupants of residential houses	High. Gardens and landscaped ground may be proposed
	6 Inhalation of dust	Workmen	Low - provided precautions taken during construction.

7 Ground subsidence	Possible shallow mining and mine shafts.	High - coal mined locally at <30m bgl.
