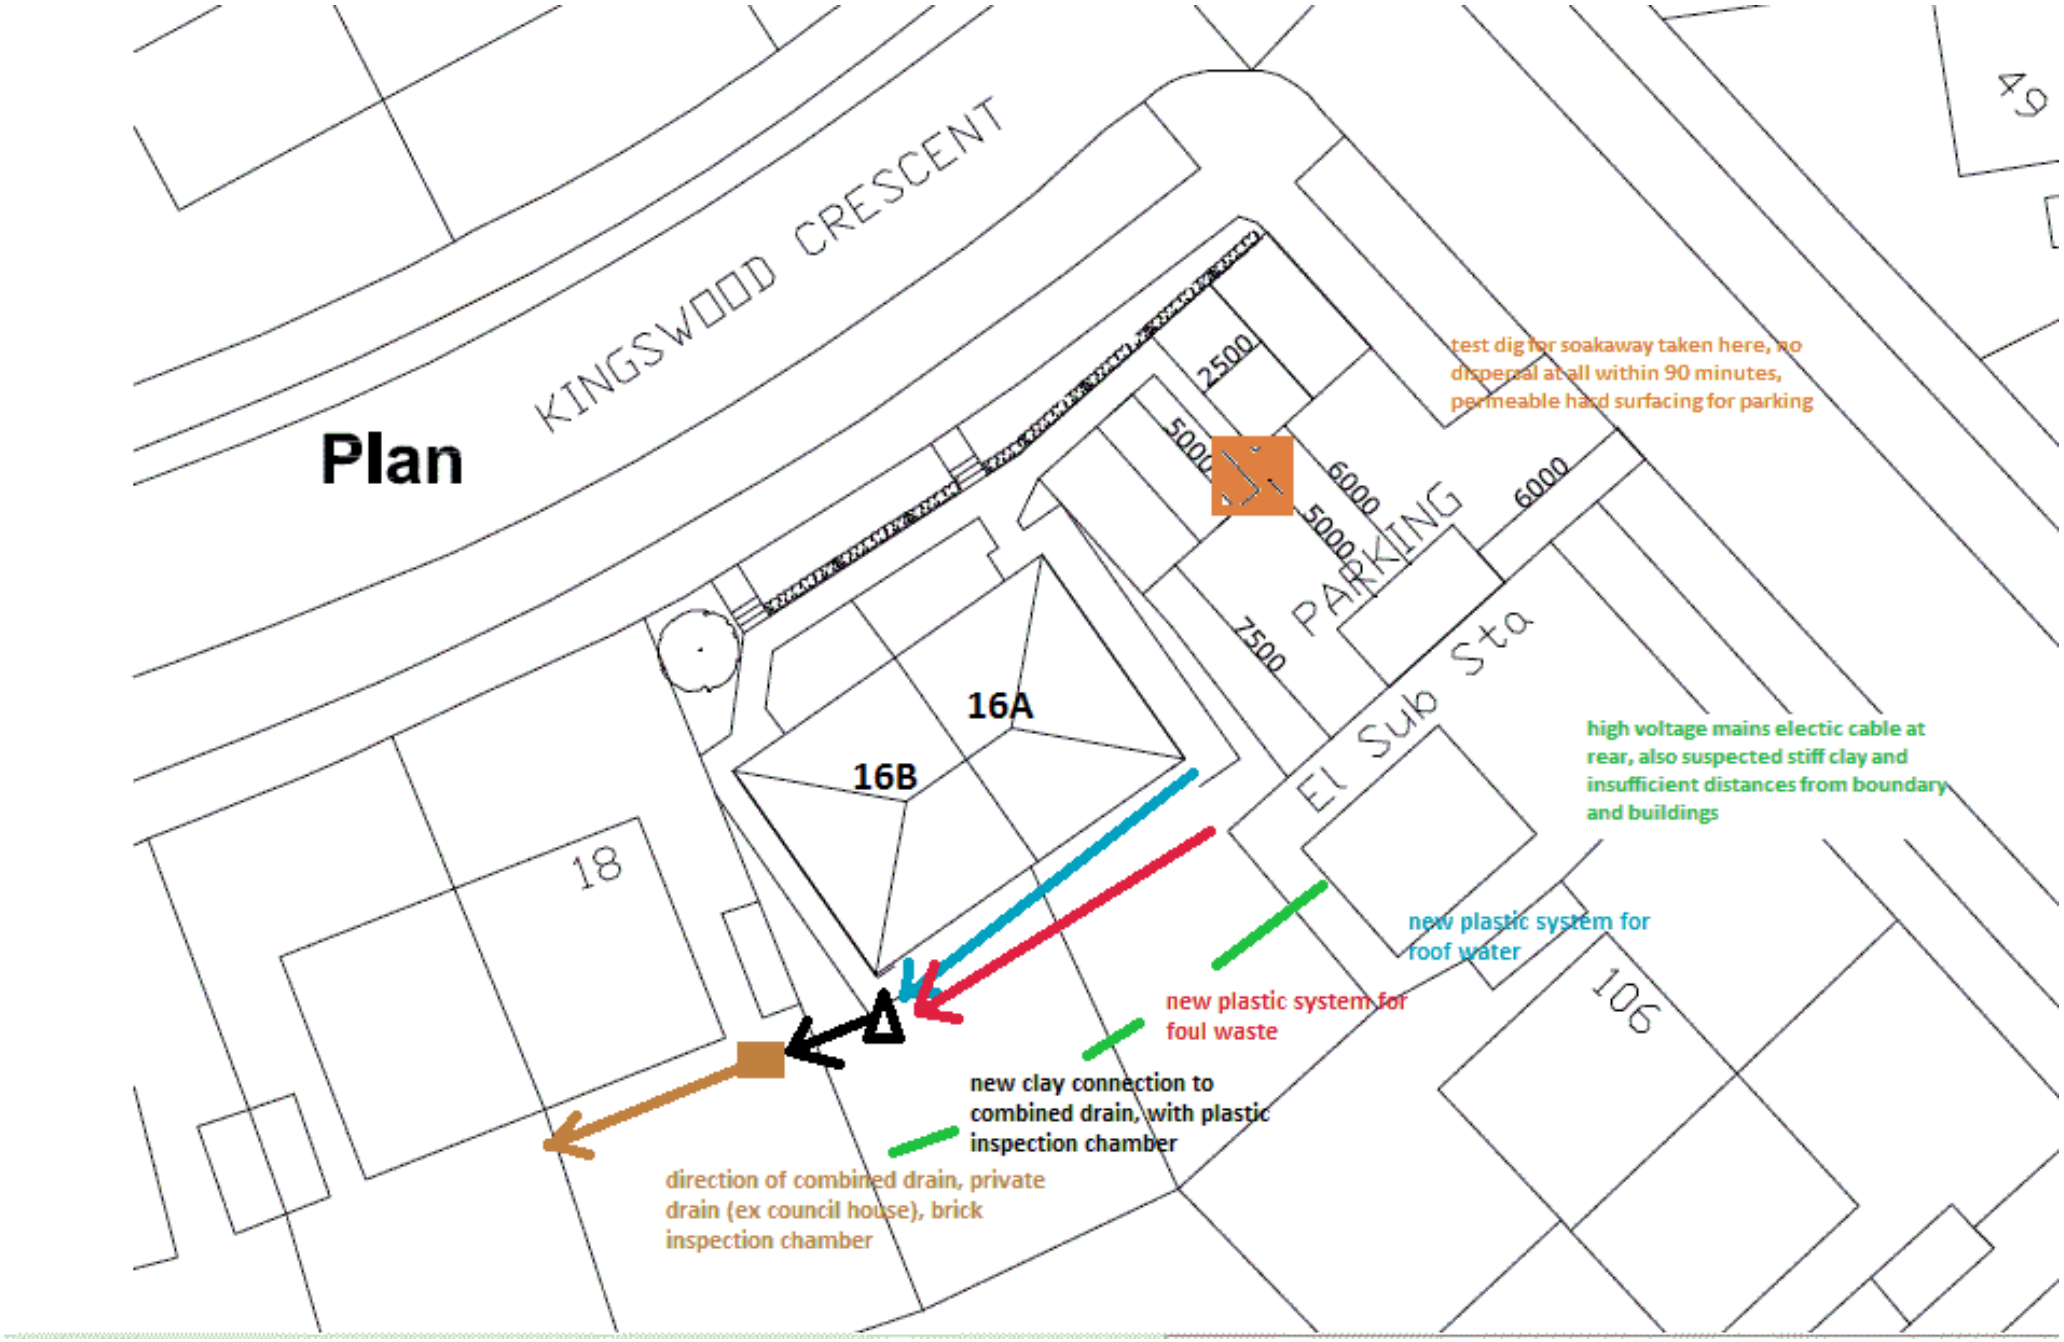
Plan
KINGSWOOD CRESCENT
16A
16B
18
2500
5000
6000
5000
6000
7500
PARKING
El Sub Sta
106
49
test dig for soakaway taken here, no dispersal at all within 90 minutes, permeable hard surfacing for parking
high voltage mains electic cable at rear, also suspected stiff clay and insufficient distances from boundary and buildings
new plastic system for roof water
new plastic system for foul waste
new clay connection to combined drain, with plastic inspection chamber
direction of combined drain, private drain (ex council house), brick inspection chamber
