Penistone Grammar School, Penistone, South Yorkshire: An Archaeological Building Record

On behalf of Barnsley Metropolitan Borough Council

CS Archaeology

October 2010

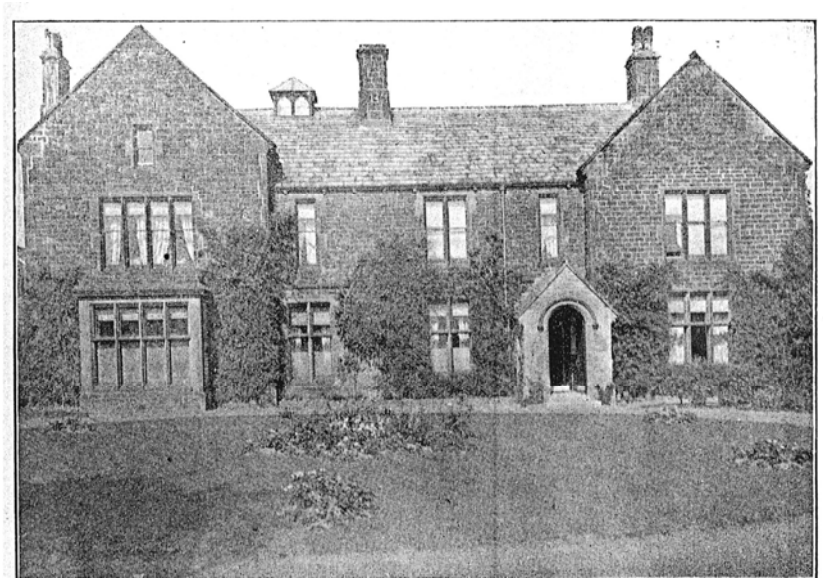
Plate 1, the front *Southeast Elevation* of Weirfield House (Dransfield 1906)

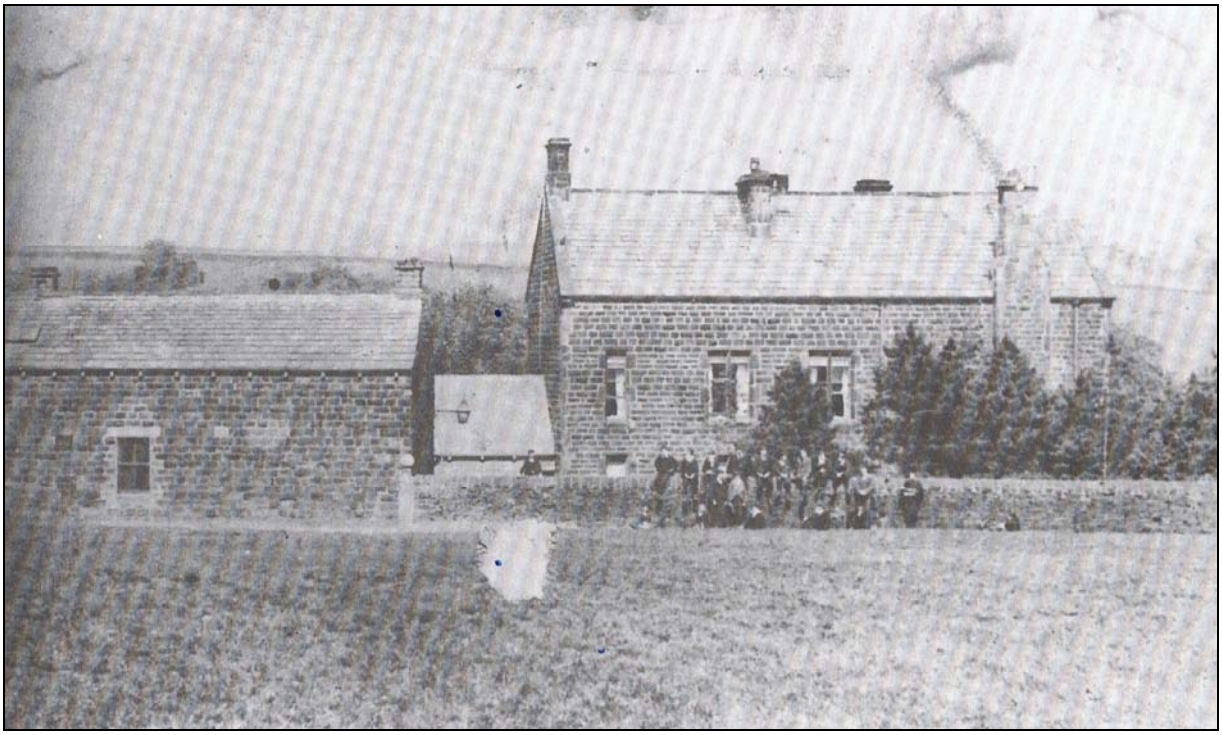
Plate 2, *Weirfield House Grammar School c. 1890(Hambleton and Young 1995)*
the Fulford Building was later built in the foreground

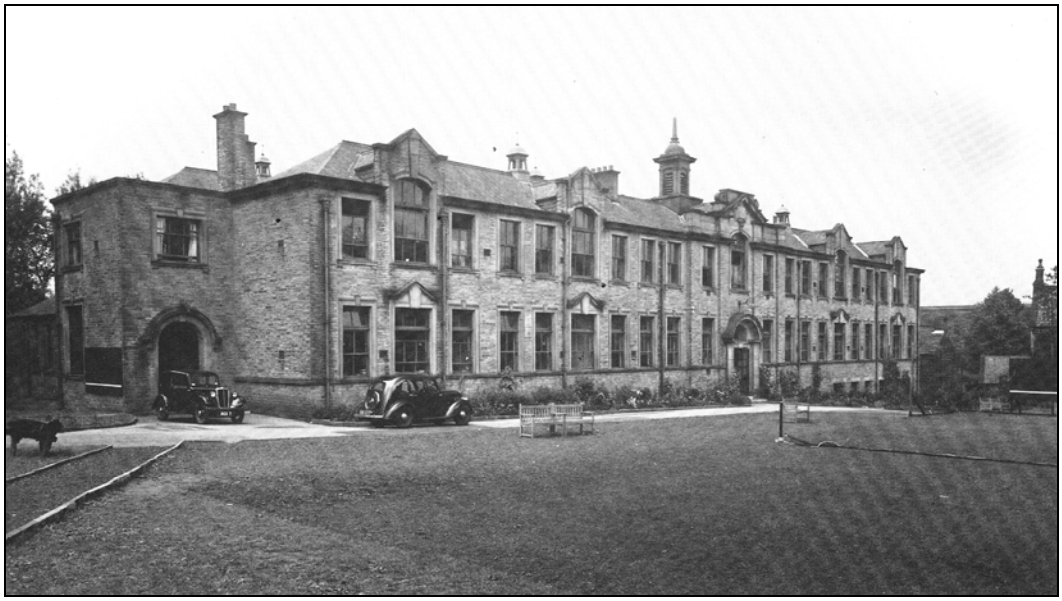
Plate 9, View of the Fulford Building c. 1940 (Penistone Grammar School's 600th anniversary Calendar 1992), looking northeast

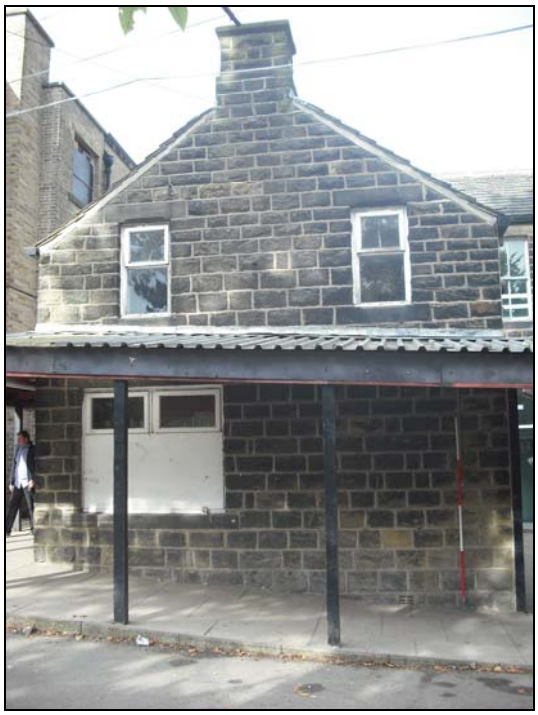
Plate 44, *96*: building 2, external, general view of the Southeast Elevation, with the two first floor windows, from the southeast

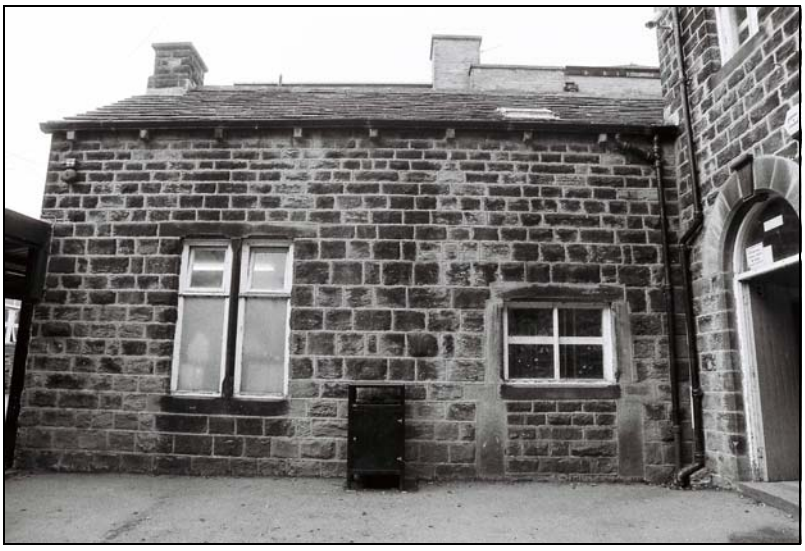
Plate 46, *92:* building 2 the original stable, view of the *Northeast Elevation*, from the northeast

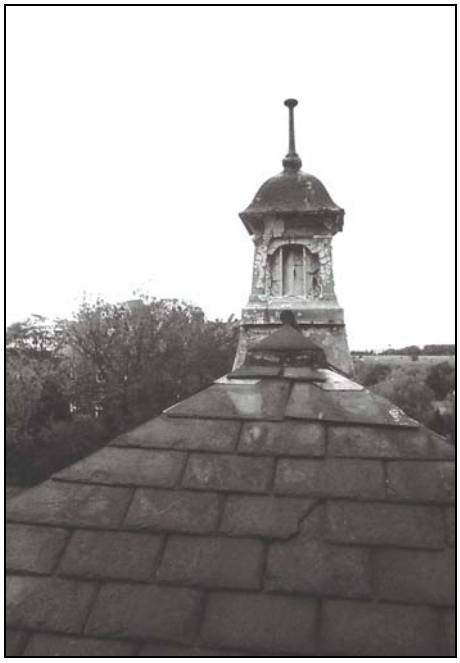
Plate 59, *327*: building 3, view of the former *Kitchen's* decorative roof ventilator, from the southeast
