Royd Hill Farm
Royd Lane
Higham
Barnsley

Design and Access Statement
& Annex Justification

August 2008

ROYD HILL FARM, ROYD LANE, HIGHAM, BARNSLEY

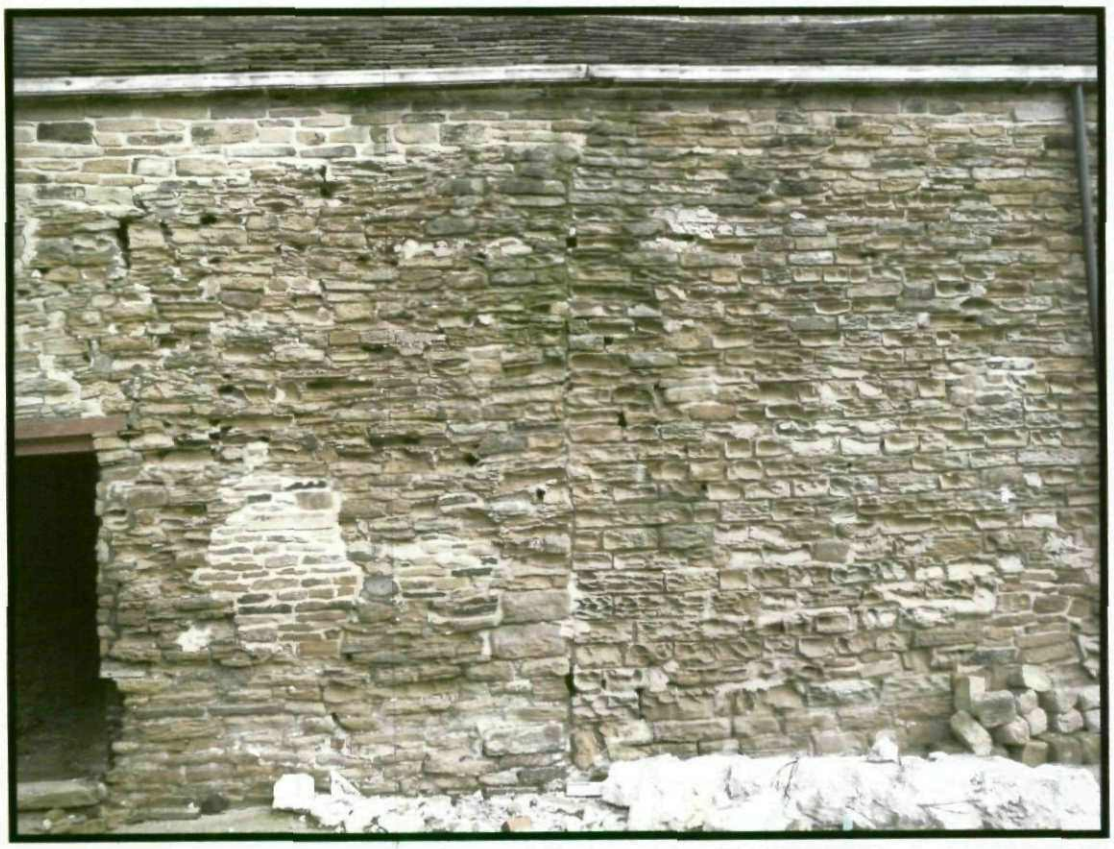
Photograph 1 – West Elevation

2.2.1 The West elevation is constructed in rubble filled random coursed stone masonry. The walls are approximately 450mm thick. The stone is showing signs of extreme weathering caused by wind and rain. This weathering is evident over approximately 75% of this elevation. In places the weathering has extended beyond the outer leaf and the rubble fill is exposed. **(Photograph 1)**

3.3 The West elevation has weathered so badly that the rubble fill has been exposed to the elements. This has allowed entry of water into the rubble fill between the two leaves of stonework. This can cause settlement of the fill inducing lateral forces on the wall causing bulging. This bulging is already evident in both the West and North elevations

4.1 The West elevation and the North Gable have been subjected to major movements and weathering and the structural integrity has been greatly impaired. This has rendered these walls beyond repair

- **Demolish the West elevation and North Gable wall and rebuild using salvaged stone from the walls where possible. The proposed construction is to be built off new concrete foundations using a blockwork inner leaf and salvaged stone laid in lime mortar. The new wall thickness should reflect the thickness of the existing wall. During construction of the new walls the timber frame will require temporary support**

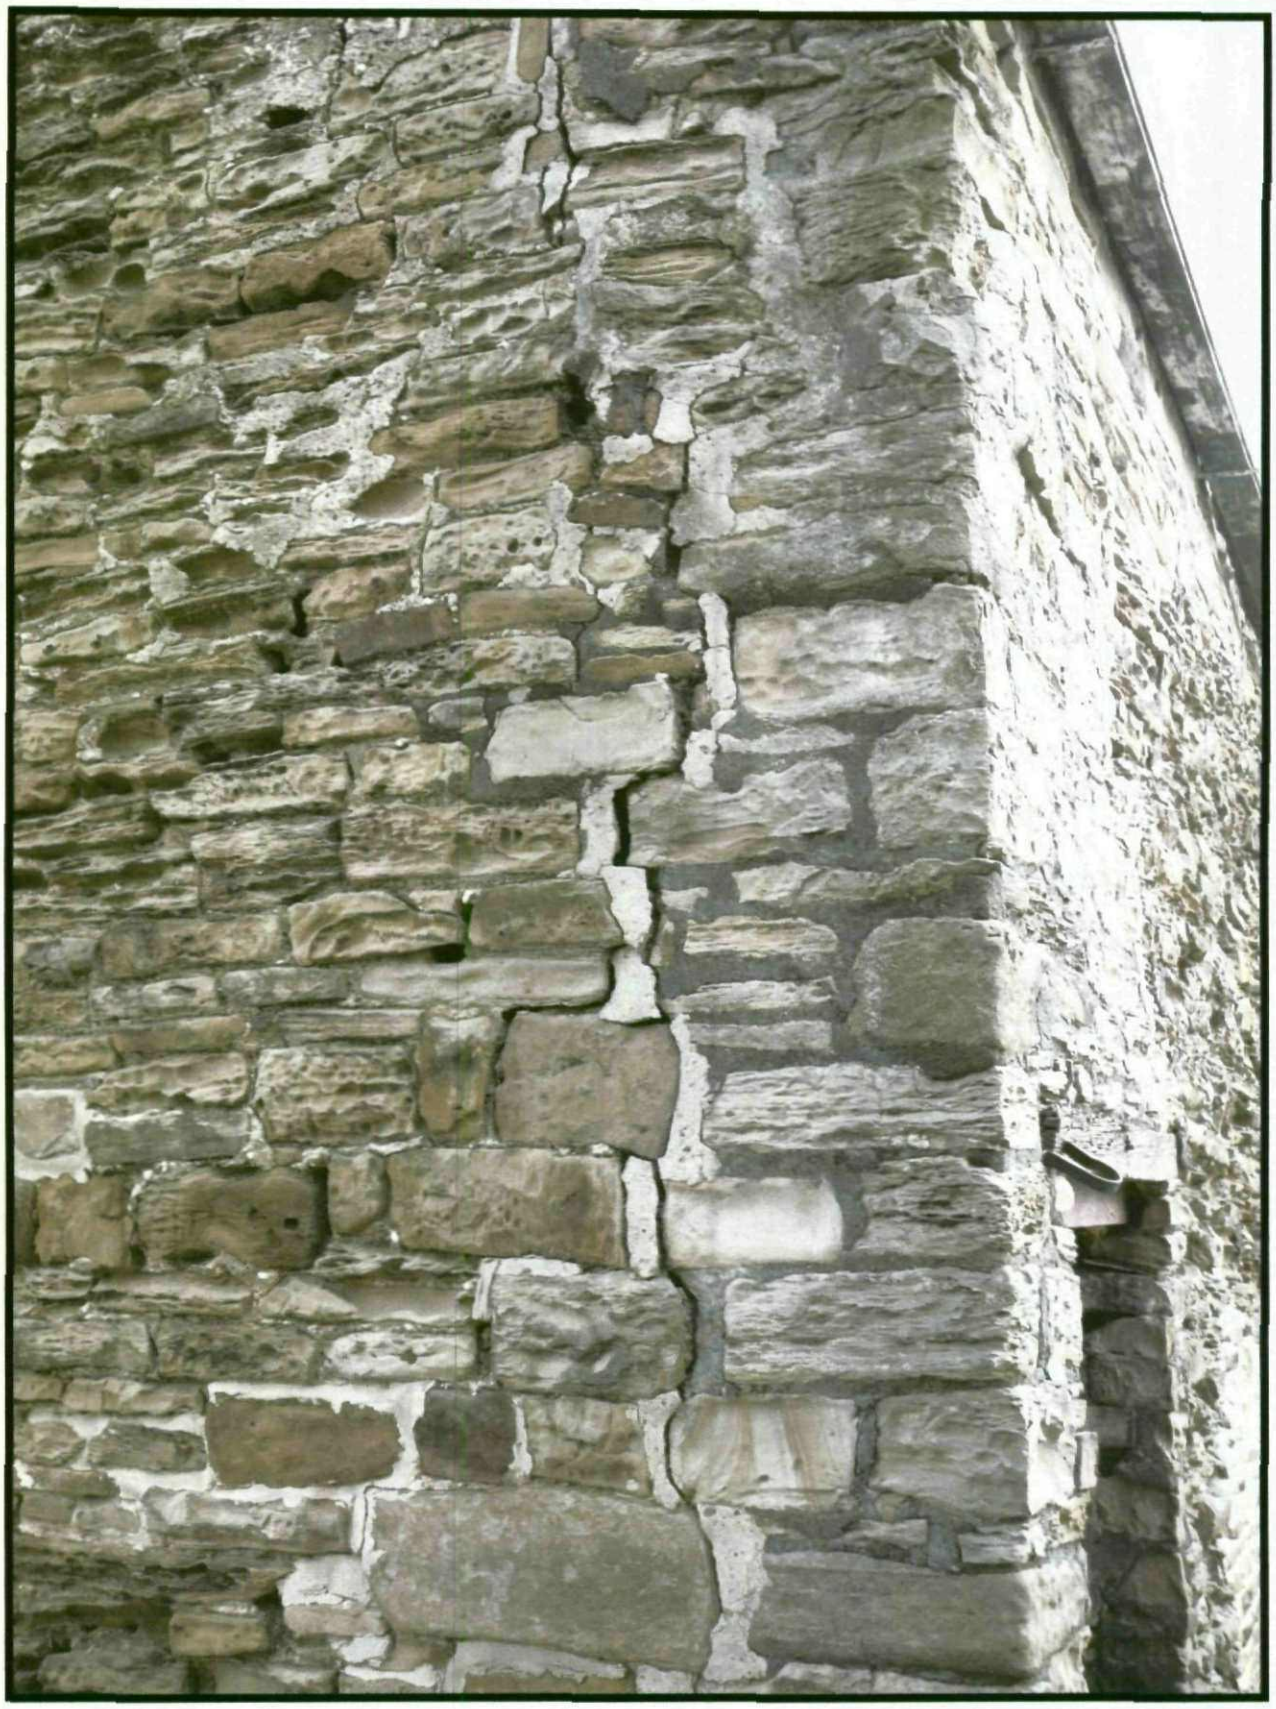
Photograph 4 – North Elevation (Gable) Crack highlighted

2.3.2 At the junction with the West elevation there is a large crack running the full height of the wall. This crack is approximately 20mm wide. It is evident that this cracking is due to outward movement of the West elevation. **(Photograph 4 & 5)**

3.4 The North elevation is in a very similar condition and is showing signs of lateral movement at high level.

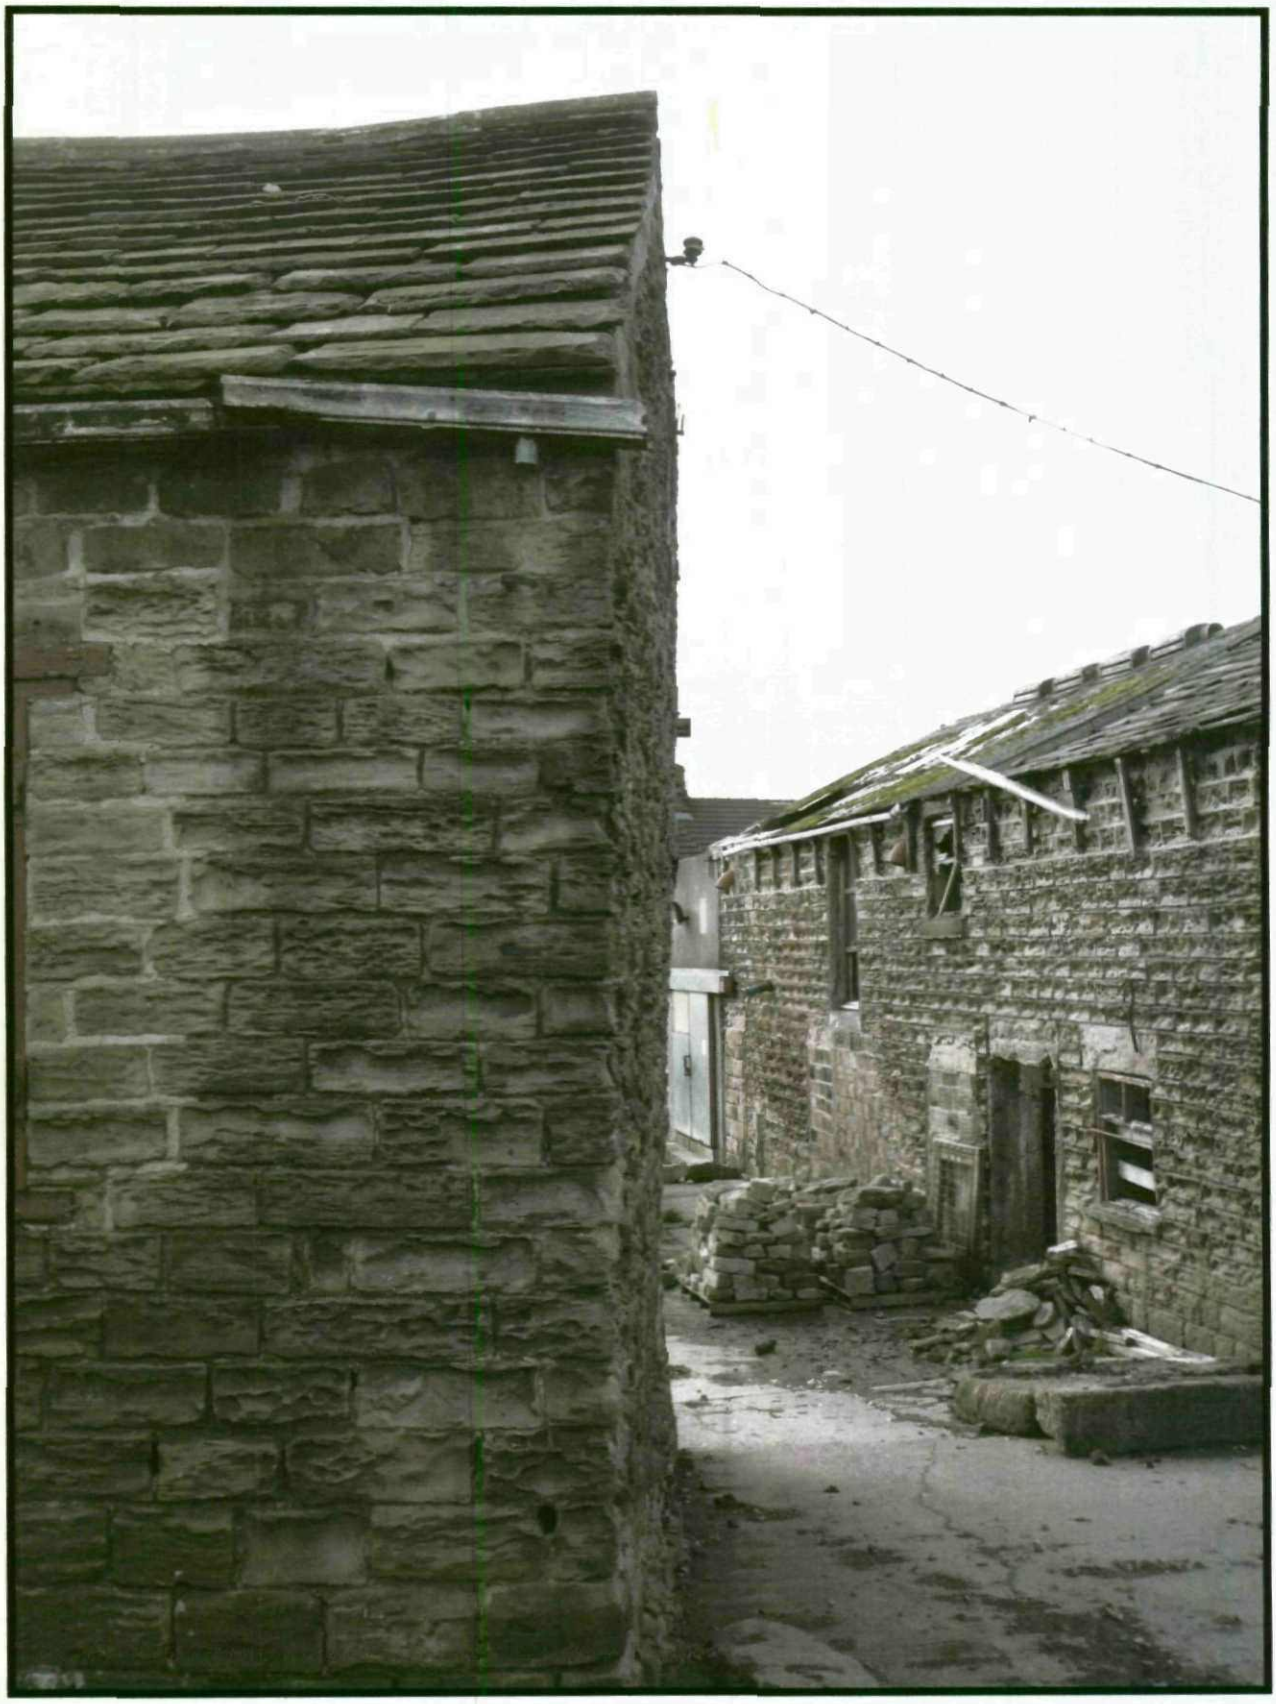
Photograph 5 – Close up of cracking in North Elevation (Gable)

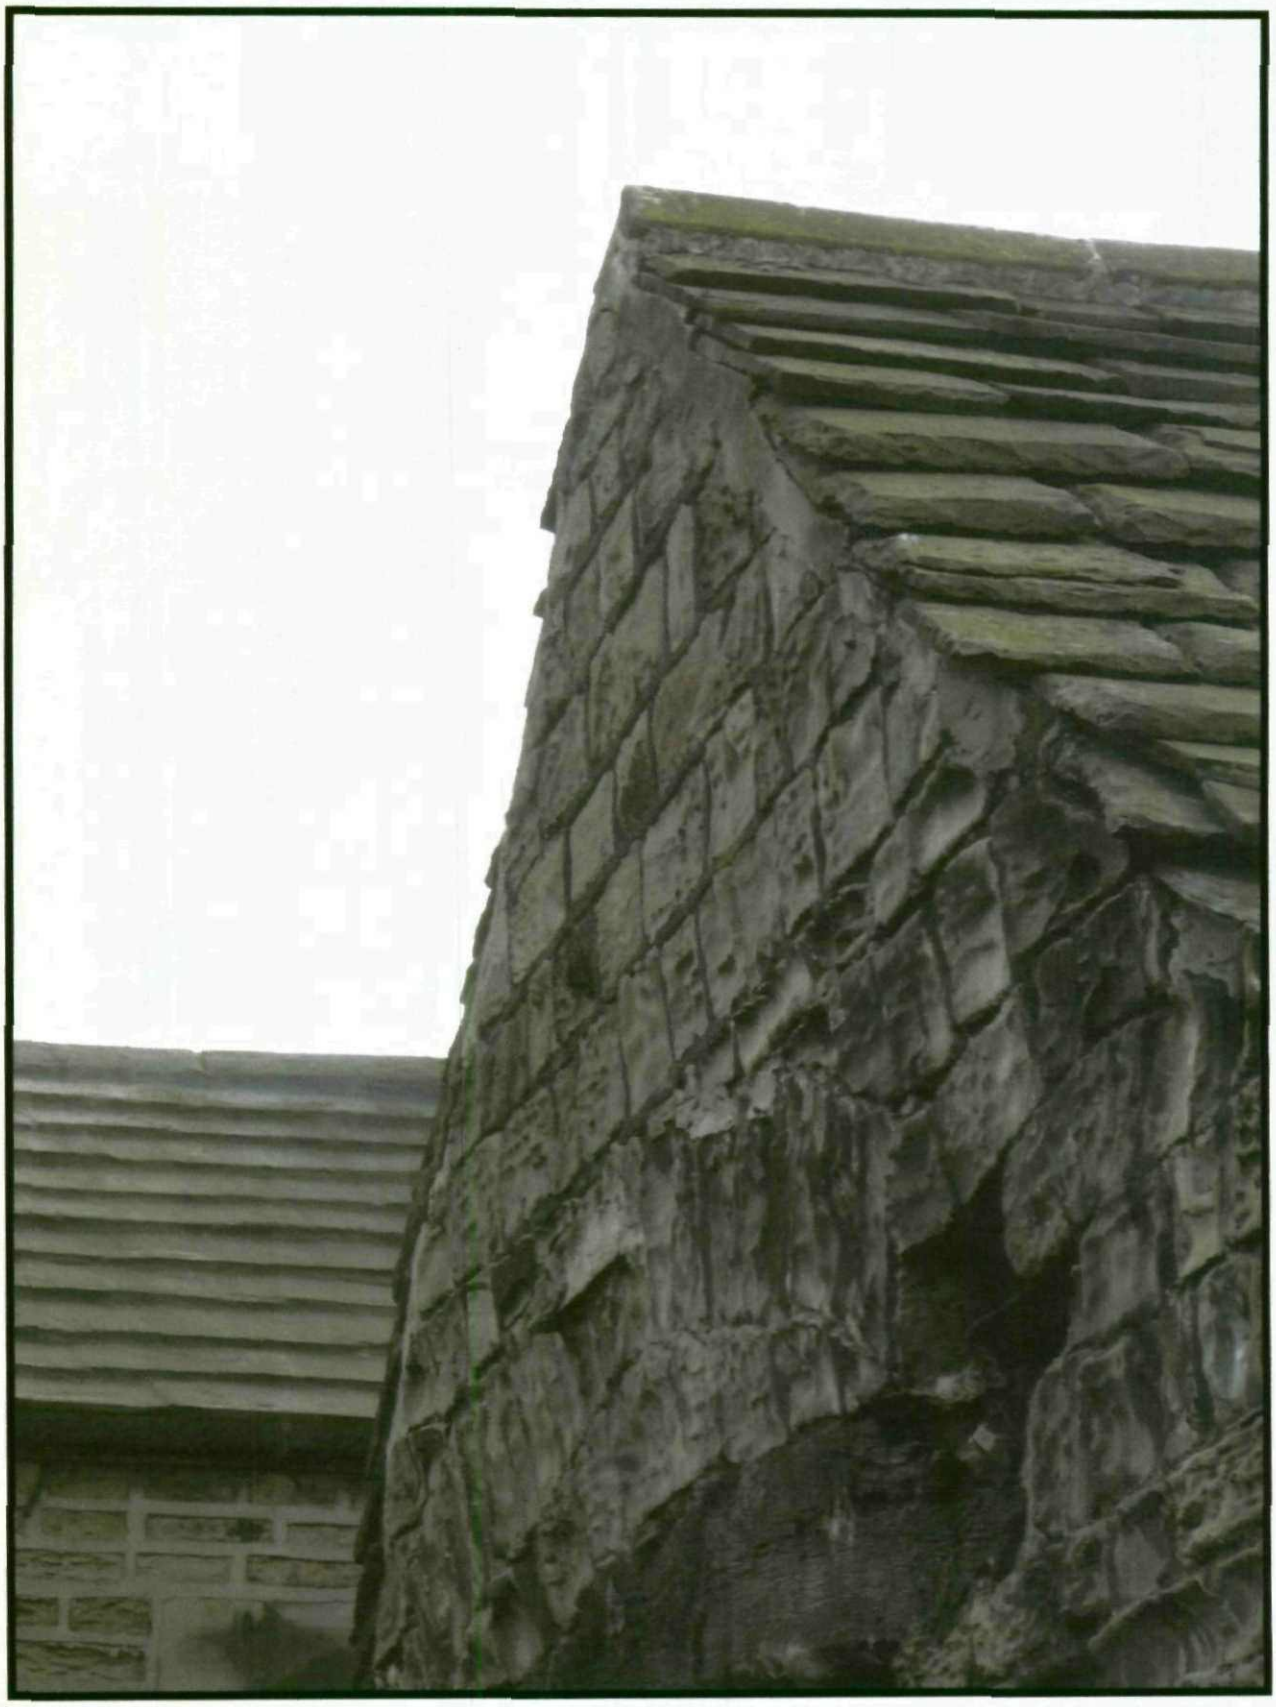
2.4.3 There are some areas of missing and damaged stonework within this elevation most notably around the gable extension within this wall. The damage around this gable is loss of masonry at eaves level, cracking to the right hand side and weathering of the stone face. **(Photograph 8)**

4.2 The East elevation has been constructed in higher quality materials and due to the sheltered nature has not suffered the levels of face deterioration and movements. There are some areas that require repair specifically above the large opening in the gable extension.

Photograph 8 – East Elevation showing damage to gable at eaves

- **The East elevation is to be retained and repair works carried out in the form of replacement of missing stonework and reconstruction of the gable wall above the existing lintel. The whole wall should be repointed using lime based mortar to improve the integrity of the wall.**
