PHASE I AND PHASE II
GEOENVIRONMENTAL
INVESTIGATION

WEST ROAD
POGMOOR
WEST YORKSHIRE

MR T SIMPSON & MR D LYCETT

JUNE 2007

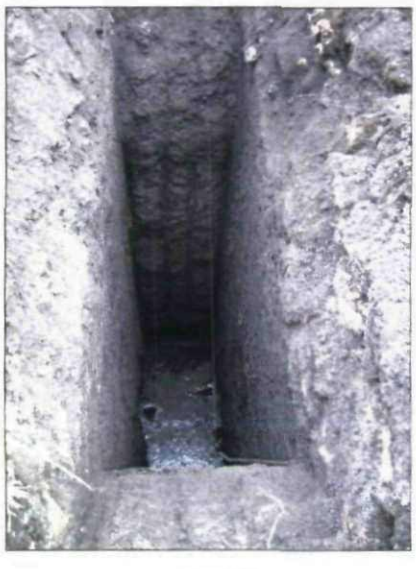
TP11.

upper made ground. In BH1 and TP1 compacted paper was encountered between 2.00m to 4.00mbgl. In TP6, TP9, TP10 and TP11 masses of broken and whole red bricks were encountered. In BH7 and BH8 the made ground comprised reworked clay with ash and brick and coal fragments and reworked clay with tiny coal fragments.
