Proposed Residential Development
Upper Woodhead Farm
Woodhead Lane
Hoyland
Barnsley
S74 9SY

Ref: 11.59
Date: March 2012

Structural Appraisal

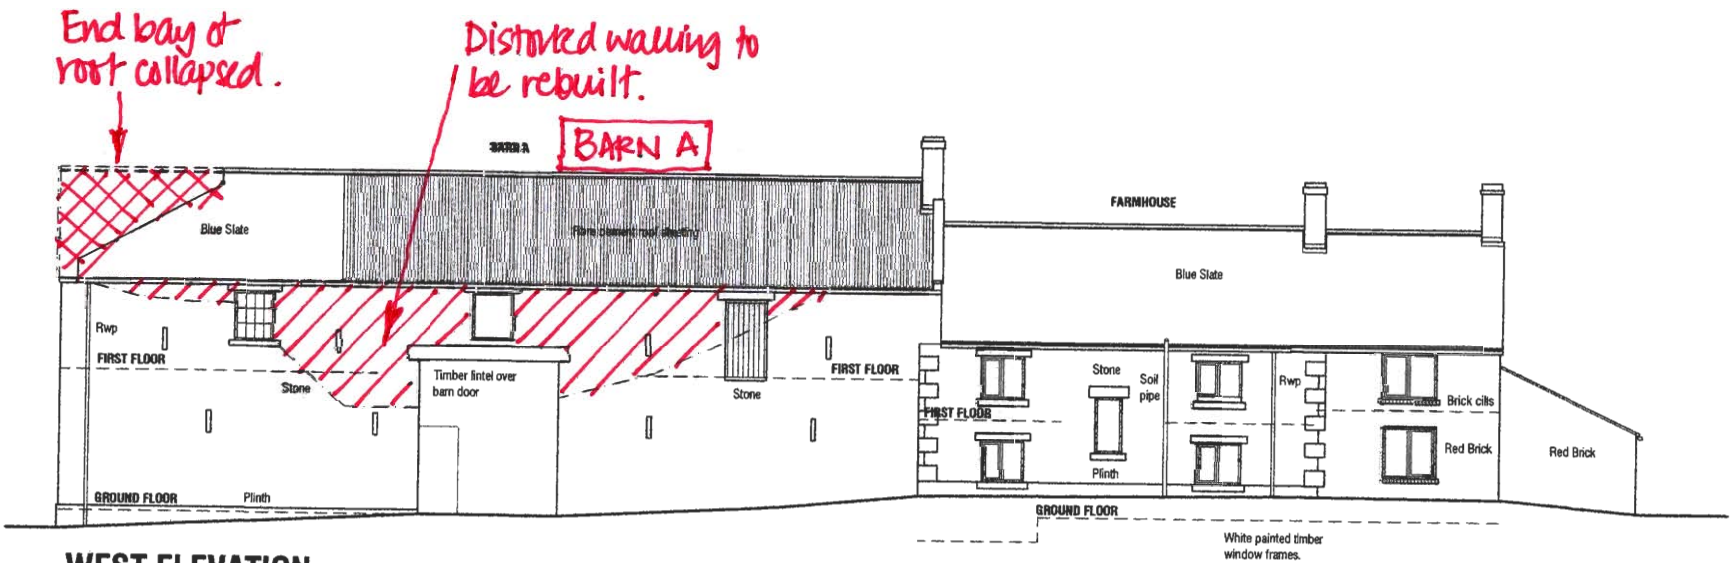
WEST ELEVATION

The open plan nature of the building which has no effective internal restraint has lead to distortion of the east and west elevations to such a degree that some rebuilding of the upper parts will be necessary. A plan is attached to the report which identifies the areas of walling affected. The majority of the external walls can be retained and the trusses reset as required. Internal scaffolding should be erected to support the trusses and retained areas of external walls to help stabilise the remainder of the building during the course of the works. New internal walls and the installation of a first floor will provide rigidity to the structure.

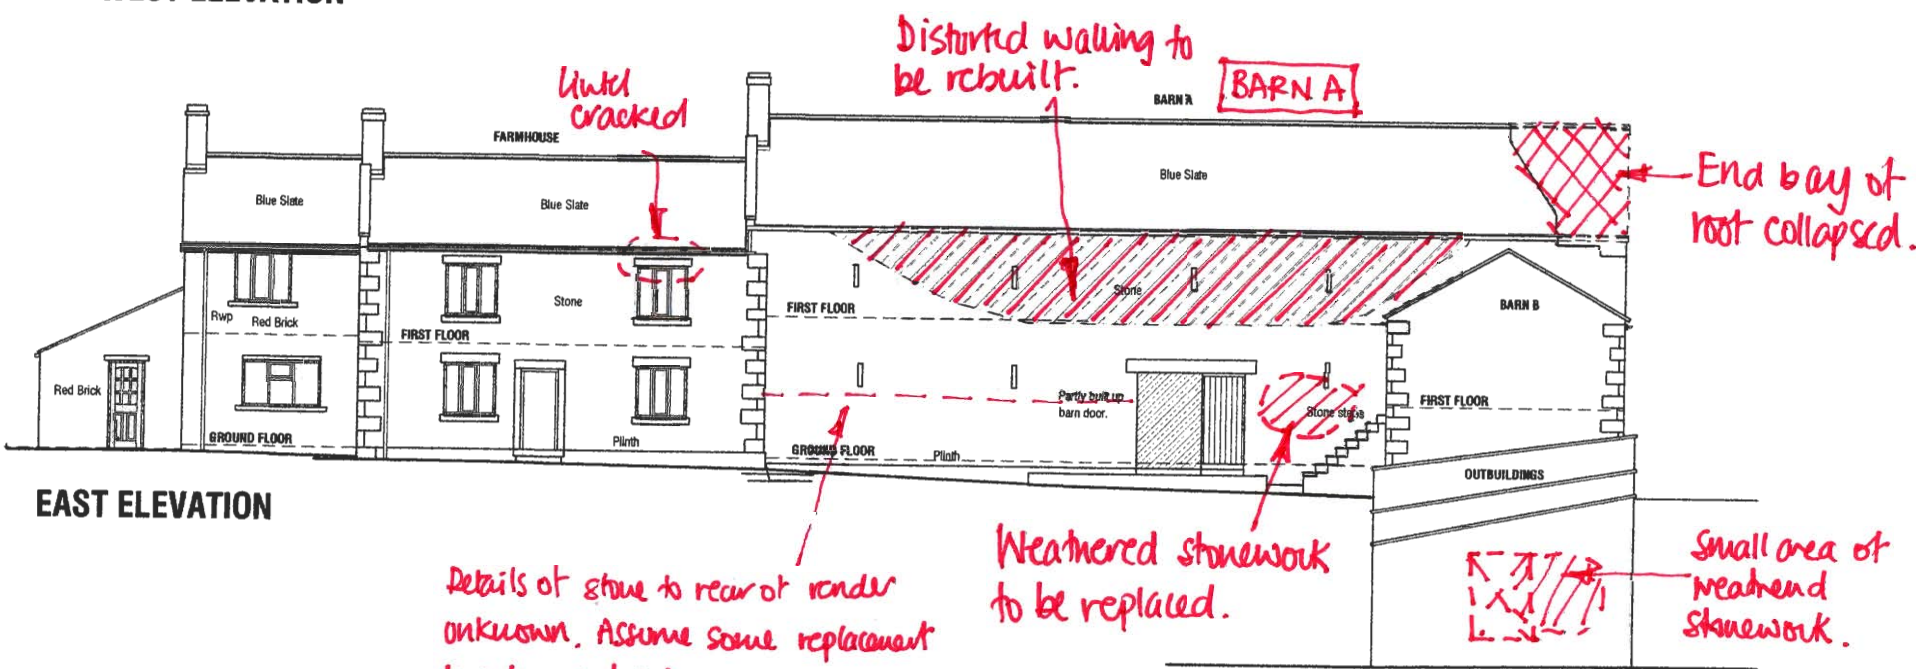
EAST ELEVATION

There is a small area of weathered stonework adjacent to the entrance door on the East elevation which will need to be replaced. There is also an area of cementitious render to the lower part of the east elevation which it is assumed has been undertaken due to weathered stonework. The render should be removed and repairs carried out to the stonework as necessary.

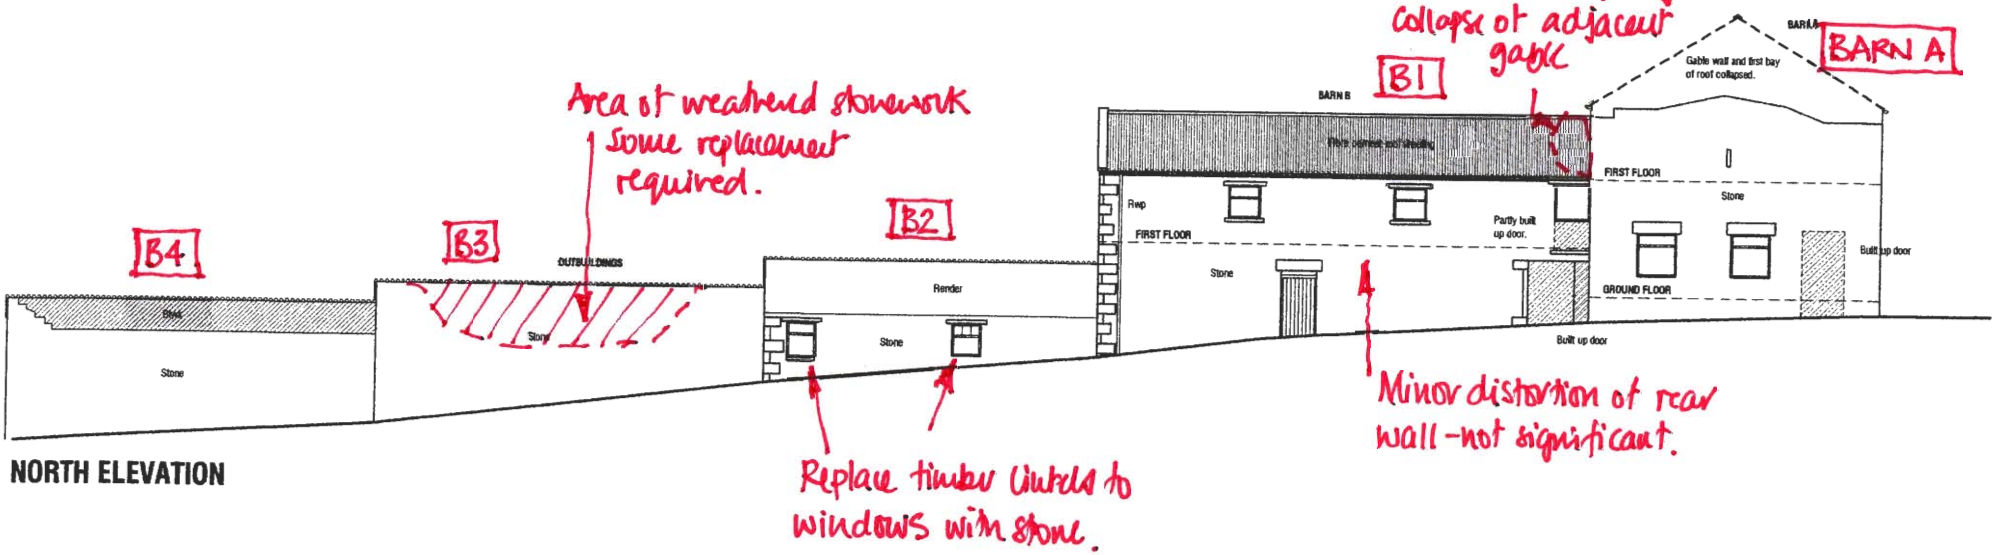
NORTH ELEVATION

The upper gable wall of the north elevation has collapsed together with the most northerly bay of the roof up to the first truss, see Fig 1. The purlins within this bay have fractured and are unsuitable for reuse. All of the trusses and the remainder of the purlins appear to be in good condition and capable of being retained, see Fig 2. The ends of the timbers trusses sit onto timber bearers and these together with the ends of the purlins at the south gable wall will require further inspection once the roof is removed to ensure that no deterioration of the bearing ends has occurred. The rafters and the wall plate will need to be replaced as part of the re-roofing works.
