NANNY MARR ROAD
(PHASE 2)
DARFIELD
HIGHWAY CONDITION SURVEY

Commissioned By:	Gary Pick
On Behalf Of:	Partner Construction
Local Authority:	Barnsley Metropolitan Borough Council
Inspection Date:	14th March 2019
JLES Project Reference:	PC/Nanny Marr Road/P2/Hw

Report Issued:	29th March 2019

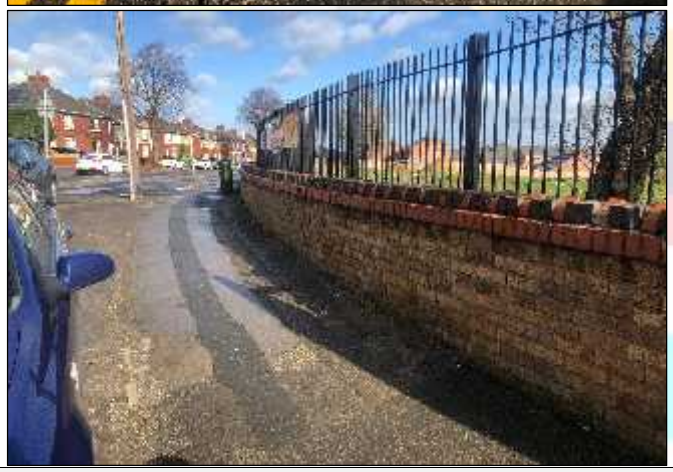
ITEM 13

LOCATION:	**Barnsley Road Footpath (100m – 150m).**
OBSERVATION:	**A) 5№ utility boxes appear to be in good condition.** **B) Footpath surface course is showing signs of wear / damage.** **C) Reinstatements are showing signs of wear.** **D) Numerous damaged kerbs.** **E) Moss / weed growth present throughout footpath.**
NOTES:	N/A.
REMEDIAL WORKS RATING:	1 2 3 4 5 6▼ 7 8 9 10 **LOW** **MEDIUM** **HIGH**
