ESTATE/PROPERTY
Wentworth Castle Gardens

DRAWING TITLE
Serpentine Bridge Repairs

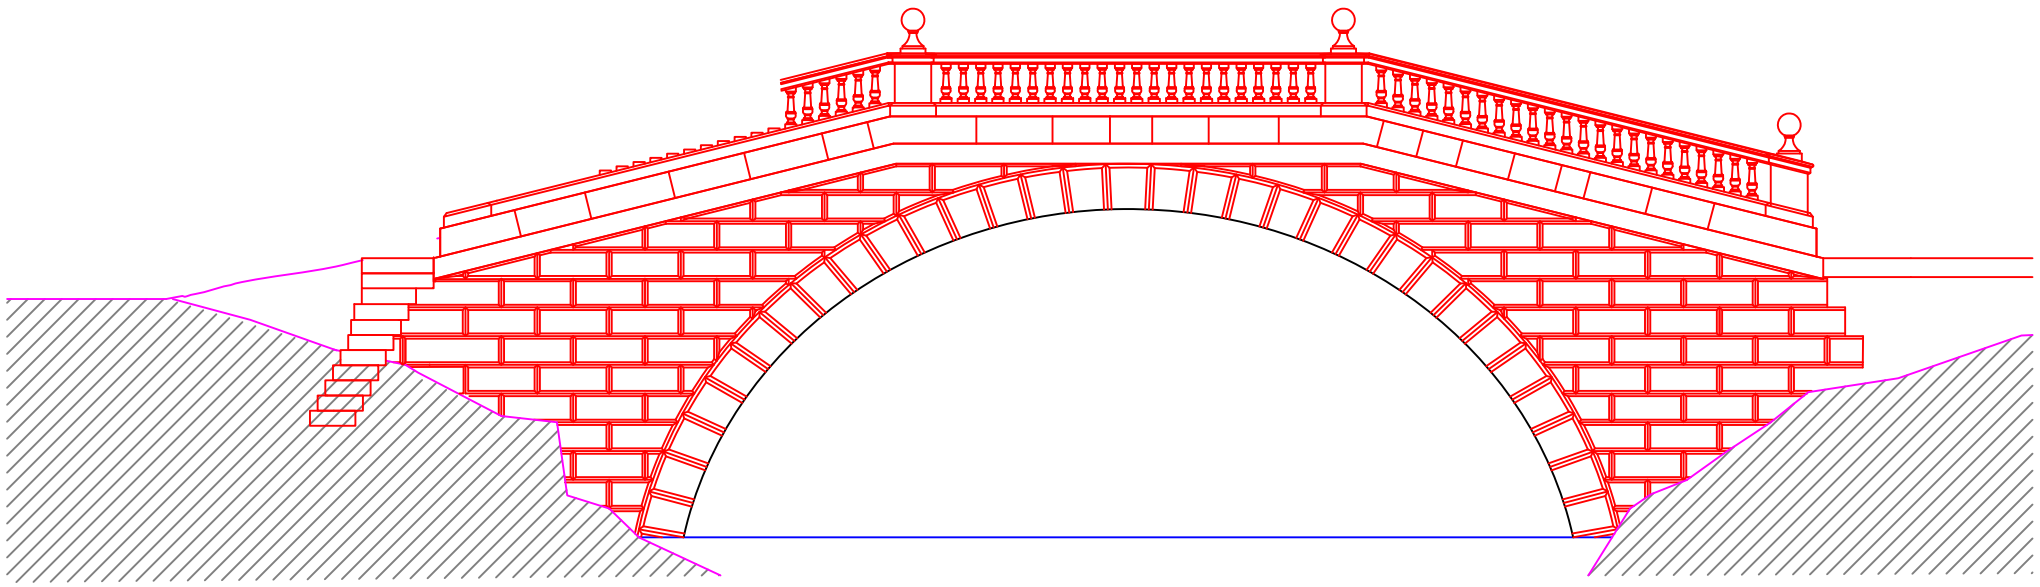
Existing Damaged Bridge

Extent of stone balustrade to be replaced. Replicate existing stone work exactly. Plinths to be installed with longer s/s dowels, embedded at least 100mm into the stone. A stronger lime mortar to be used when reinstating stonework.
