ESTATE/PROPERTY
Wentworth Castle Gardens

DRAWING TITLE
Estate Wall Repairs

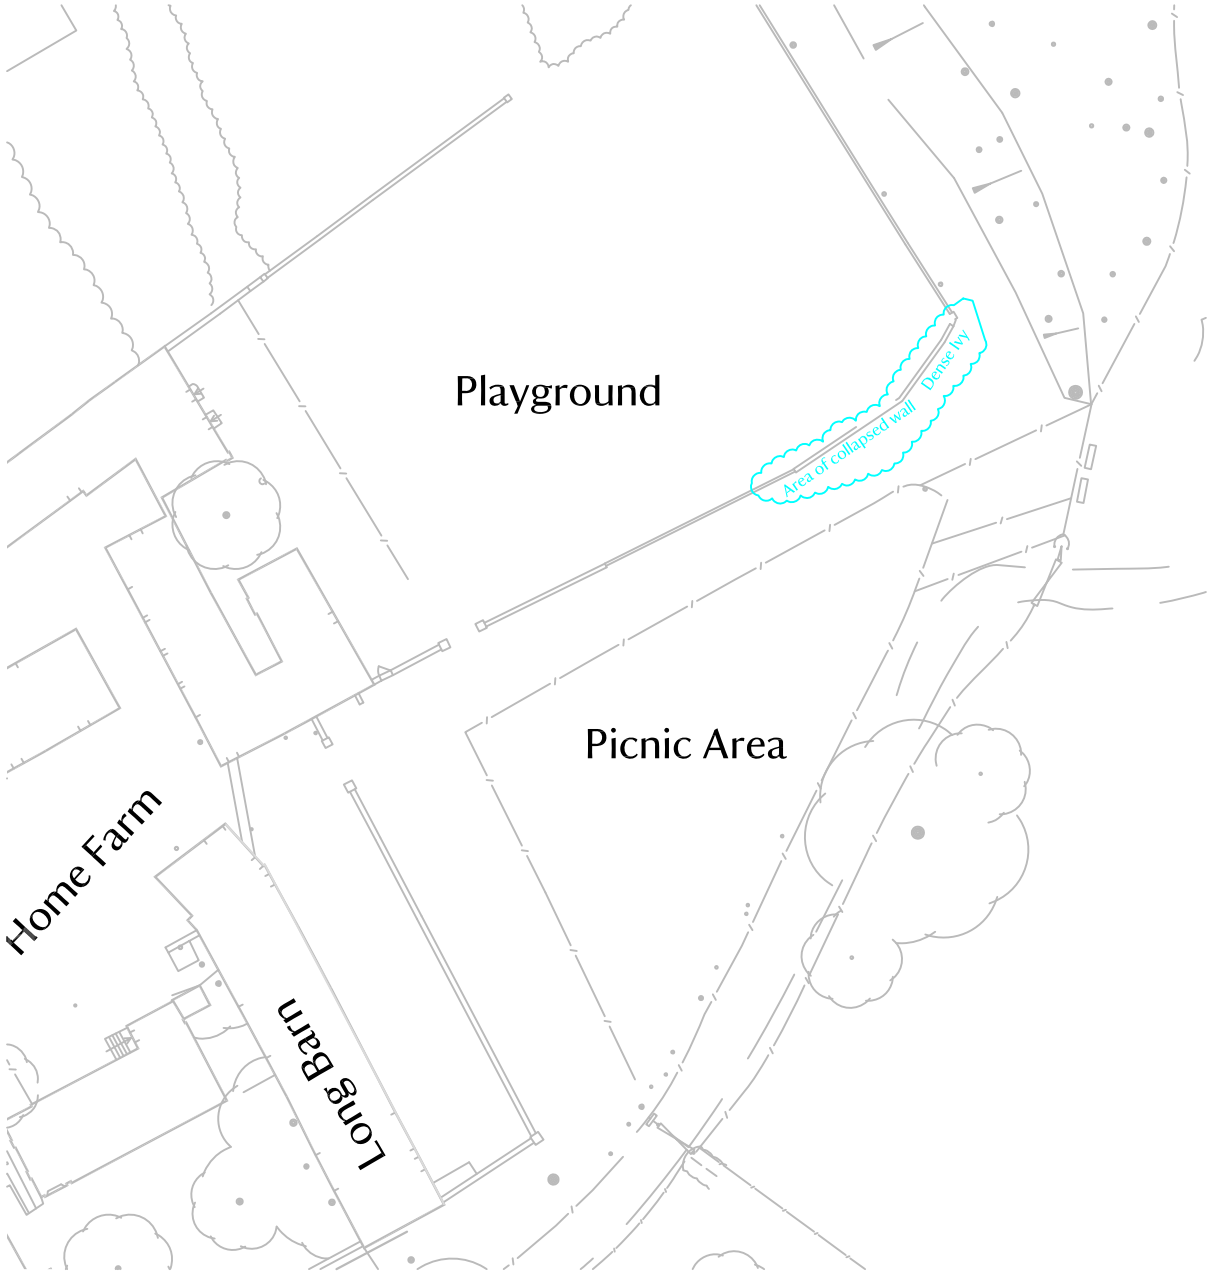
Area of wall that needs re-pointing and stone replacement. Remove ivy and vegetation. Using hand tools remove defective mortar. Remove any defective stones. Match any replacement stone and take lime mortar sample
for matching new lime mortar to.
All as per specification.

Area of severely eroded stonework. Carefully cut out defective stone with hand tools . Match in replacement stone and take lime mortar sample for matching.

Area of collapsed stone wall proposed to rebuild. Remove ivy and recover stone to be reused. Match any replacement stone and take lime mortar sample for matching.
