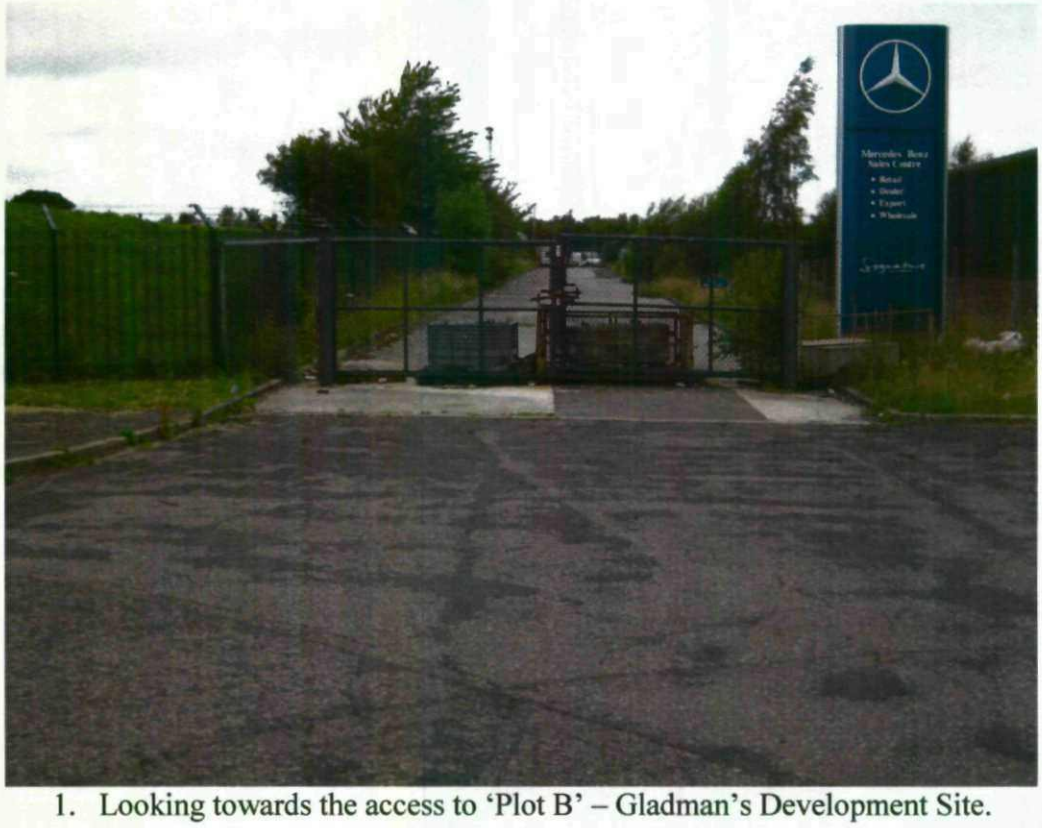
1. Looking towards the access to 'Plot B' – Gladman's Development Site.

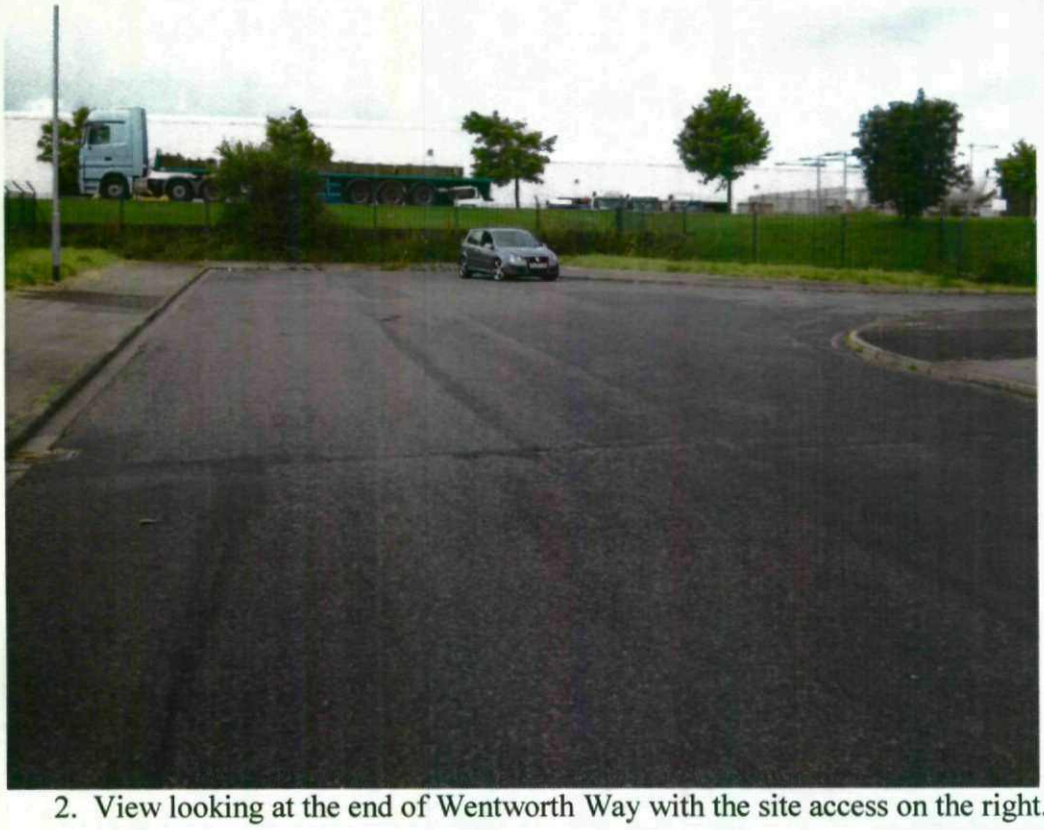
2. View looking at the end of Wentworth Way with the site access on the right.

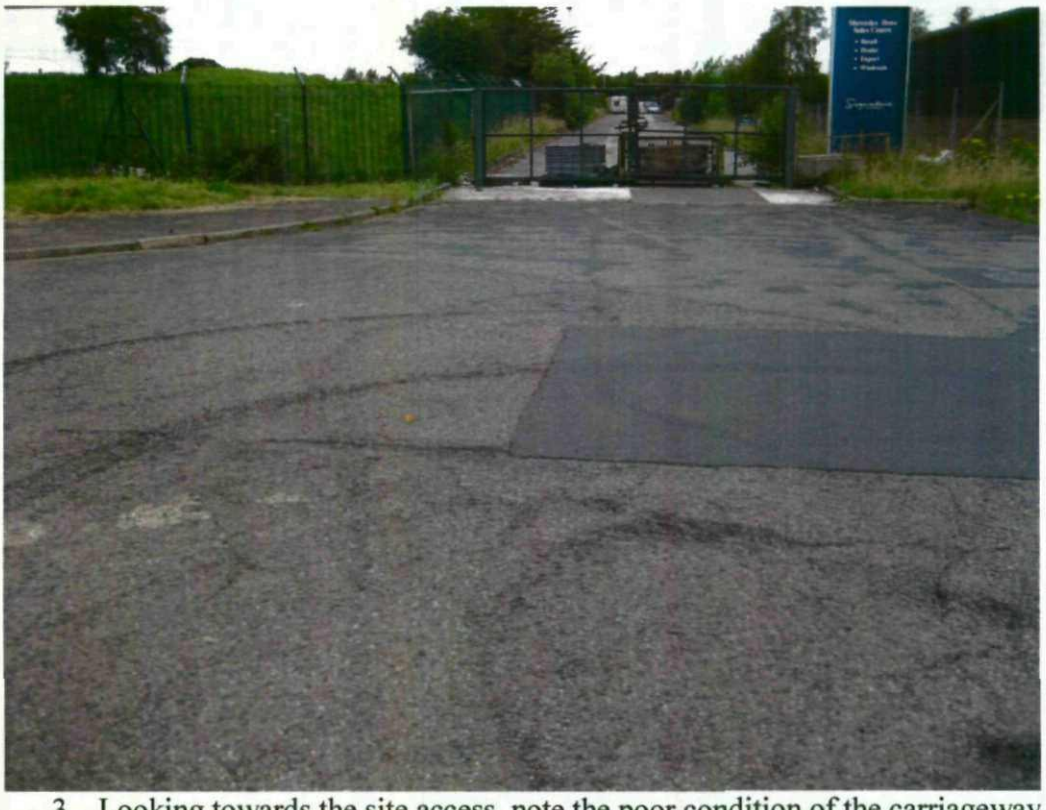
3. Looking towards the site access, note the poor condition of the carriageway surface.

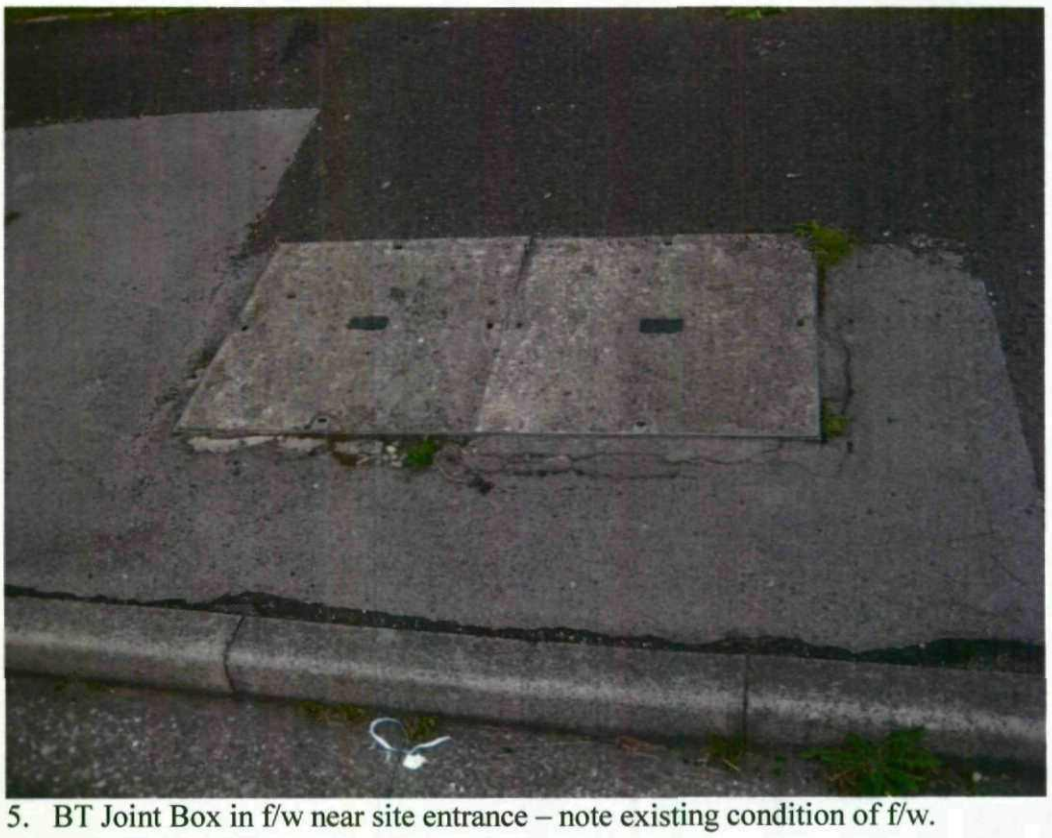
5. BT Joint Box in f/w near site entrance – note existing condition of f/w.
