STRUCTURAL INSPECTION

BARN BUILDINGS

CLIFF HOUSE FARM

Reference No. **11/101**

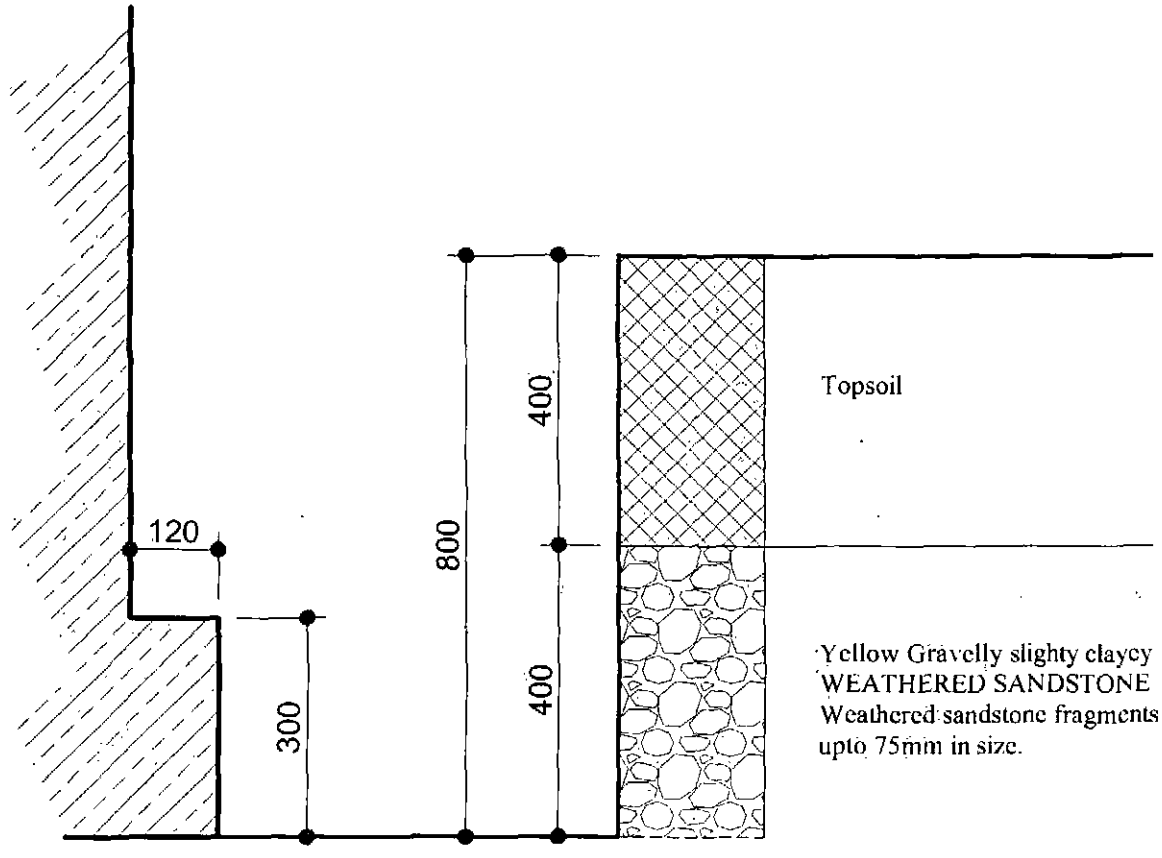
SECTION THROUGH TRIAL PIT
ON
WEST ELEVATION OF LAITH BARN

2.1.3.10 A trial pit was dug on this elevation. The underside of the foundation was located only 500mm below ground level. The ground comprised approximately 150mm of topsoil and then and clay and gravel weather sandstone subsoil. No tree roots were observed in the trial pit. **(Photograph 14) & (Figure 1)**

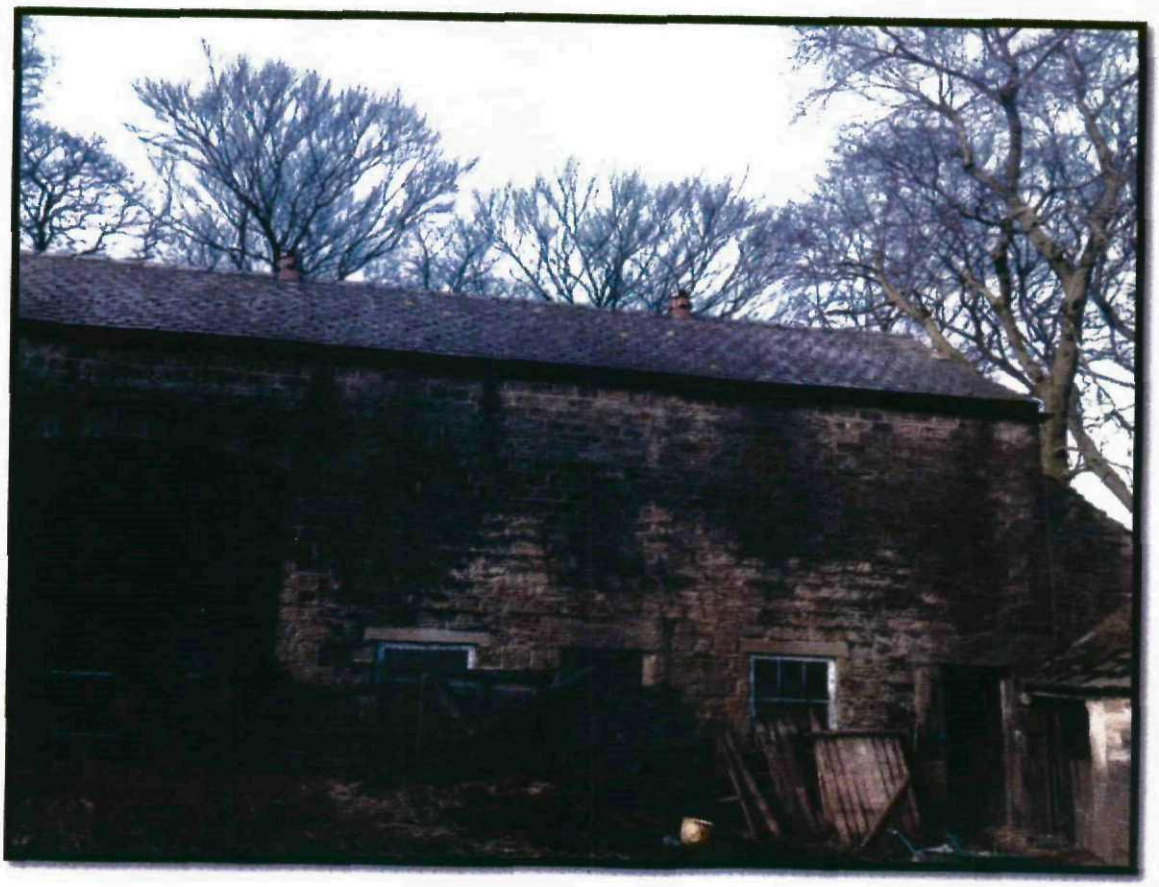
Photograph 2 – East Elevation

2.1.2.6 Lintels over doorways and windows are generally in good condition. One lintel at first floor level shows signs of outward movement. Two lintels at ground floor level have been replaced with modern concrete lintels **(Photograph 2)**

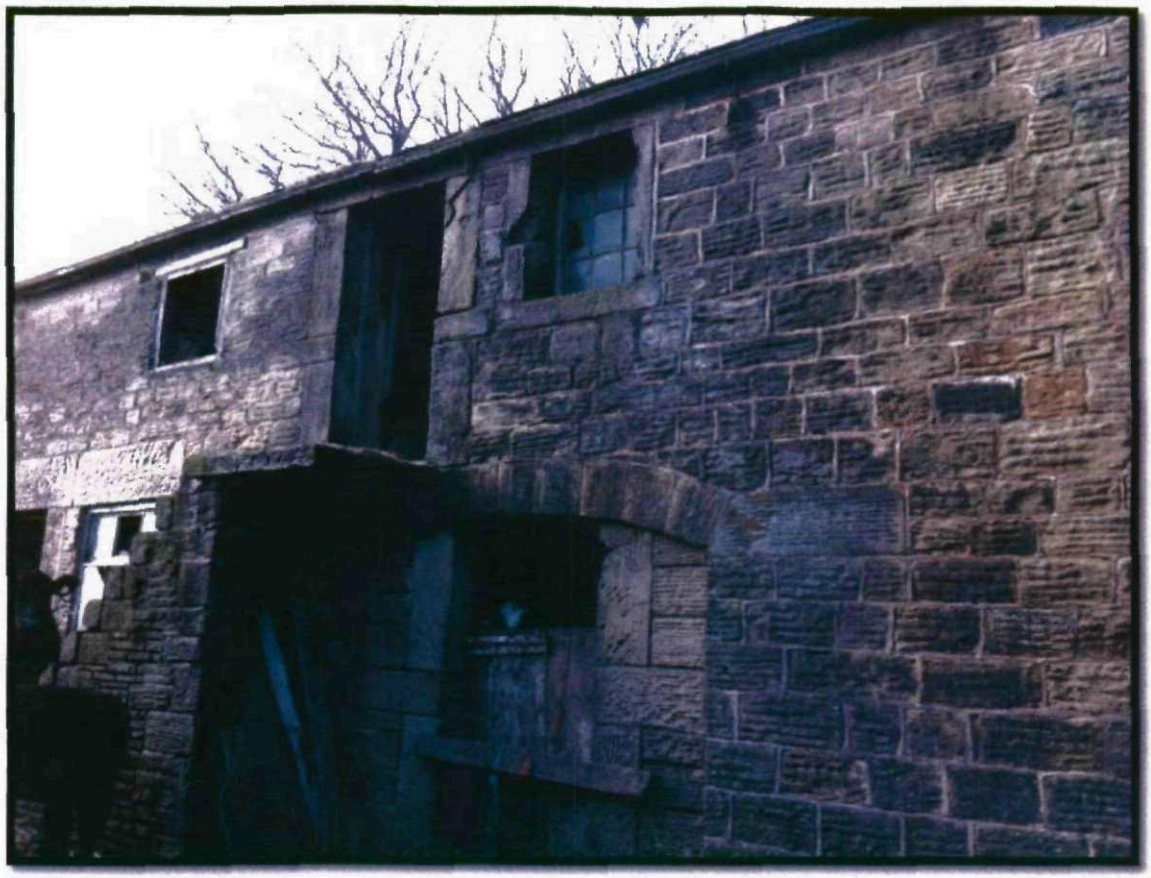
2.1.2.5 There are two archway door openings in this elevation. Both openings are in good structural condition showing no signs of settlement or failure. The smaller opening has had infill masonry each side to make a smaller door opening. **(Photograph 3)**

Photograph 3 – View of small arch opening

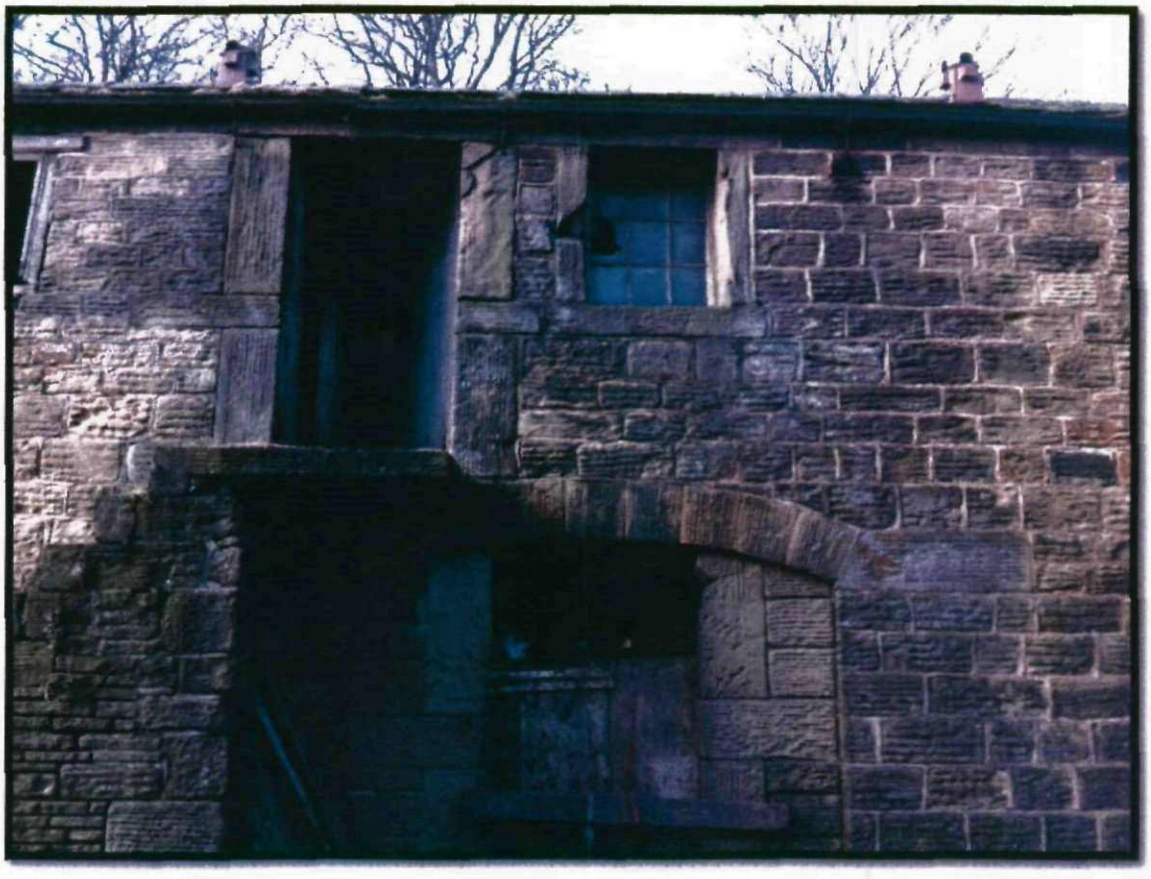
2.1.2.7 Most of the doorways and one of the windows at first floor level have vertical stone reveals which are generally in good condition with some cracks noted to two of the reveals **(Photograph 4)**

Photograph 4 – View of damage to stone reveals

2.3.3 Carry out repairs to stone reveals around doors and windows.

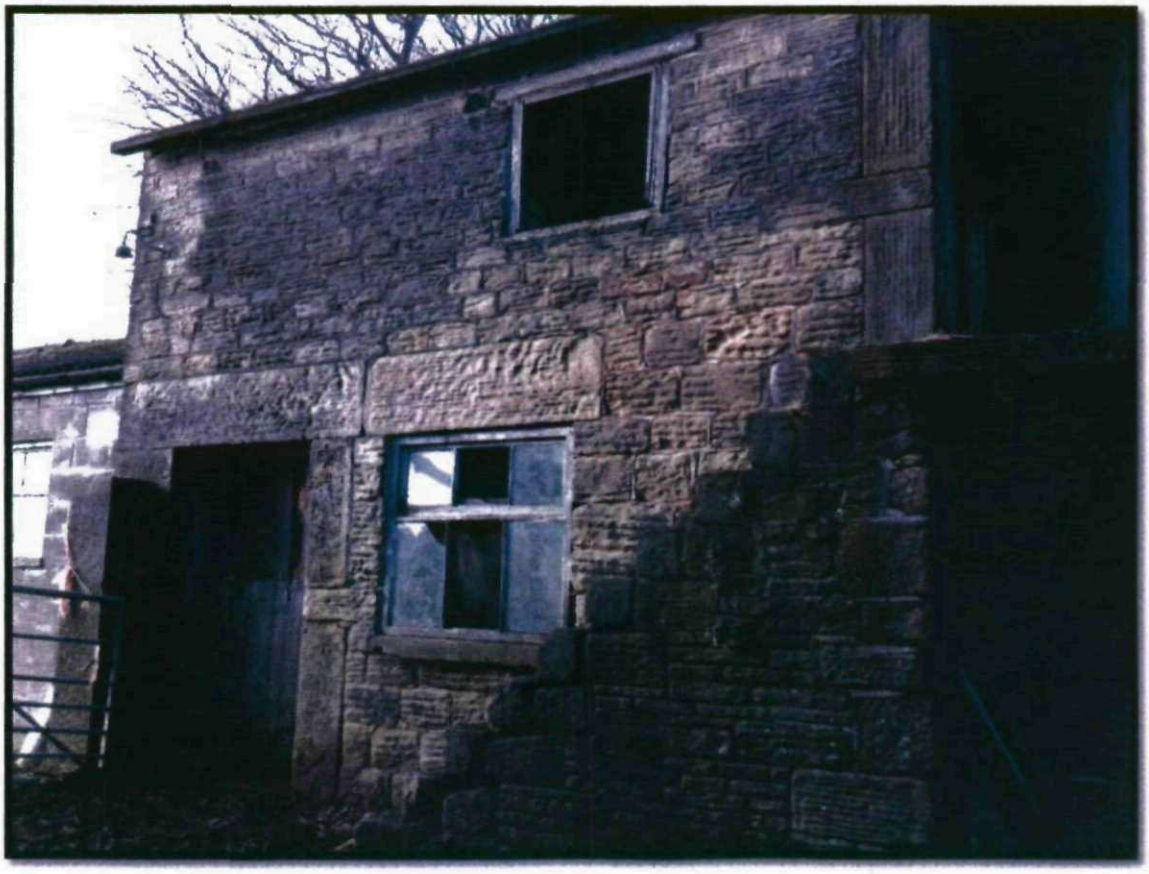
2.1.2.8 There are a set of external stone steps at the North end of this elevation. The walls to these steps are constructed in stone masonry and are in good condition. The original stone steps have had insitu concrete threads cast on top. There is a cantilever stone landing at first floor level which is in good condition. **(Photograph 5, 6 & 7)**.

Photograph 5 – View of external steps

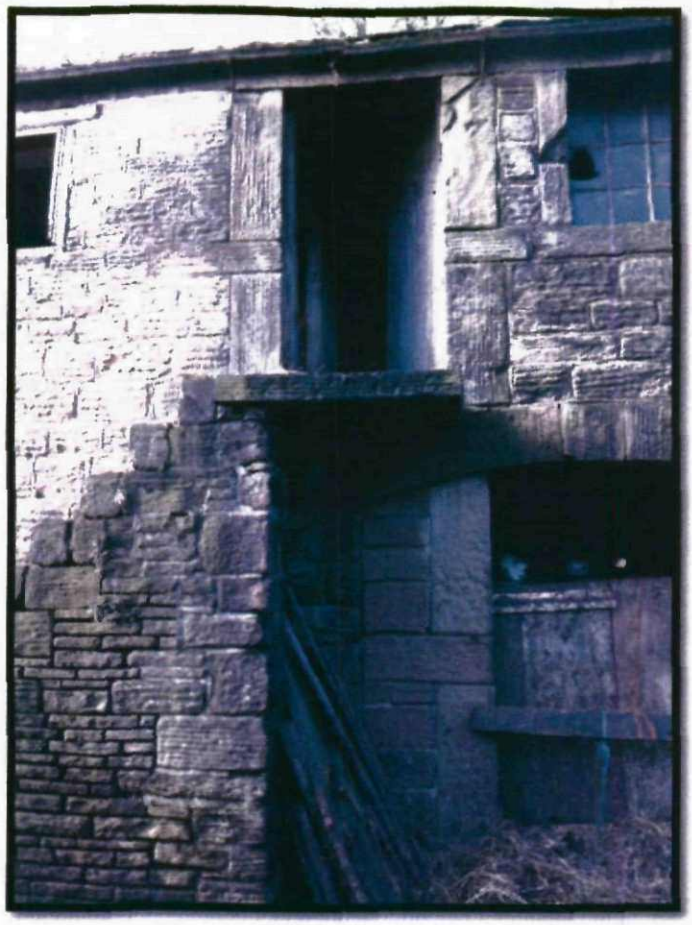
Photograph 7 – View of cantilever landing

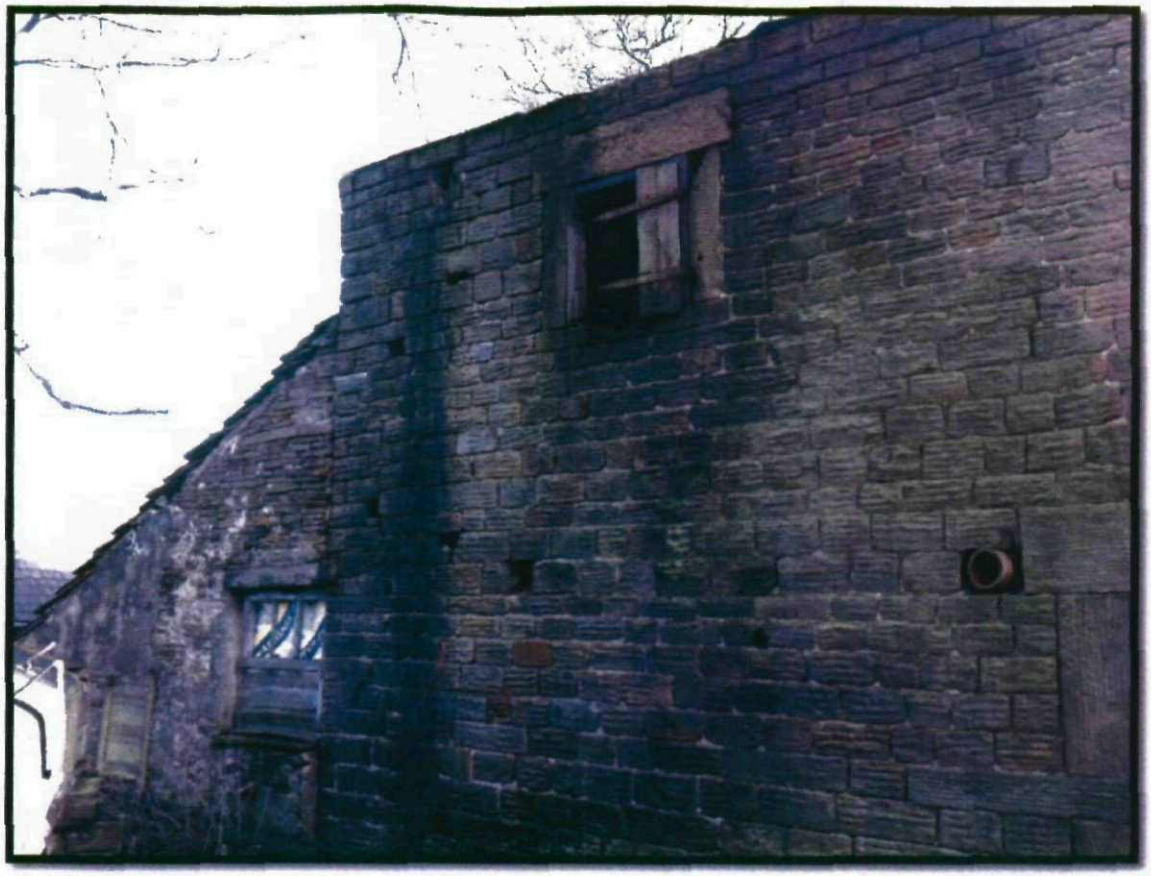
2.1.3.2 The wall is generally in good condition with some localised major weathering and damage to the stonework at the Northern and Southern ends caused by rainwater discharge from roof caused by missing guttering and down pipes. **(Photograph 9 & 10)**

Photograph 9 – View of Northern end of West elevation

2.3.1 Although the external walls have suffered some minor movement and weathering they are generally stable and showing no signs of distress or major movements. Where excessive erosion, movement and stones are missing this should be replaced with reclaimed stone to maintain a weather tight outer face.

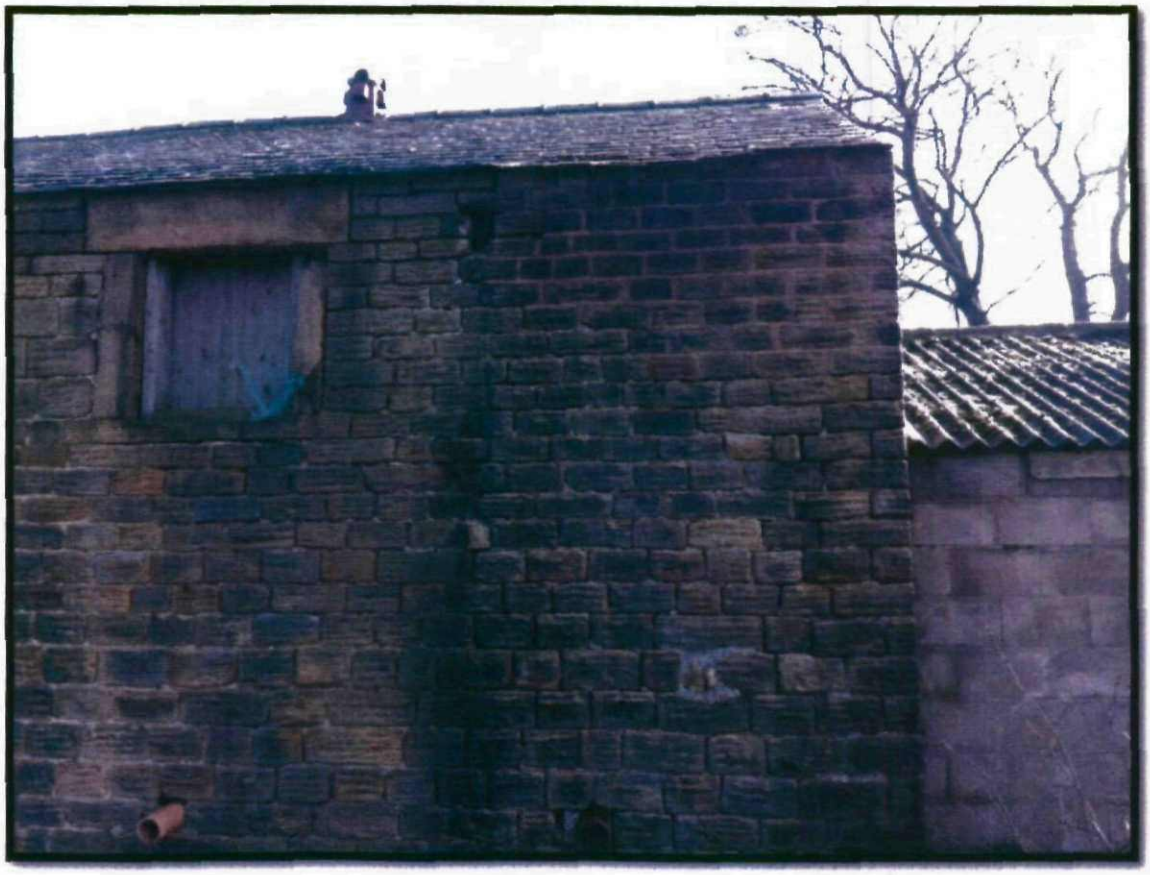
2.1.3.7 The vertical stone reveals to the windows and doors in many of the locations have cracked or are weathered. **(Photograph 10, 11 & 13)**

Photograph 10 – View of Southern end of West elevation

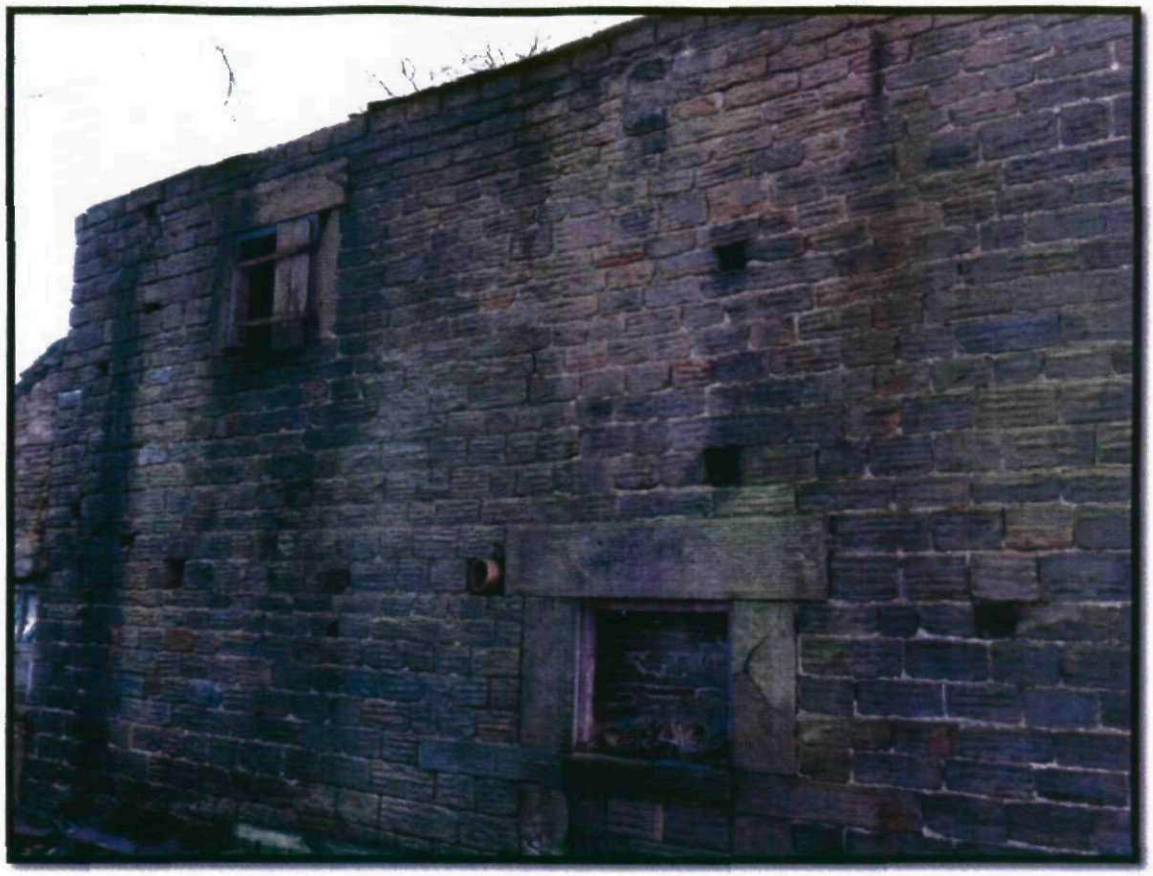
2.1.3.4 The wall shows no signs of major bulging, cracking or movement in both the vertical and horizontal planes. There was some minor cracking noted to the corner of one of the ground floor windows **(photograph 11)**.

Photograph 11 – View of crack above window

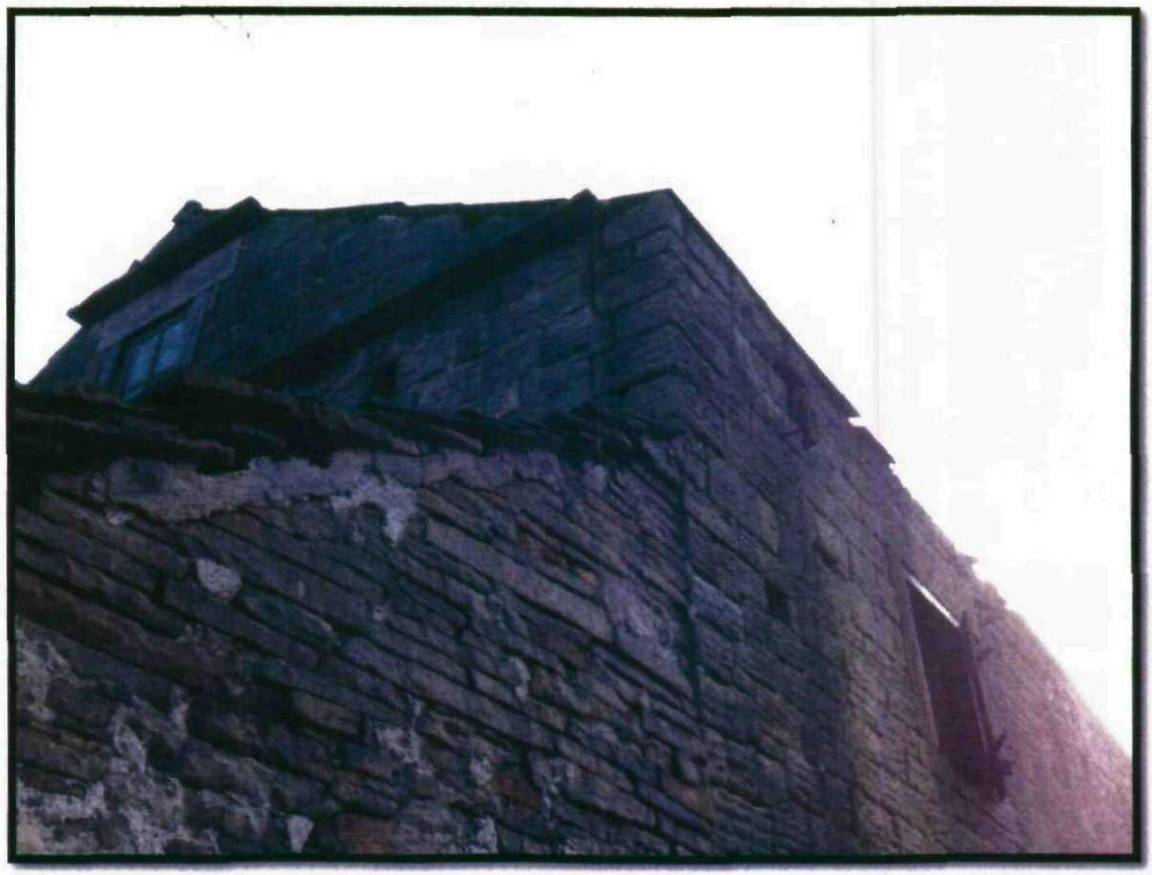
2.1.3.6 Some minor localised horizontal outward movement of the wall was also noted at eaves level.

Photograph 12 – View of first floor window showing outward horizontal movement of lintel

2.3.4 Where outward movement at eaves has occurred this should be repaired and tied back to the roof structure.

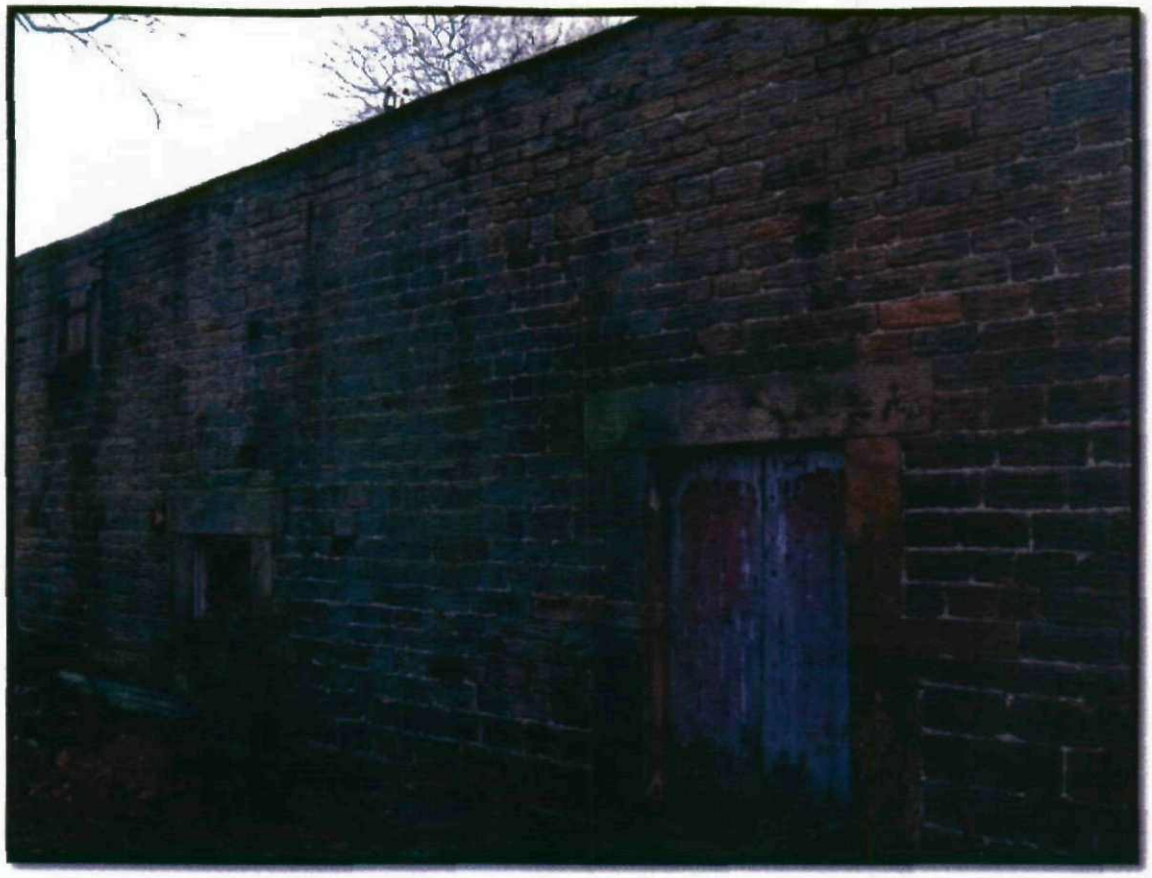
Photograph 13 – Showing damage to stone window reveal

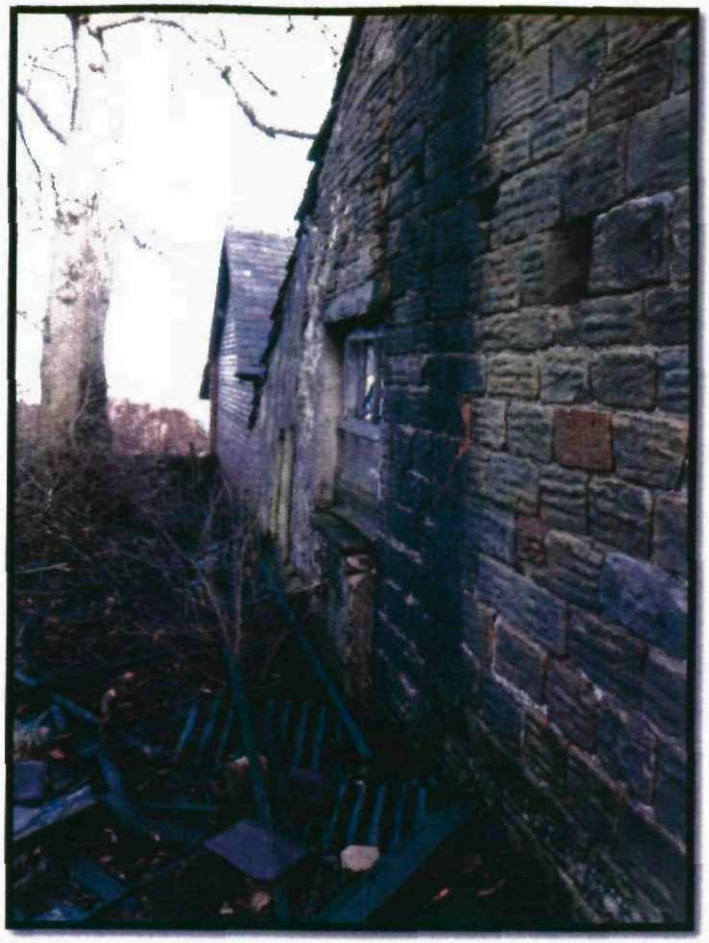
2.2.16 The trial pit that was dug on the West elevation revealed that the foundations were very shallow (only 500mm below ground level). The ground encountered was granular weathered sandstone with some clay content. There were no root present in the trial pit

Photograph 14 – View of trial pit dug on East Elevation

2.3.8 The foundations to the external walls are very shallow however, there is no sign of major cracking or movement and the ground at foundation level is of a good ground bearing capacity. Due to the granular nature of the subsoil seasonable moisture affects should be minimal.

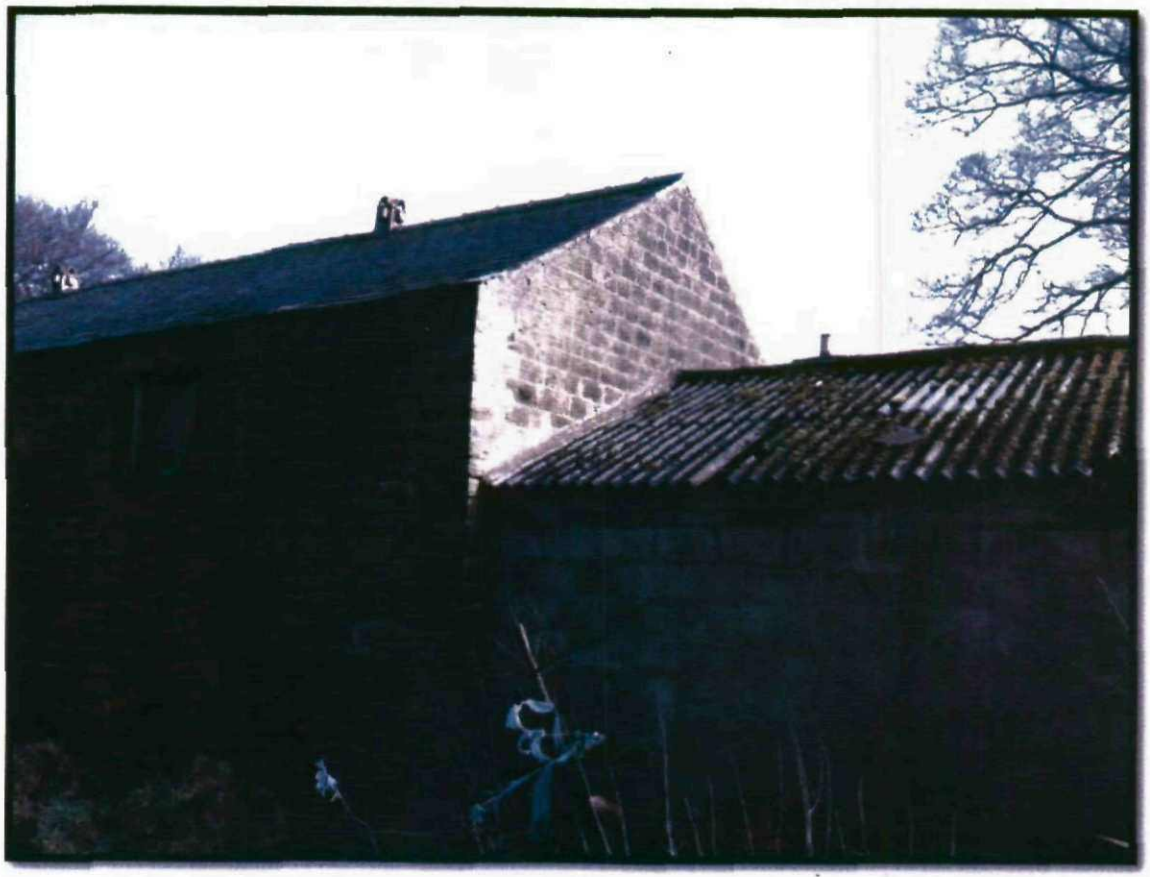
2.1.4.1 The South elevation is a gable wall approximately 500mm thick and is constructed in coursed stone masonry. **(Photograph 16)**

Photograph 16 – View of South Elevation

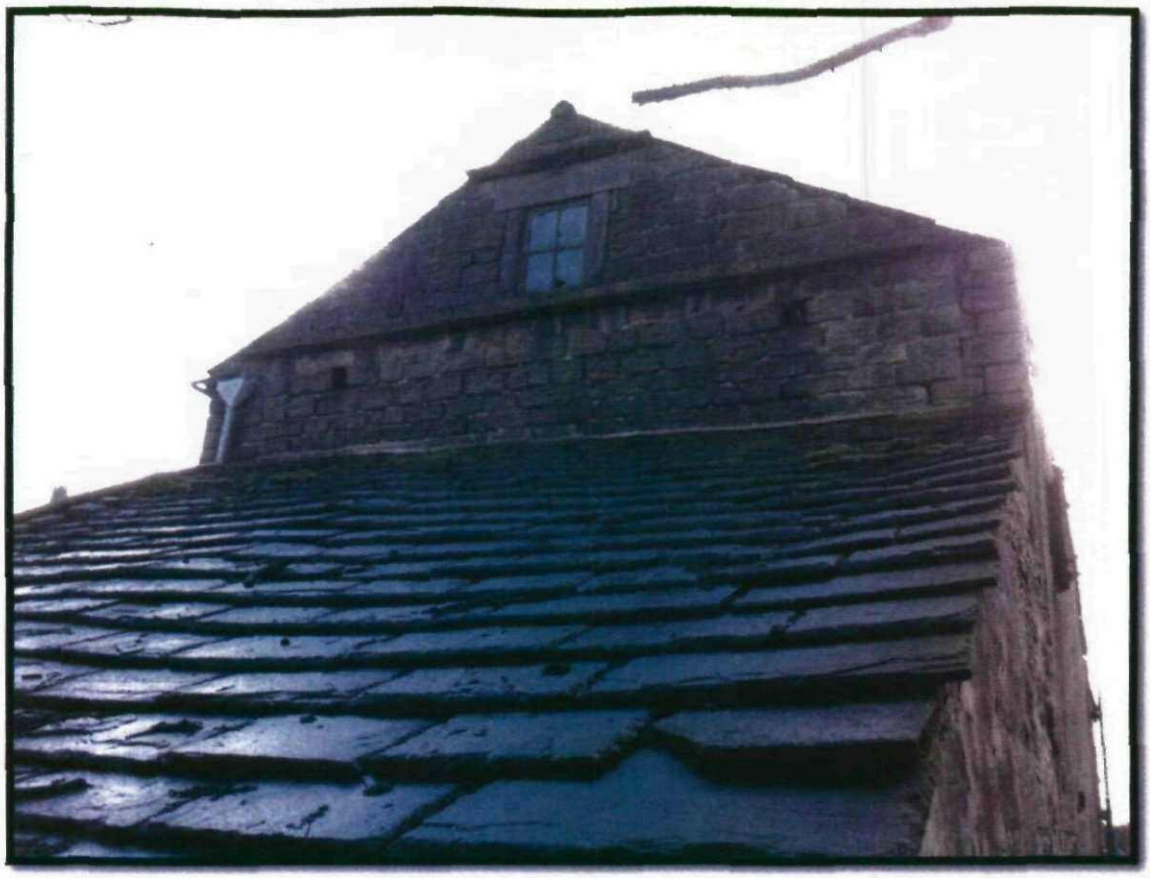
2.1.5.3 The wall is generally in good condition with some localised cracking and movement noted at eaves level on the Western corner. **(Photograph 17)**

Photograph 17 – View of North Elevation

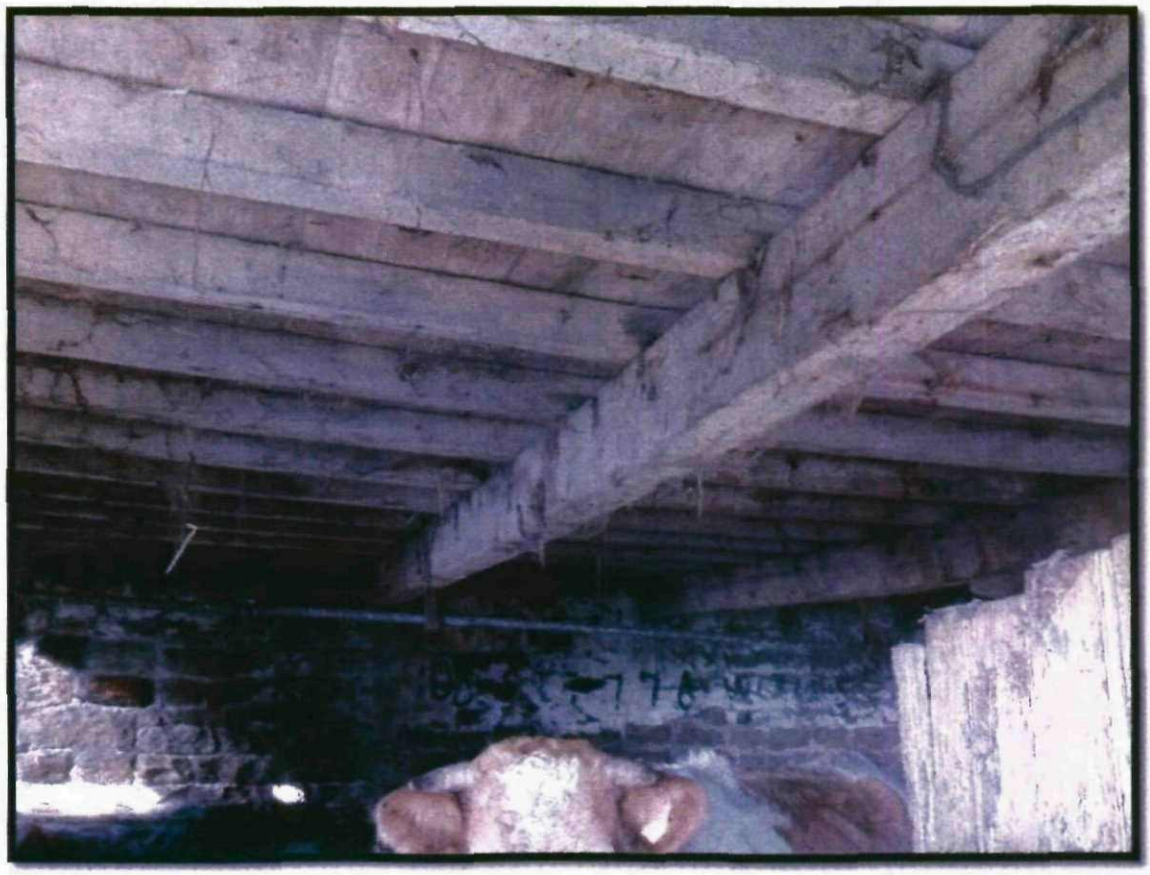
2.1.8.2.5 The first floor construction comprises of timber beams at third points that spanning on to the East and West elevations. Joists span between the beams and walls and support timber floorboards. In the adjacent section the timber joists span between supporting walls. The main beams are exhibiting large deflections and are showing signs of insect infestation. A specialist report on their condition is recommended. At the time of the survey the first floor level was used to store hay and the condition of the floor could not be fully assessed. **(Photograph 18)**

Photograph 18 – View of underside of first floor (South Section)

2.3.7 The existing timber first floors in the North and South sections are in reasonable condition. However, they are exhibiting excessive permanent deflections and should be replaced. In addition the headroom is very low and may not comply with building regulations.

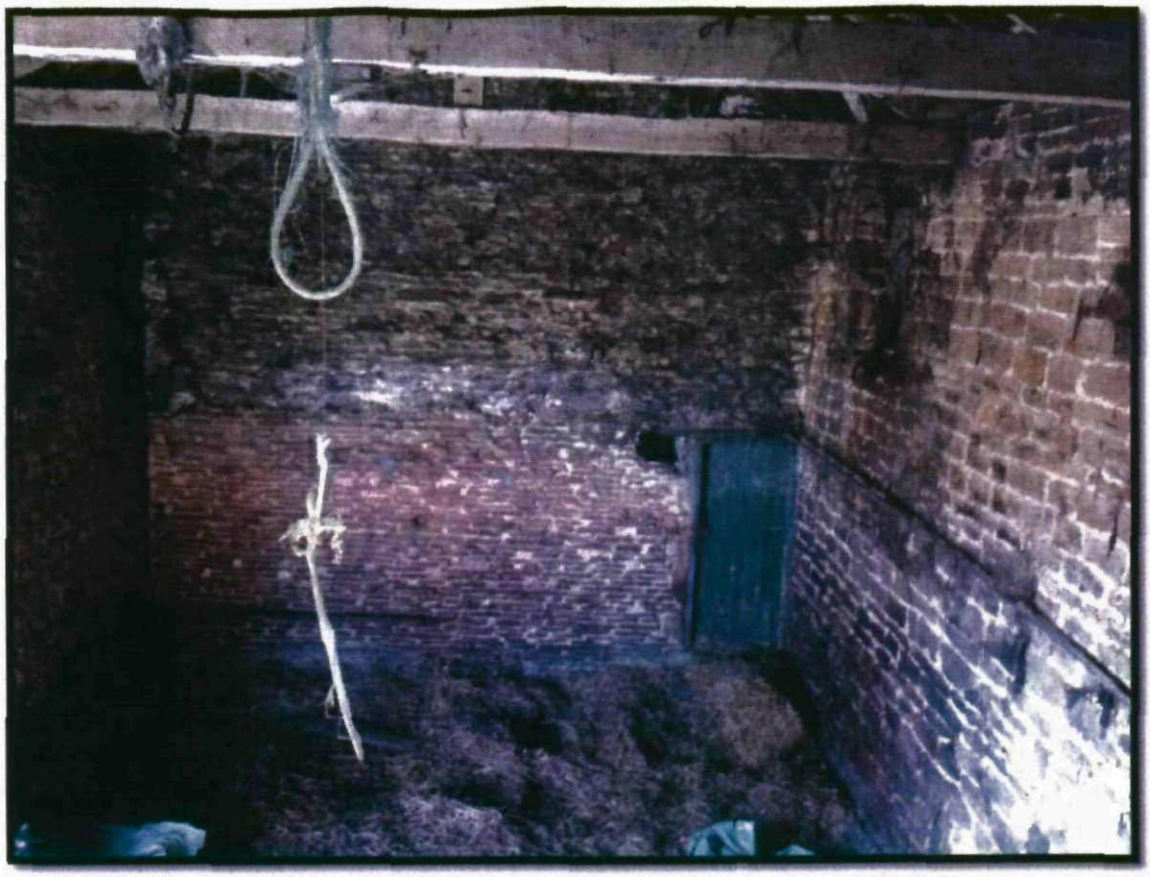
2.1.8.2.7 The roof comprises of a central king post truss spanning on to the East and West elevations. Purlins at third points span between the truss and masonry walls which support timber rafters. In the adjacent section purlins at third points span onto internal masonry walls and support timber rafters. All the timbers appear in good condition with no signs of rot or insect infestation. **(Photograph 19 & 20)**

Photograph 20 – First floor level showing roof (South Section)

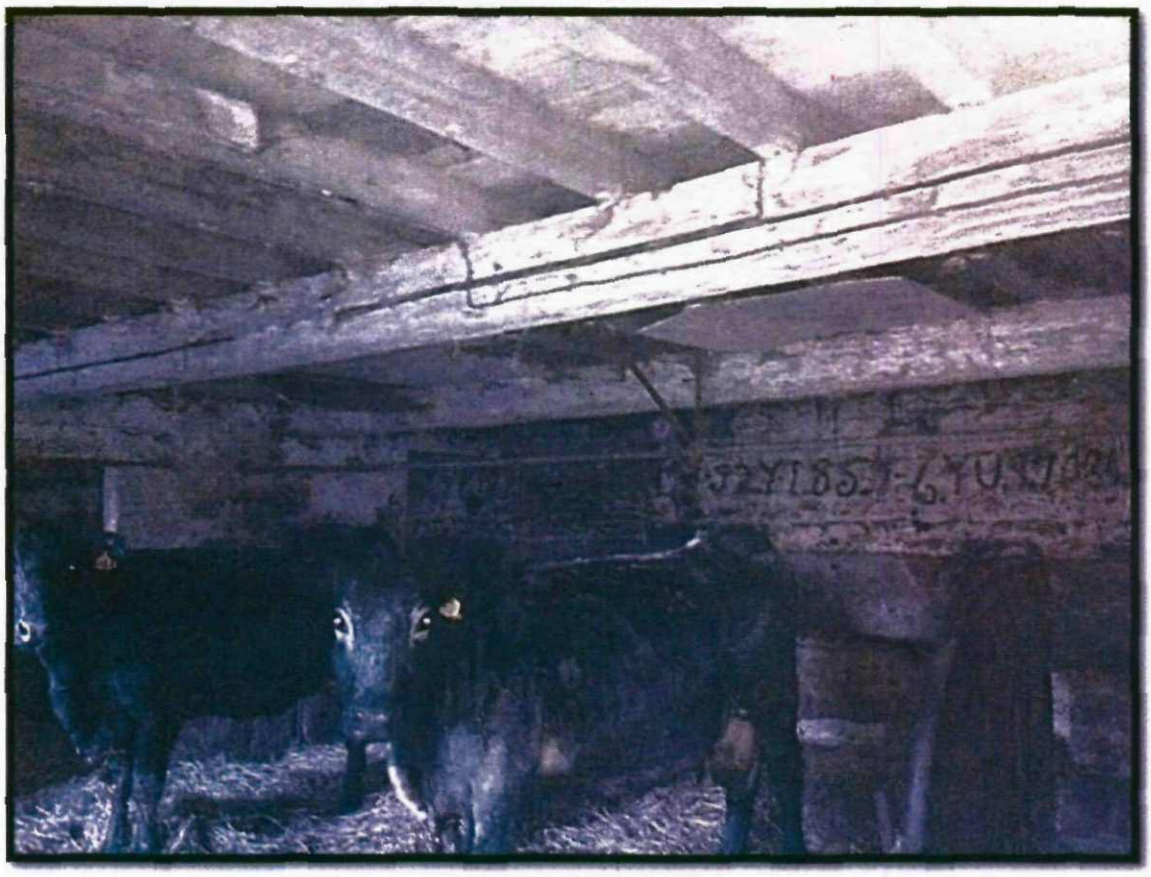
2.1.8.4.3. Where visible the inner leaves of the external walls and inner dividing walls were constructed in random coursed stone masonry that was in good structural condition. **(Photograph 25)**

Photograph 25 – View of First floor level (North Section)

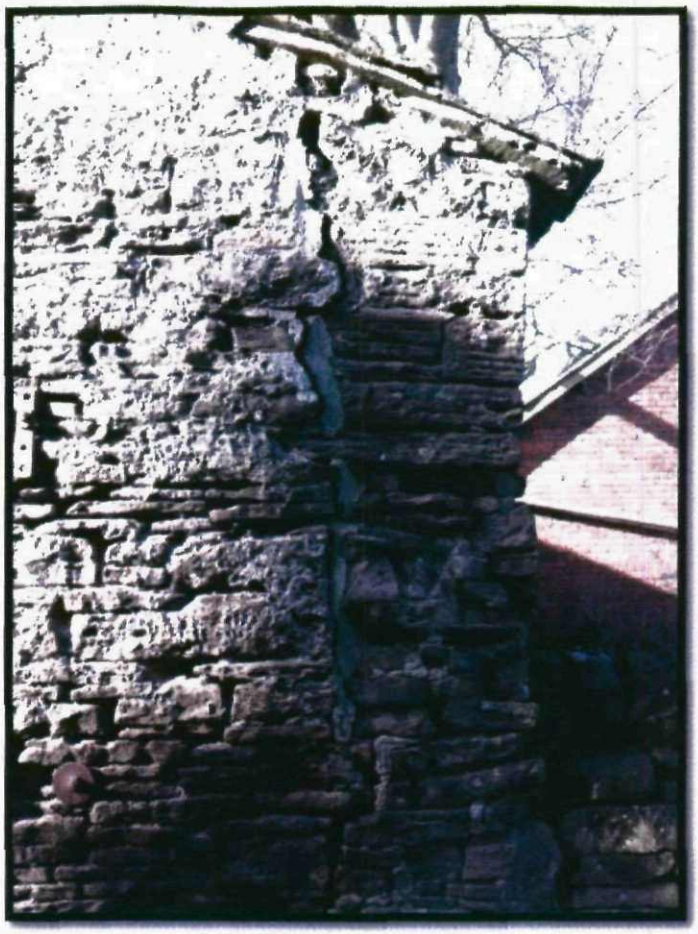
3.1.2.3 Immediately to the left of the vertical crack the wall has bulged outwards approximately 75mm centrally on the wall. **(Photograph 30)**

Photograph 29 – View of East Elevation showing bulging of wall#

3.3.2 Where vertical cracking has occurred at the North East corner this should be either locally taken down and rebuilt or stitched together. The bulging also noted should be repaired.

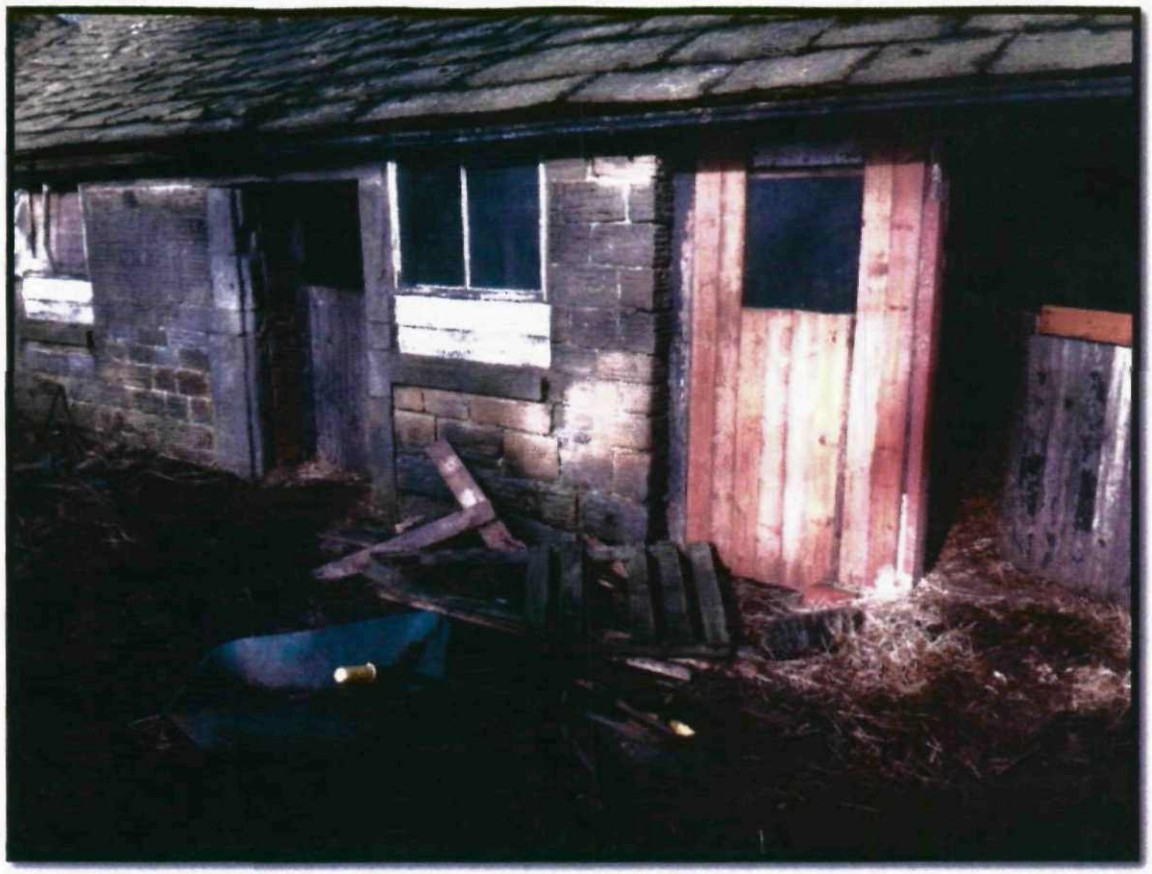
3.1.4.1 The South elevation constructed in coursed and dressed stone and is approximately 500mm thick. The stonework is in good condition with no weathering or erosion of the stone face. **(Photograph 31)**

Photograph 31 – View of South Elevation

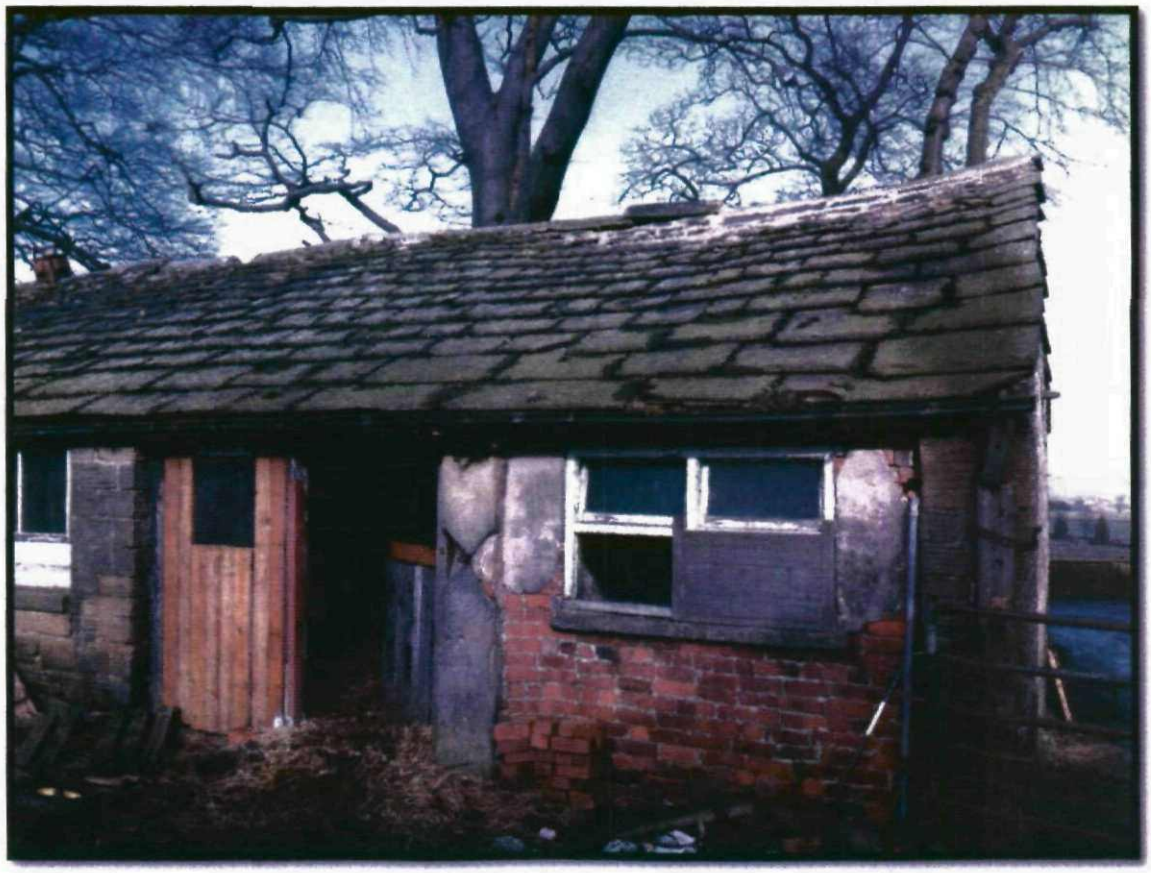
3.1.4.5 The doors have vertical stone reveals which are generally in good condition. To the left of the red brick infill panel there is a stone reveal that has cracked in an X pattern approximately two third up from ground level. At the location of this crack the reveal has lost much of its cross section. It was noted from the internal inspection that this reveal supported the bearing of one of the king post trusses. **(Photograph 33)**

3.2.5 One of the vertical stone reveals has suffered major damage. The reveal in question supports the bearing of one of the main roof trusses

Photograph 33 – South Elevation showing cracked and damaged stone column

3.3.4 Repairs to the badly damaged stone reveal supporting the truss bearing should either be repaired or replaced

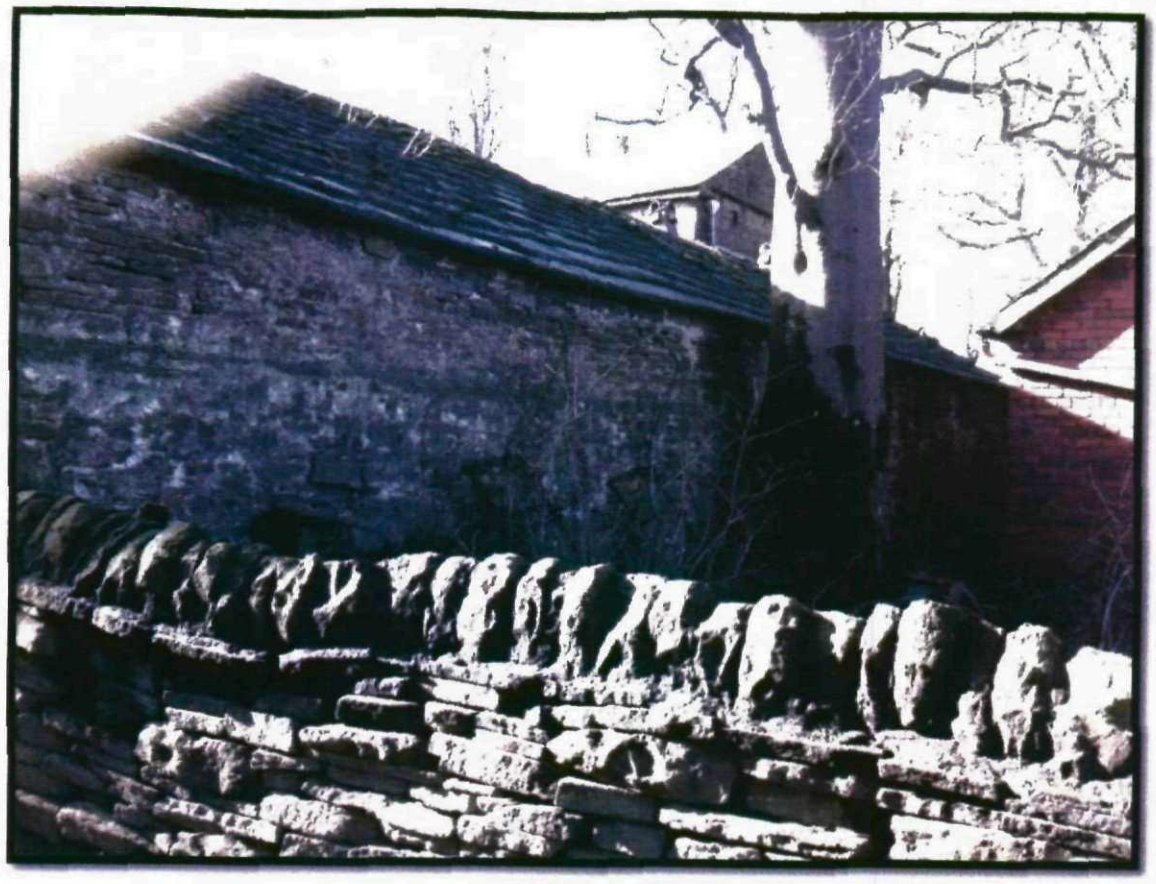
3.1.5.1 The North elevation is constructed in random coursed stone masonry. The masonry is generally in reasonable condition with no bulging or cracking observed. The wall is approximately 500mm thick **(Photograph 34 & 35)**

3.1.5.4 The gutters and rainwater downpipes to this elevation are completely missing. **(Photograph 34 & 35)**

Photograph 34 – View of North Elevation
