STRUCTURAL INSPECTION

BARN BUILDINGS

CLIFF HOUSE FARM

Reference No. **11/101**

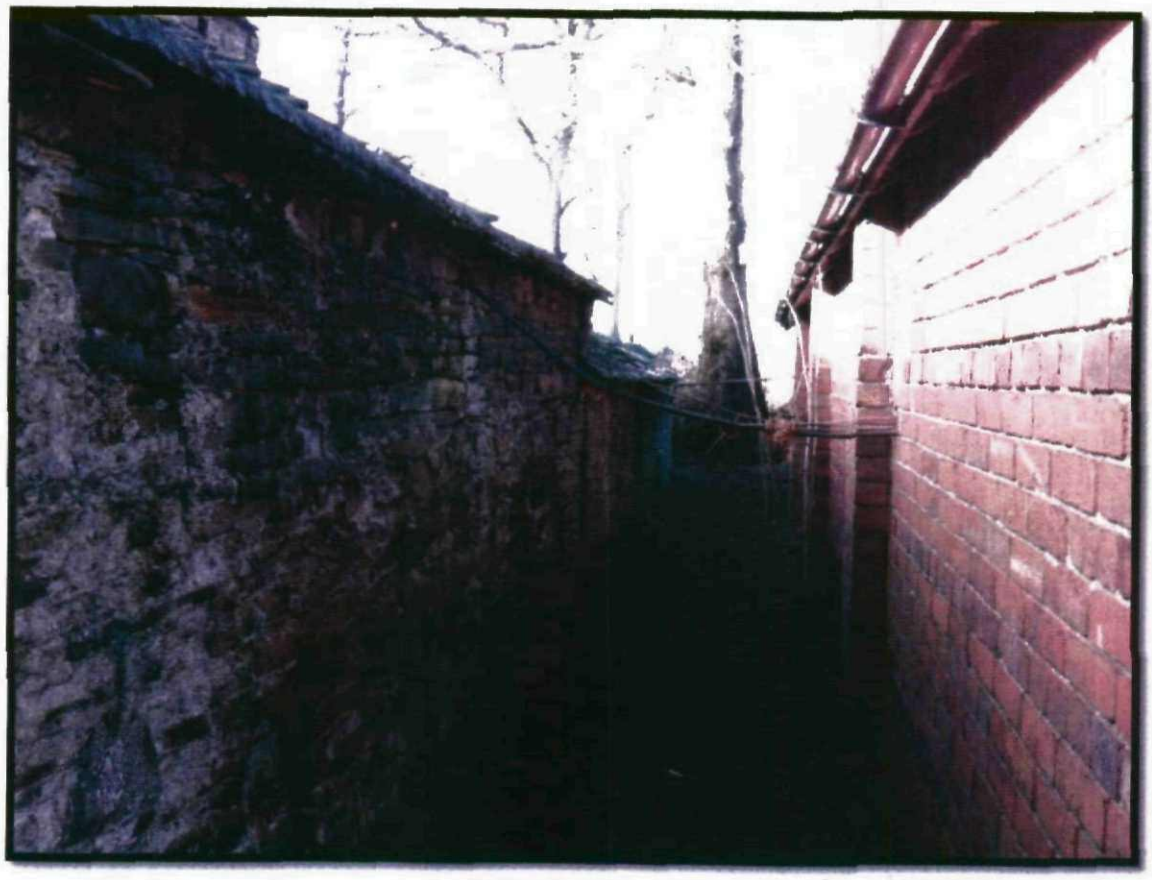
3.1.5.1 The North elevation is constructed in random coursed stone masonry. The masonry is generally in reasonable condition with no bulging or cracking observed. The wall is approximately 500mm thick **(Photograph 34 & 35)**

3.1.5.4 The gutters and rainwater downpipes to this elevation are completely missing. **(Photograph 34 & 35)**

Photograph 35 – View of North Elevation
